DATE: OCTOBER 2011 SCALE: 1" = 100'

Northern Virginia Stream Restoration Bank
The Glade - Reach 6 Storm Repair
Fairfax County, Virginia

Design Narrative & Overall Site Exhibit

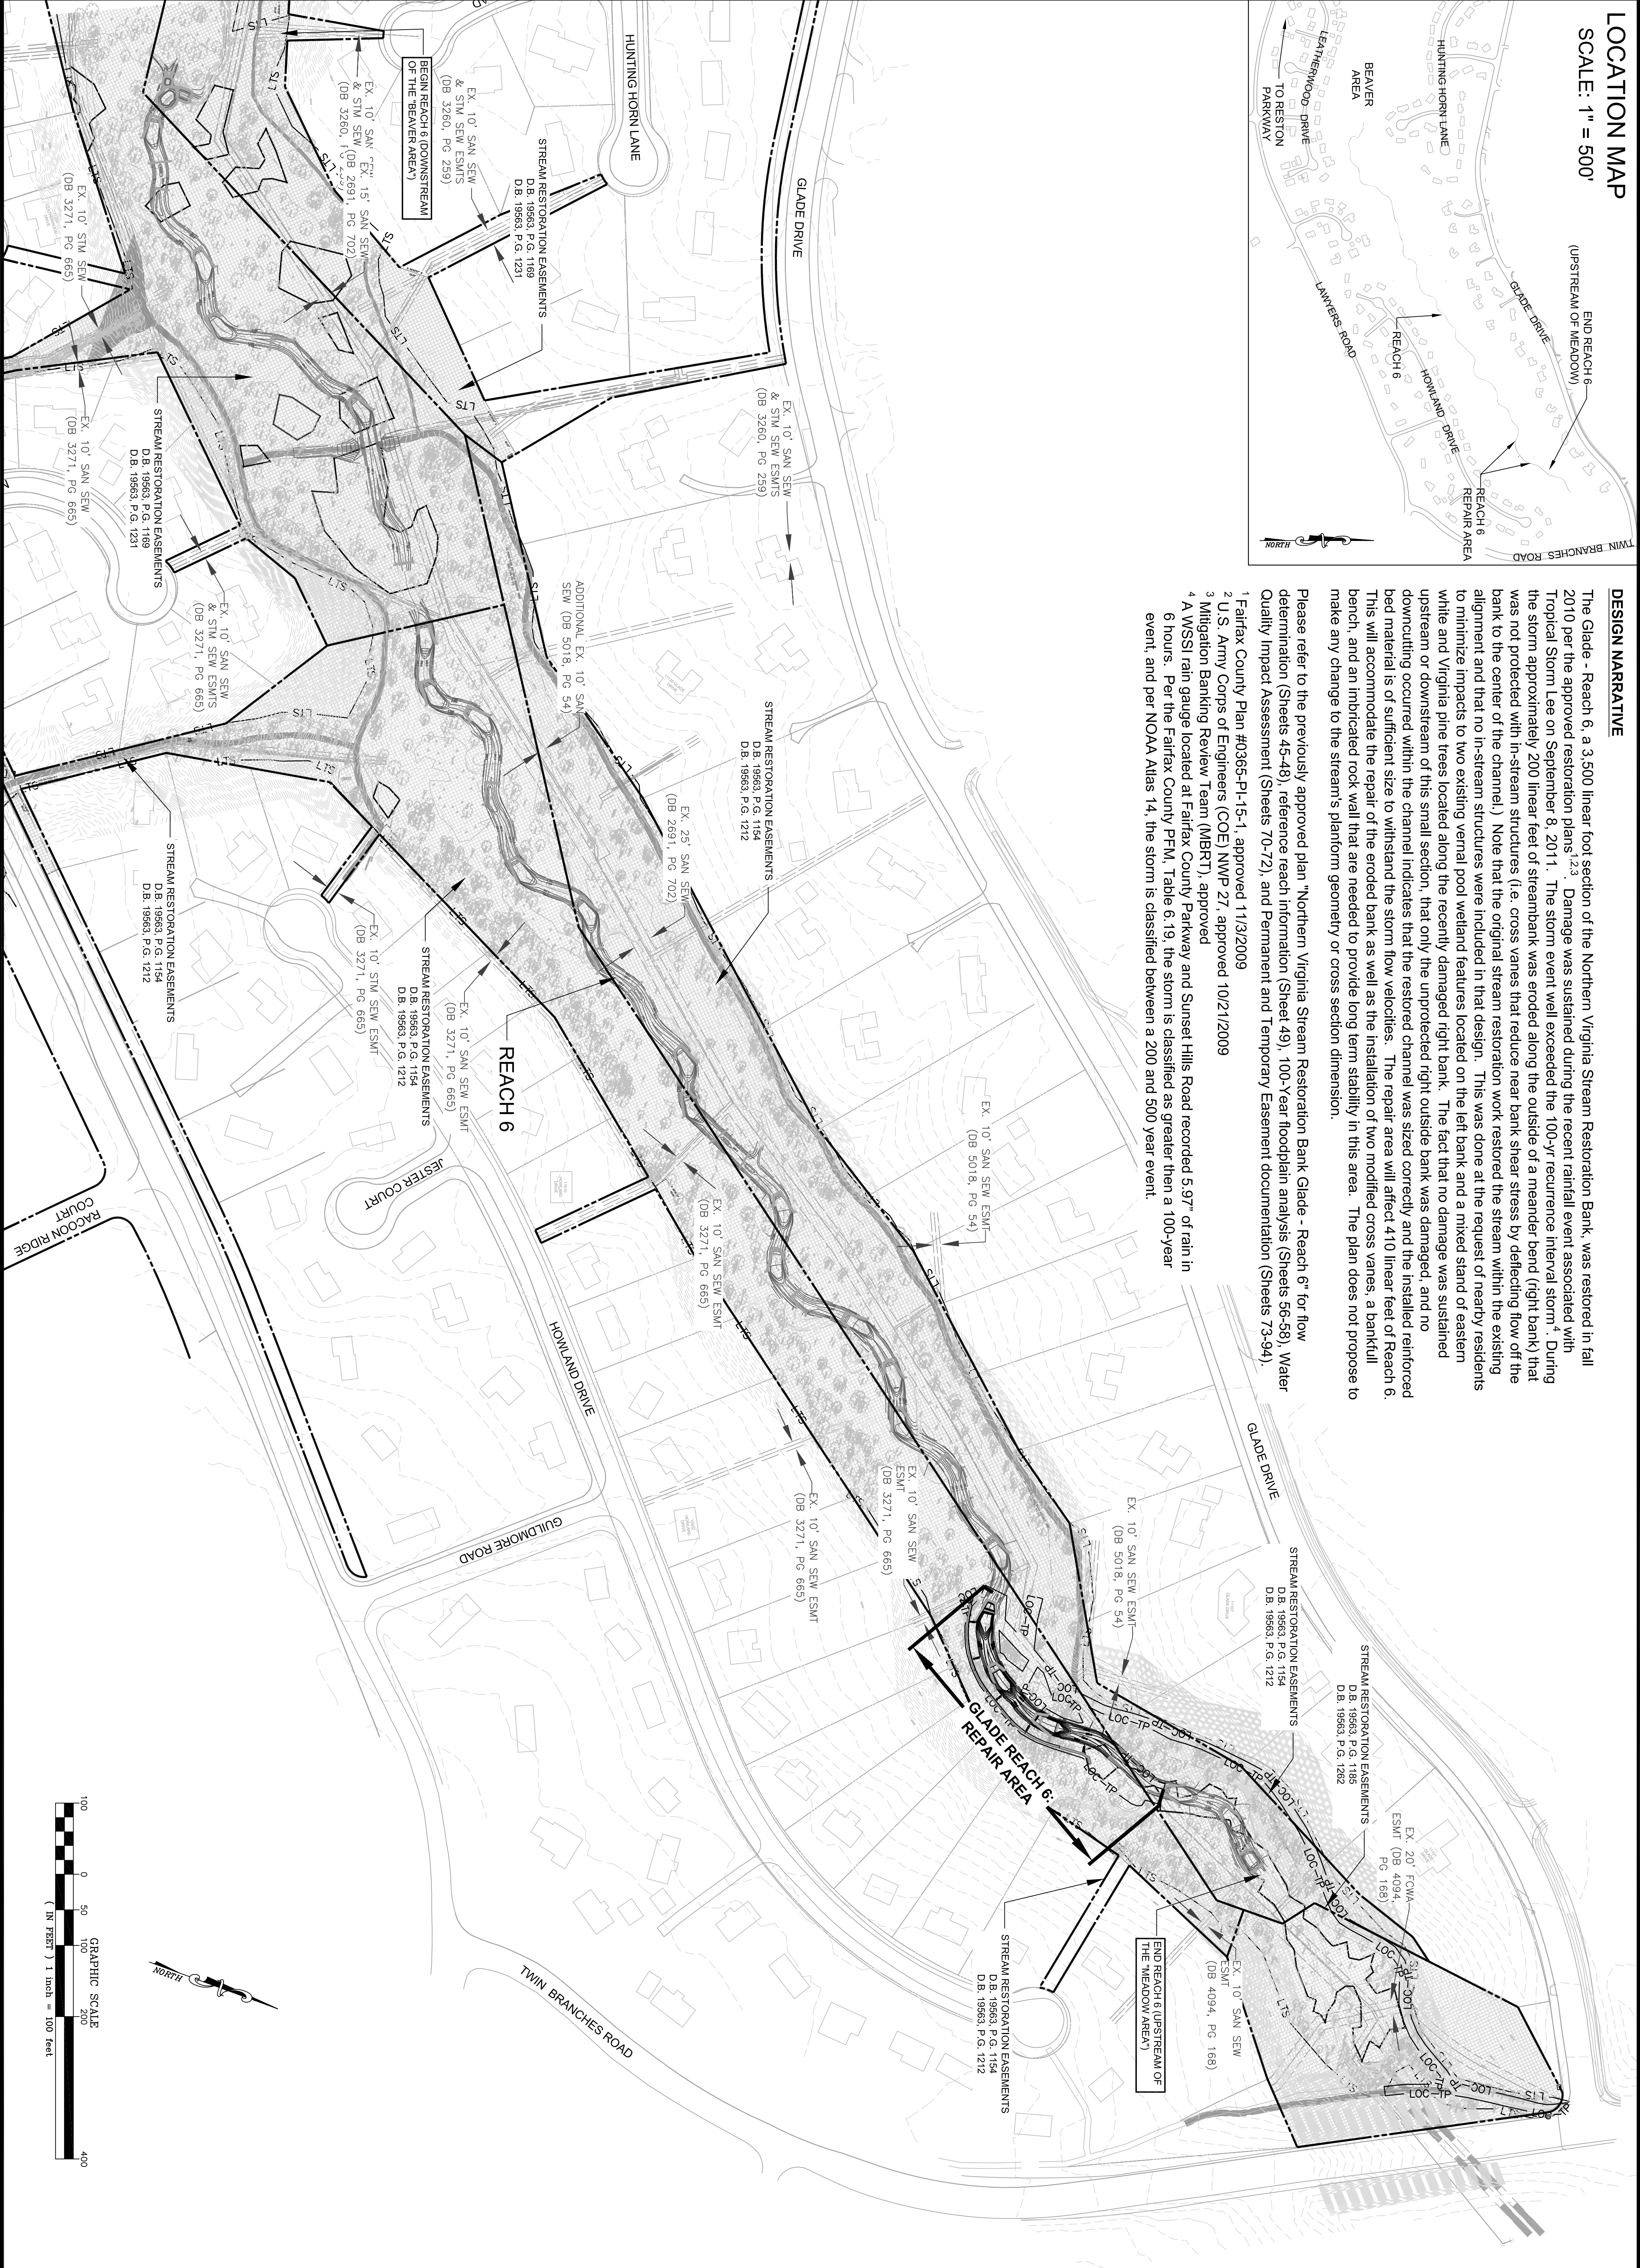
The Glade - Reach 6, a 3,500 linear foot section of the Northern Virginia Stream Restoration Bank, was restored in fall 2010 per the approved restoration plans.^{2,3} Damage was sustained during the recent rainfall event associated with Tropical Storm Lee on September 8, 2011. The storm event well exceeded the 100-yr recurrence interval storm.⁴ During the storm approximately 200 linear feet of streambank was eroded along the outside of a meander bend (right bank) that was not protected with in-stream structures (i.e. cross vanes that reduce near bank shear stress by deflecting flow off the bank to the center of the channel). Note that the original stream restoration work restored the stream within the existing alignment and that no in-stream structures were included in that design. This was done at the request of nearby residents to minimize impacts to two existing vernal pool wetland features located on the left bank and a mixed stand of eastern white and Virginia pine trees located along the recently damaged right bank. The fact that no damage was sustained upstream or downstream of this small section, that only the unprotected right outside bank was damaged, and no downcutting occurred within the channel indicates that the restored channel was sized correctly and the installed reinforced bed material is of sufficient size to withstand the storm flow velocities. The repair area will affect 410 linear feet of Reach 6. This will accommodate the repair of the eroded bank as well as the installation of two modified cross vanes, a bankfill bench, and an imbricated rock wall that are needed to provide long term stability in this area. The plan does not propose to make any change to the stream's planform geometry or cross section dimension.
