NORTHERN VIRGINIA STREAM RESTORATION BANK  
SNAKEDEN BRANCH WATERSHED

MITIGATION MONITORING REPORT

FIRST MONITORING SEASON (2009)

November 17, 2009

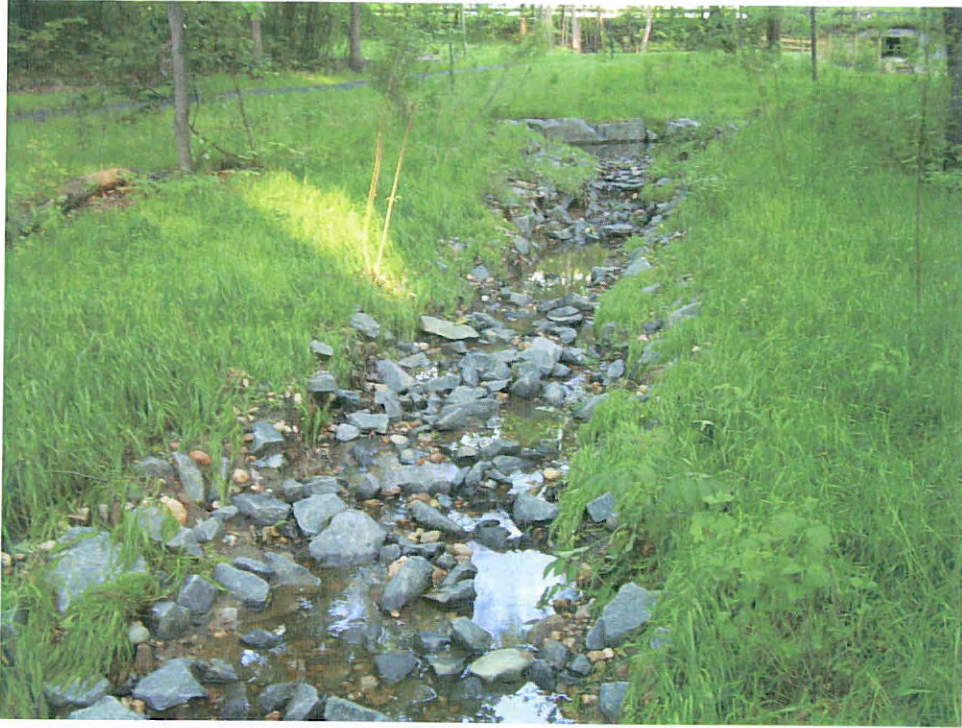
The affected area was in a riffle in Reach 1 (see attached sketch) where the reinforced bed material had been improperly installed, enabling a small head-cut to develop. When this section of the reach was being constructed, there was a field change performed to lower the channel (to correct for some errors in the aerial topography). In the process, the proper amount of reinforced bed material had not been replaced, leaving this section vulnerable. This had been noted in previous inspections conducted after other rain events (events that resulted in bankfull conditions, but did not meet the 2-yr storm criteria). The decision was made to replace the proper amount of reinforced bed material, which was completed on May 16<sup>th</sup>. Photos of both the pre and post remediation conditions are attached.

Photo 1 – Looking upstream at affected riffle prior to repair. Small head-cut is visible toward the top of the riffle.

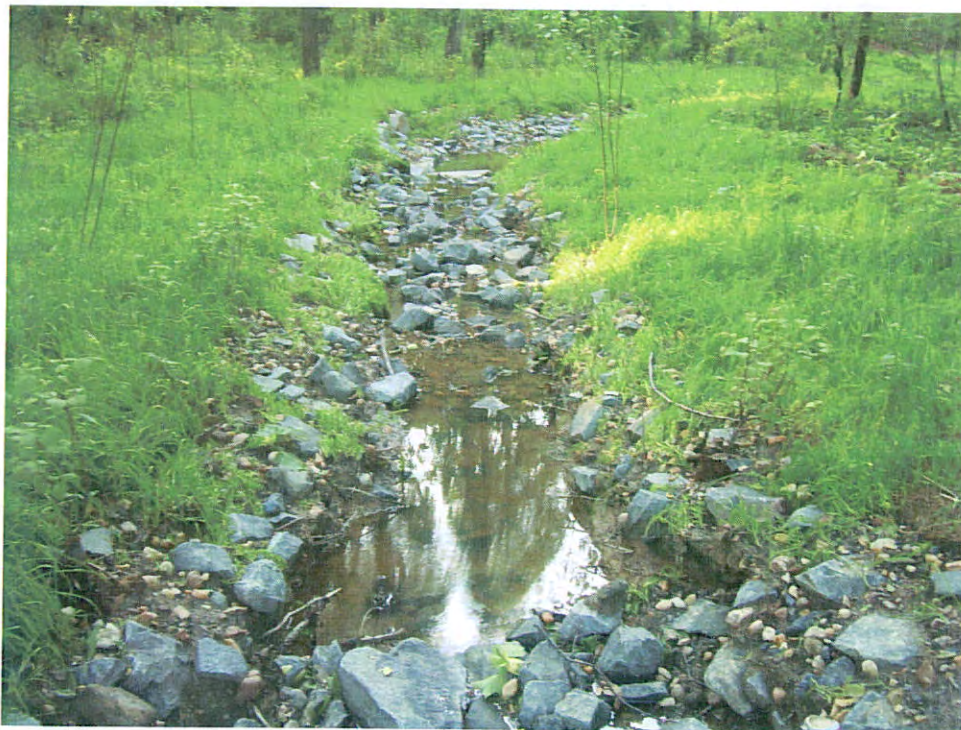
Photo 2 – Looking downstream at affected riffle prior to repair, just above small head-cut.

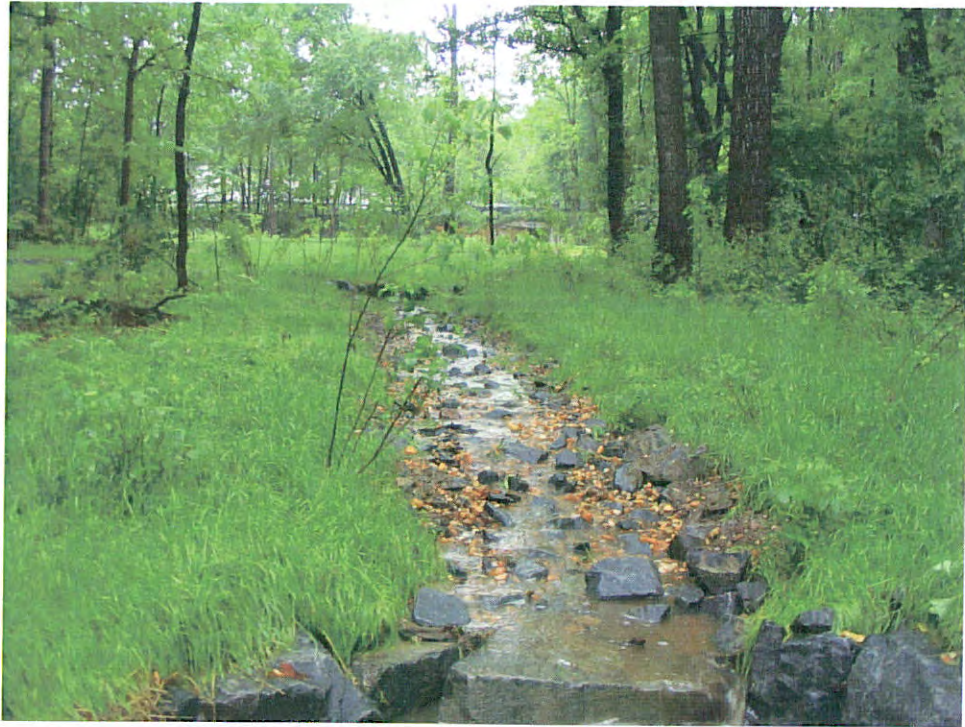
Photo 3 – Looking upstream at affected riffle after repair and additional rain event of approximately 0.75". Bed remained stable.

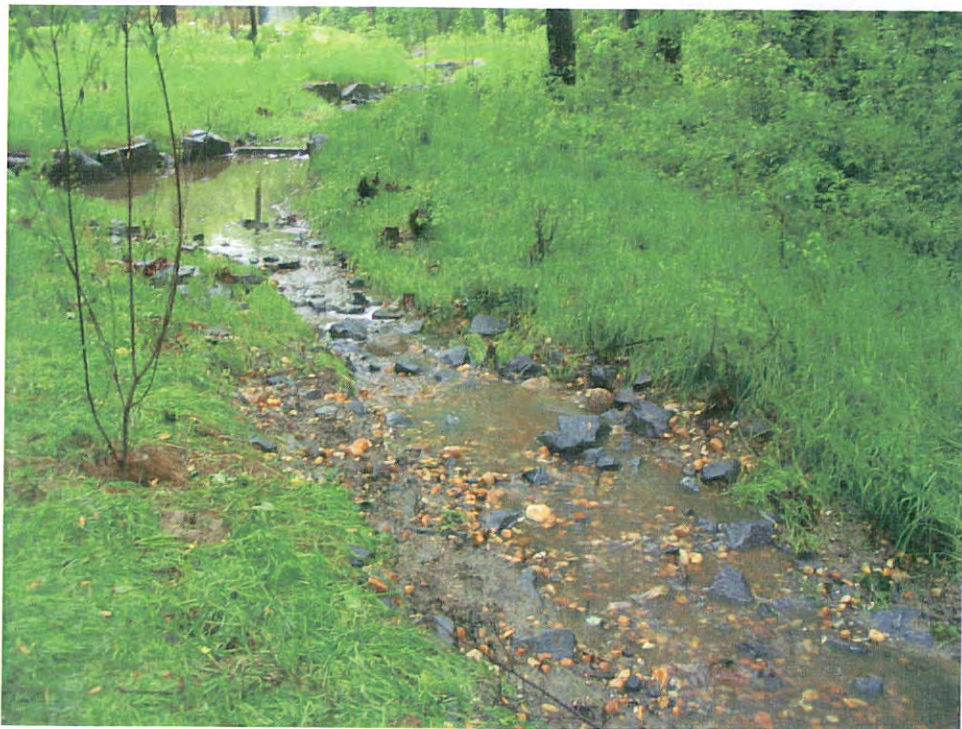
Photo 4 – Looking upstream at previous head-cut after repair and additional rain event of approximately 0.75". Bed remained stable.

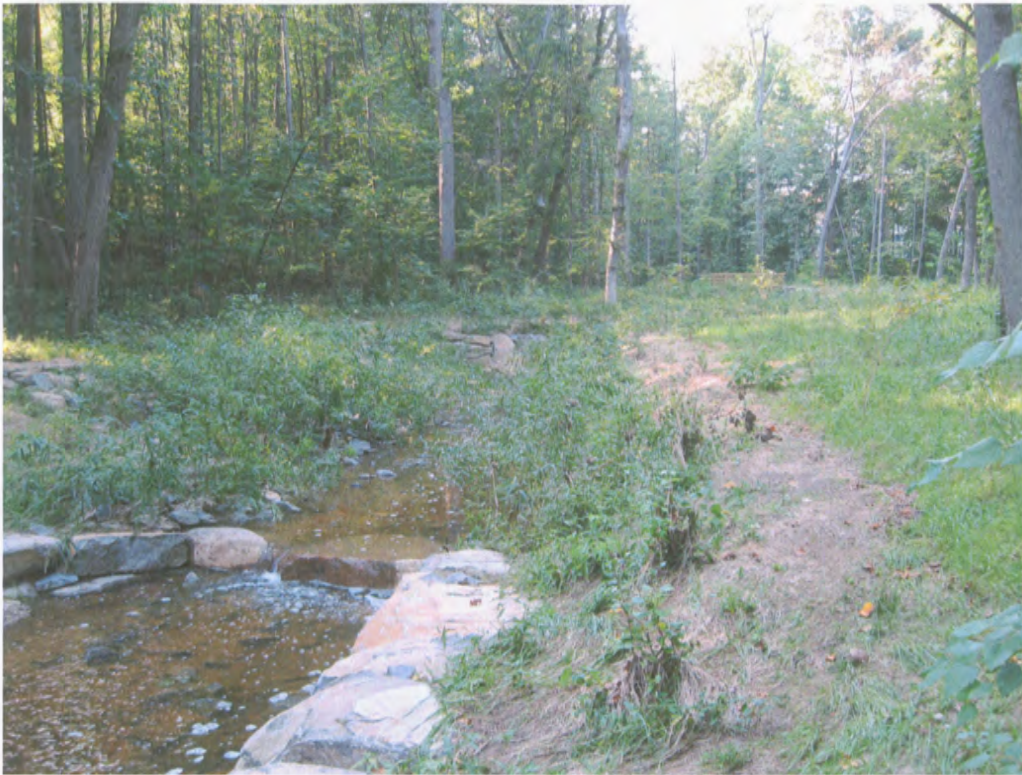
Photo 5 – Reach 3. High Water mark is evident.

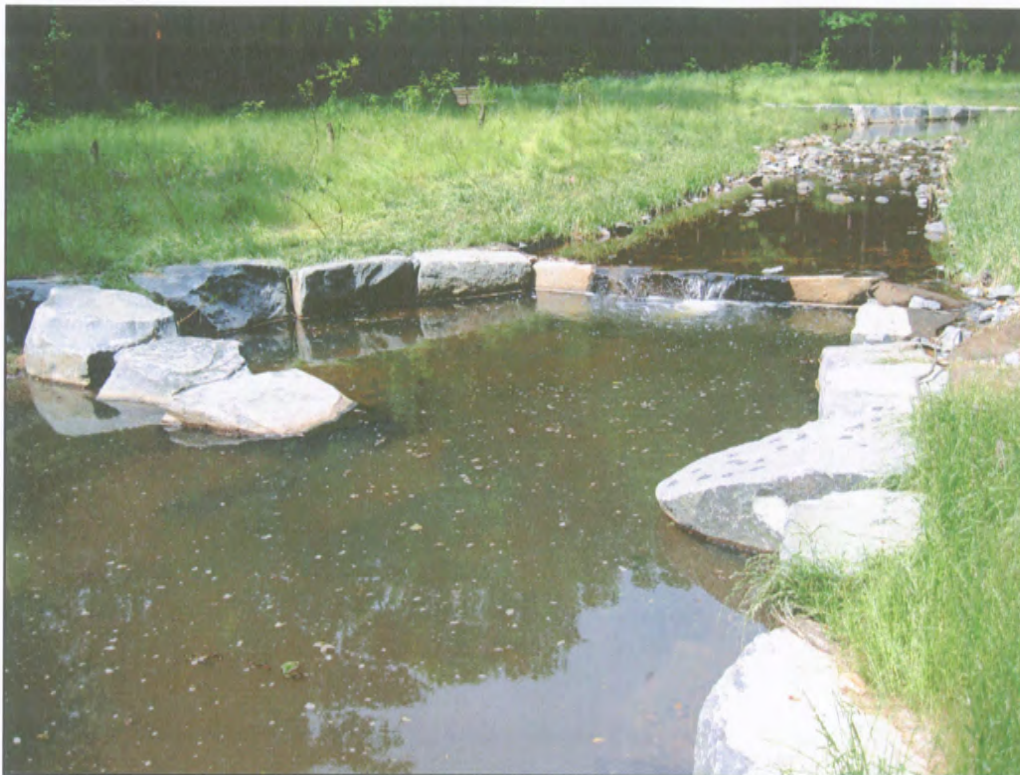
Photo 1 – Rocks displaced in the second step.

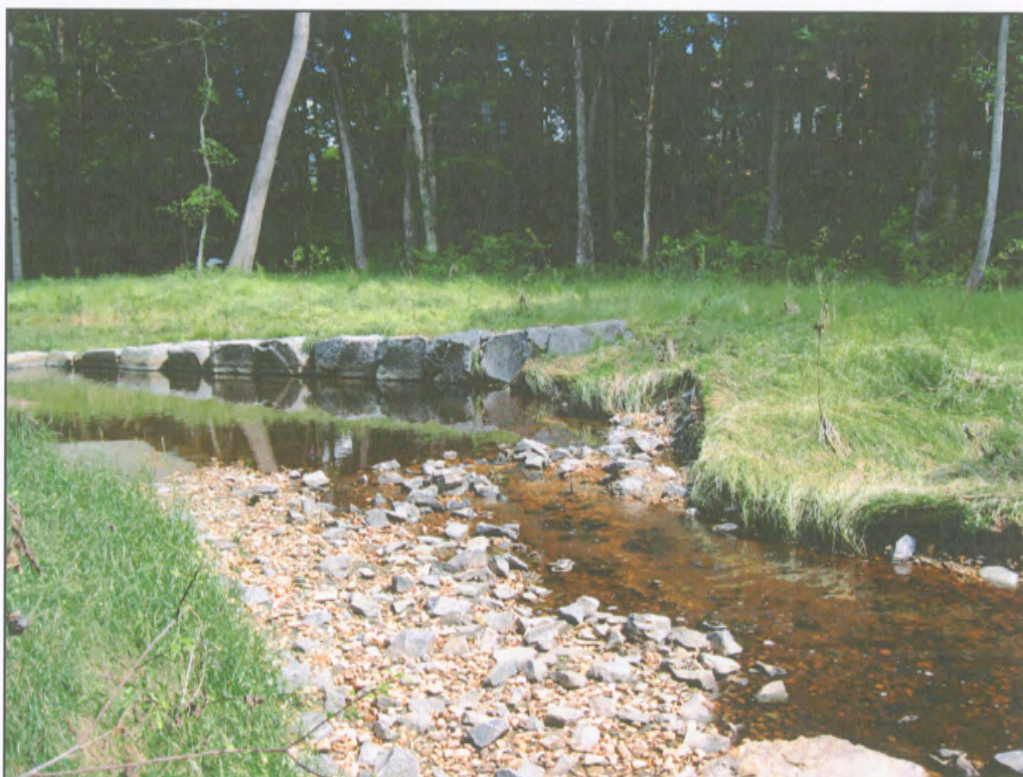
- **Third rock structure up from Lake Audubon in Reach 17 (XS 17-04)** – As shown in photo #2, there has been some bank erosion just below the structure. It appears as though the original was such that it constricted the channel in this area, resulting in the erosion. The repair will consist of grading back the bank to increase the channel capacity, along with placement of facines and brush mattresses to provide additional stabilization.

Photo 2 – Erosion along left bank below structure, likely due to improper grading.

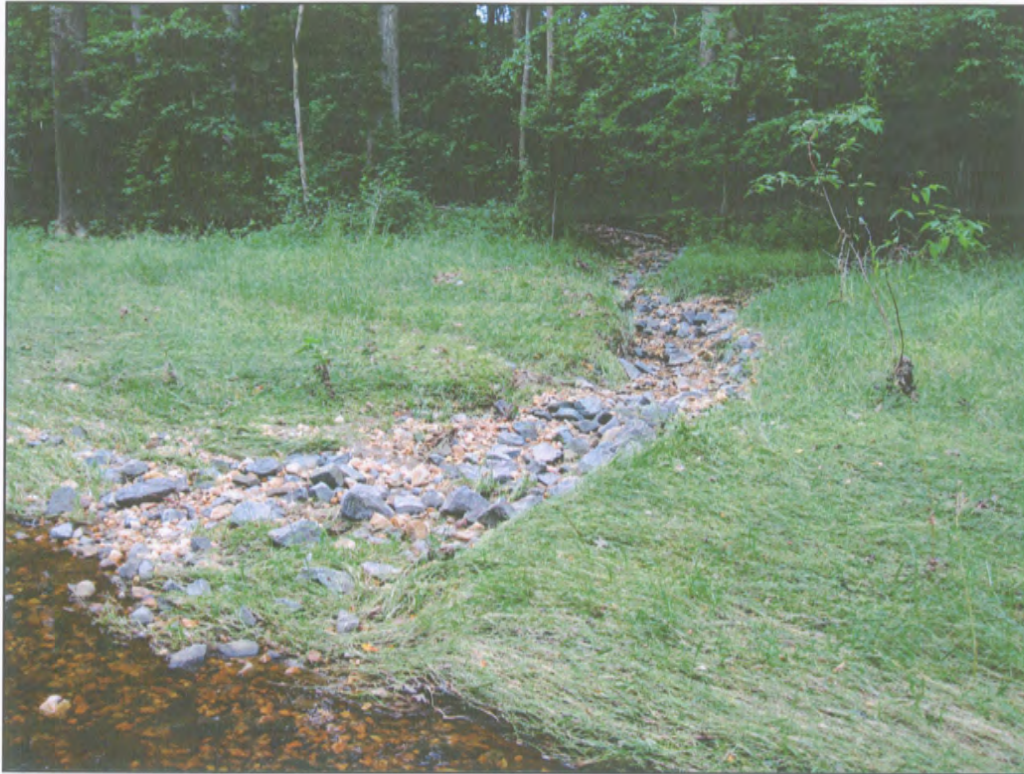
Photo 3 – Small tributary to Reach 9 requiring additional stabilization.
