Northern Virginia Stream Restoration Bank Annual Status Report

December 15, 2011

Wetland Studies and Solutions, Inc.
5300 Wellington Branch Drive · Suite 100 · Gainesville · Virginia 20155
www.wetlandstudies.com

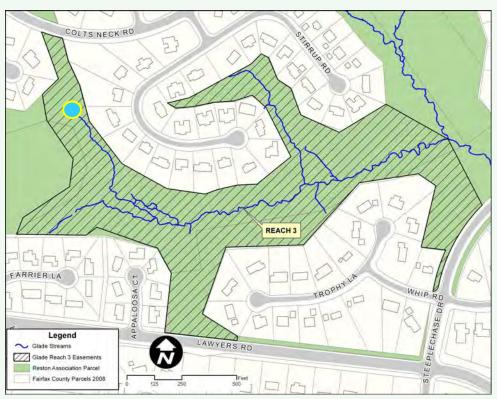
The Glade – Reach 3 Channel Re-grade

• Deposition of material that washed out from upstream culvert system.

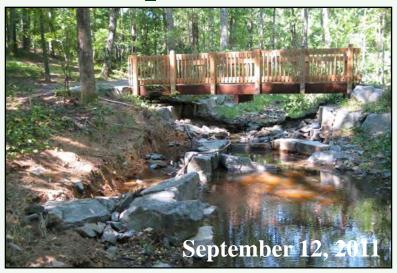
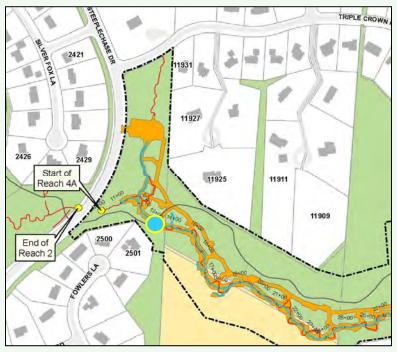
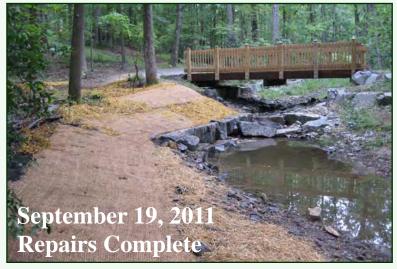
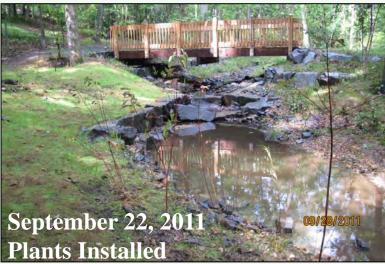
The Glade – Reach 4A 2-Step Cross Vane

- One rock slipped (only structure that had a problem).
- Placed rock behind vane arm.
- Re-graded and replanted area.

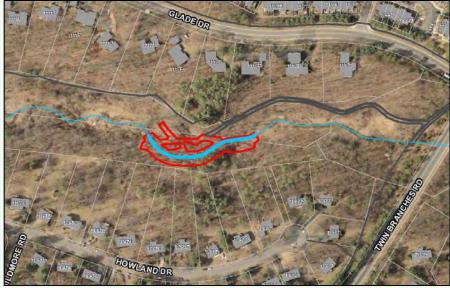
The Glade – Reach 6 (cont'd)

- Damage sustained in The Glade Reach 6
 - Approx. 200' of outside meander bend eroded (right bank)
 - Loss of vegetation on eroded bank
 - Reinforced bed deposited along right bank downstream of erosion
- Why the damage here?
 - Per citizen request, meander was not shifted toward the left bank, and the right bank was previously not protected by in-stream structures in an effort to protect:
 - Two (2) existing vernal pool wetland features (left bank), and
 - Mixed stand of primarily Eastern White Pine, Virginia Pine, and Red Maple trees (right bank)
 - No damage upstream or downstream of meander

- Proposed repairs (return to original design)
 - Install 2 new modified cross vanes
 - Install a 320' long, 12' wide bankfull bench with an imbricated rock wall on the right bank (allows vanes to work - increases flow conveyance capacity and reduces shear stress and velocity)
 - Repair small erosional area behind existing vane arm (at beginning of meander)
 - Tie-out grading to existing cross vane downstream of meander.
 - Plant heavily with native seed mix and tublings.

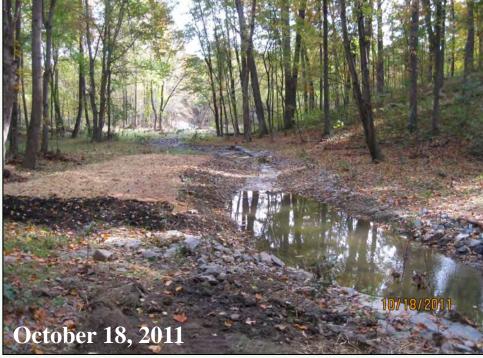
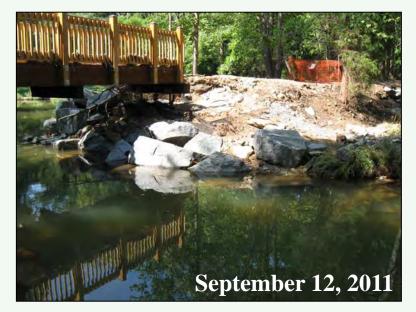
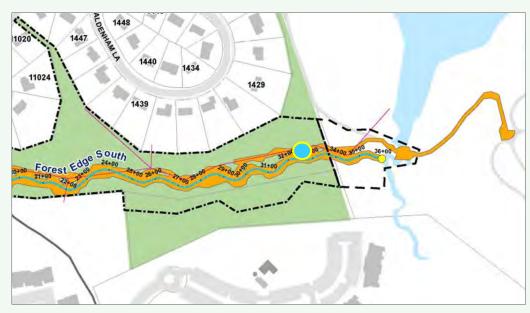
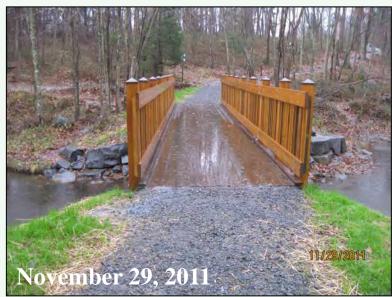
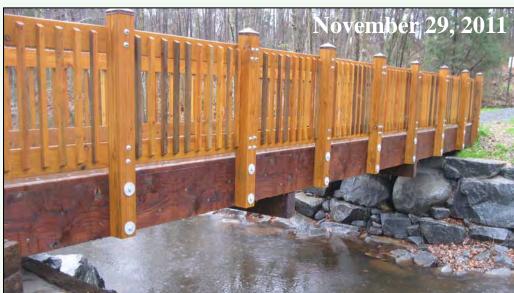
Colvin Run (Forest Edge North & South):

Crews finished minor grading and redistribution.

Final plantings scheduled for early next year.
