## WILDLIFE HABITAT FEATURE INVENTORY

NORTHERN VIRGINIA STREAM RESTORATION BANK

*THE GLADE – REACH 1 and 1A*

JANUARY 12, 2009

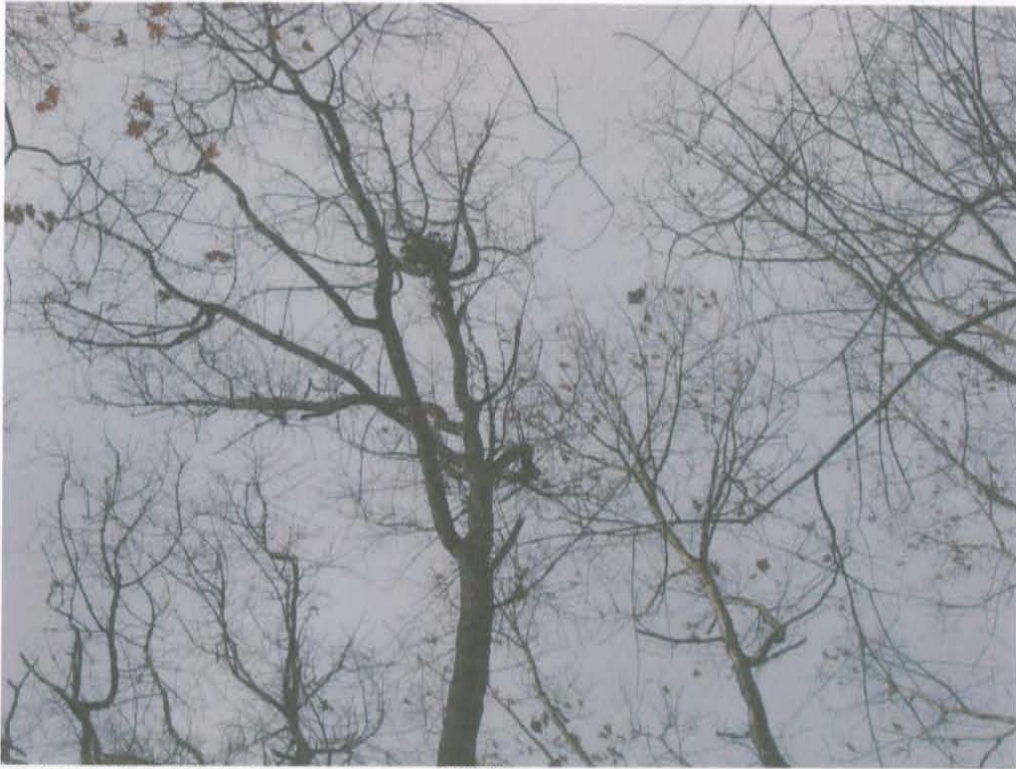
**1. Inactive unidentified stick nest in tree #10289.**

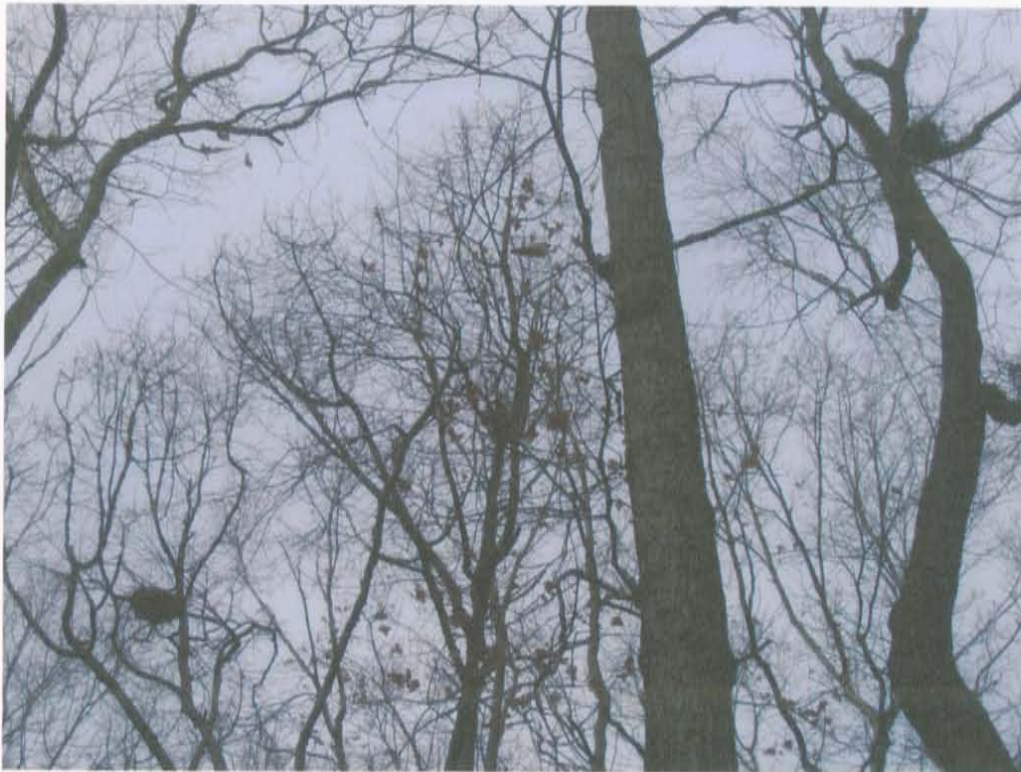
**2. Unoccupied red shouldered hawk nests in trees #10303, #10309 and #10313.**

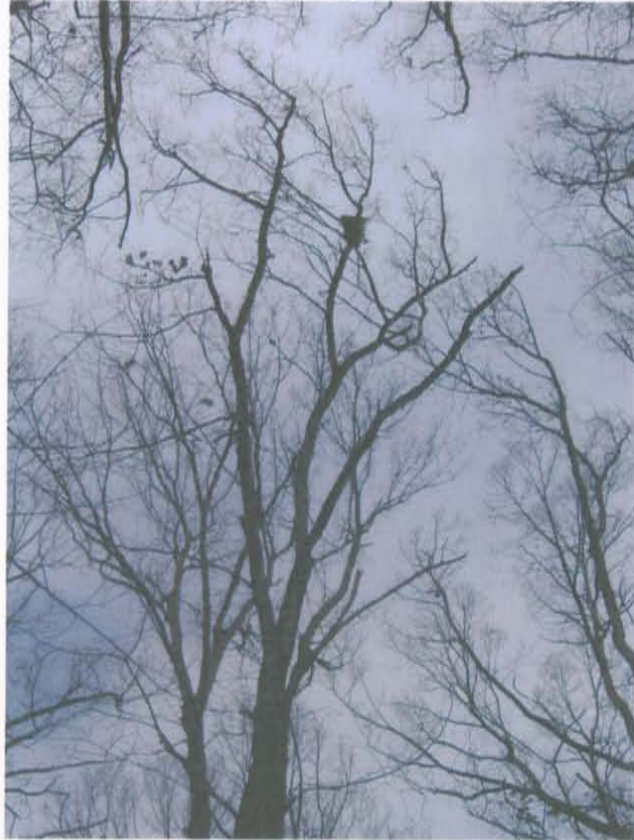
**3. Squirrel nest in tree #10248.**

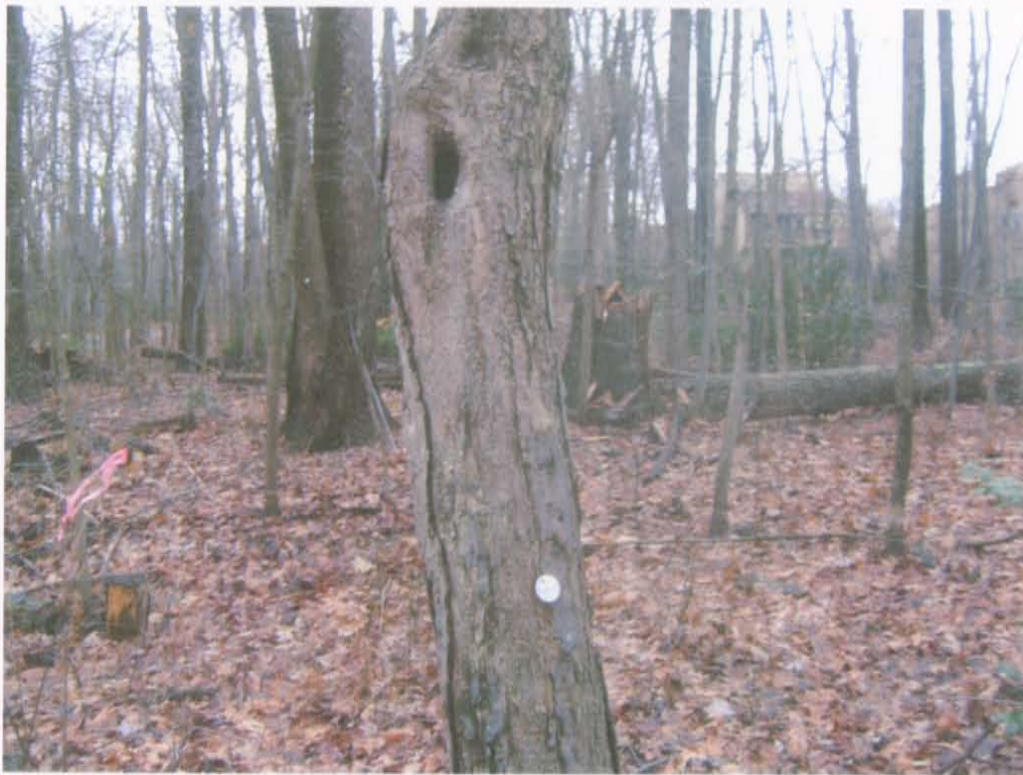
**4. Inactive unknown cavity in live tree #14039.**

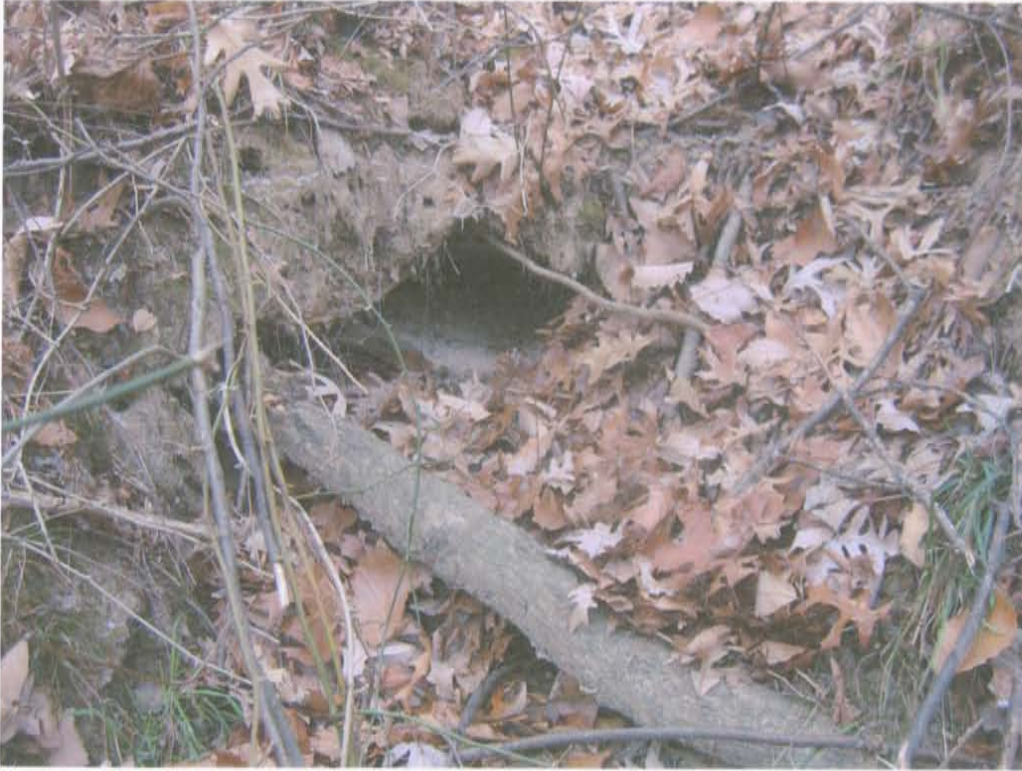
5. Active subsurface erosional feature used by fox at tree #14191.

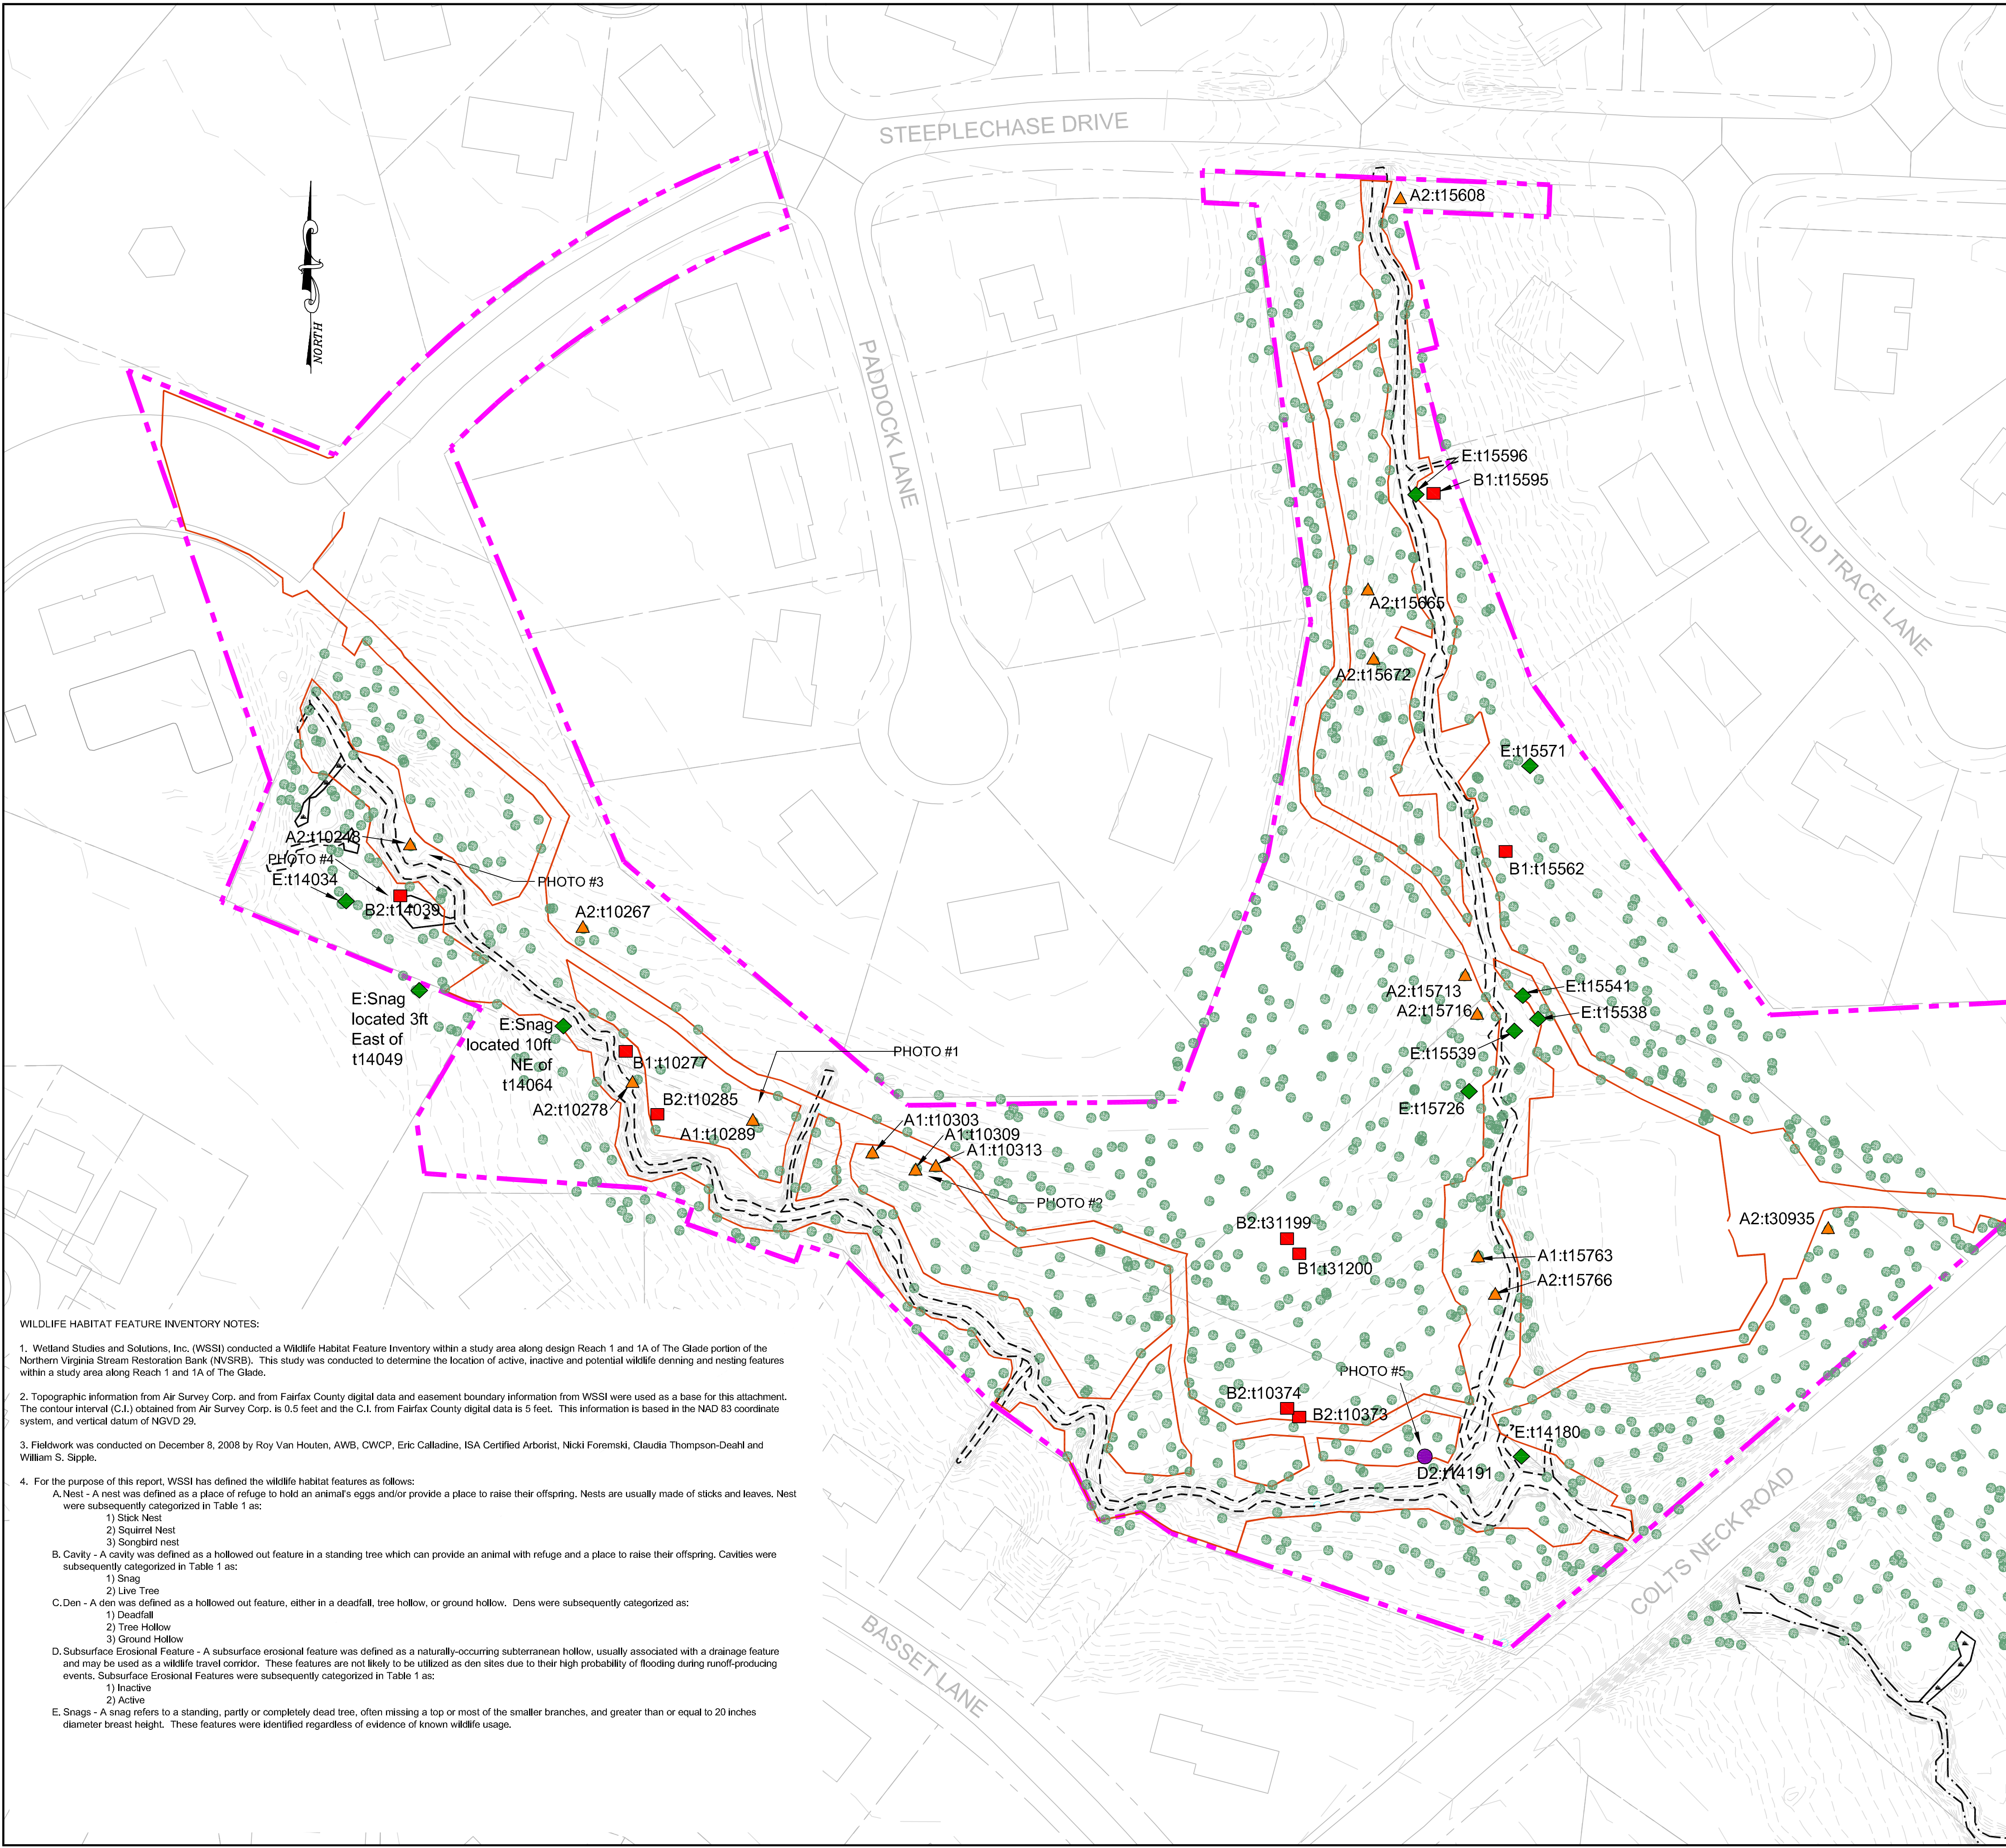
Exhibit 5:  
Wildlife Habitat Feature Location Map

Several wildlife habitat features were located in design Reach 1 and 1A of The Glade during this inventory, including stick and squirrel nests, cavities, snags, and subsurface erosional features. The location of these features is depicted on the Wildlife Habitat Feature Location Map (Exhibit 5) and is summarized in Table 1 below. The results of this inventory will be used by project engineers to further limit the stream restoration project's impact on local wildlife habitat features.
