# **WILDLIFE HABITAT FEATURE INVENTORY**

# NORTHERN VIRGINIA STREAM RESTORATION BANK THE GLADE – REACH 2 FAIRFAX COUNTY, VIRGINIA

WSSI Project #20030

JANUARY 12, 2009

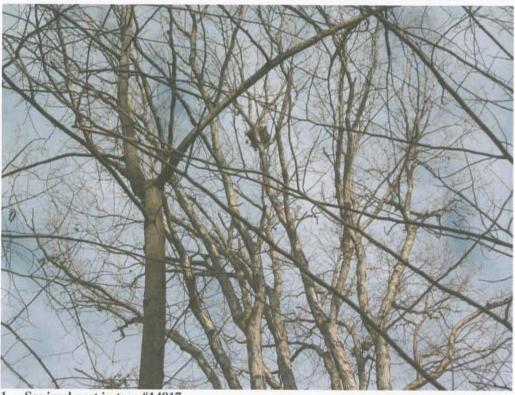
1. Squirrel nest in tree #14817.

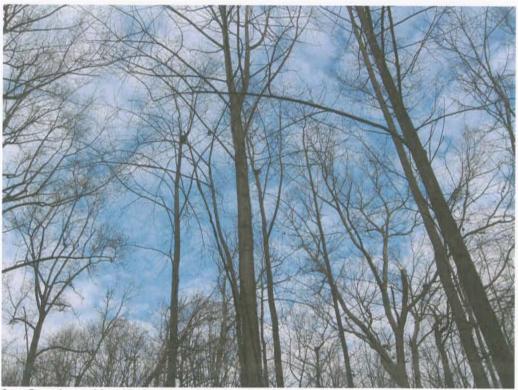
2. Inactive unidentified stick nest in tree #14591.

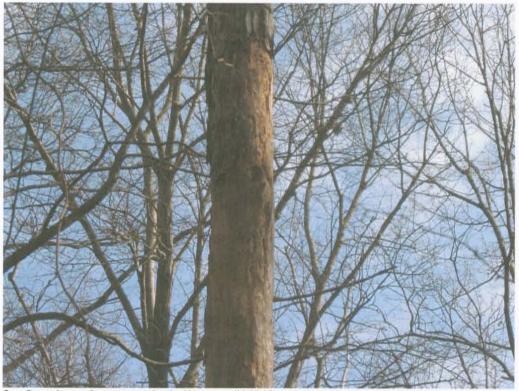
3. Inactive unknown cavity in live tree #14242.

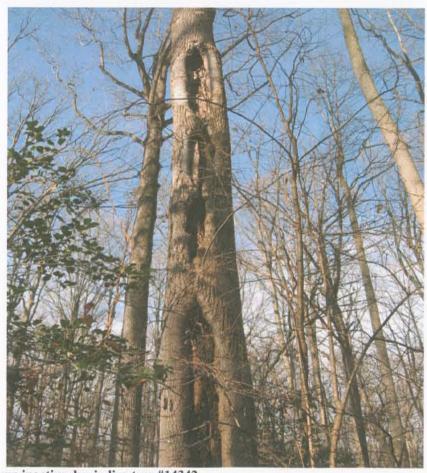
4. Unknown inactive den in live tree #14342.

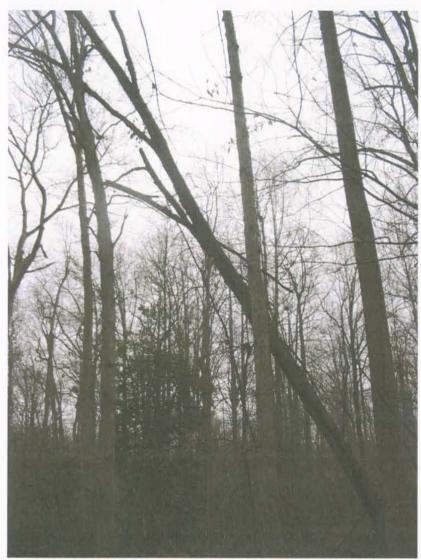
5. Standing dead snag tree #14387.
