## WILDLIFE HABITAT FEATURE INVENTORY

NORTHERN VIRGINIA STREAM RESTORATION BANK

*THE GLADE – REACH 3*

JANUARY 12, 2009

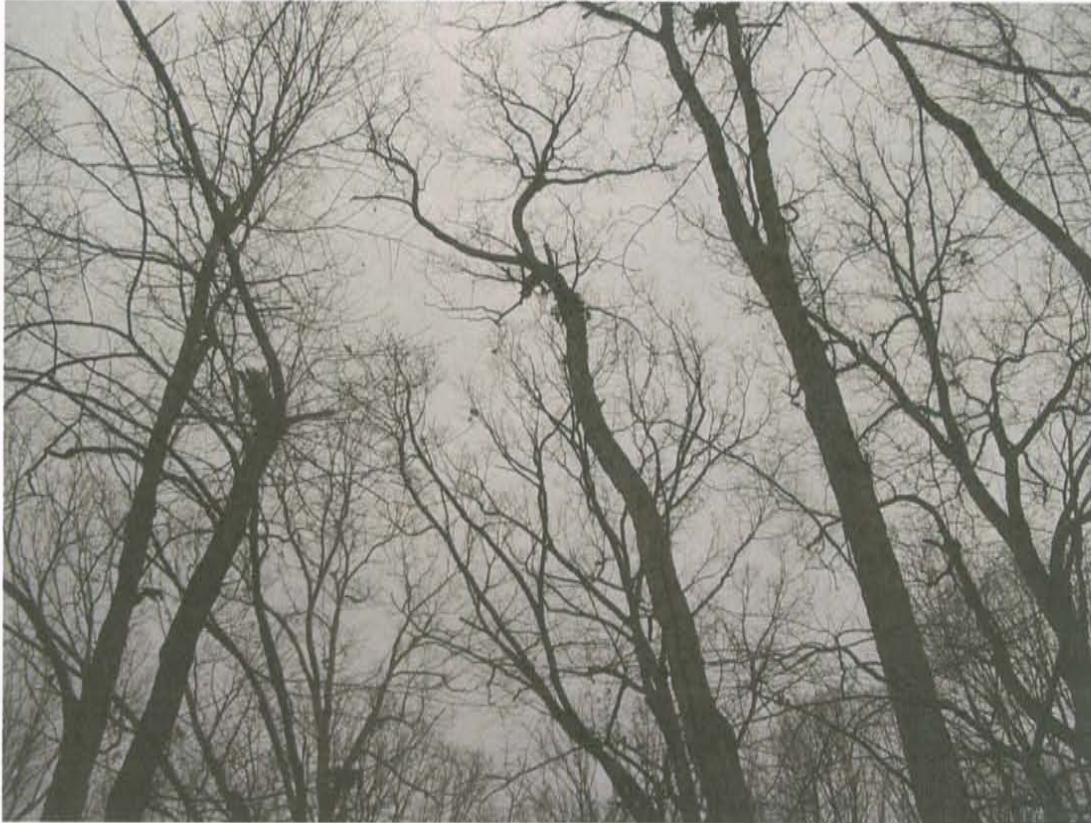
**1. Inactive unidentified stick nest in tree #14429.**

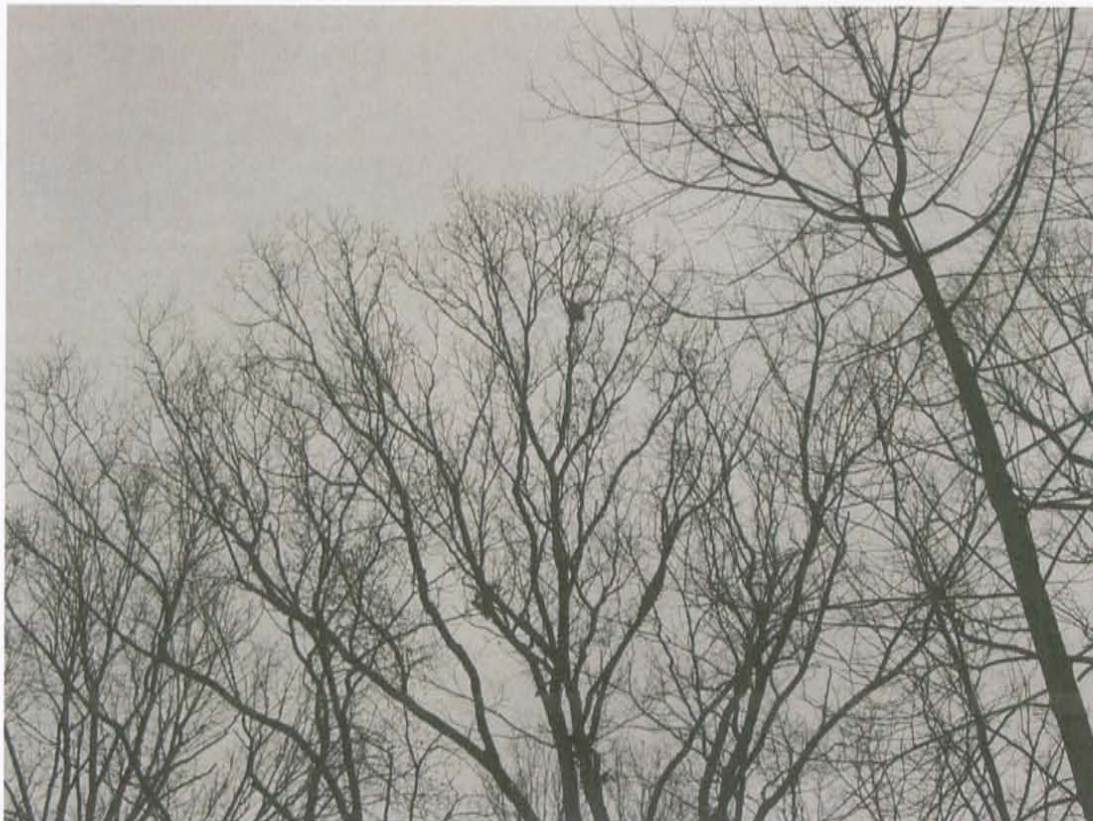
**2. Inactive squirrel nest in tree #14426.**

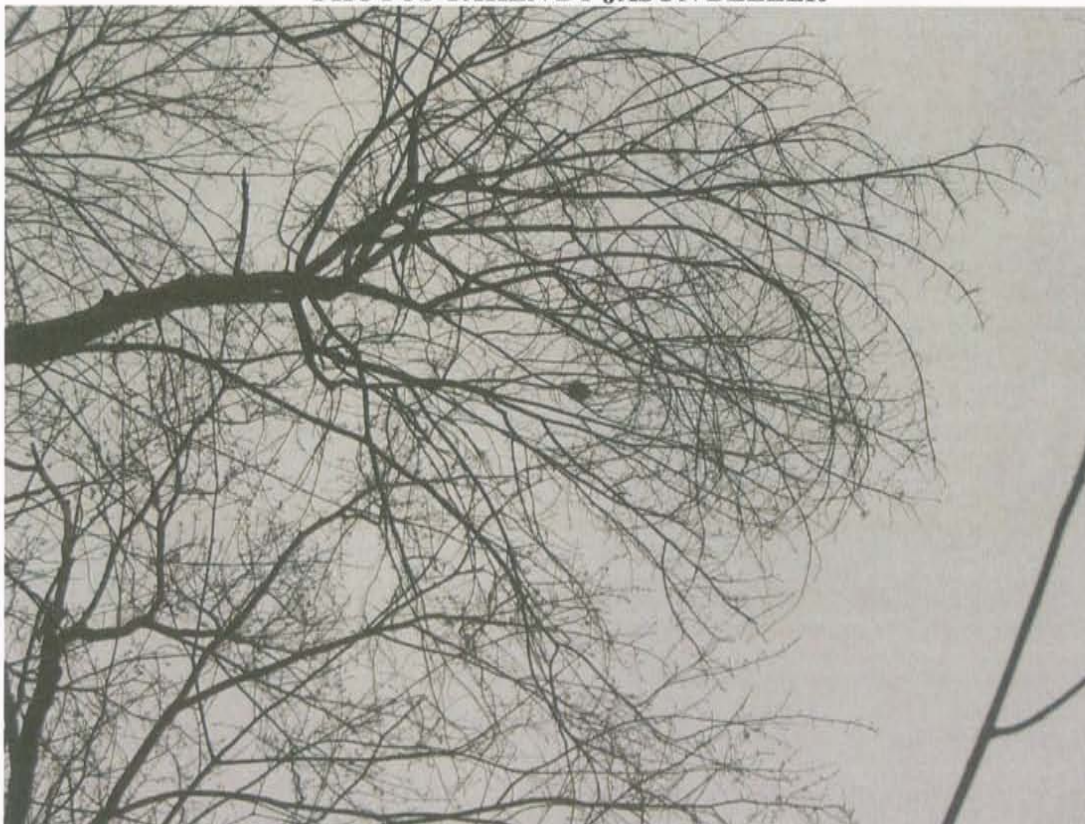
**3. Inactive unidentified song bird 16058.**

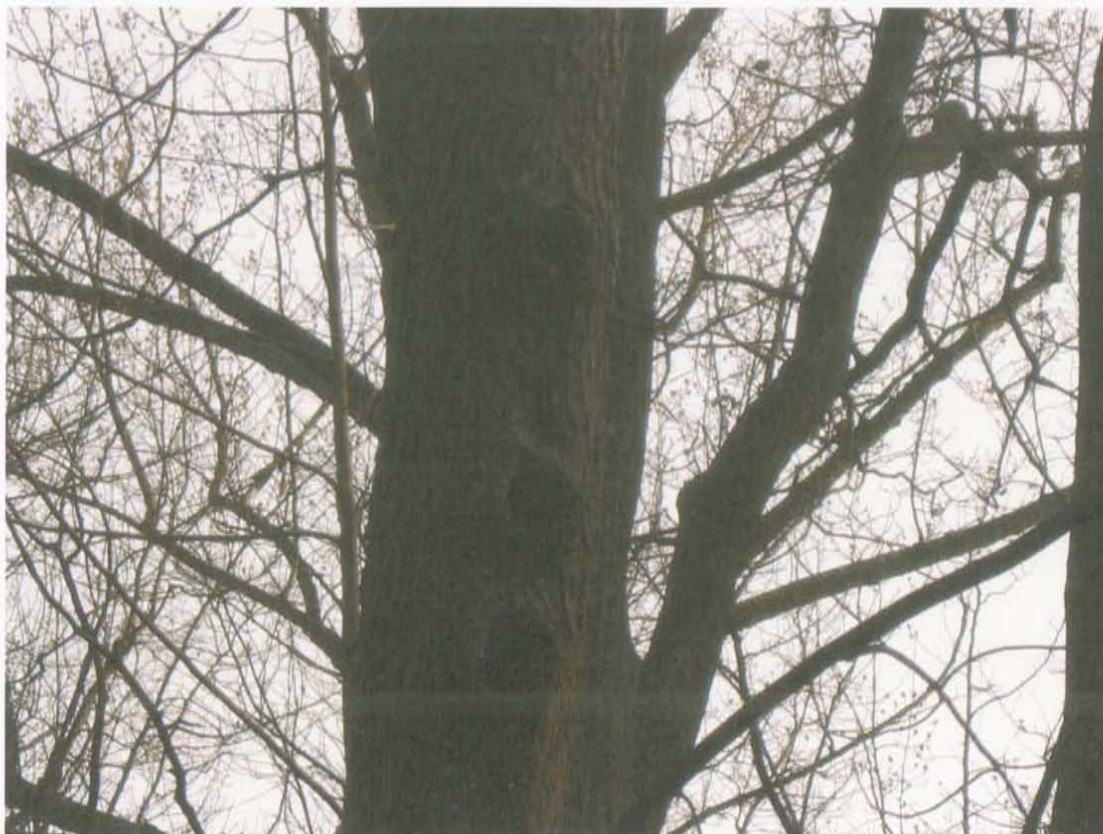
**4. Inactive unknown cavity in live tree #30438.**

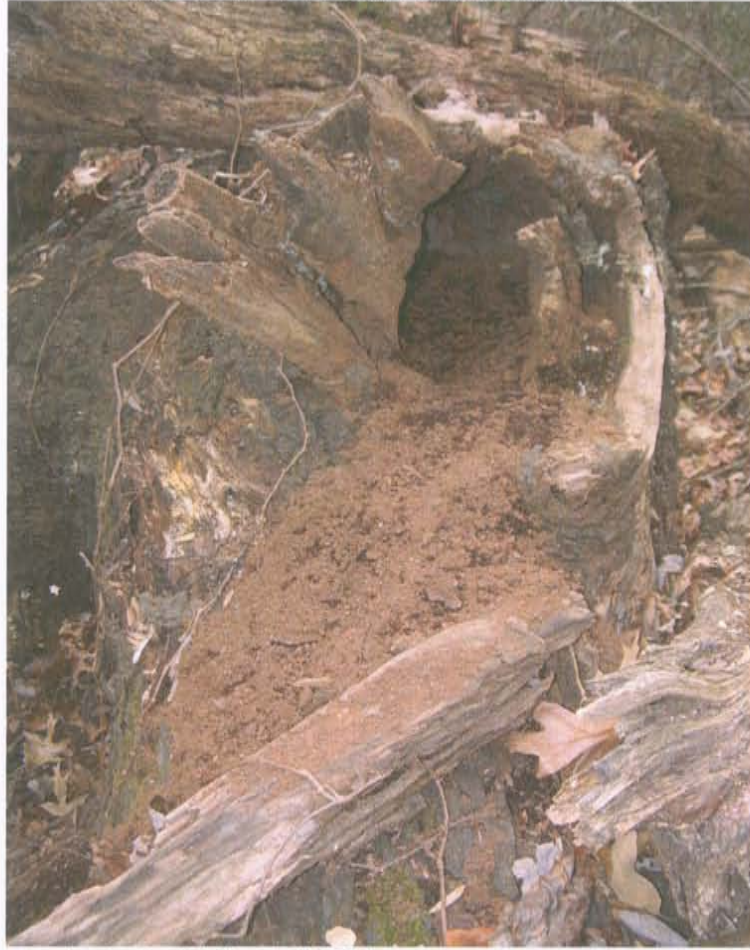
**5. Active unknown den in dead fall tree #30374.**

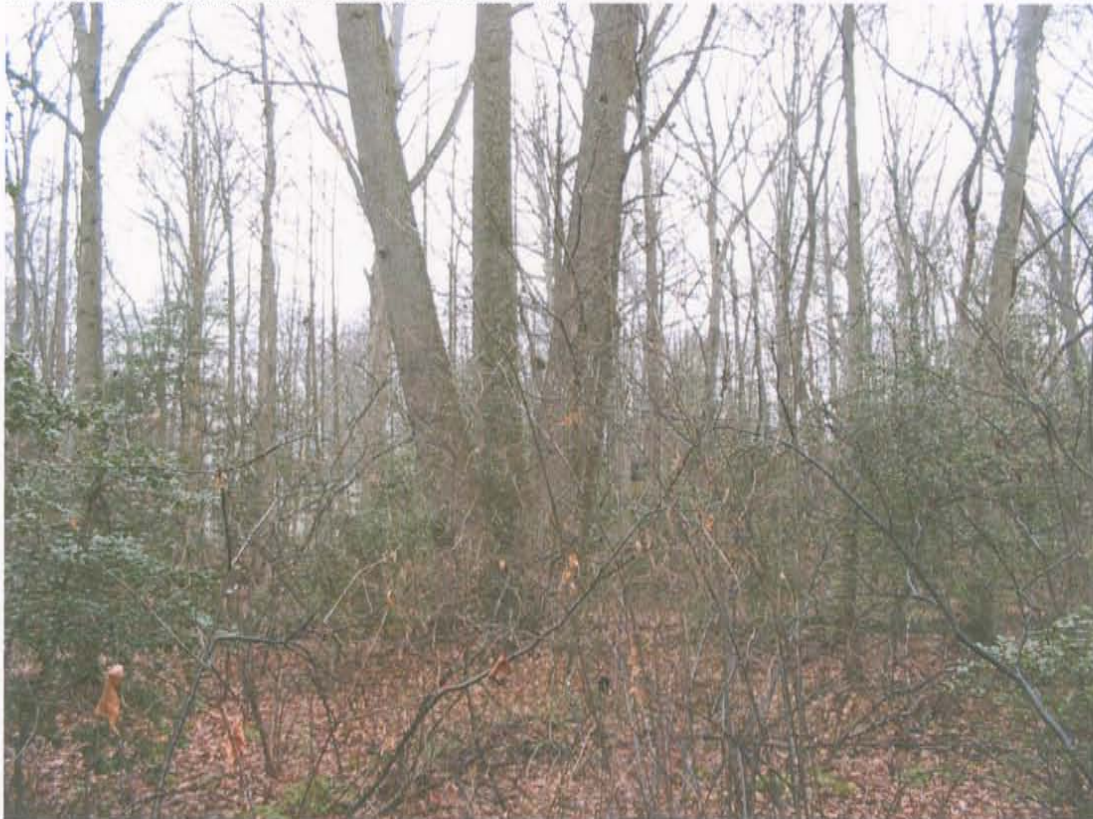
**6. Large tree *Liriodendron tulipifera* #16068.**

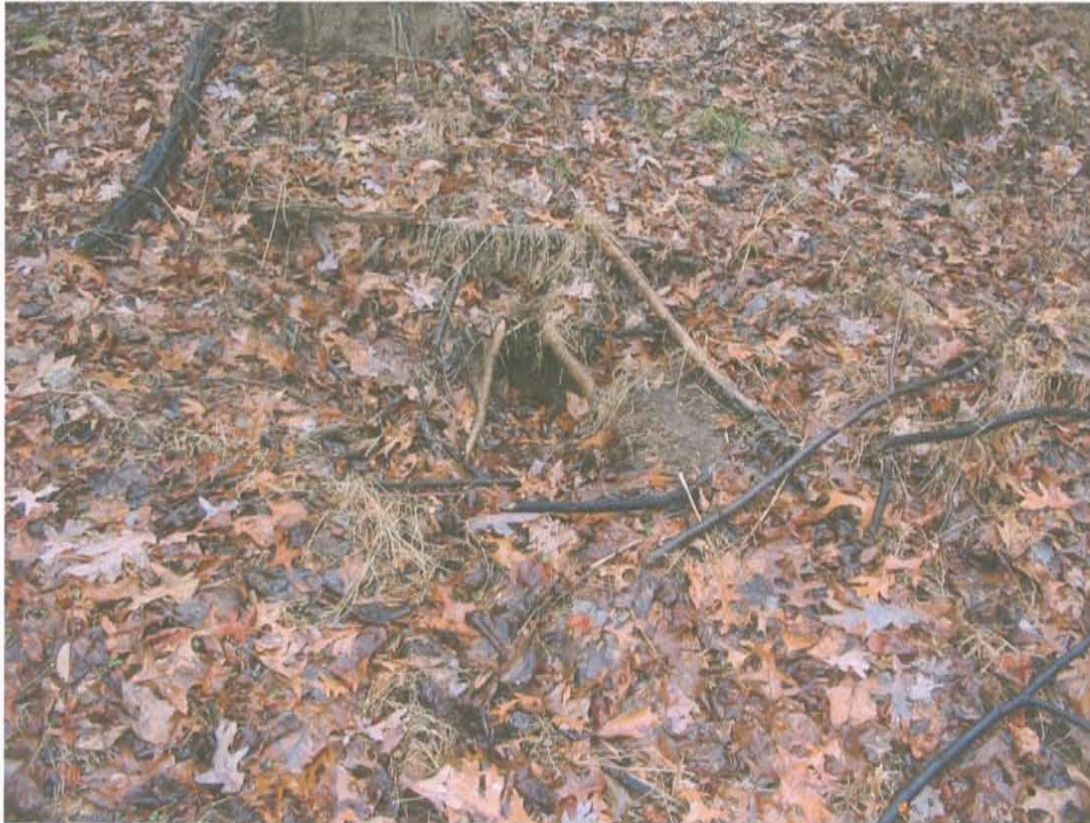
**7. Inactive subsurface erosional feature adjacent to tree #16056.**

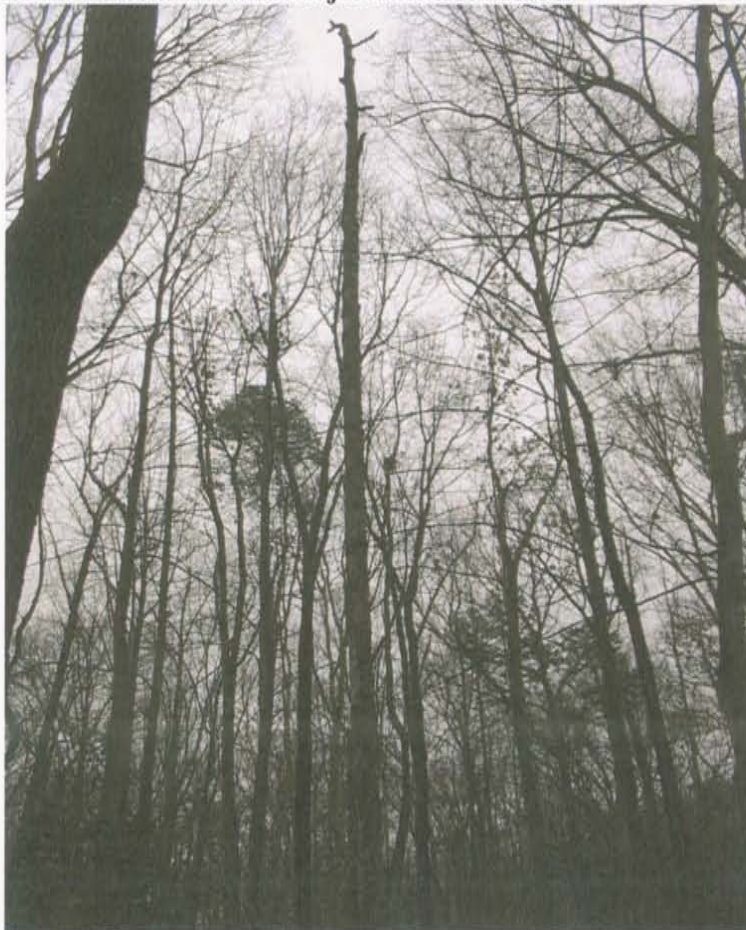
**8. Snag located 11 feet northeast of tree #30185.**

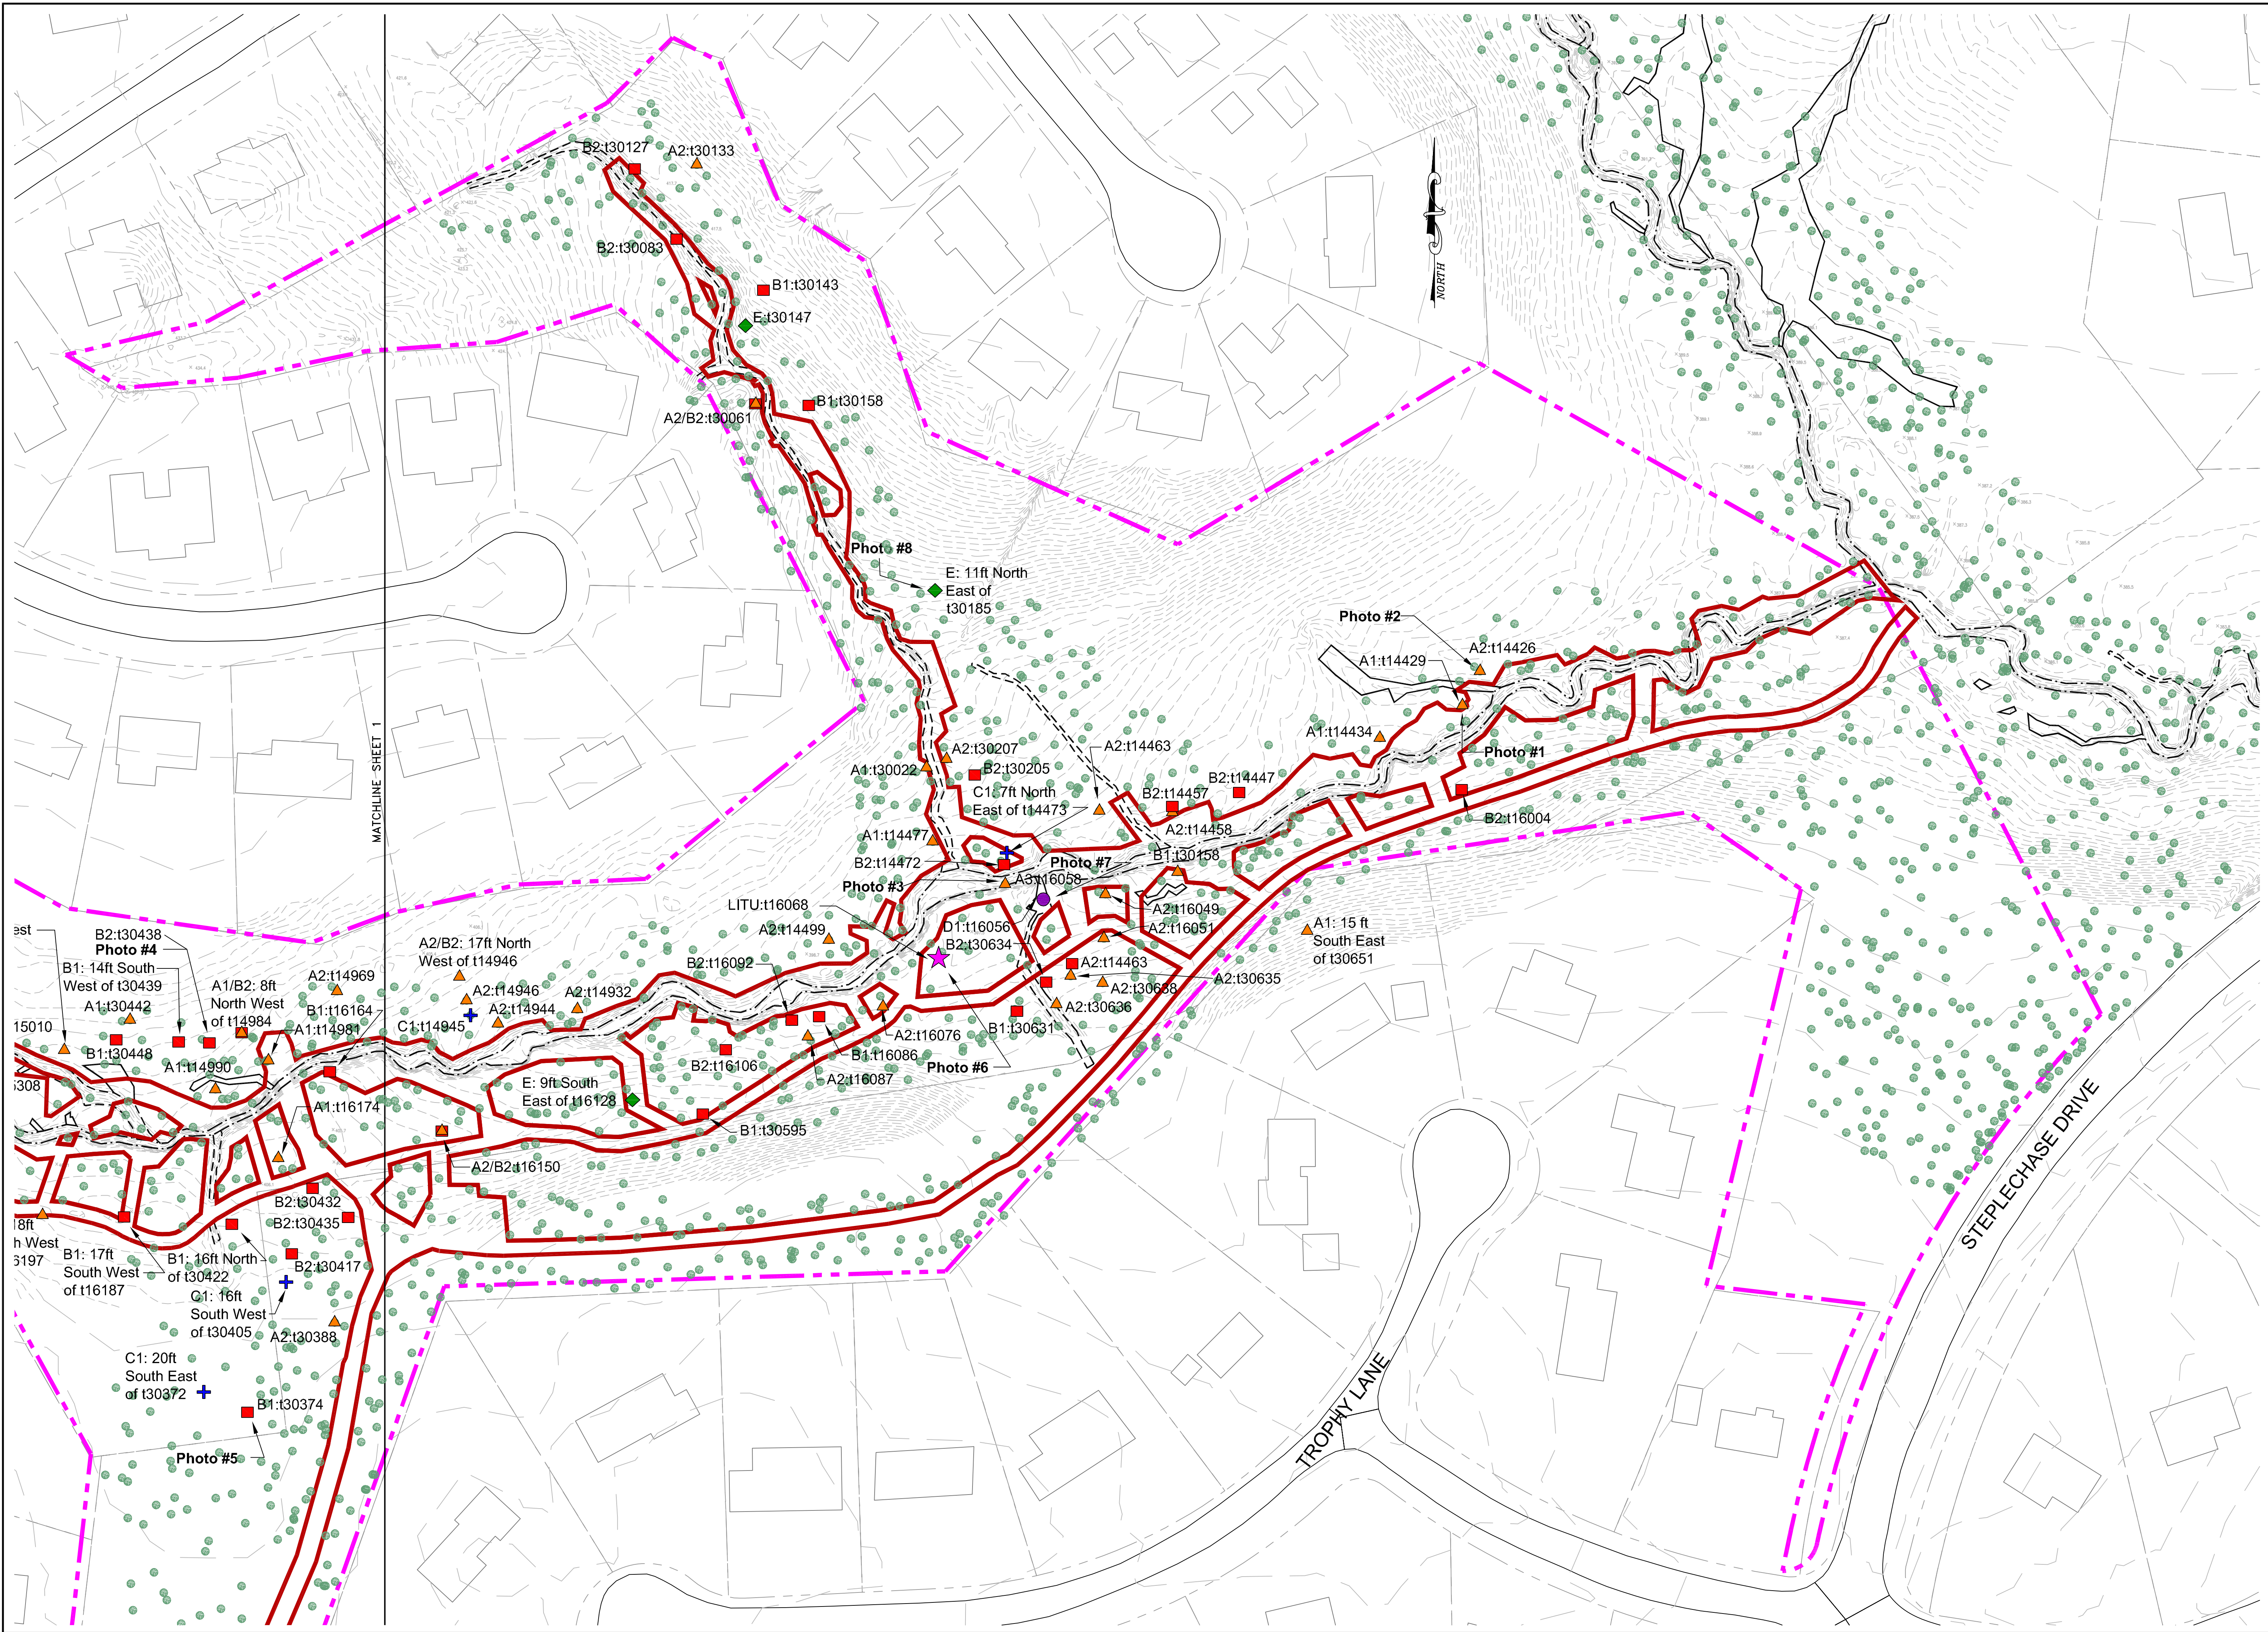
Exhibit 5:  
Wildlife Habitat Feature Location Map  
Prepared For: Northern Virginia Stream Restoration, L.C.  
The Glade - Reach 3  
Fairfax County, Virginia

A number of wildlife habitat features were located in design Reach 3 of The Glade during this inventory, including stick and squirrel nests, cavities, snags, and subsurface erosional features. The location of these features is depicted on the Wildlife Habitat Feature Location Map (Exhibit 5) and is summarized in Table 1 below. The results of this inventory will be used by project engineers to further limit the stream restoration project's impact on local wildlife habitat features.
