# **Northern Virginia Stream Restoration Bank- The Glade-Reaches 1 and 1A** Fairfax County, Virginia

WSSI #20030, Task I6

**Mitigation Monitoring Report** Seventh Growing Season (2015)

November 20, 2015

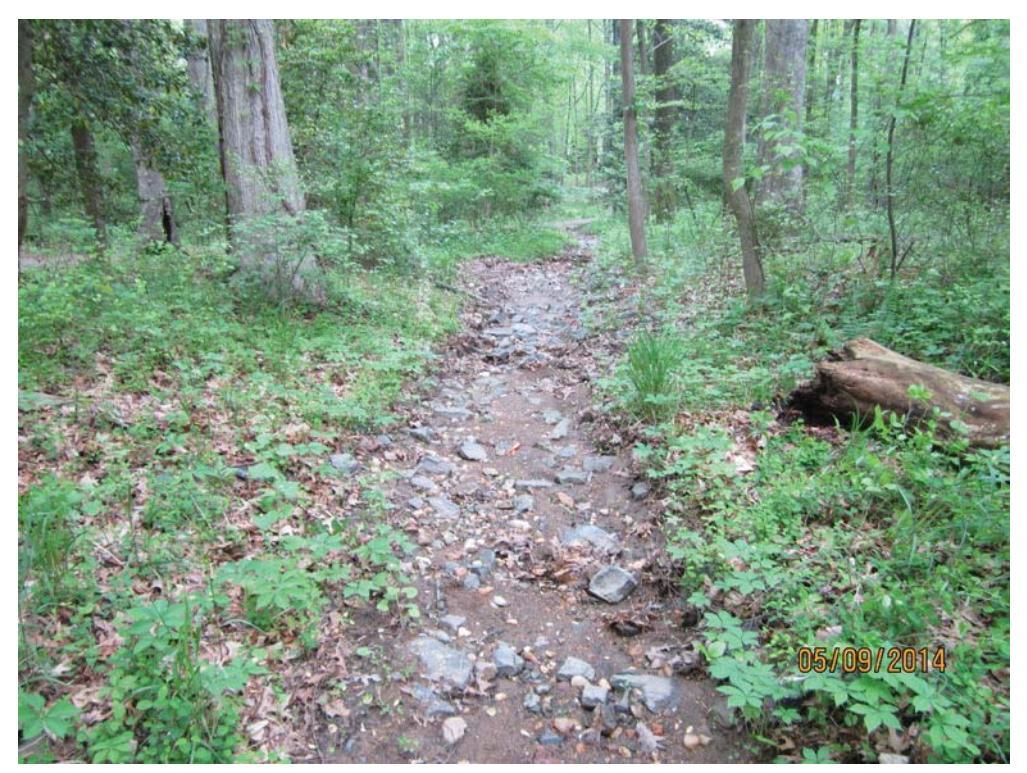
Photo 2: Snakeden Reach 10; after down tree removal.

Reach 10 (Photo 1). The down tree in Snakeden Reach 10 has already been removed (Photo 2) and the down tree in Snakeden Reach 9 is scheduled to be removed during the week of 5/12/2014.

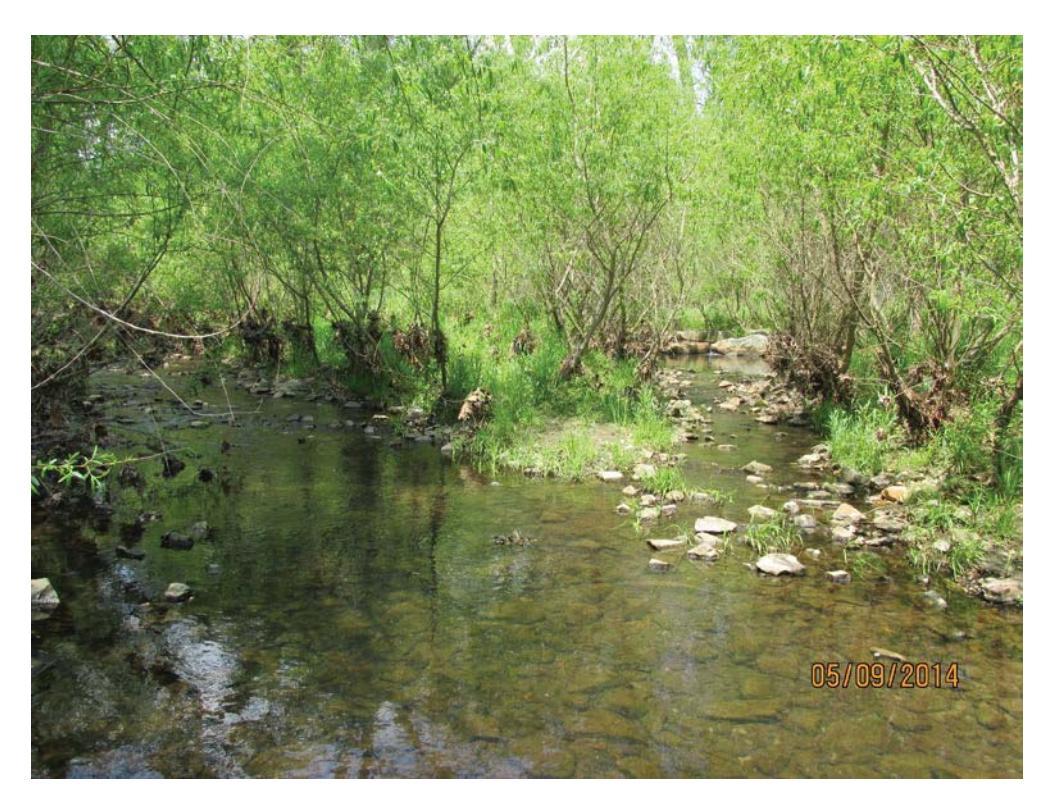
Photo 3: Looking upstream in Snakeden at the confluence of Reaches 12 and 16. Rack lines on trees illustrate the bankfull event. No damage observed; no remediation required.

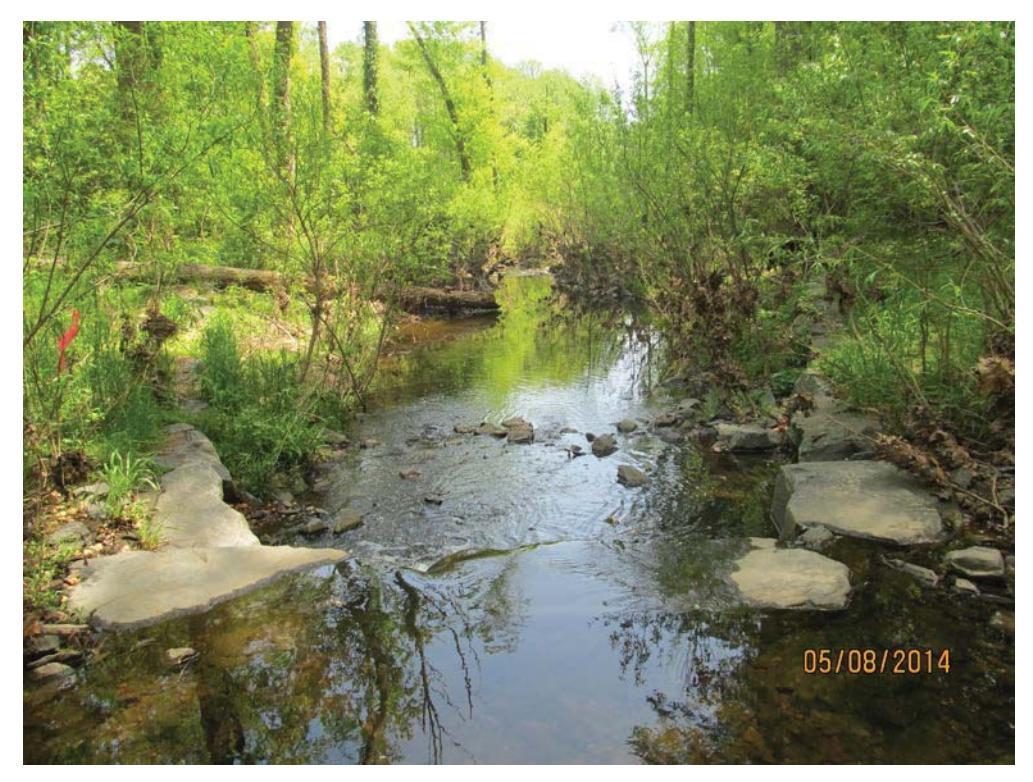
Photo 4: Looking downstream at fallen tree within bankfull in Snakeden Reach 9. No damage observed; tree is scheduled to be removed.

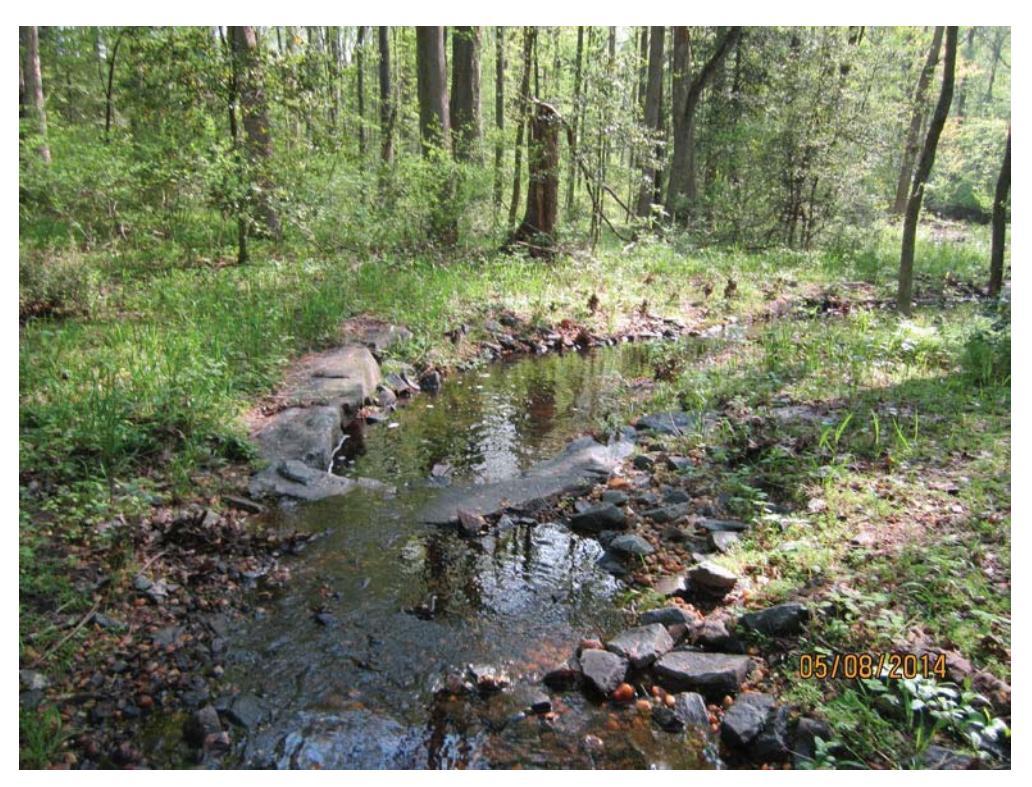
Photo 5: Looking downstream at cross vane structure in Glade Reach 3. No damage observed; no remediation required.

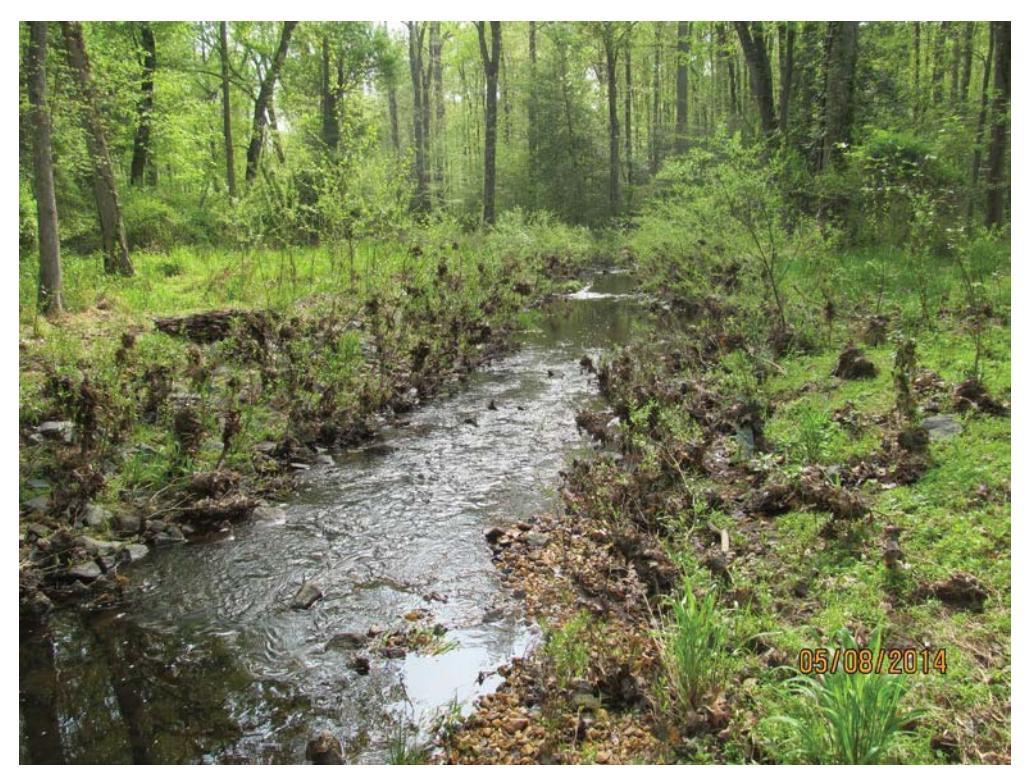
Photo 6: Looking downstream in Glade Reach 5. Rack lines on shrubs and banks indicating bankfull event. No damage observed; no remediation required.

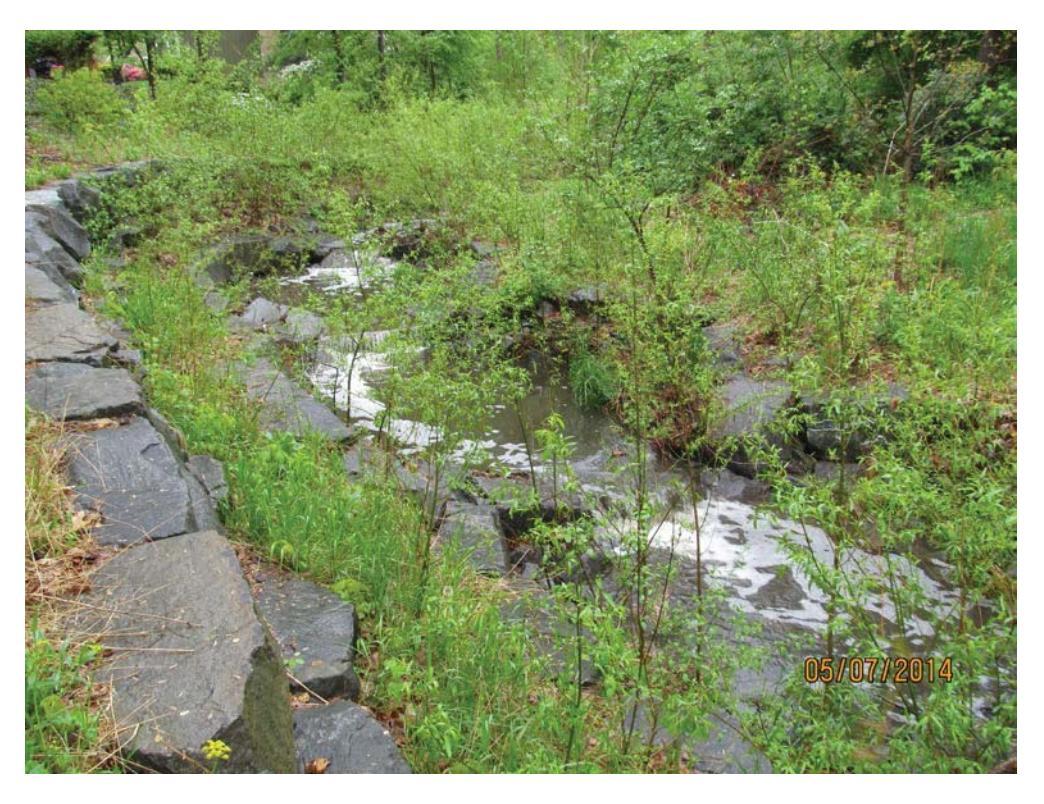
Photo 7: Looking upstream in Colvin Run (Forest Edge North). No damage observed; no remediation required.

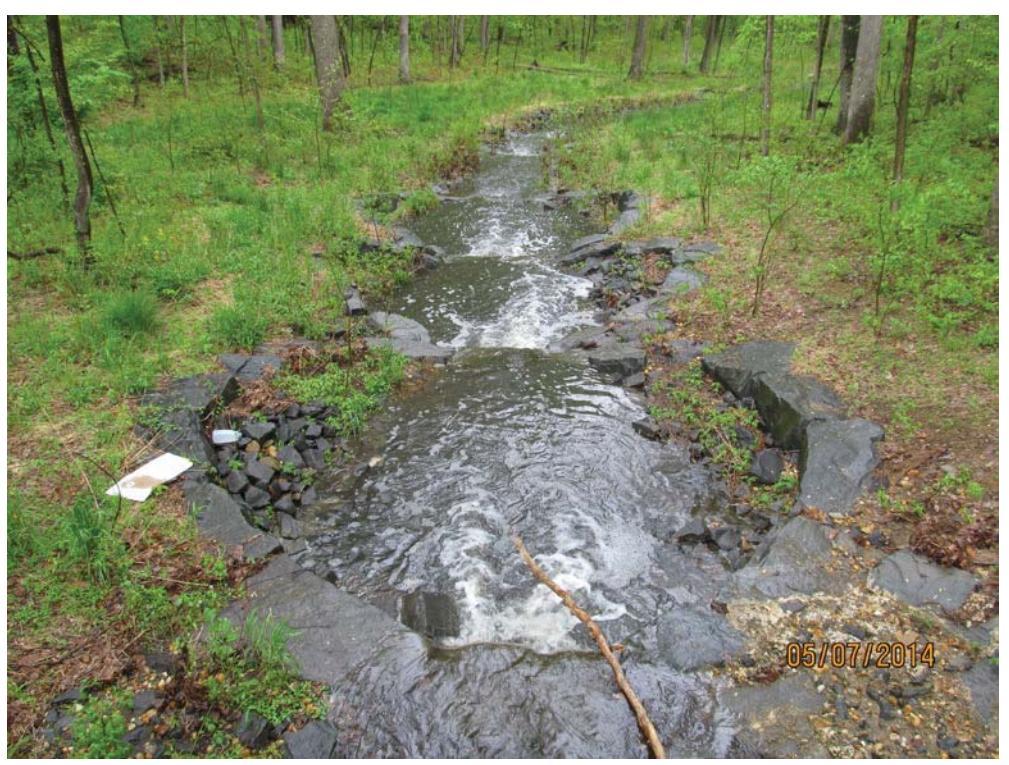
Photo 8: Looking downstream at step pool structures in Colvin Run (Forest Edge South). No damage observed; no remediation required.

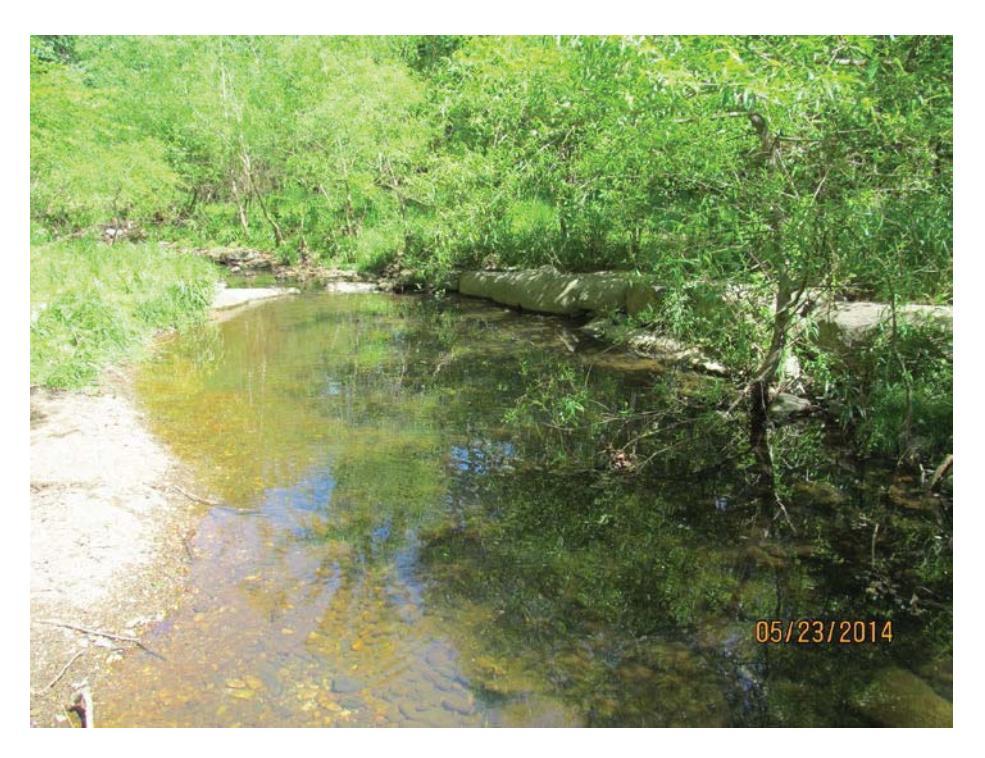
Photo 4: Looking downstream at fallen tree in Glade Reach 4a. Tree scheduled for removal.

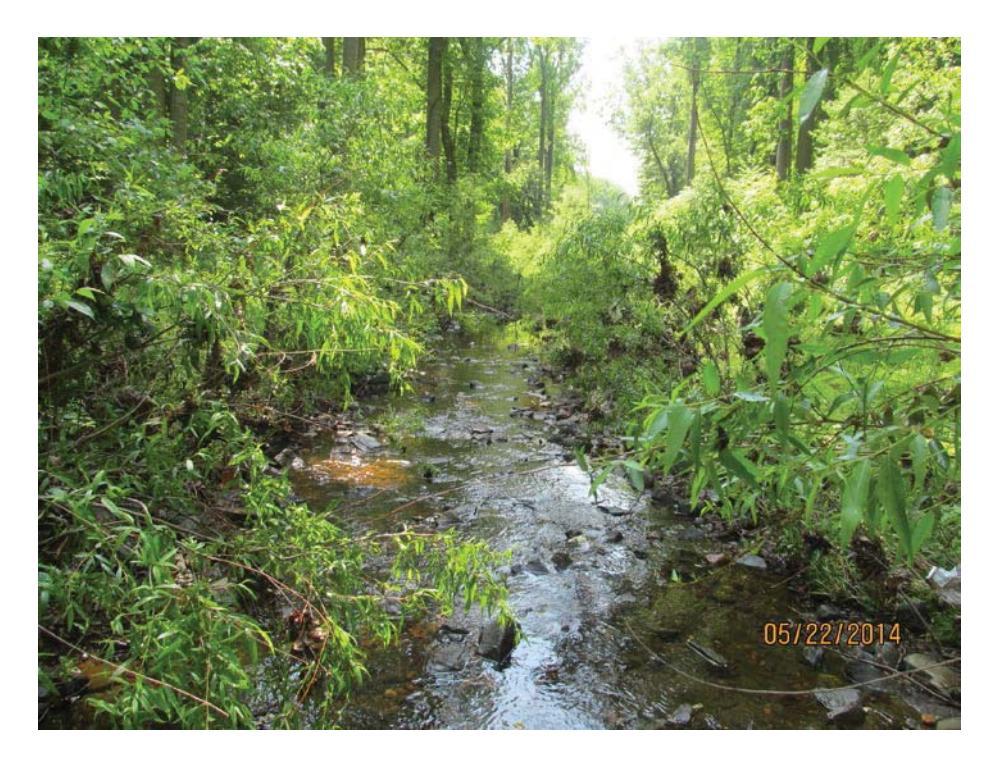
Photo 5: Looking upstream at cross vane structure in Snakeden Reach 3. No damage observed; no remediation required.

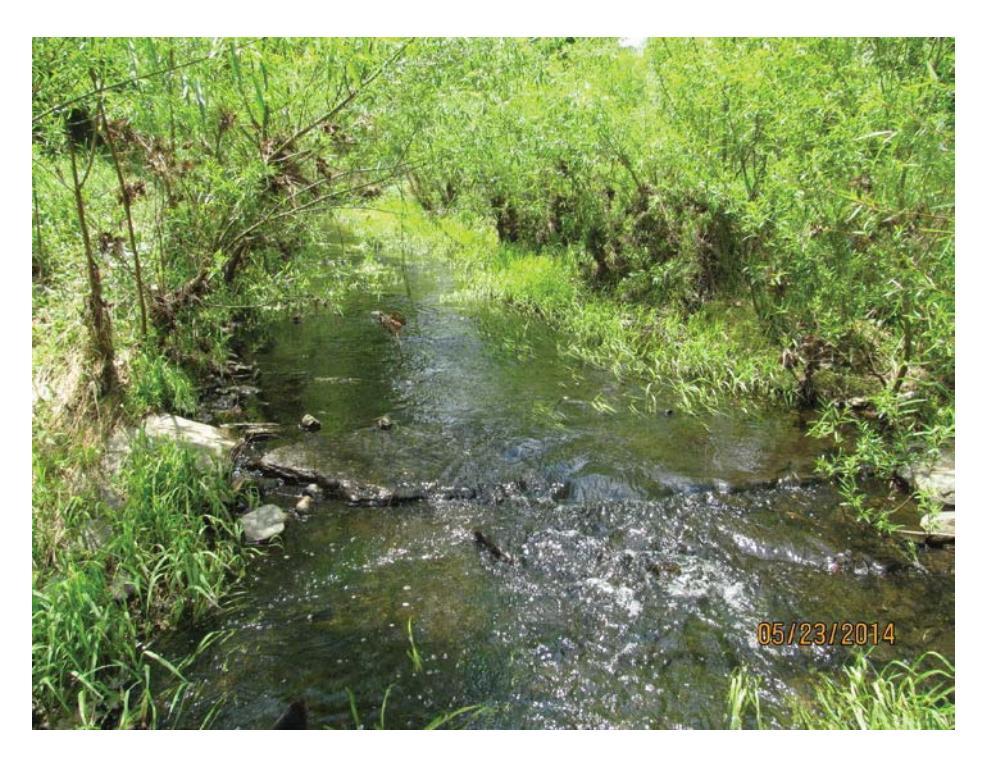
Photo 6: Looking downstream in Snakeden Reach 9. Rack lines on shrubs indicating bankfull event. No damage observed; no remediation required.

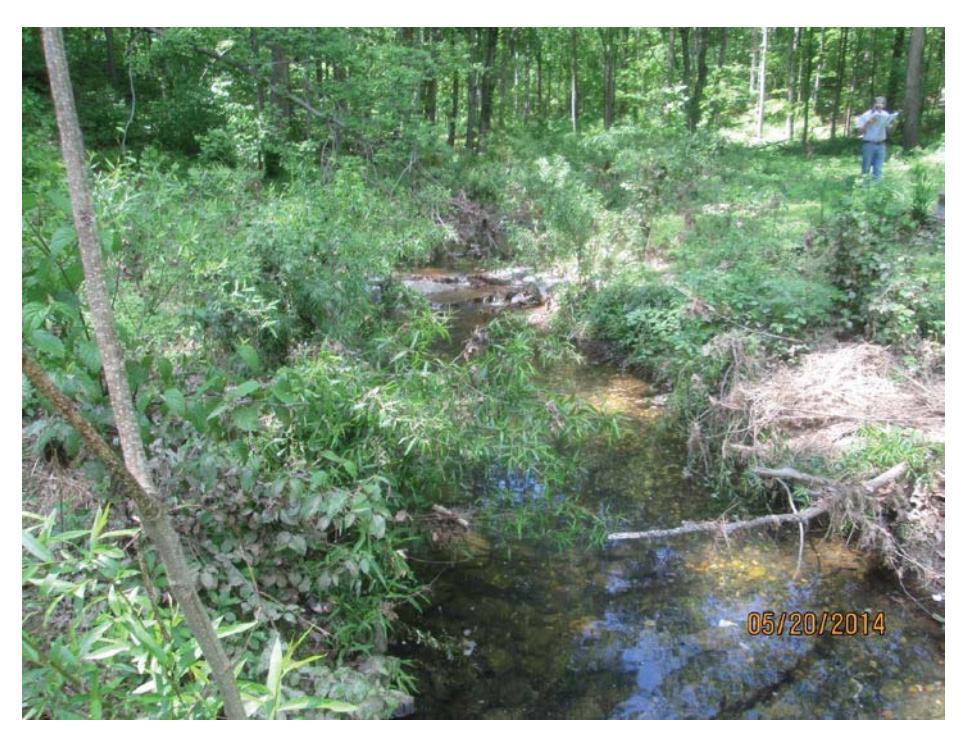
Photo 7: Looking upstream in Glade Reach 6. No damage observed; no remediation required.
