# **Northern Virginia Stream Restoration Bank Reston Status**

# **Northern Virginia Stream Restoration Bank Baron Cameron Final Plan**

**August 21, 2012**

## Baron Cameron

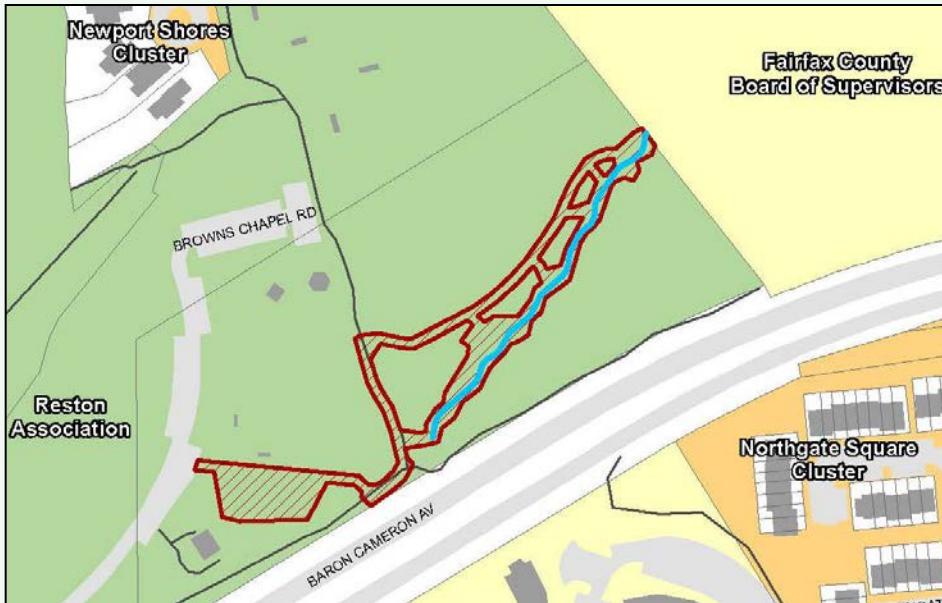
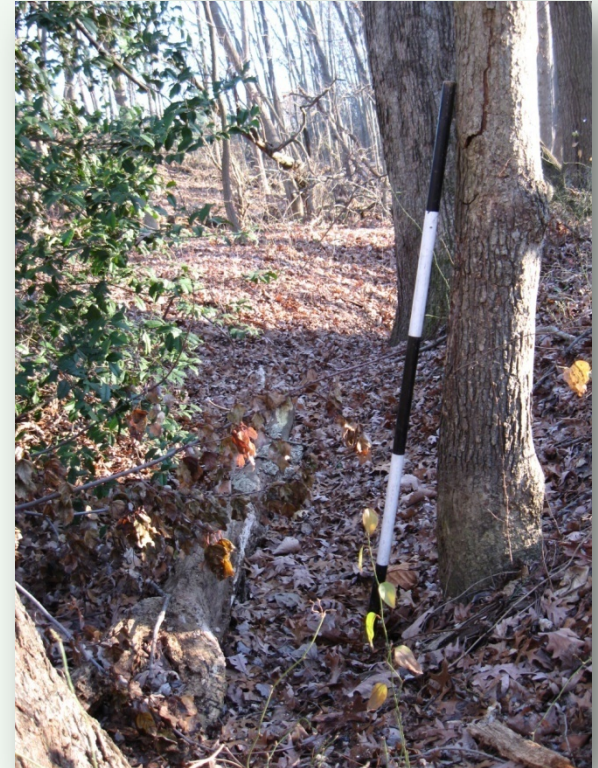
# Baron Cameron- Existing Conditions

- Existing swale approximately 300 ft upstream of project area on Fairfax County property

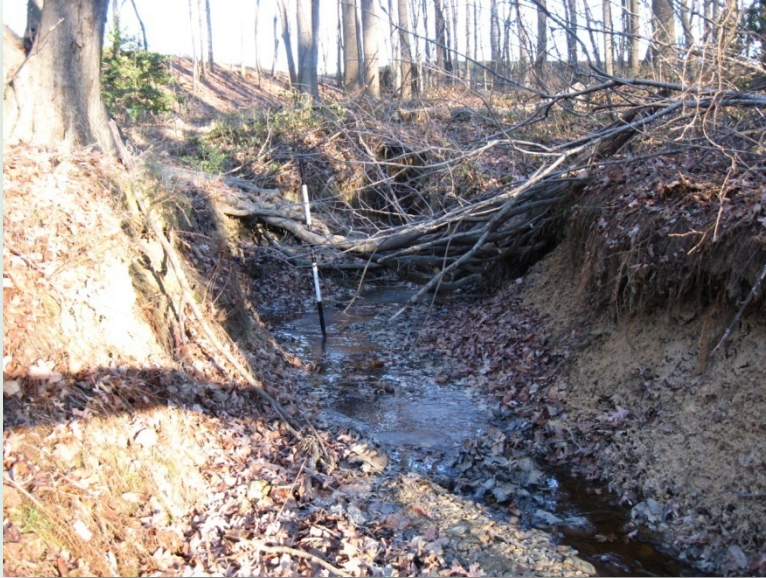
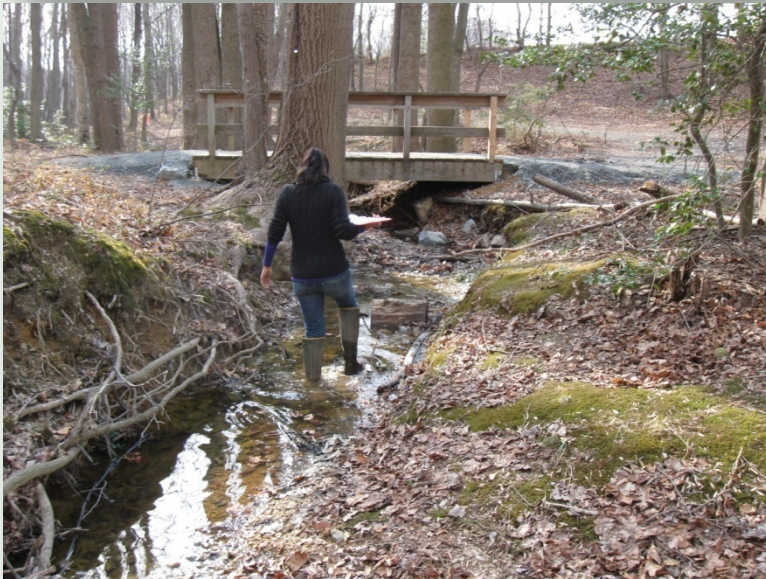
# Baron Cameron- Existing Conditions

- Exposed tree roots and incised banks immediately upstream of project area
- Upstream extent of project area

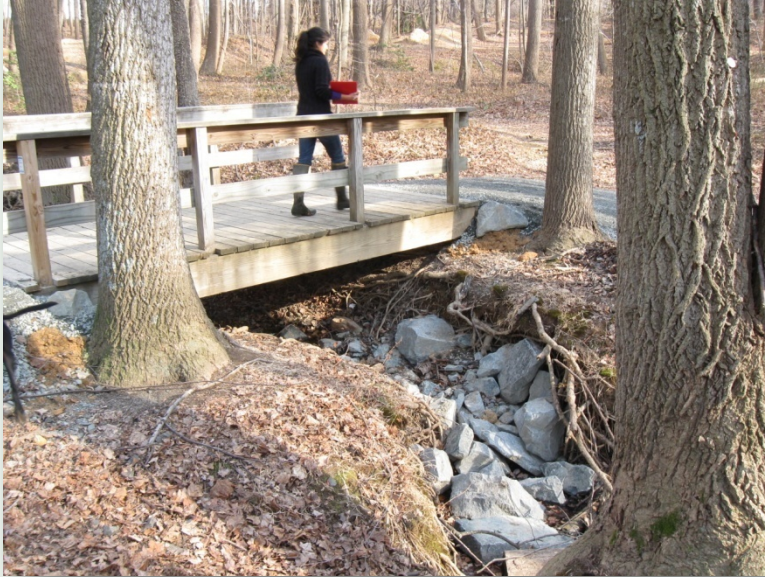
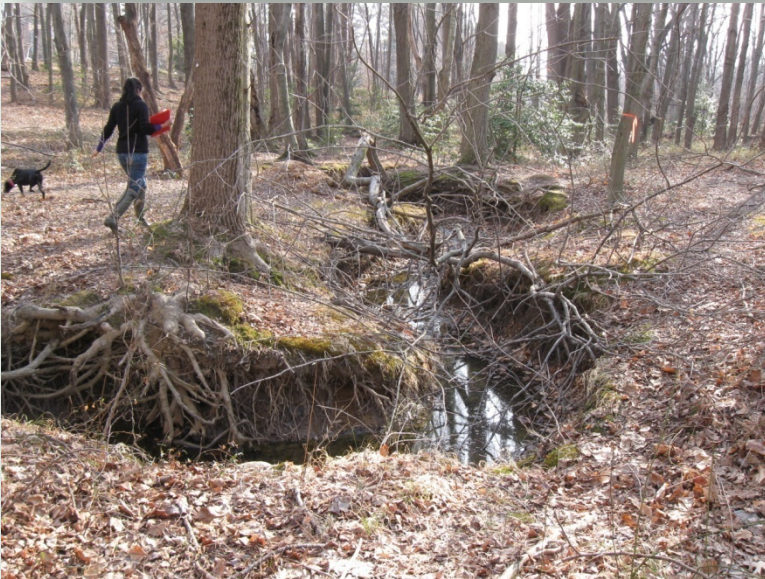
# Baron Cameron- Existing Conditions

- Existing bridge to be replaced
- Exposed tree roots and incision downstream of existing bridge

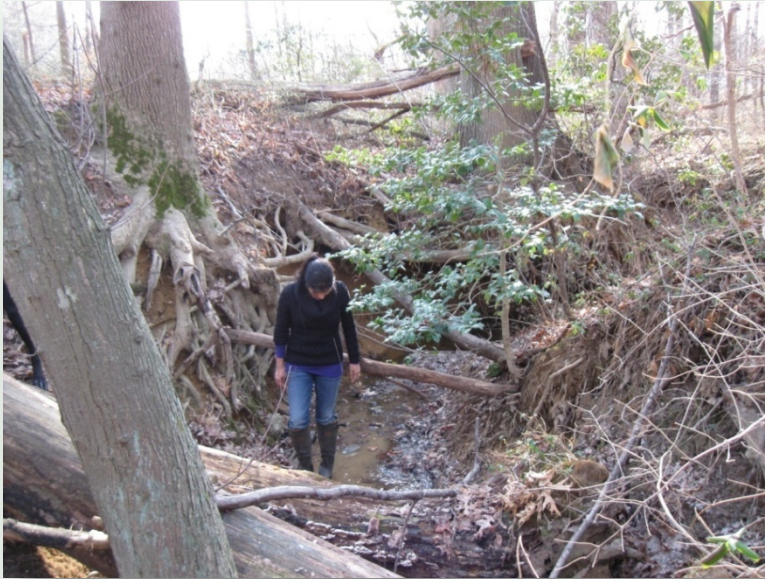
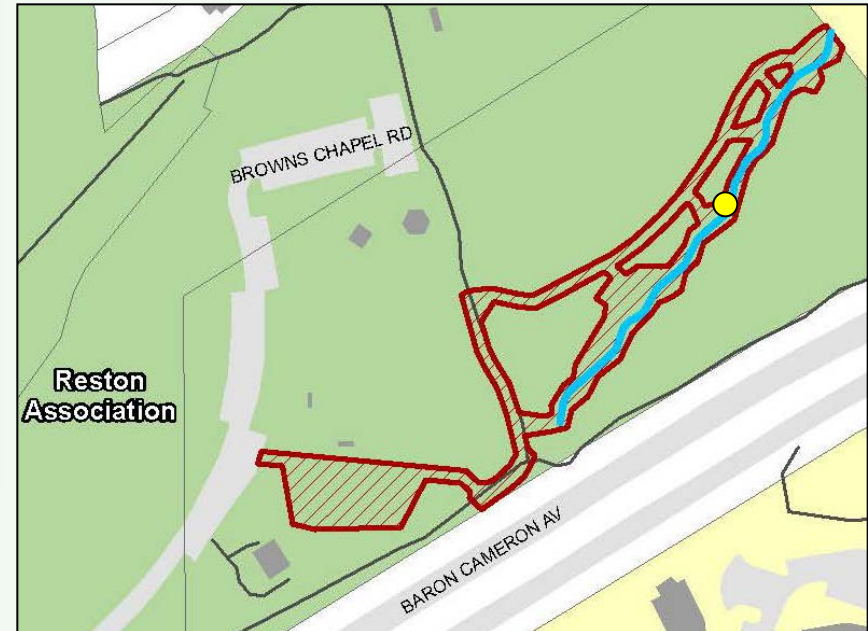
# Baron Cameron- Existing Conditions

- Severe incision and tree damage in project area

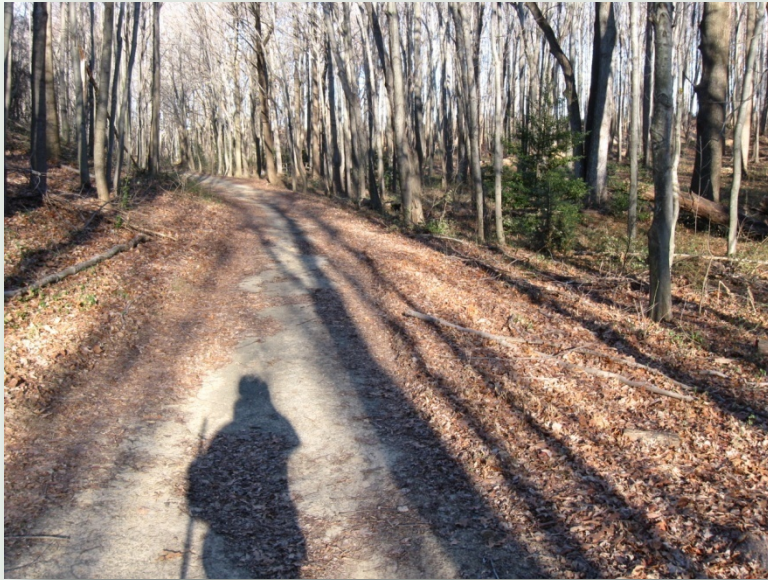
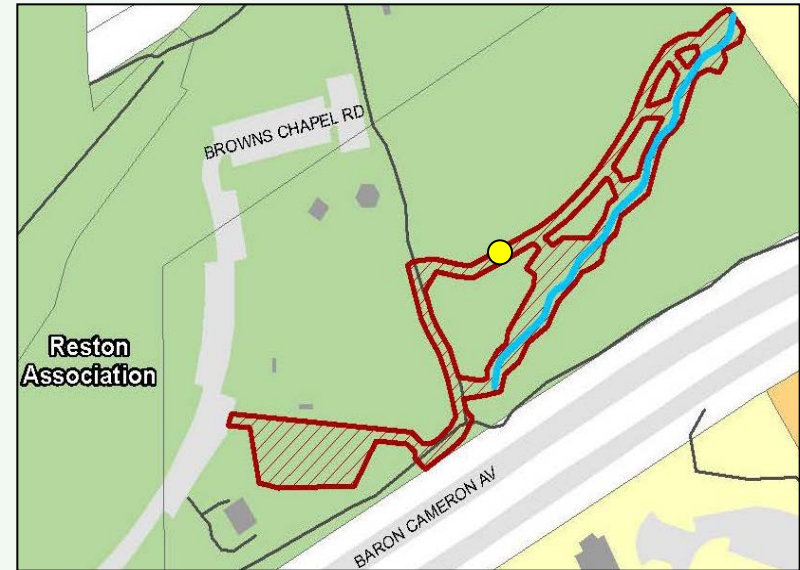
# Baron Cameron- Existing Conditions

- Existing unpaved path will be the Temporary Construction Access Path

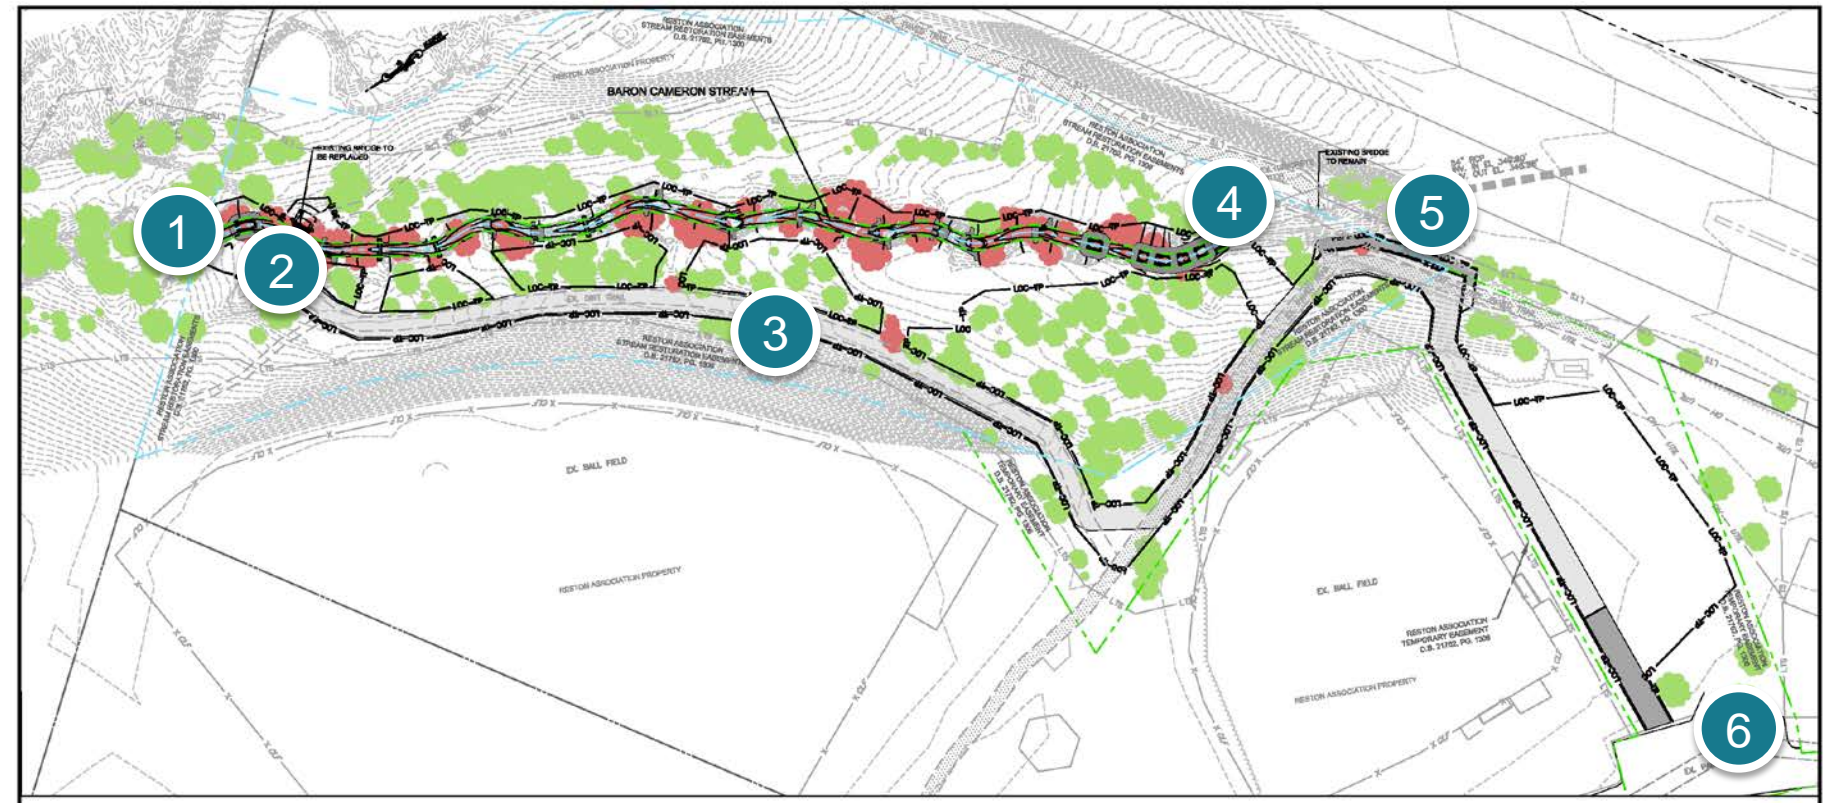
# Baron Cameron – Design Highlights

1. Upstream tie out at Fairfax County Property
2. Replace existing bridge
3. Access along dirt trail
4. Downstream tie out at concrete ditch

5. Mulch trail bypass along paved trail
6. Site access from small parking area behind Brown's Chapel to limit park disturbance

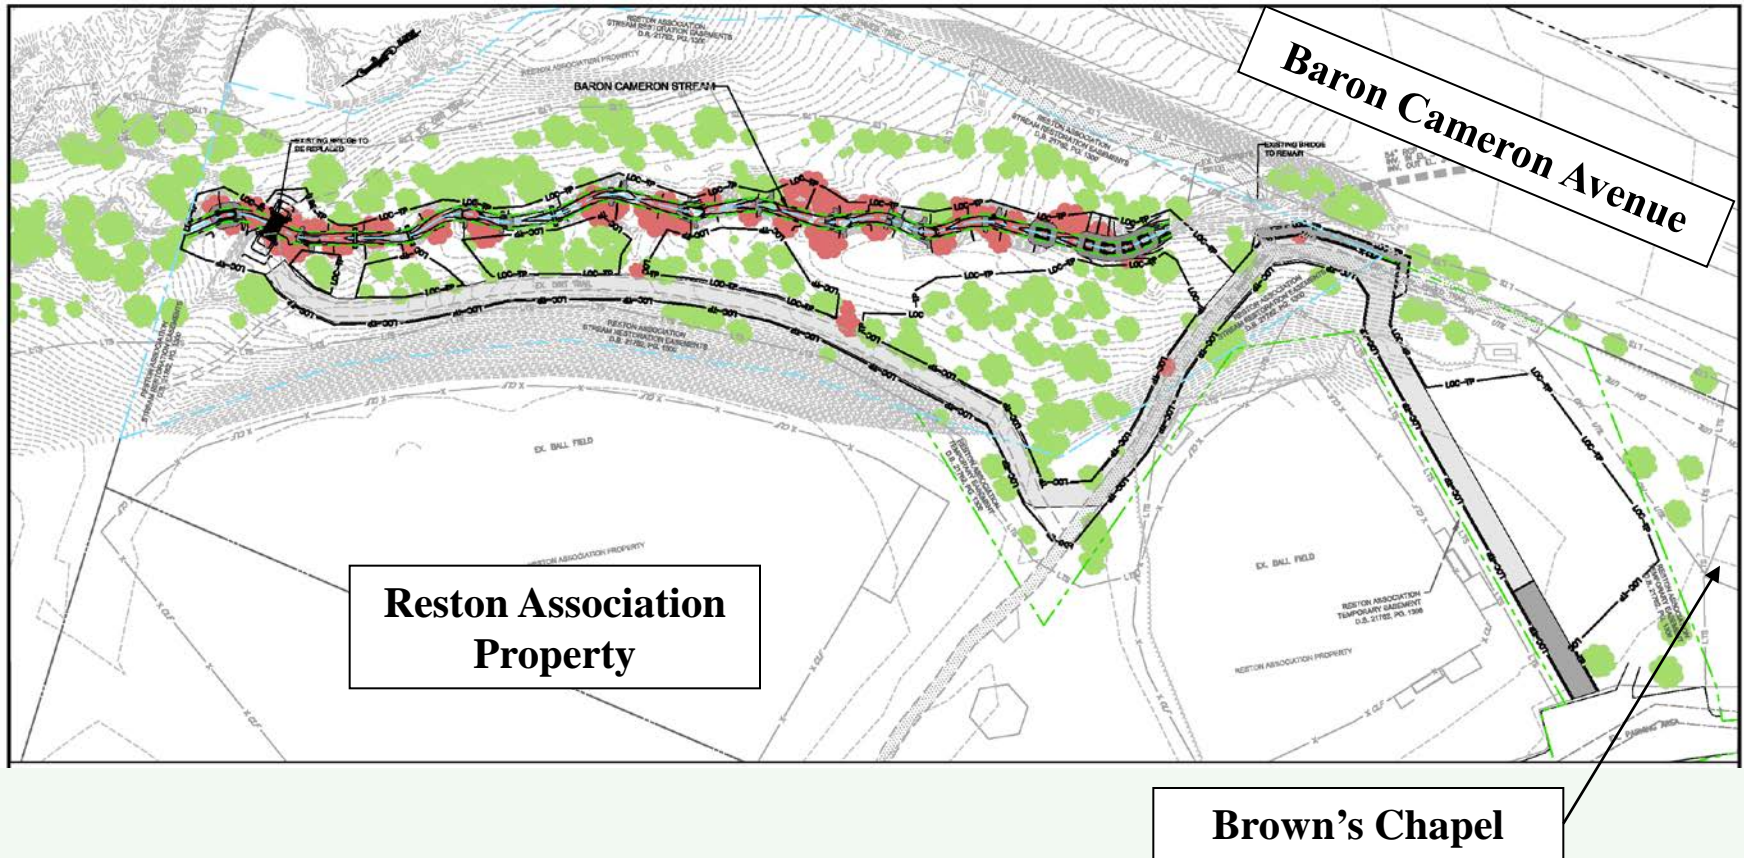
# Baron Cameron– Tree Survey

**432 Trees Surveyed on Reston Association Property**
