Northern Virginia Stream Restoration Bank  
 Lake Anne West  
 Fairfax County, Virginia

Grading Plan and Longitudinal Profile

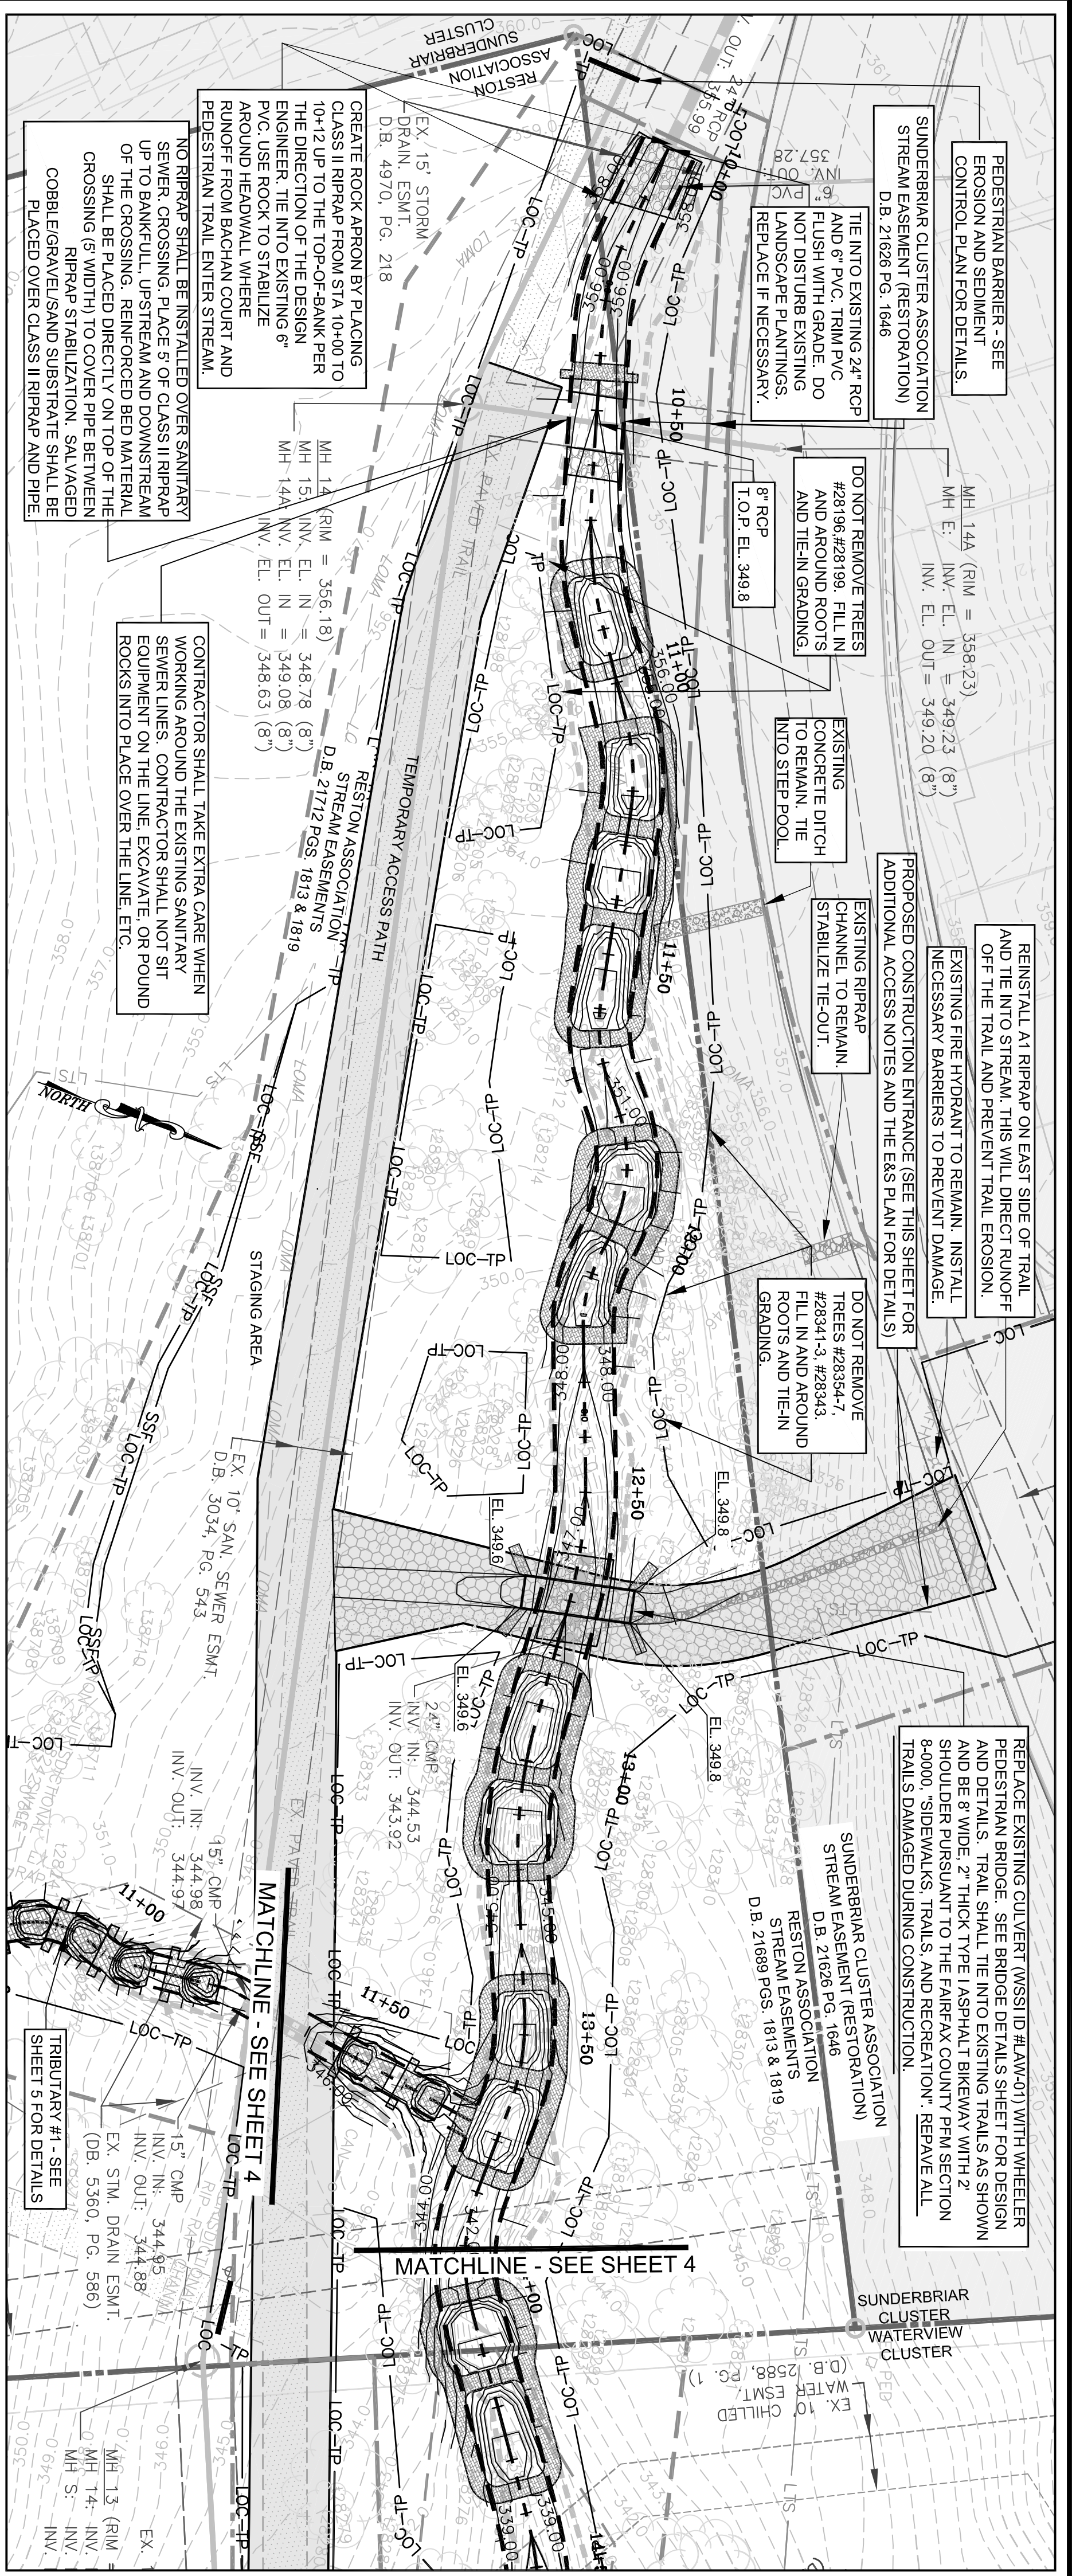
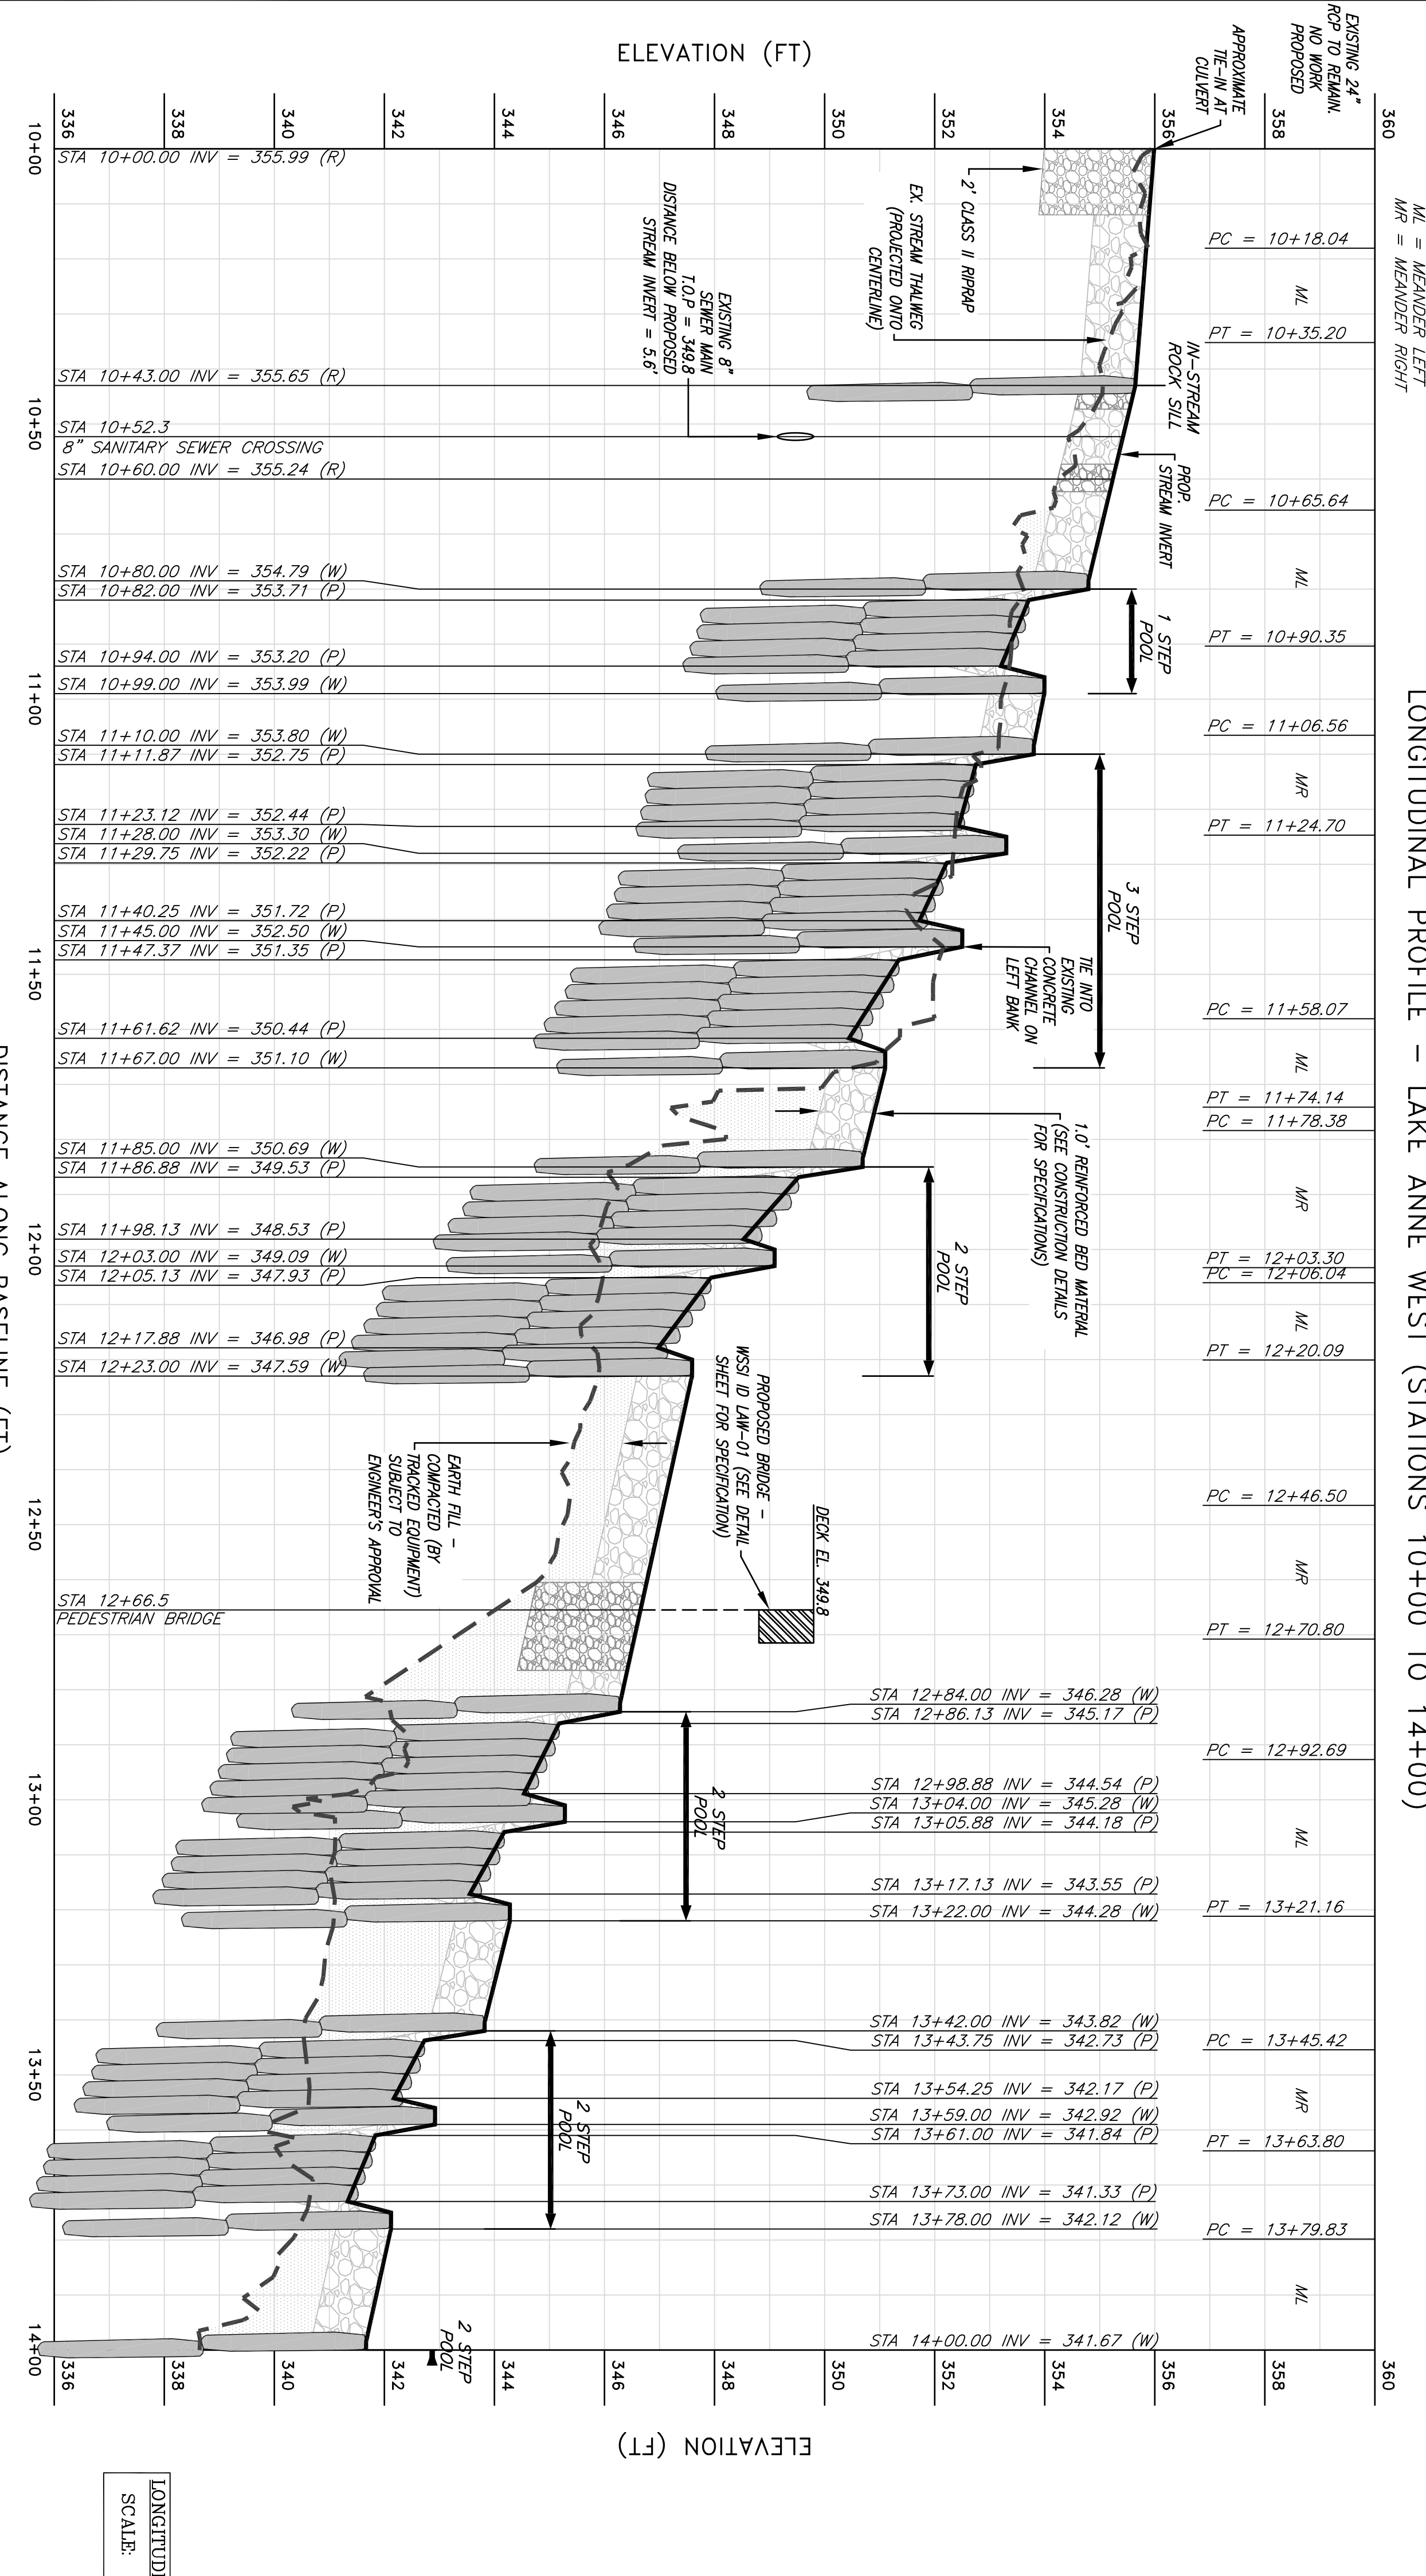
LONGITUDINAL PROFILE SCALE: H: 1" = 20' V: 1" = 2'
