Northern Virginia Stream Restoration Bank Reston Status

Northern Virginia Stream Restoration Bank Vantage Hill Final Plan

Vantage Hill – Final Plan

Grading Plan and Longitudinal Profile

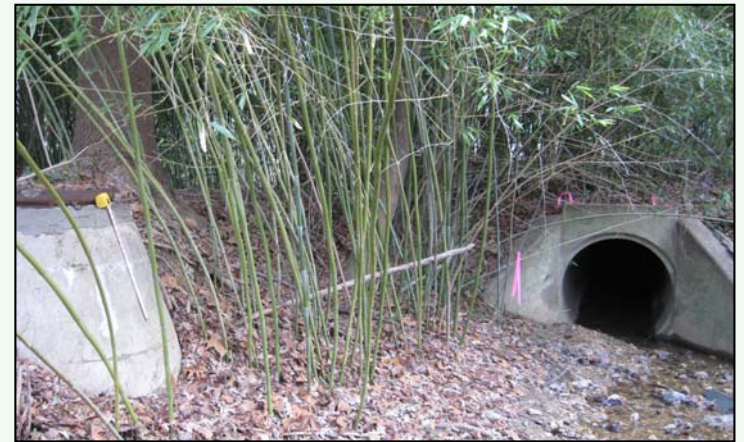
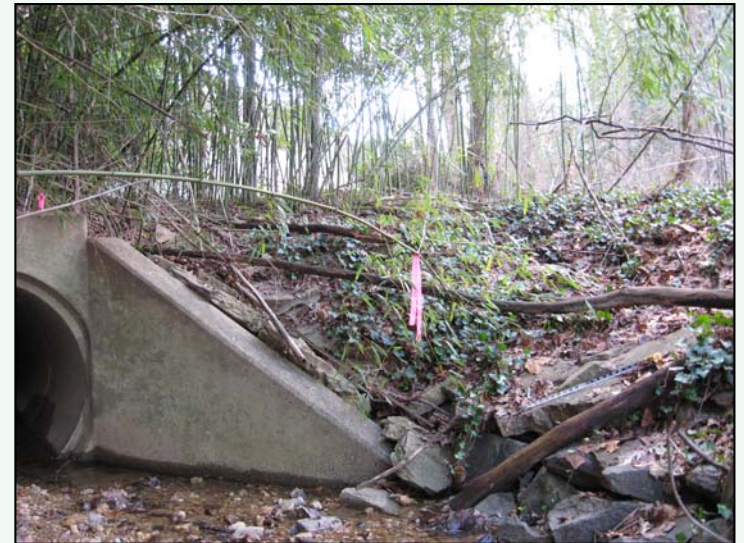
- Culvert at Hickory Cluster
- Invasive bamboo, sanitary crossing

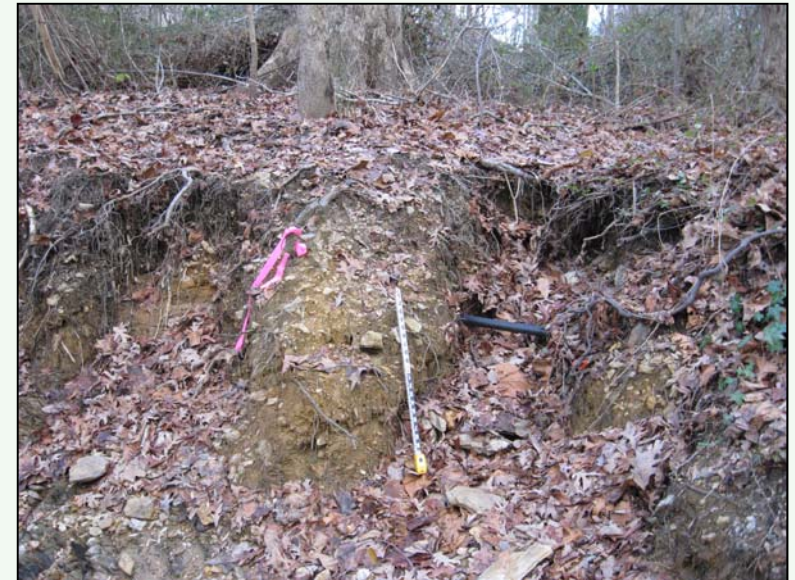
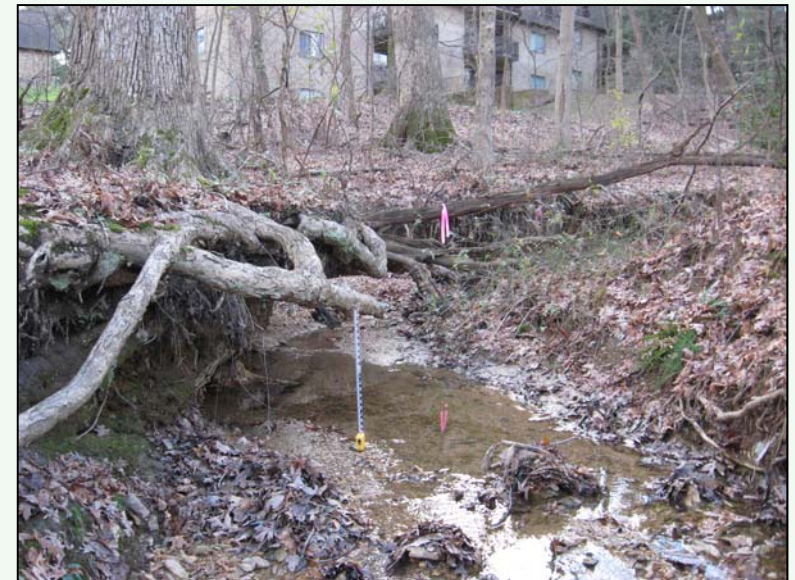
- Exposed utilities
- Undercut trees

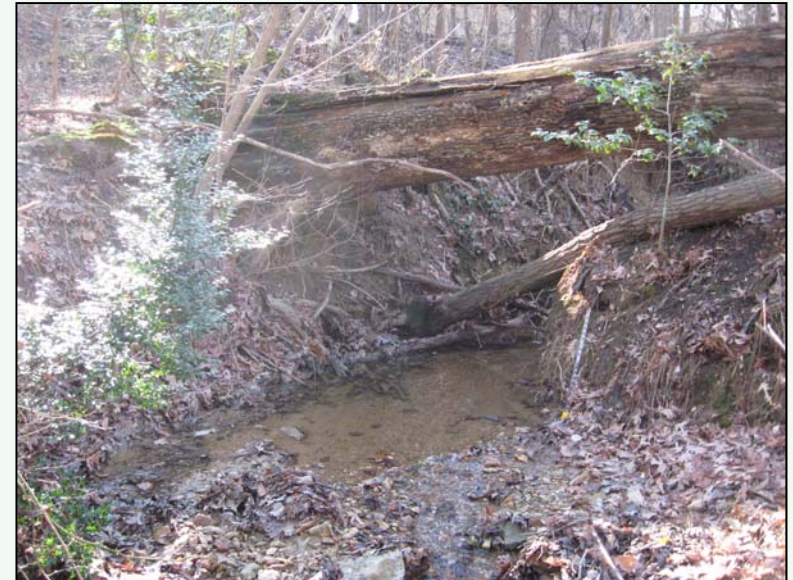
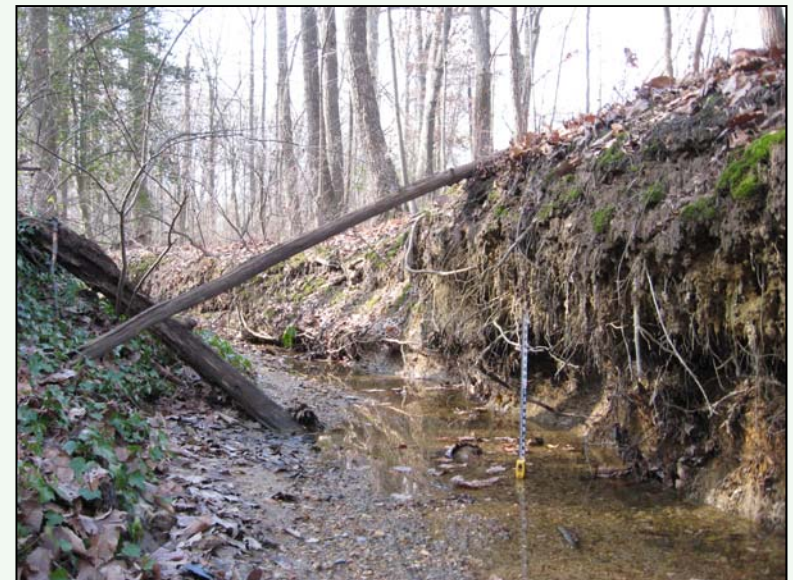
- Tree fall, 4+ foot eroded bank, invasive English ivy

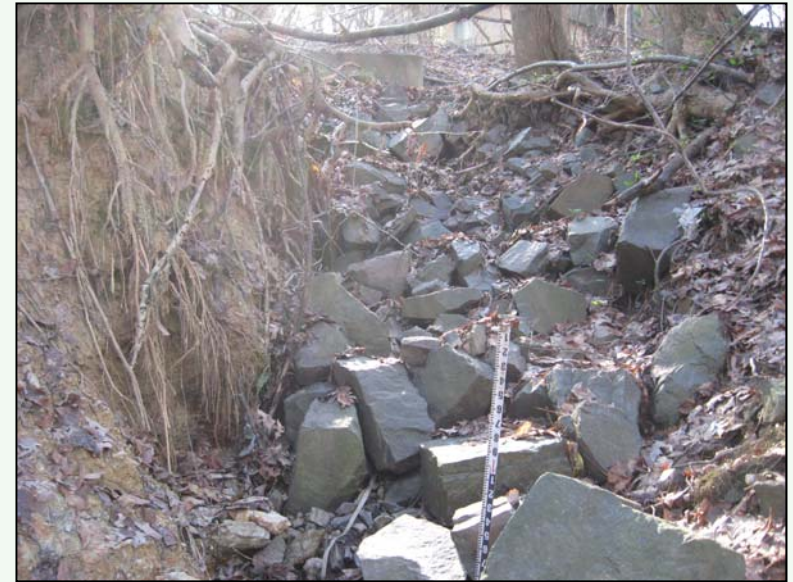
- Steep, unstable culvert tie-in

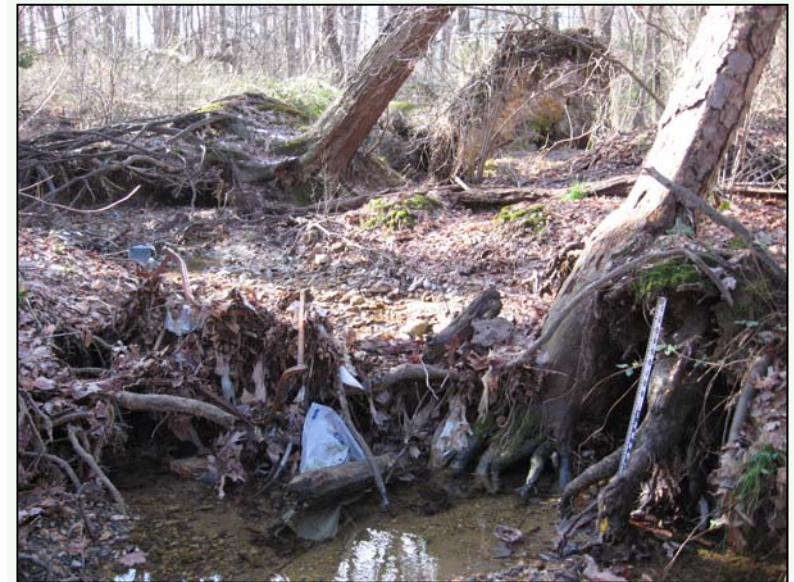
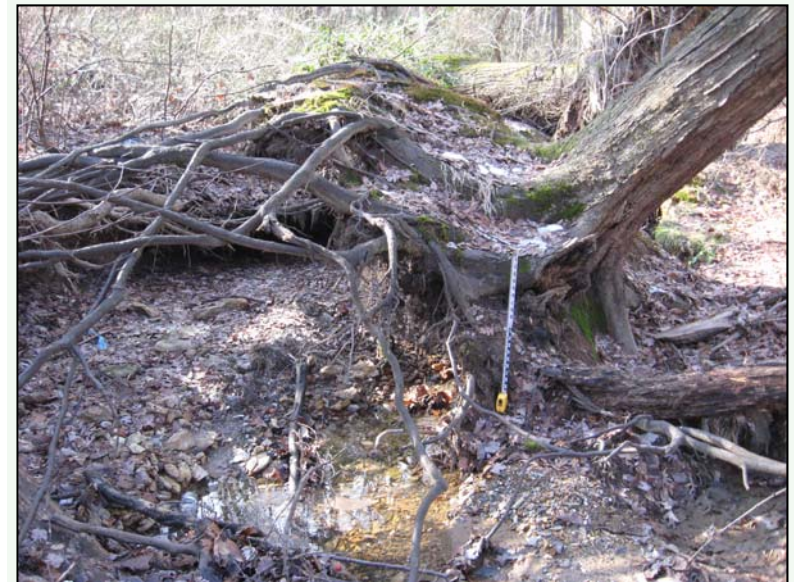
- Headcut migrating towards
Baron Cameron Avenue

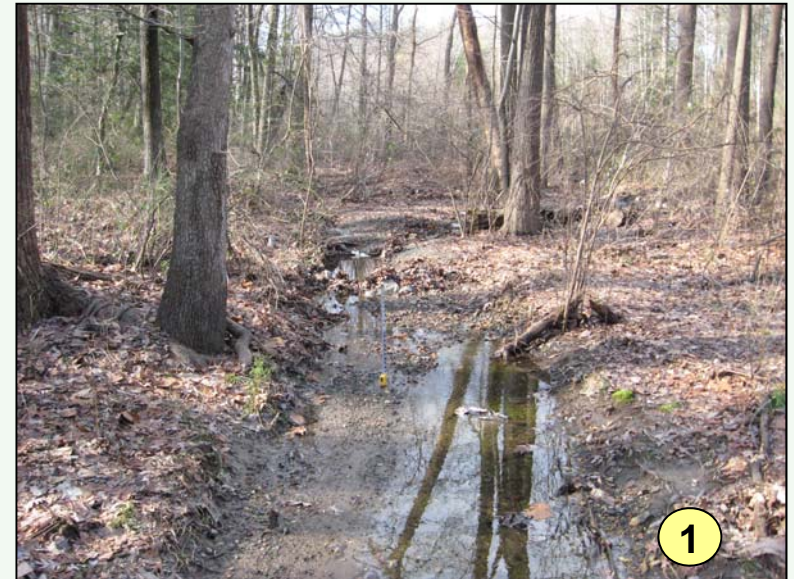
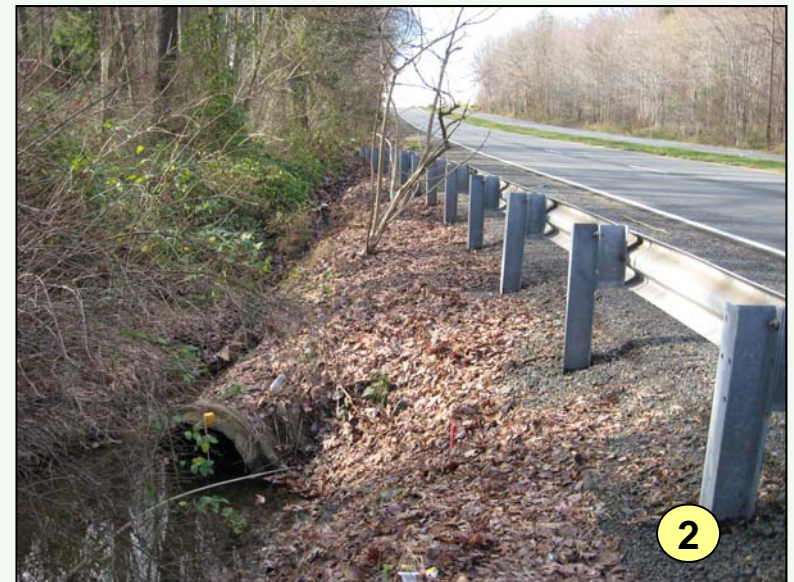
- Upstream of headcut channel is less than 1' deep
- 18" RCP crossing Baron Cameron

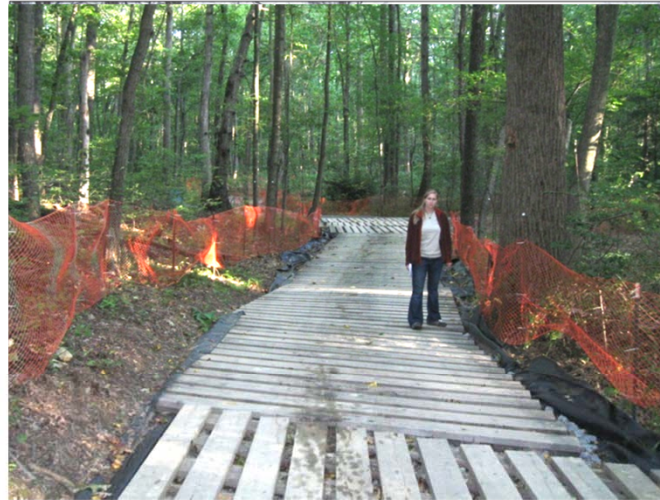
ACCESS ROAD DECK MAT NOT TO SCALE

- NOTES:
1. MAT SHALL BE "DECK MAT" BY CAROLINA MAT INCORPORATED OR APPROVED EQUAL.
 2. MATS SHALL BE INSTALLED SUCH THAT THE SURFACE TIMBER RUNS PARALLEL WITH THE VEHICLE TREAD. SUBSEQUENT MATS SHALL BE INSTALLED SUCH THAT THEY BUTT UP AGAINST EACH OTHER.
