Northern Virginia Stream Restoration Bank Reston Status and Wiehle South Final Plan

September 18, 2012

Wetland Studies and Solutions, Inc.

Wiehle South – Final Plan

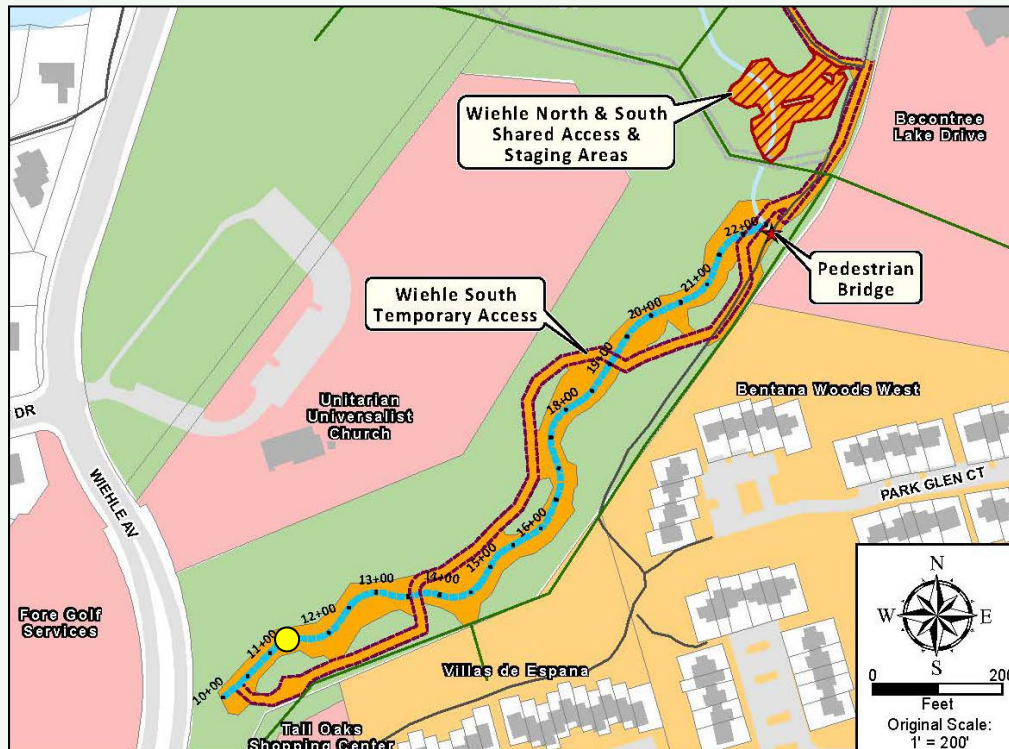
- Vertical banks typical throughout reach.
- Eroded bank at meander – debris jam accumulated since tornado damage.

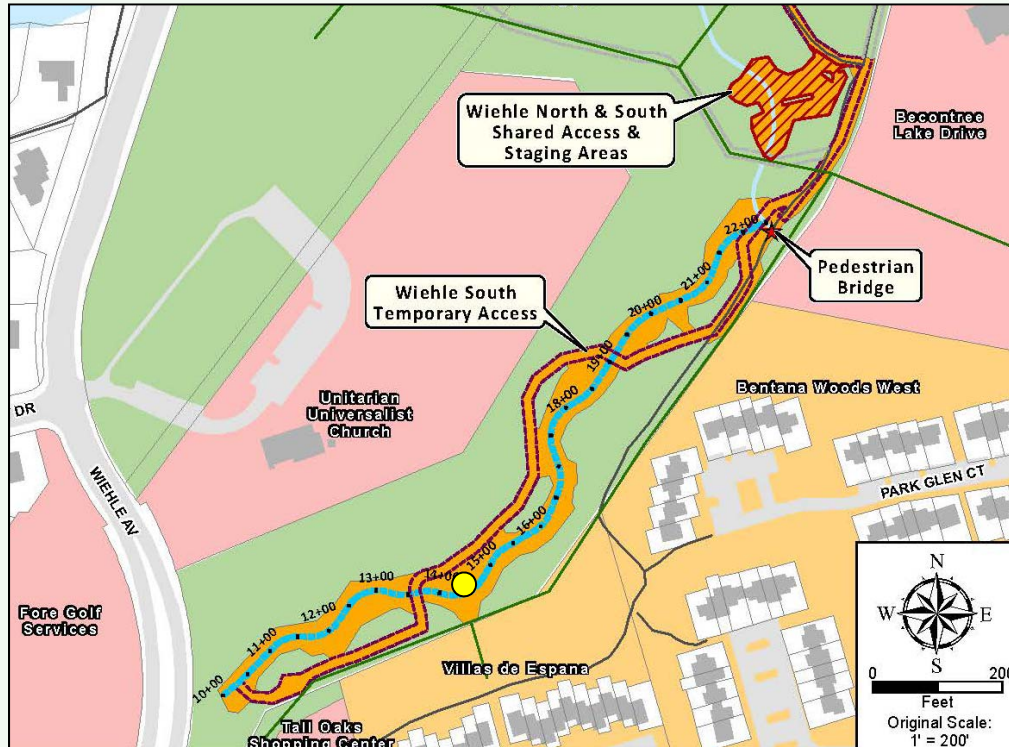
- Tree fall (left bank) at disconnected culvert outfall on the right bank.
