Design: KLS	Draft: KLS	Approved: FRG
Sheet #	6 of 93

Northern Virginia Stream Restoration Bank
 The Glade - Reach 5
 Fairfax County, Virginia

Grading Plan and Longitudinal Profile (cont'd)

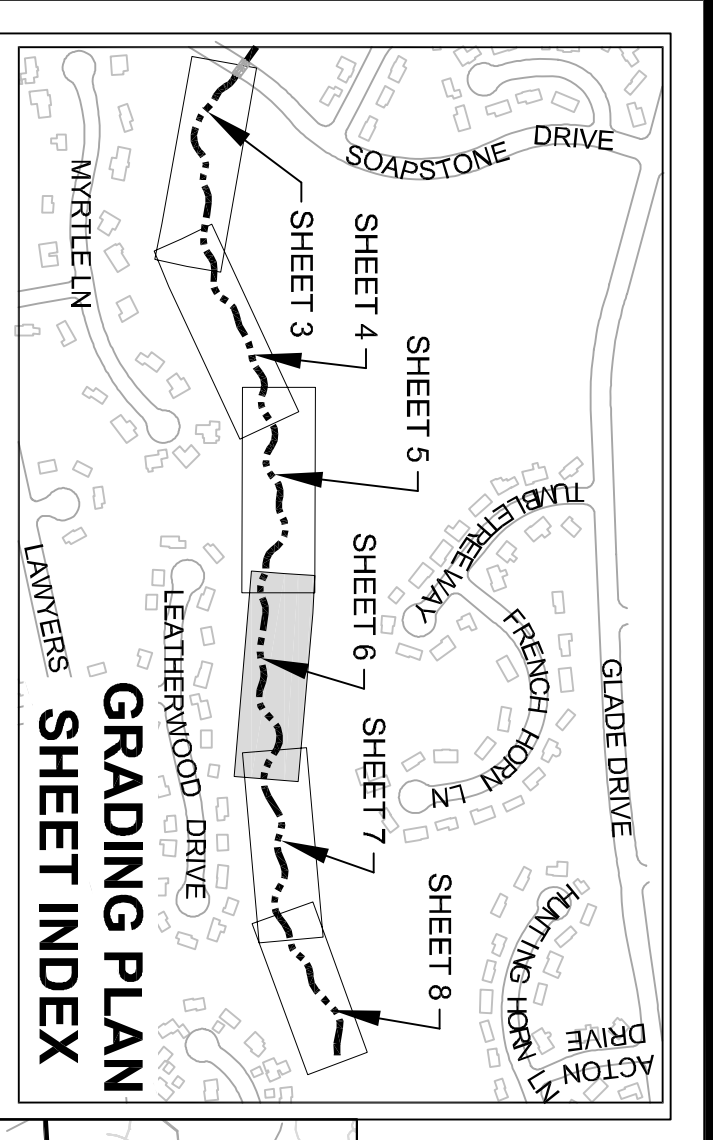
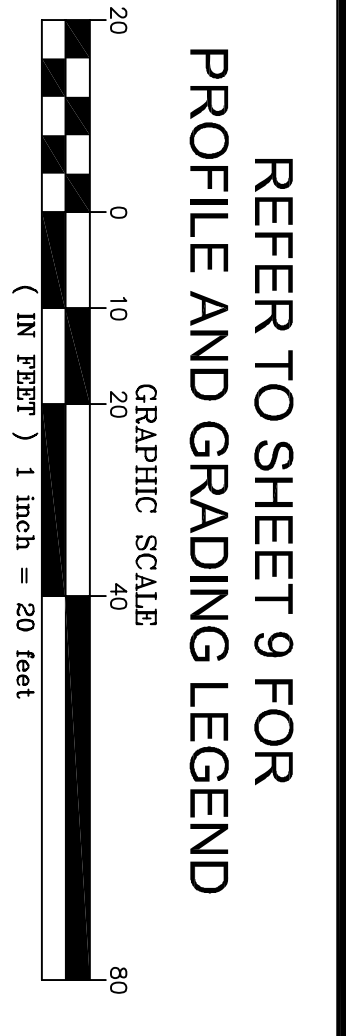
LONGITUDINAL PROFILE - REACH 5 (STA 27+00 TO 32+50)

STABILIZE SWALE WITH REINFORCED BED

LONGITUDINAL PROFILE SCALE: H: 1" = 20' V: 1" = 2'

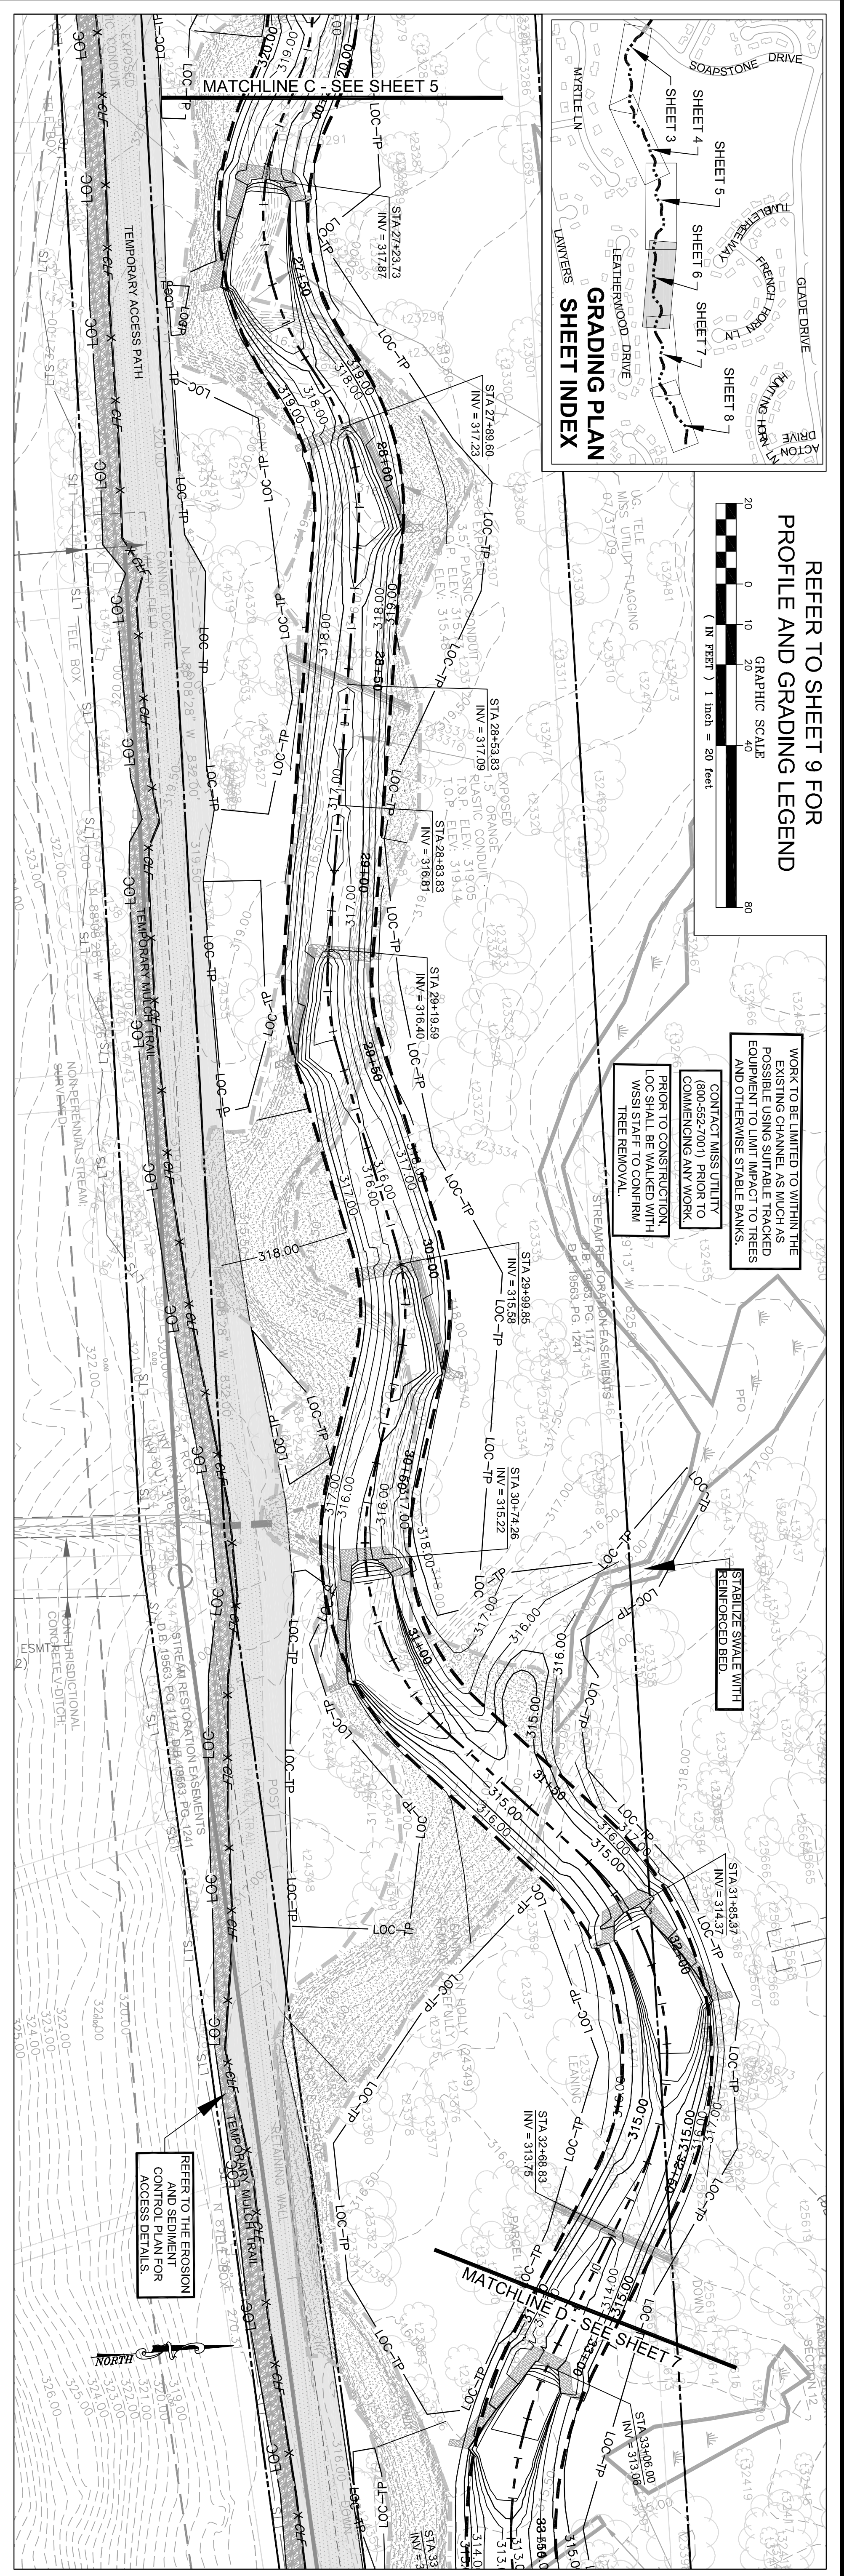
WORK TO BE LIMITED TO WITHIN THE EXISTING CHANNEL AS MUCH AS POSSIBLE USING SUITABLE TRACKED EQUIPMENT TO LIMIT IMPACT TO TREES AND OTHER WILD LIFE BANNS. CONTACT MISS UTILITY (800-555-7001) PRIOR TO COMMENCING ANY WORK. PRIOR TO CONSTRUCTION, LOC SHALL BE WALKED WITH WASSI TREE REMOVAL.

REFER TO THE EROSION AND SEDIMENT CONTROL PLAN FOR ACCESS DETAILS.
