# NORTHERN VIRGINIA STREAM RESTORATION BANK- THE GLADE REACHES 1 & 1A, 2, AND 3

**Presented by Michael S. Rolband**  
**P.E., P.W.S., P.W.D.**

# PROJECT STATUS – GLADE REACHES 1 & 1A, 2, AND 3

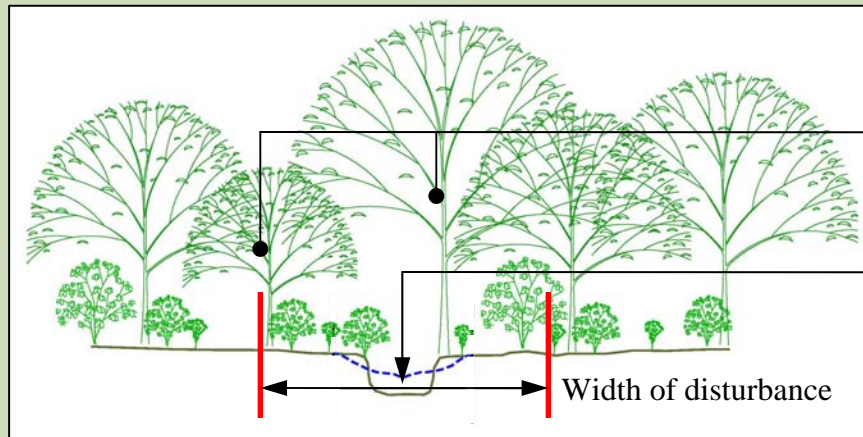
## Snakeden Branch Reach 2 – Priority 1 Restoration

**Priority 1 Restoration** - Raise stream to reconnect with the floodplain.

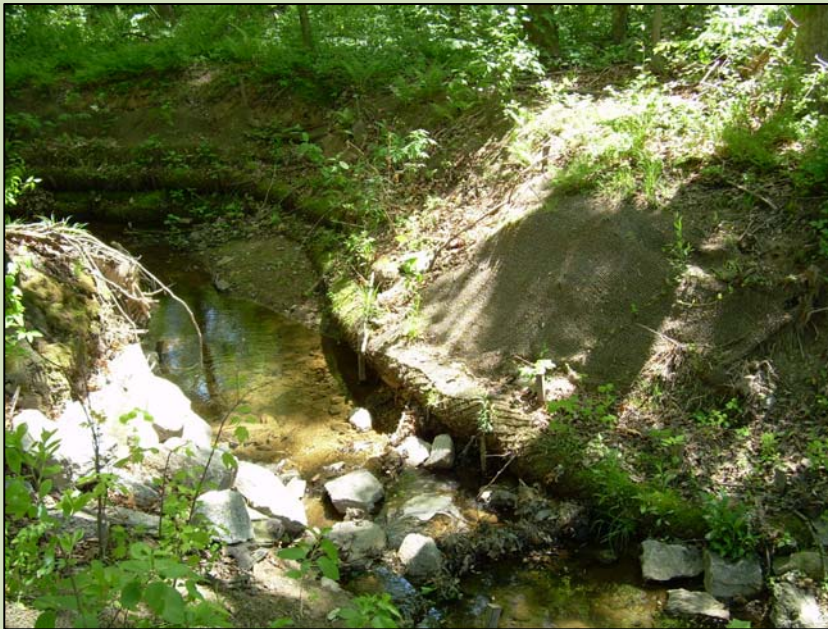
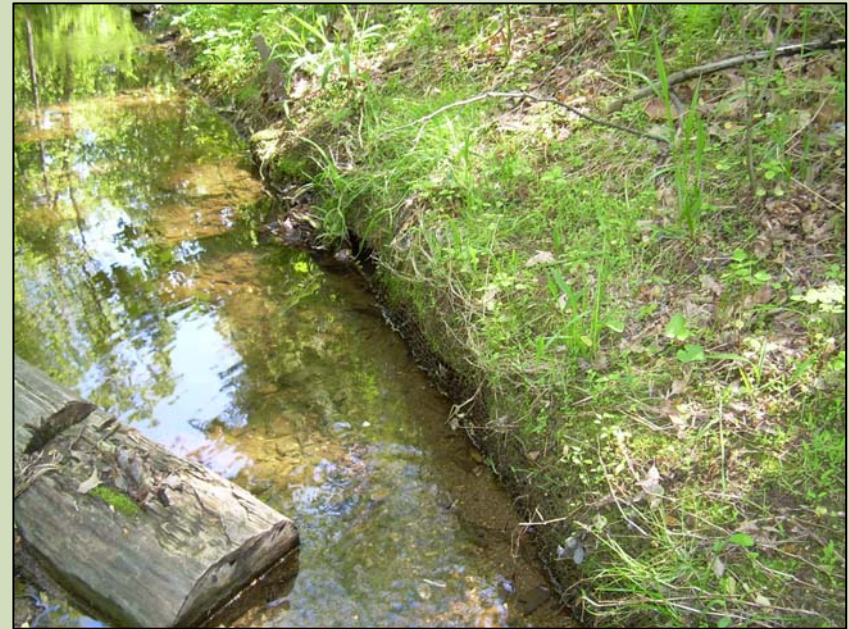
## Priority 4 Restoration – Stabilize in-place

Snakeden Branch Reach 2 (2003, by others) – Long-term stability not achieved using this approach.

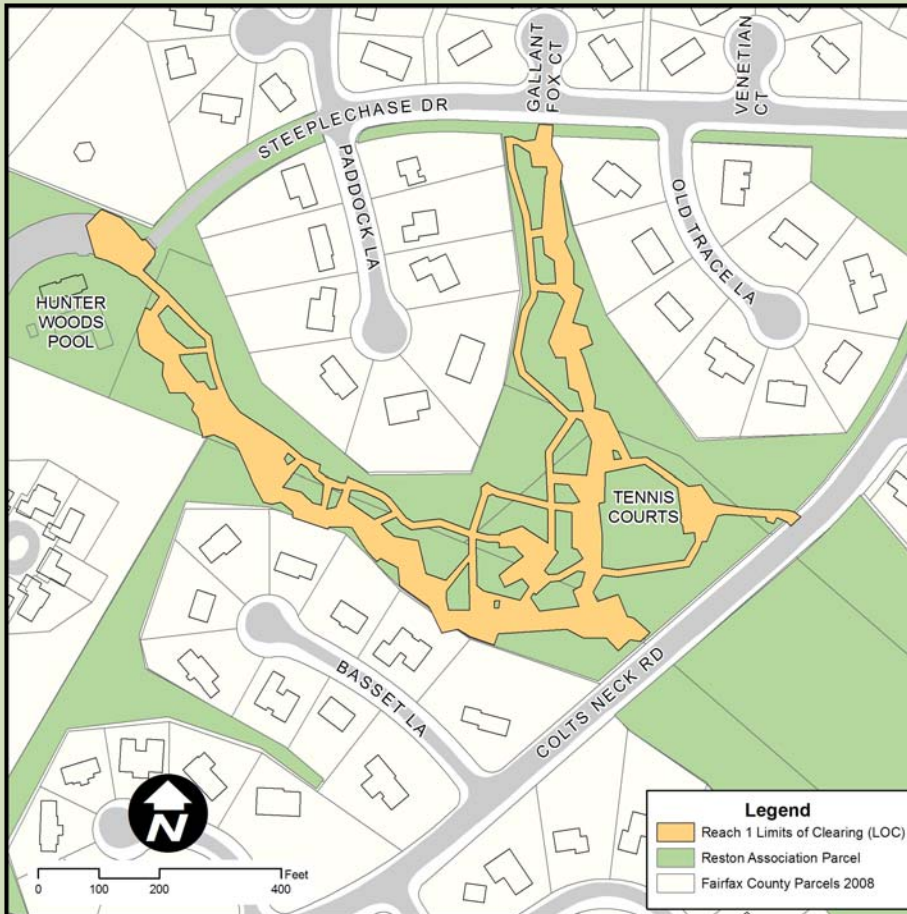
Previous LOC - 2.9 ac

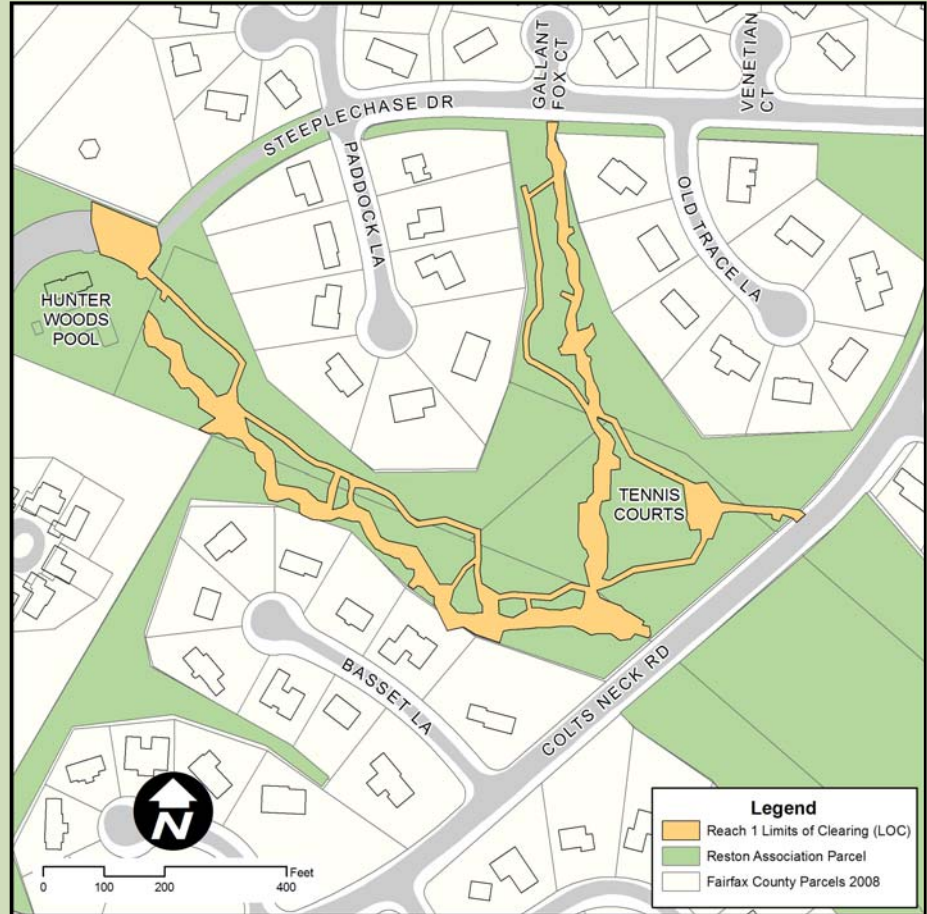
Revised LOC - 2.1 ac

LIMITS OF CLEARING SUMMARY THE GLADE - REACHES 1 & 1A		
<b>Area Within LOC</b>		
Parking	0.30	acres
Trails (paved)	0.11	acres
Trails (unpaved)	0.20	acres
Utility Easement	0.02	acres
Natural Areas	1.5	acres
<b>Total LOC</b>	<b>2.1</b>	<b>acres</b>
<b>Total Easement Area</b>	<b>9.5</b>	<b>acres</b>

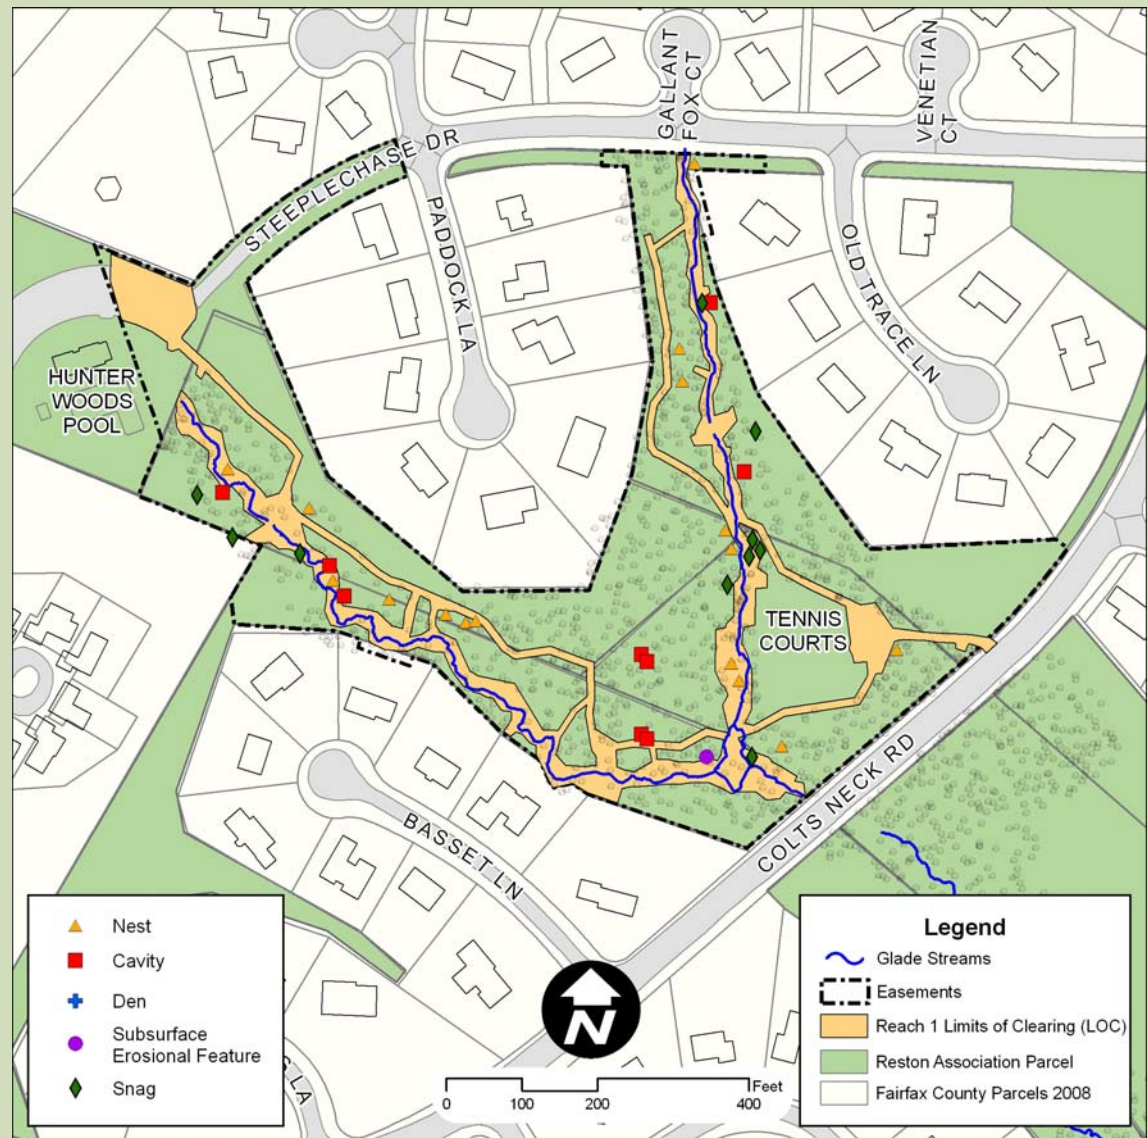
# WILDLIFE EVALUATION – REACHES 1 & 1A

- Woodpecker/Cavity Nest - 6
- Stick Nest - 3
- Squirrel Nest - 5
- Redshouldered Hawk Nest - 3
- Fox (Subsurface Run) - 3
- Snag - 5

- squirrel nest
- inactive cavity

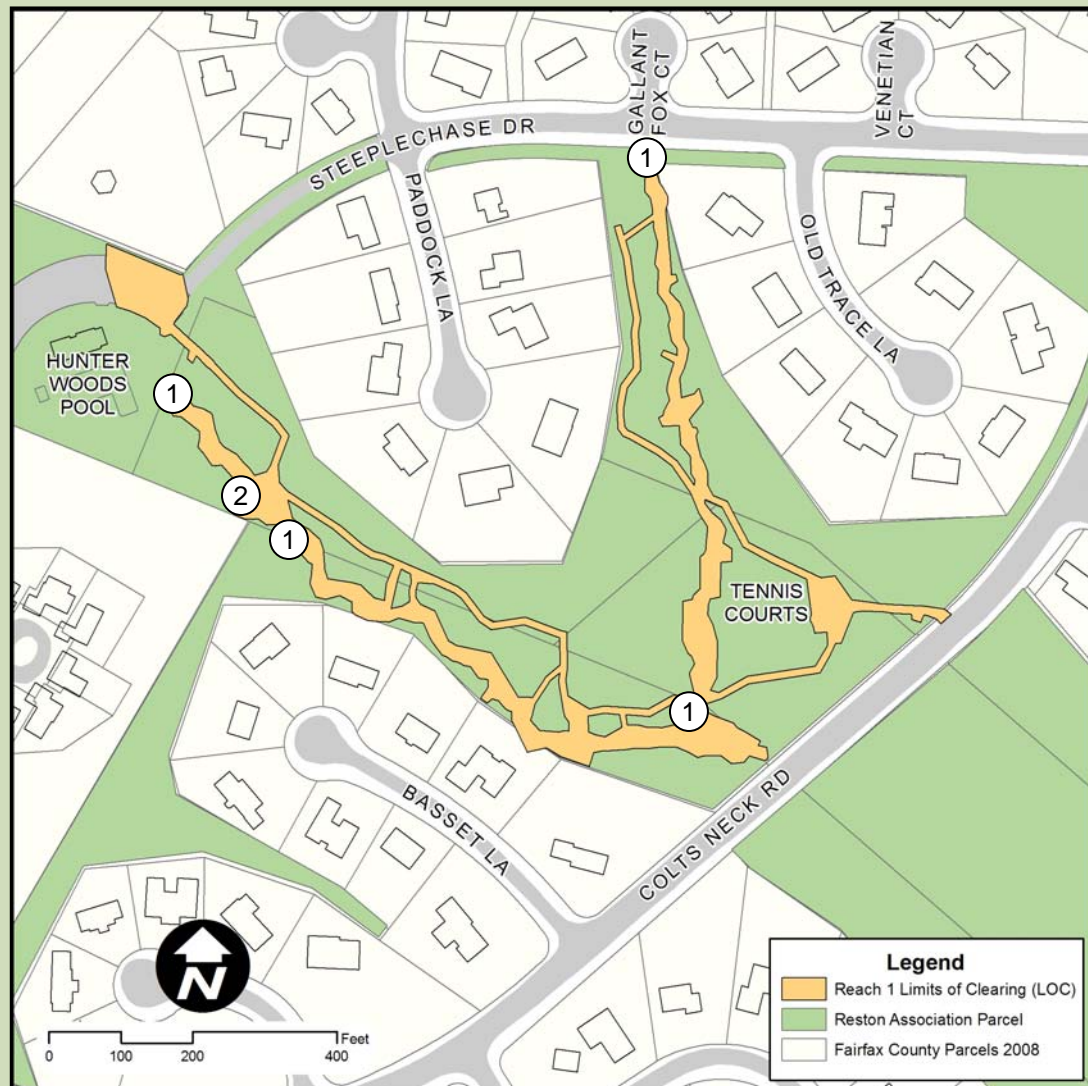
# DESIGN REFINEMENTS - REACHES 1 & 1A

- ① Wall features to protect trees.
- ② Bridge adjustment/relocation.

*Note : Structures may also be field modified as necessary to reduce impacts to adjacent trees.*

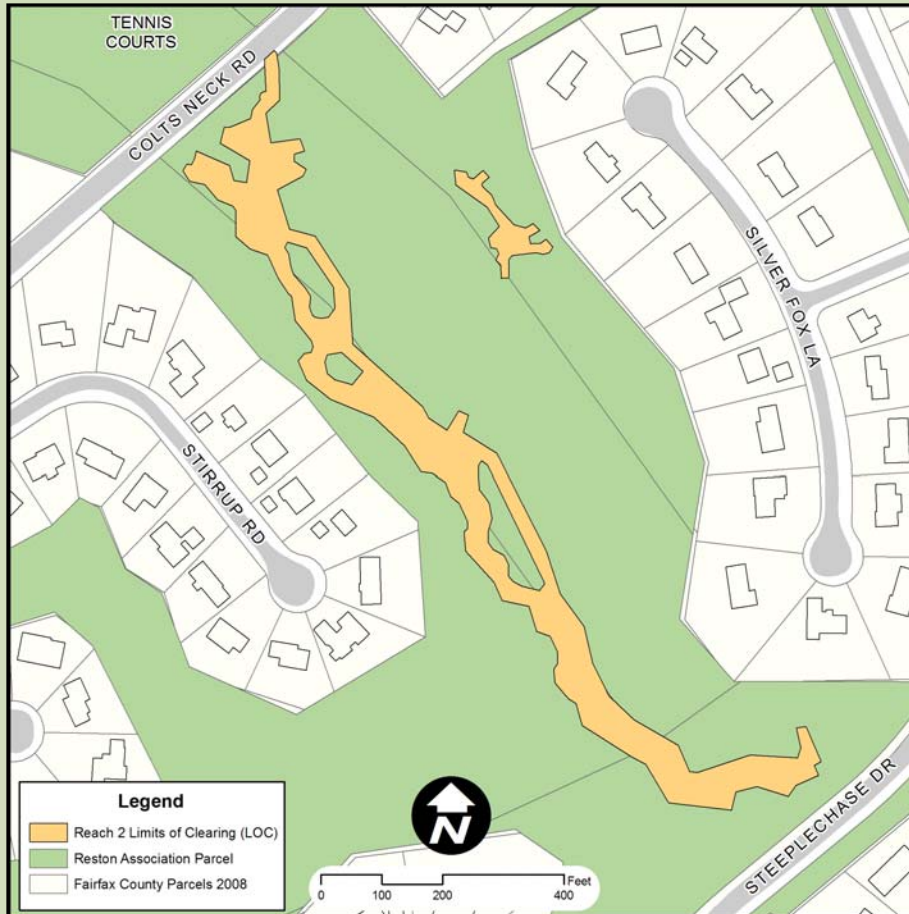
Previous LOC – 3.5 ac

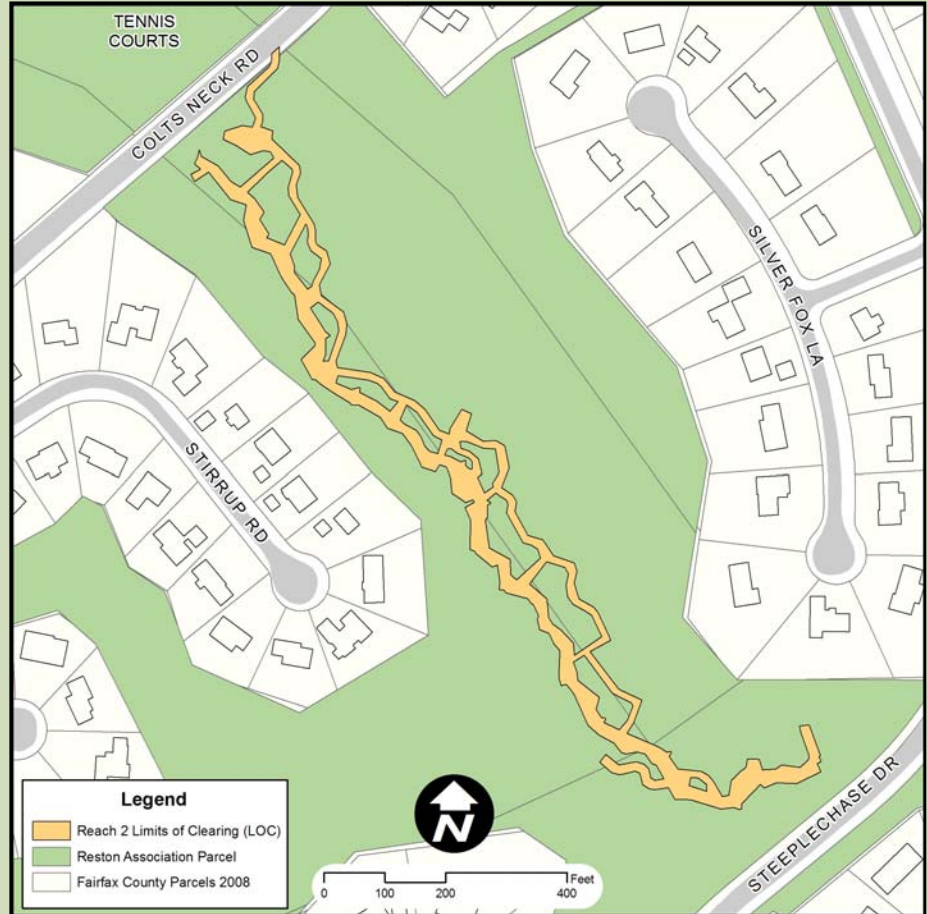
Revised LOC – 1.7 ac

LIMITS OF CLEARING SUMMARY THE GLADE - REACH 2		
<b>Area Within LOC</b>		
Trails (unpaved)	0.03	acres
Trails (paved)	0.02	acres
Utility Easements	0.03	acres
Natural Areas	1.6	acres
<b>Total LOC</b>	<b>1.7</b>	<b>acres</b>
<b>Total Easement Area</b>	<b>16.0</b>	<b>acres</b>

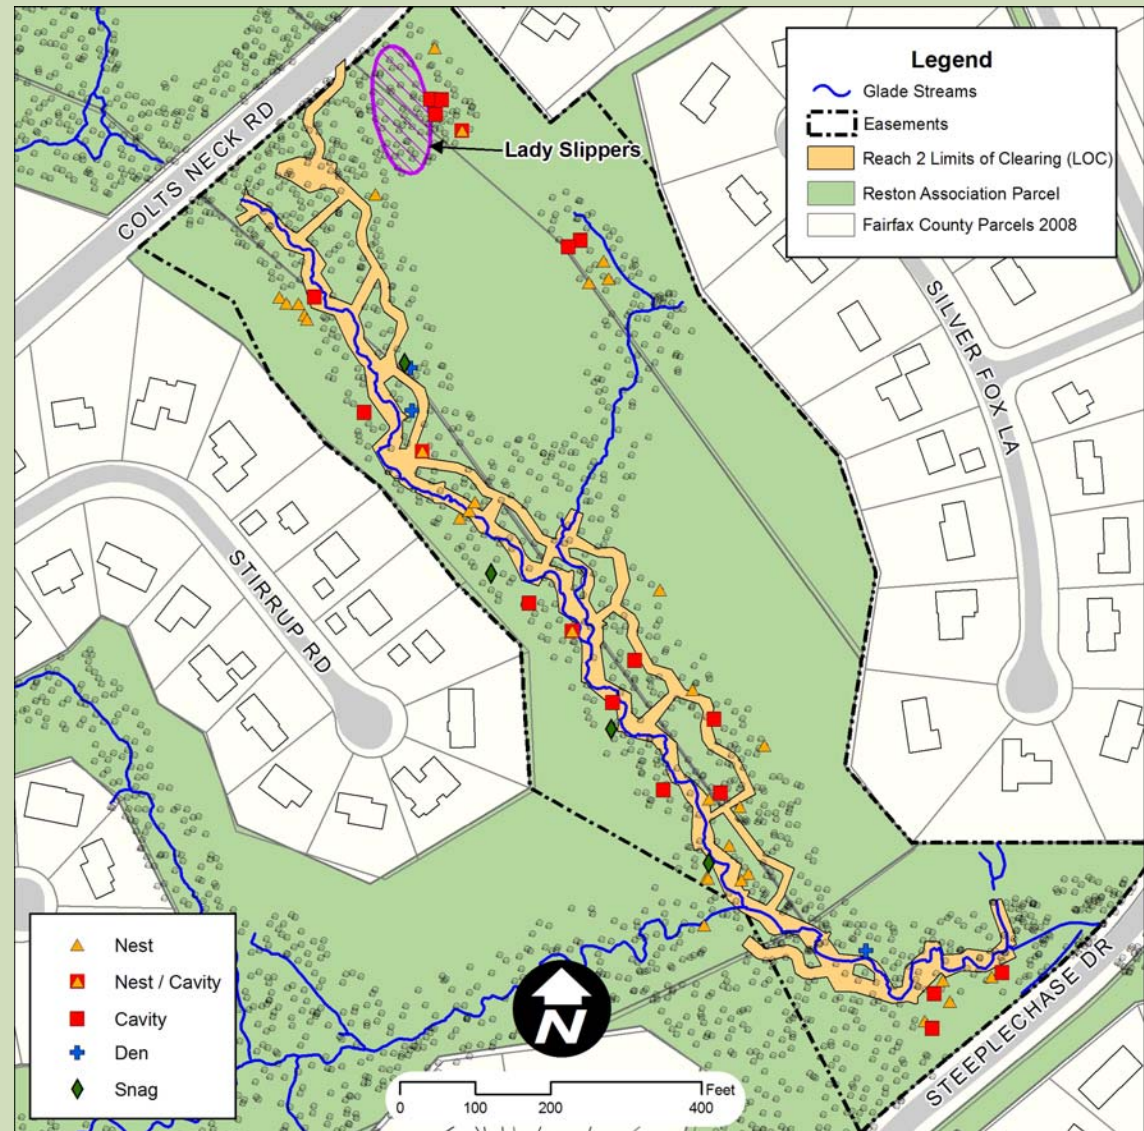
# WILDLIFE EVALUATION – REACH 2

- Woodpecker/Cavity Nest - 20
- Stick Nest - 4
- Squirrel Nest - 27
- Unknown Den - 3
- Snag - 4

- inactive cavity in snag

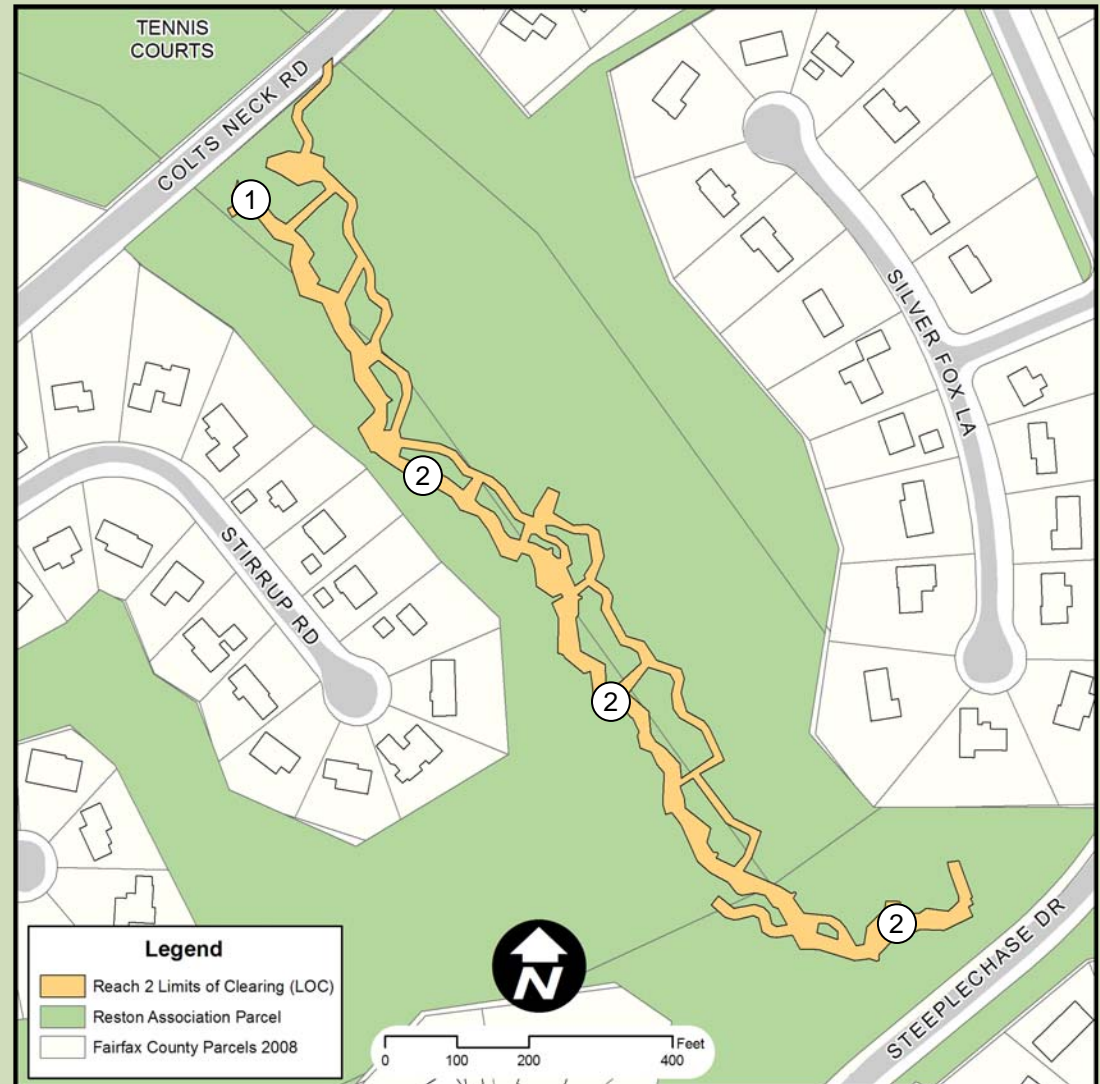
# DESIGN REFINEMENTS - REACH 2

- ① Wall feature to protect trees.
- ② Channel realignment area.

*Note : Structures may also be field modified as necessary to reduce impacts to adjacent trees.*

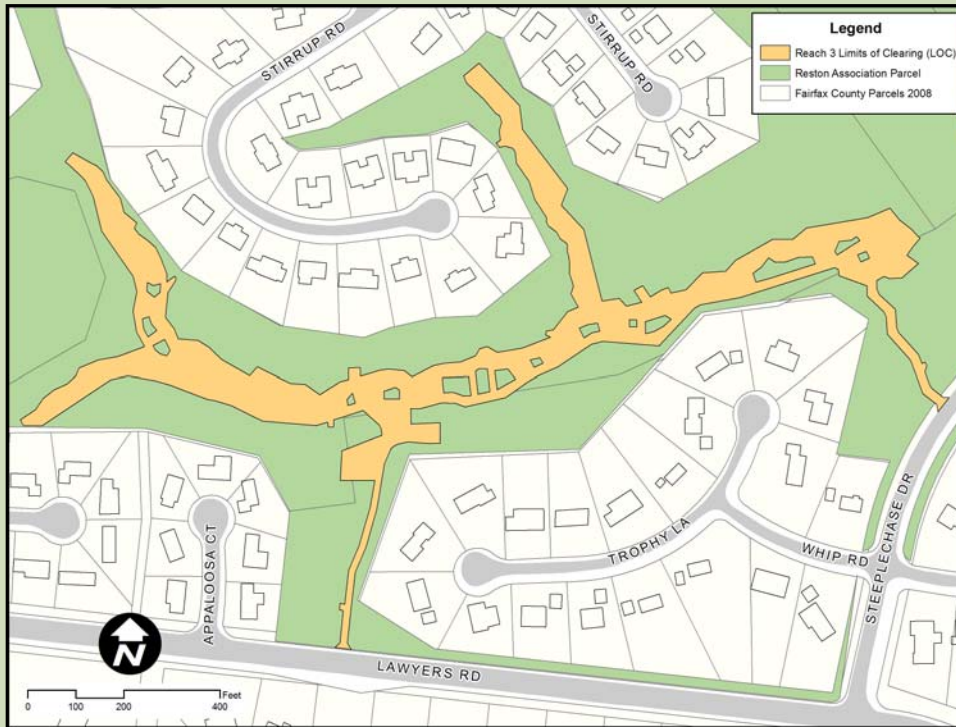
Previous LOC - (5.2 ac)

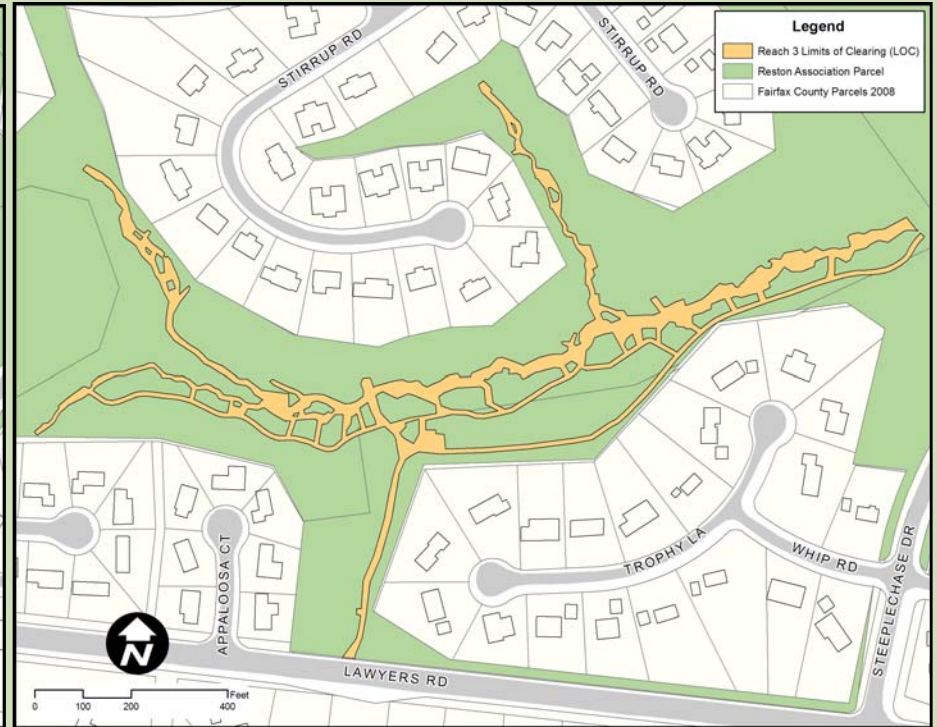
Revised LOC - (2.7 ac)

LIMITS OF CLEARING SUMMARY THE GLADE - REACH 3		
<b>Area Within LOC</b>		
Trails (paved)	0.04	acres
Trails (unpaved)	0.60	acres
Utility Easement	0.09	acres
Natural Areas	2.0	acres
<b>Total LOC</b>	<b>2.7</b>	<b>acres</b>
<b>Total Easement Area</b>	<b>20.7</b>	<b>acres</b>

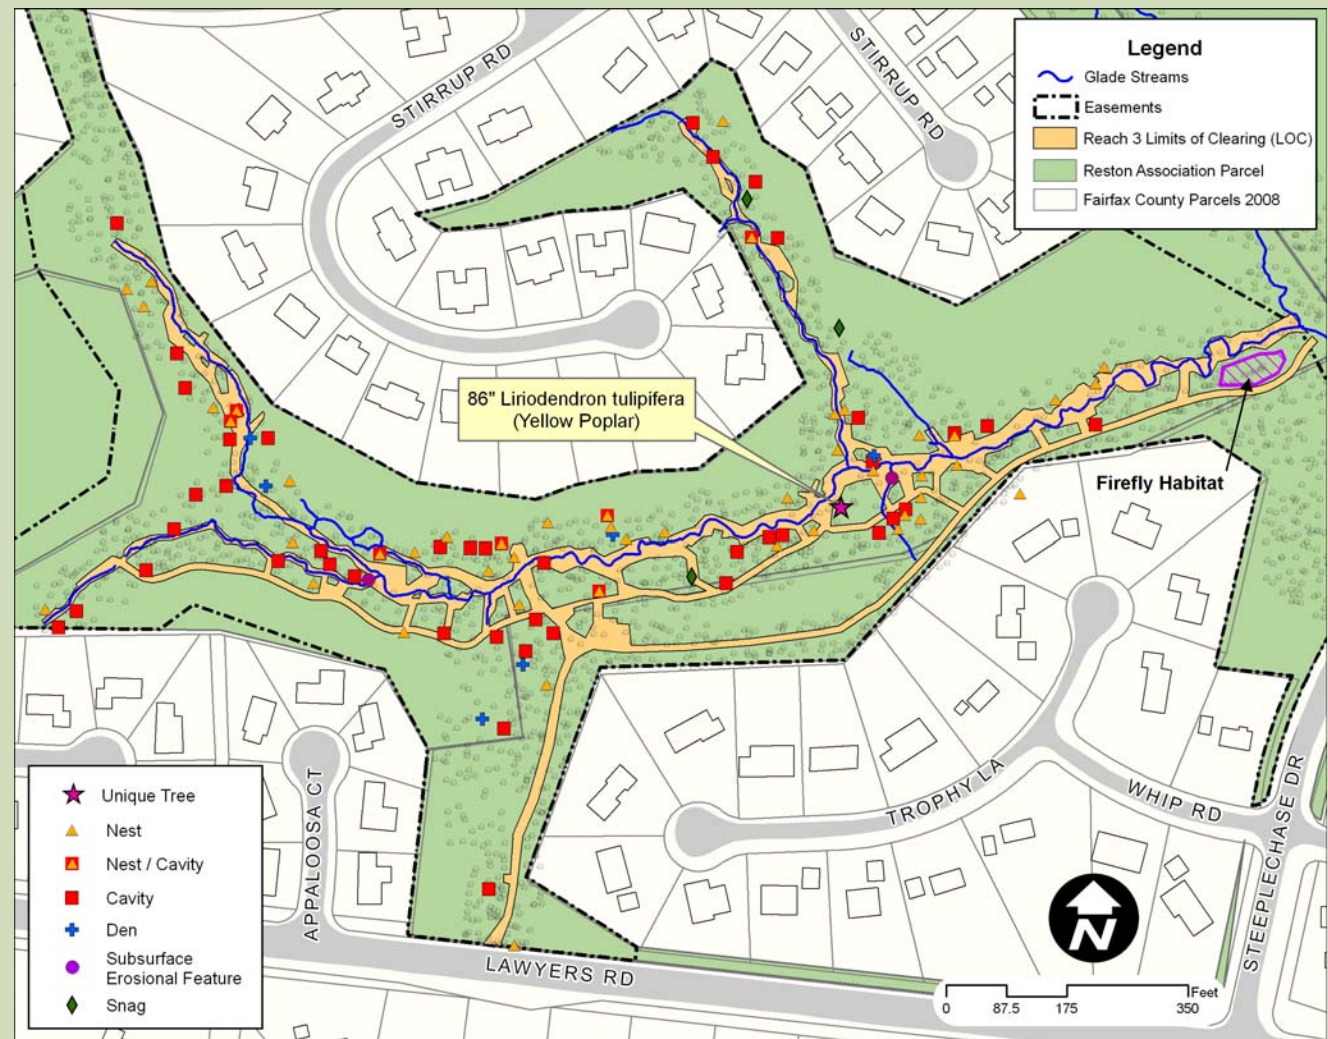
# WILDLIFE EVALUATION – REACH 3

- Woodpecker/Cavity Nest - 49
- Stick Nest - 17
- Squirrel Nest - 29
- Subsurface Run - 2
- Snag - 3
- Den in Deadfall - 6
- Song Bird Nest - 1

- inactive song bird nest
- inactive subsurface run
- snag in live tree
- stick nest and cavity in snag.

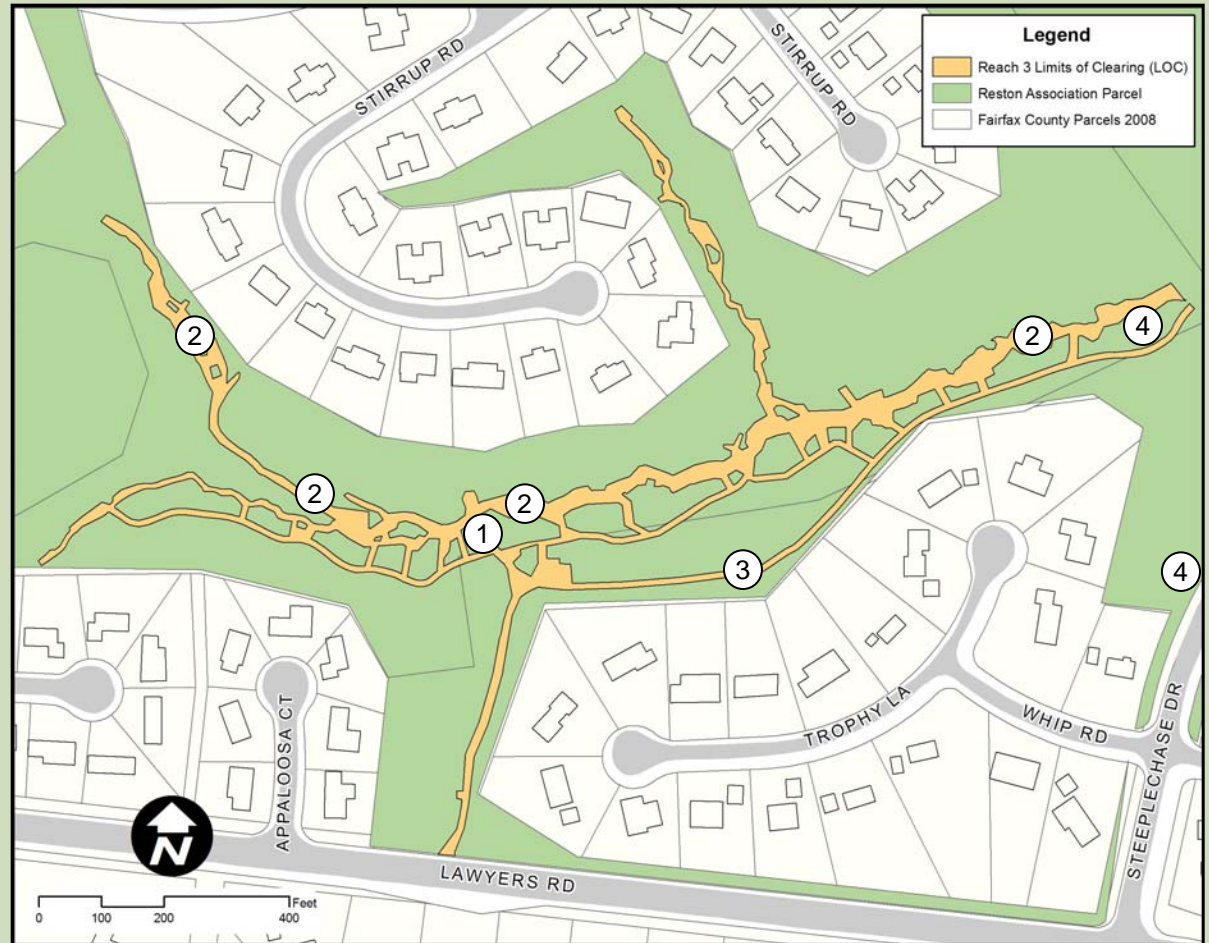
# DESIGN REFINEMENTS - REACH 3

- ① Bridge Realignment.
- ② Channel realignment area.
- ③ Greater use of trails for access.
- ④ Remove Entrance and Stockpile Area.

*Note : Structures may also be field modified as necessary to reduce impacts to adjacent trees.*

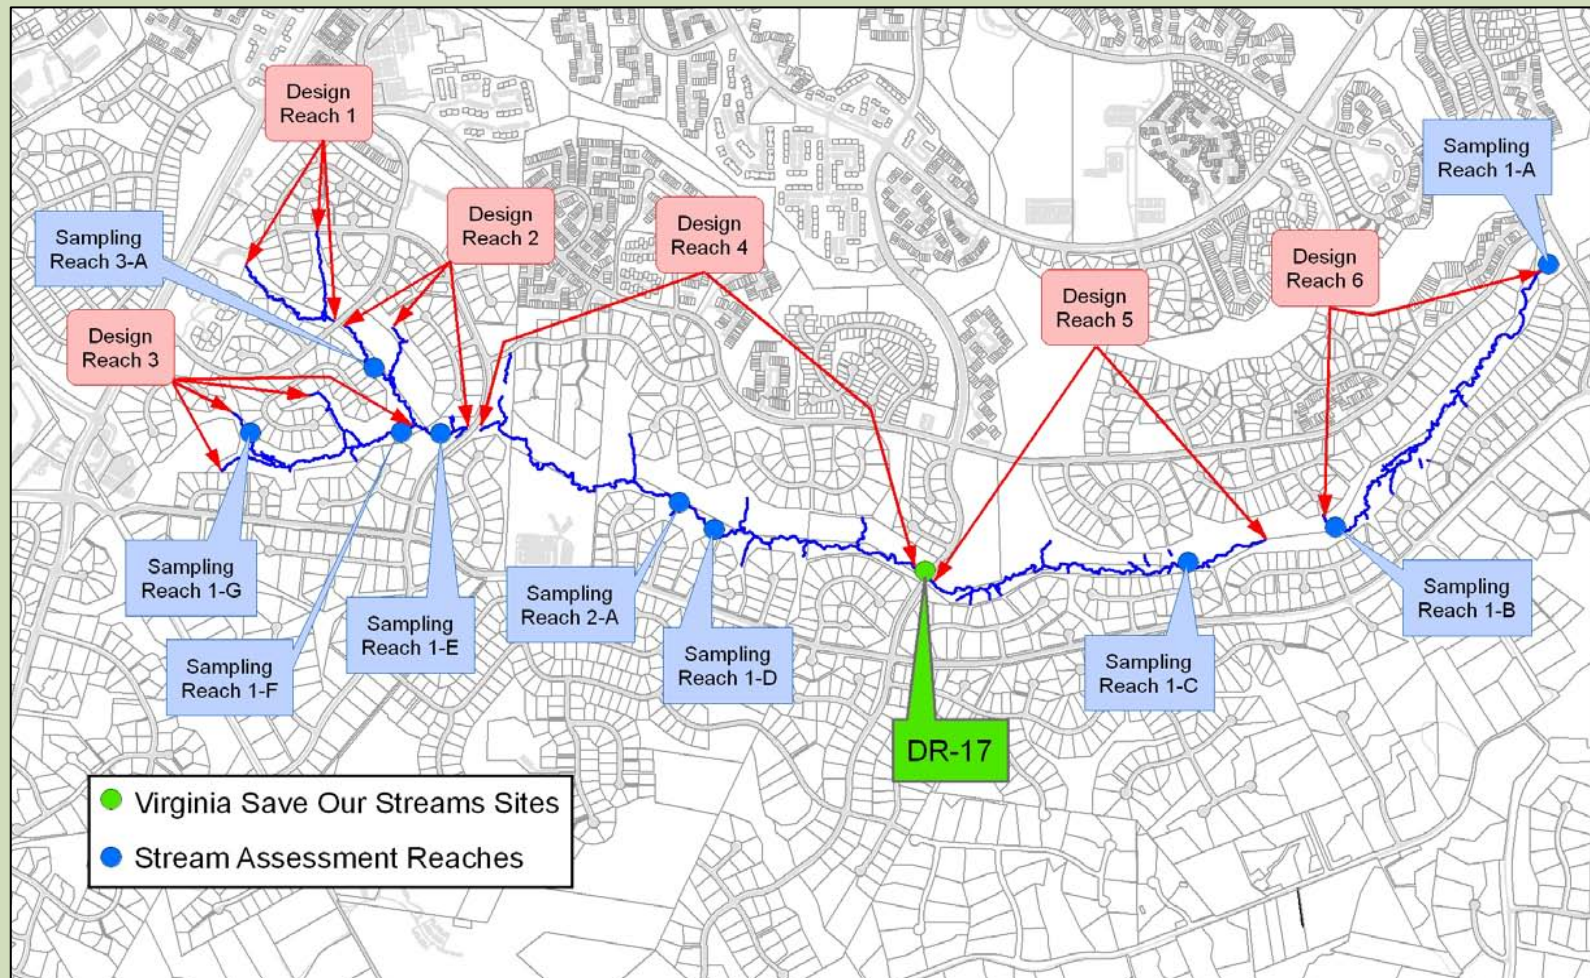
# BASILINE BIOLOGICAL STREAM MONITORING LOCATION MAP

**The location of WSSI's biological monitoring reaches and Virginia Save Our Streams sites in relation to the stream restoration design reaches in The Glade watershed.**

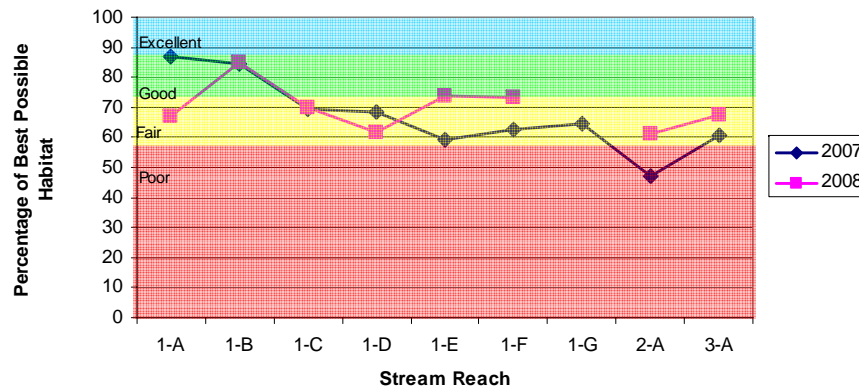
**Comparison of Habitat Assessment Scores for 2007 and 2008  
Pre-construction Monitoring for The Glade**

- WSSI conducting long-term biological stream monitoring - habitat and benthic macroinvertebrates.
- 2007 and 2008 Baseline Results - stream habitat on average is “Fair” and the benthic macroinvertebrate community is in “Severe stress” prior to restoration.
- Virginia Save our Streams data from The Glade indicates “Unacceptable Ecological Condition”.

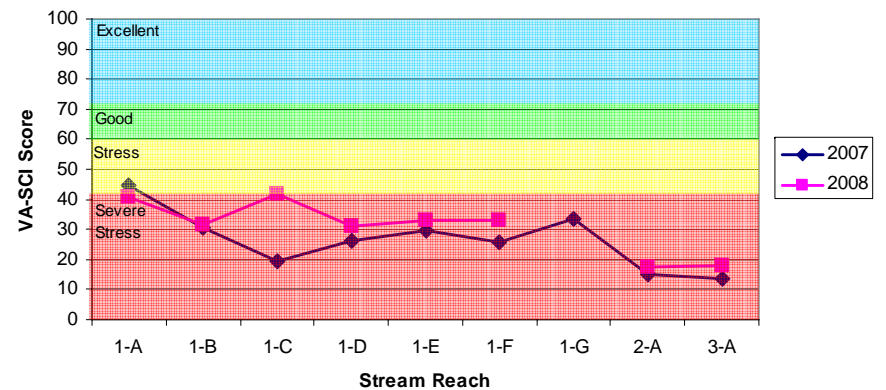
**Comparison of Virginia Stream Condition Index Scores for  
2007 and 2008 Pre-construction Monitoring for The Glade**

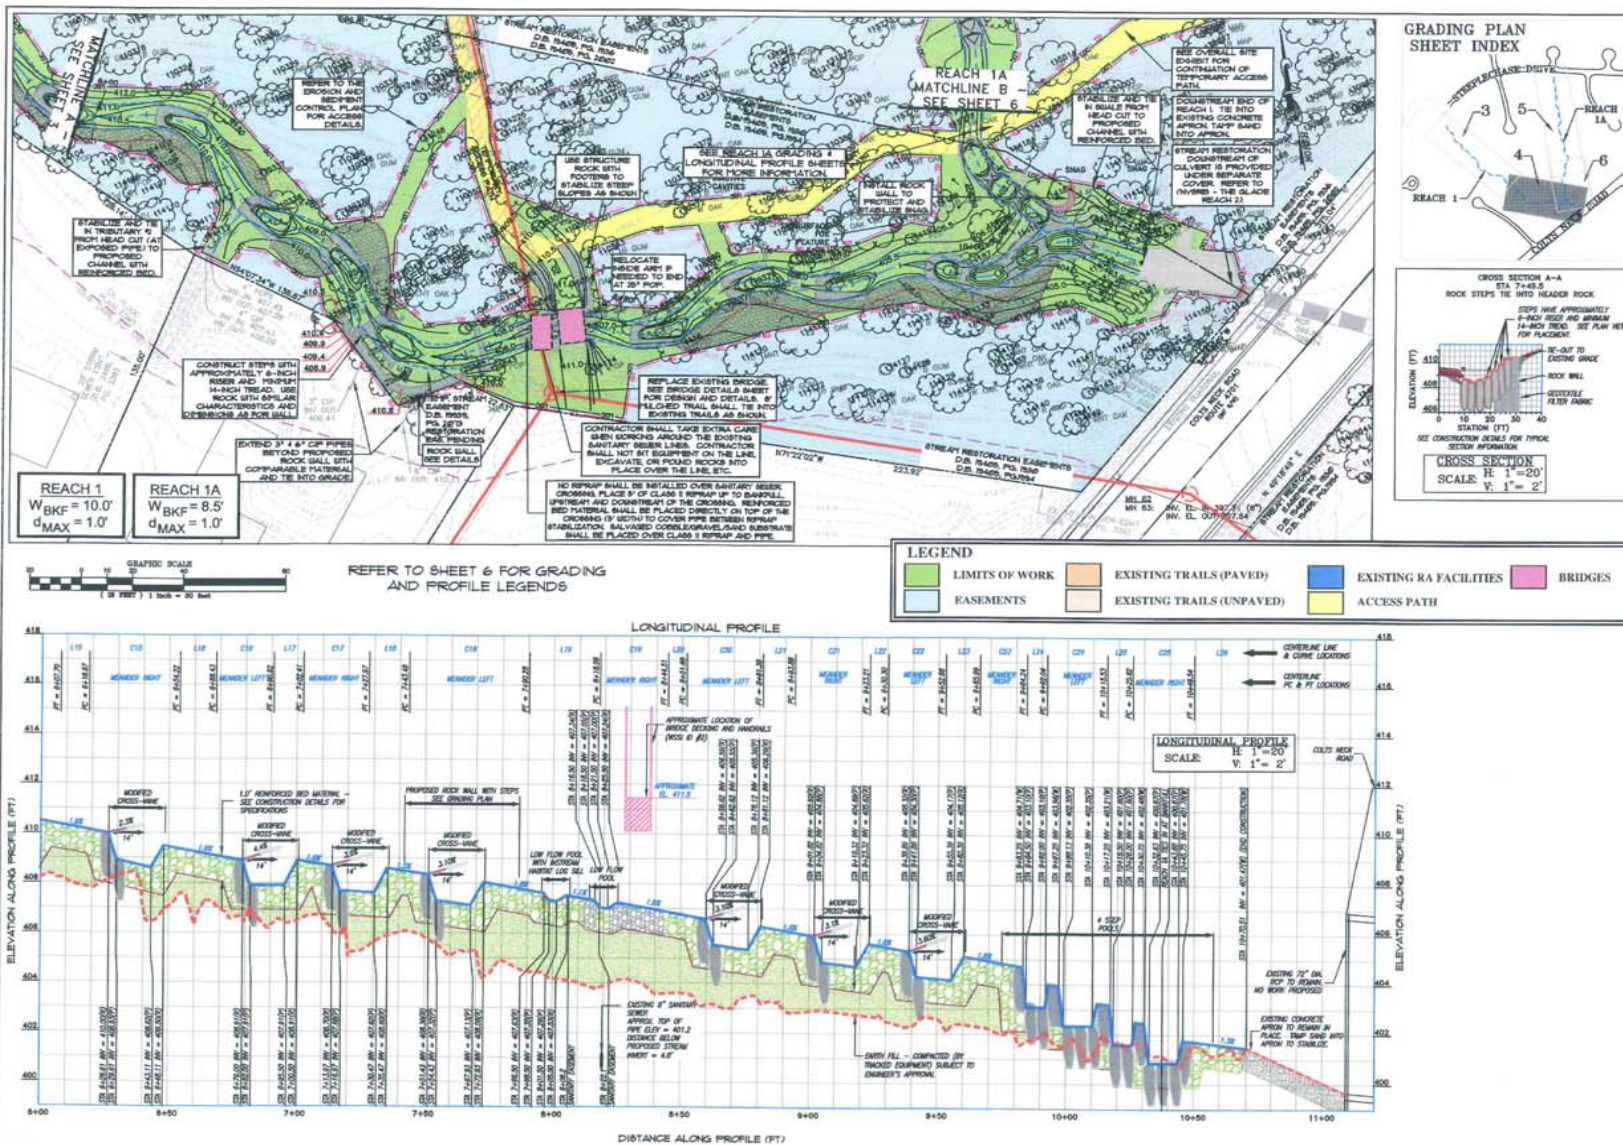
# TYPICAL GRADING PLAN - REACHES 1 & 1A

Reach 1 Grading Plan and Longitudinal Profile (cont'd)

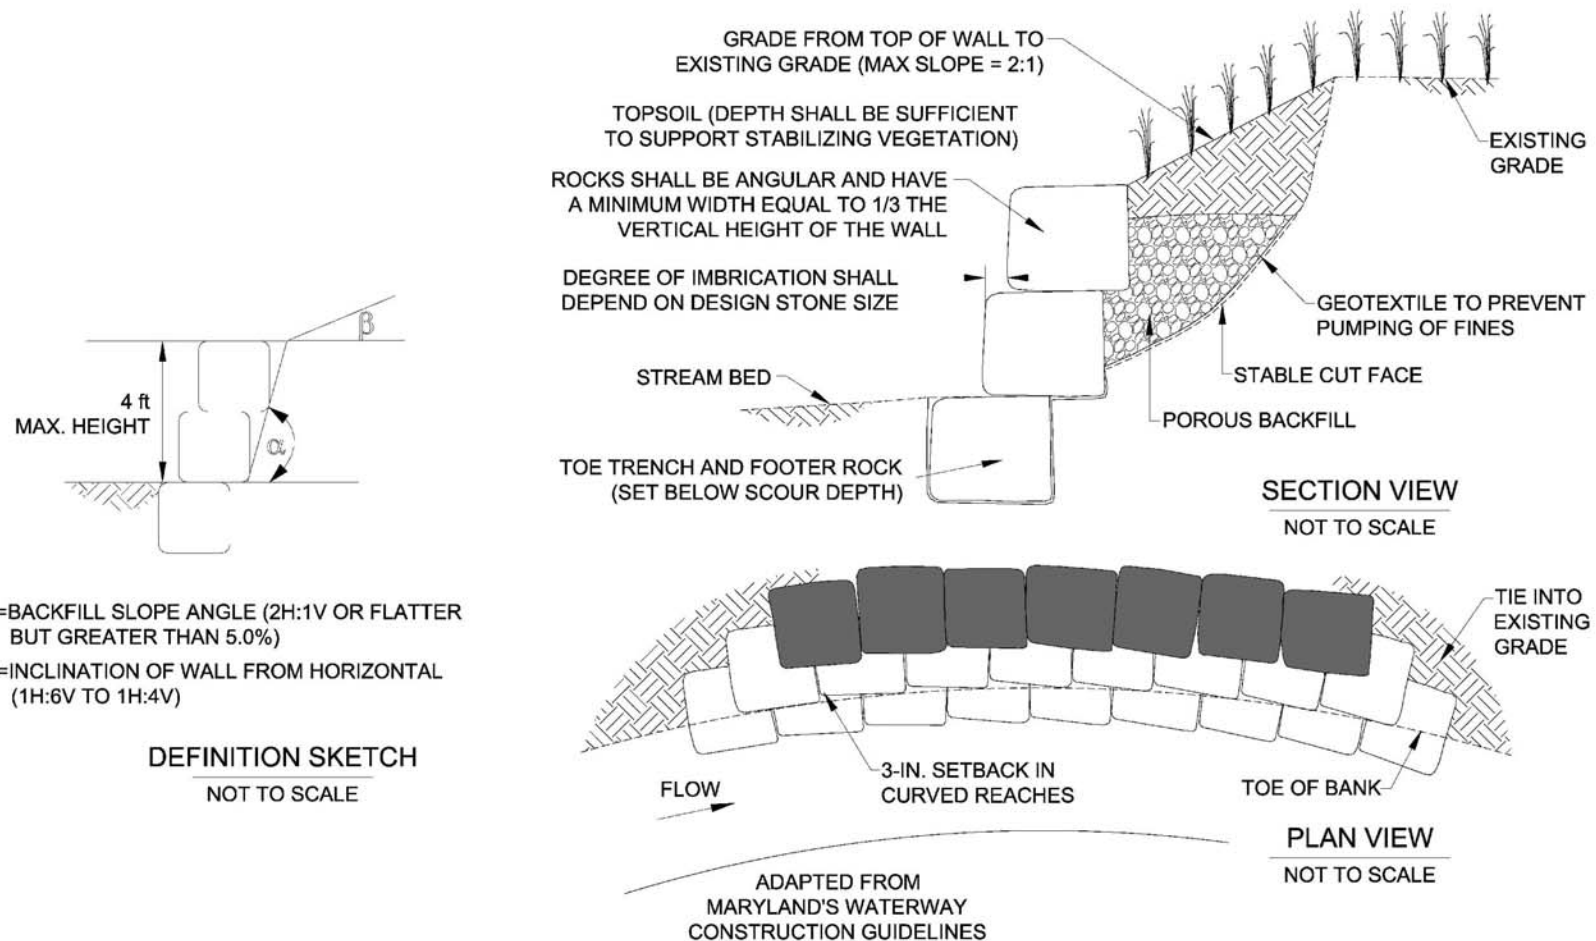
**IMBRICATED RIPRAP WALL**  
NOT TO SCALE

CONSTRUCTION NOTE:  
STONE BLOCKS SHALL BE ROTATED INTO THE BANK DURING PLACEMENT SUCH THAT THE UPSTREAM BLOCKS OVERLAP THE DOWNSTREAM BLOCKS BY A MINIMUM OF 3 INCHES.
