NORTHERN VIRGINIA STREAM RESTORATION BANK THE GLADE REACHES 5 & 6 PRELIMINARY PLAN

AUGUST 18, 2009

THE GLADE – REACHES 5 & 6

PURPOSE OF PRELIMINARY PLAN

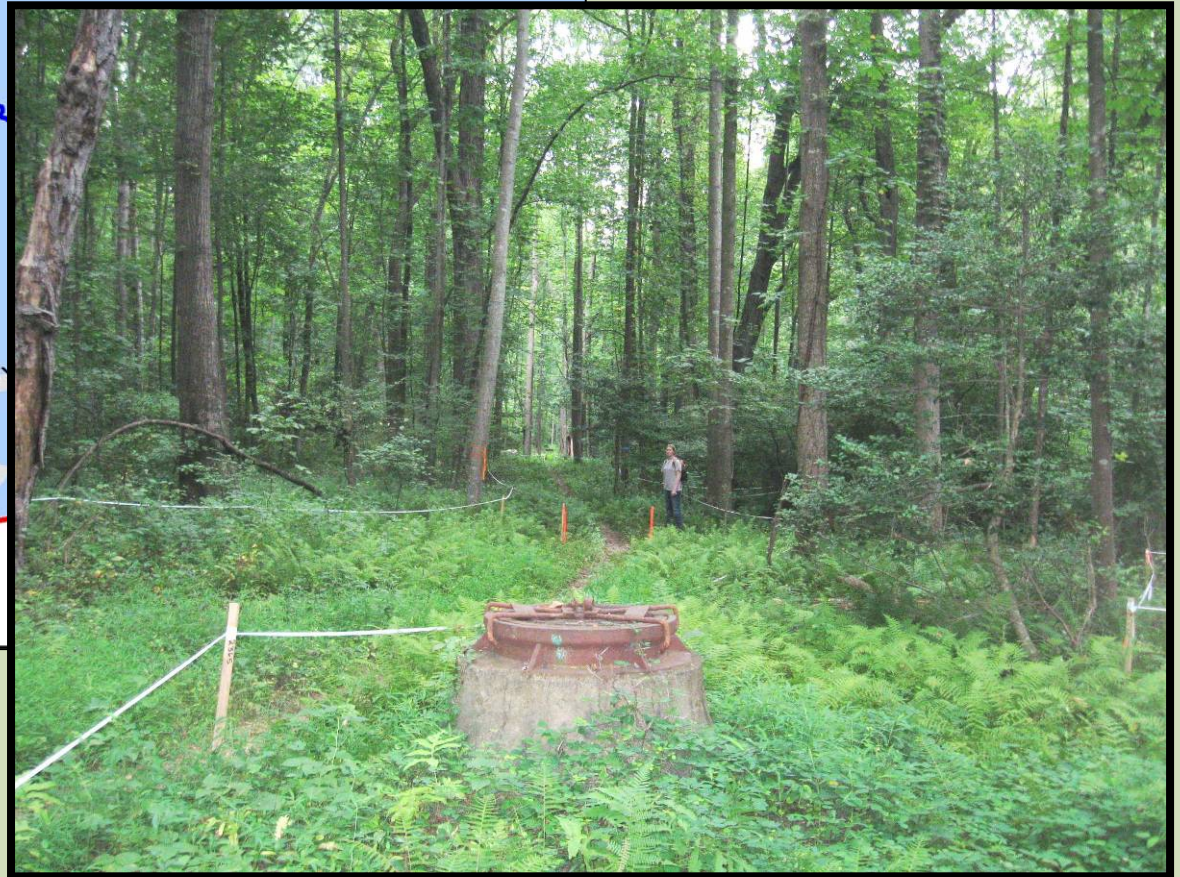
EXISTING SANITARY SEWER EASEMENT / ACCESS PATH THE GLADE REACH 5

ACCESS ROAD DECK MAT

ACCESS ROAD DECK MAT NOT TO SCALE

NOTES:
1. MAT SHALL BE "DECK MAT" BY CAROLINA MAT INCORPORATED OR APPROVED EQUAL.

2. MATS SHALL BE INSTALLED SUCH THAT THE SURFACE TIMBER RUNS PARALLEL WITH THE VEHICLE TREAD. SUBSEQUENT MATS SHALL BE INSTALLED SUCH THAT THEY BUTT UP AGAINST EACH OTHER.

EXAMPLE INSTALLATION USING 10' WIDE DECK MAT

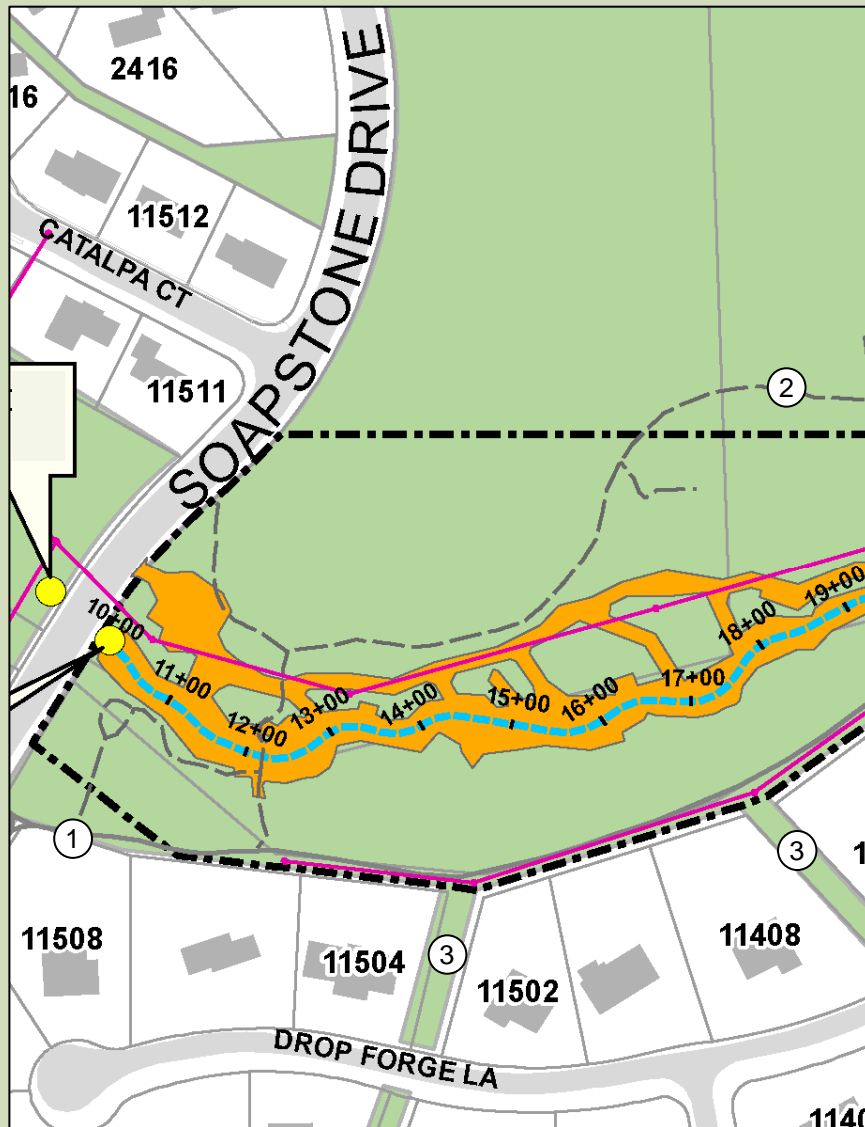
ACCESS OPTIONS CONSIDERED

- ① Using this Paved Path would disturb established native flower garden & disrupt pedestrian access
- ② Using this Paved Path would also disrupt pedestrian access & is too far from stream in many areas (requires long cut-ins)
- ③ Using these narrow access points require tree removal, disturbs residents, and has no suitable staging areas.

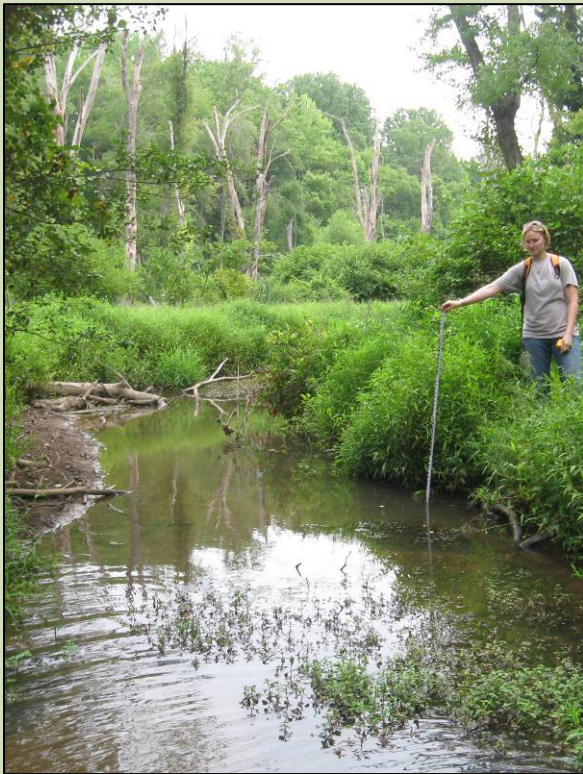
**Reach 5 ties into Beaver Area
where incision ends and marsh area begins**

Immediately downstream
of Reach 5

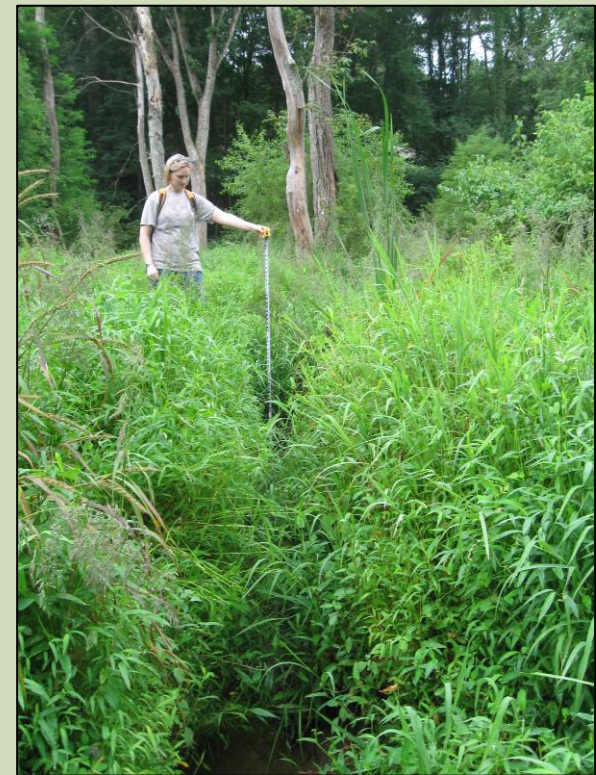
Marsh Area

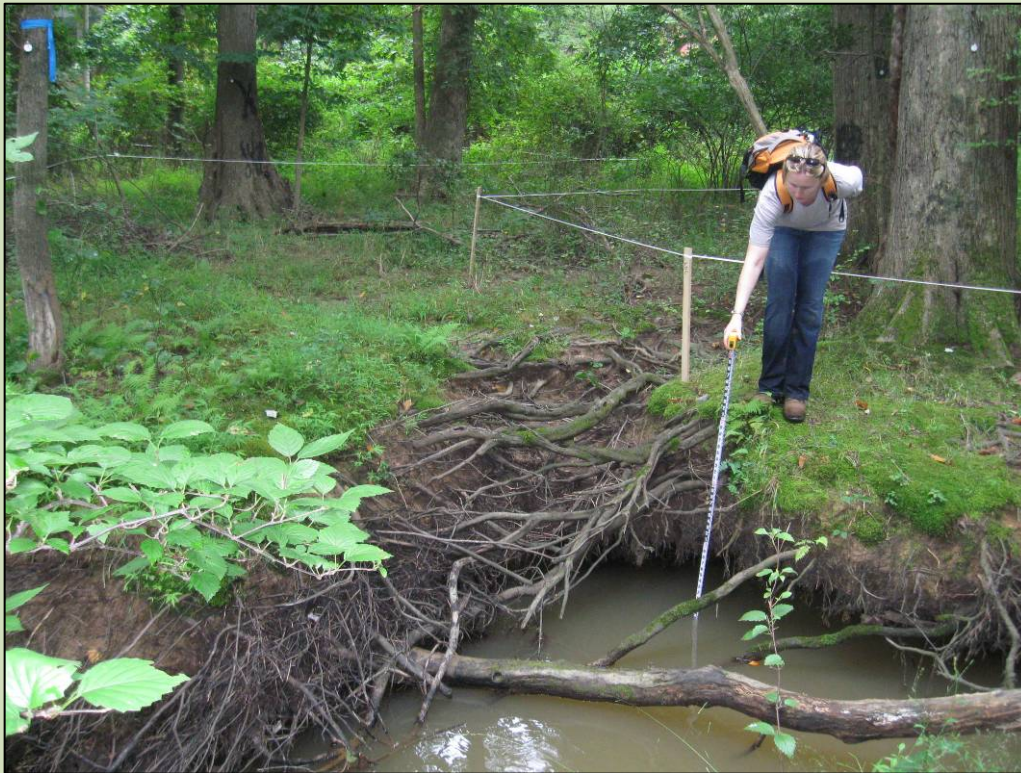
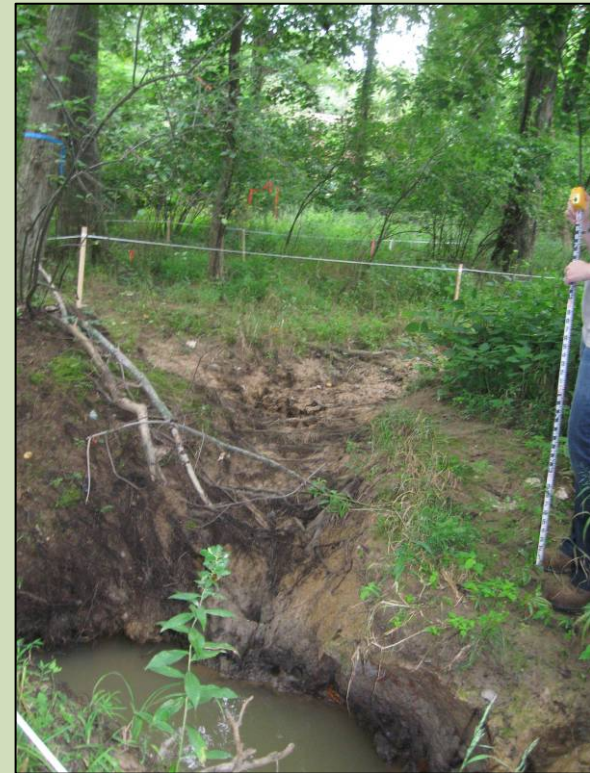
BEAVER AREA

**Reach 6 starts at 3 headcuts,
650 ft downstream of Reach 5**

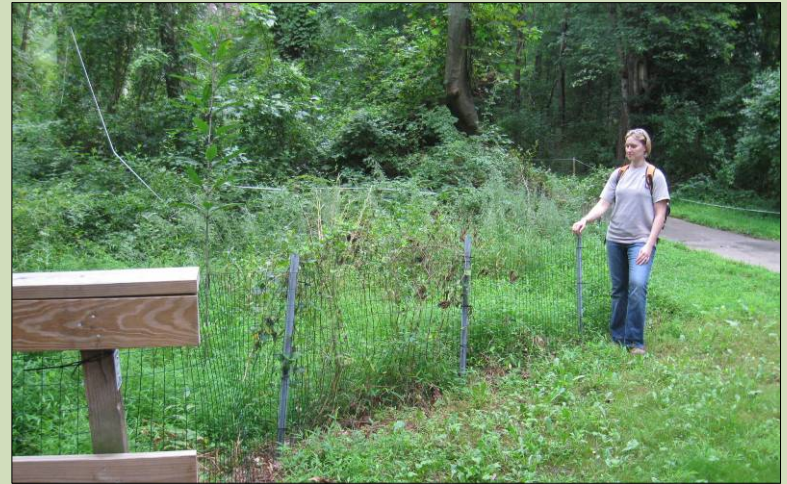
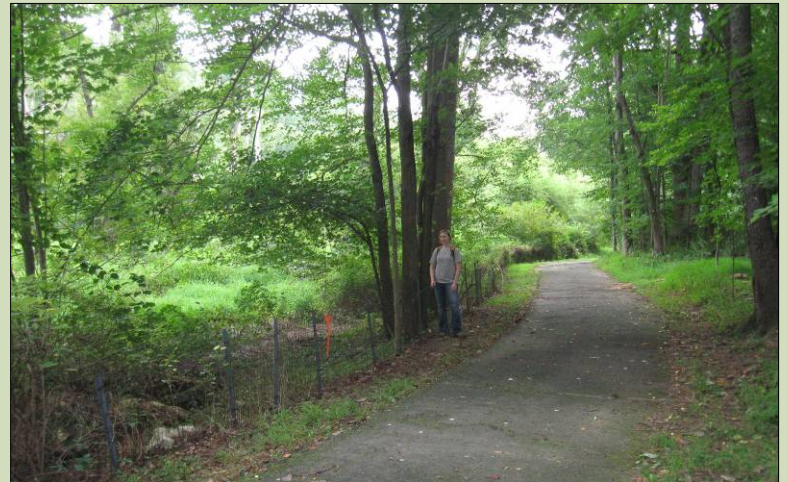
BEAVER AREA

WSSI will only replace fence
where impacted by our work
– we are not installing or
removing entire fence.

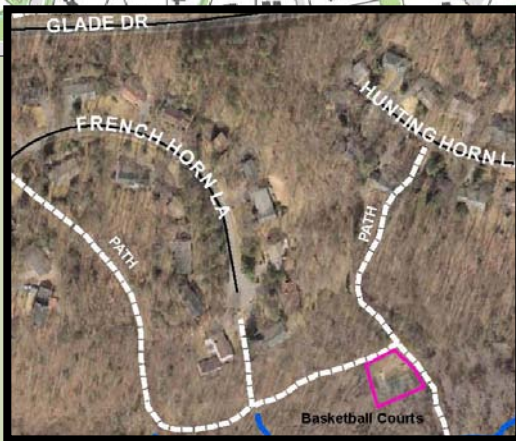
Reach 6 Summary

Bankfull Width = 24 ft

Bankfull Depth = 2.3 – 2.4 ft

Restored Length

Reach 6 = 3,345 ft

Tributary 1 = 53 ft

Tributary 2 = 44 ft

Total Length = 3,442 ft

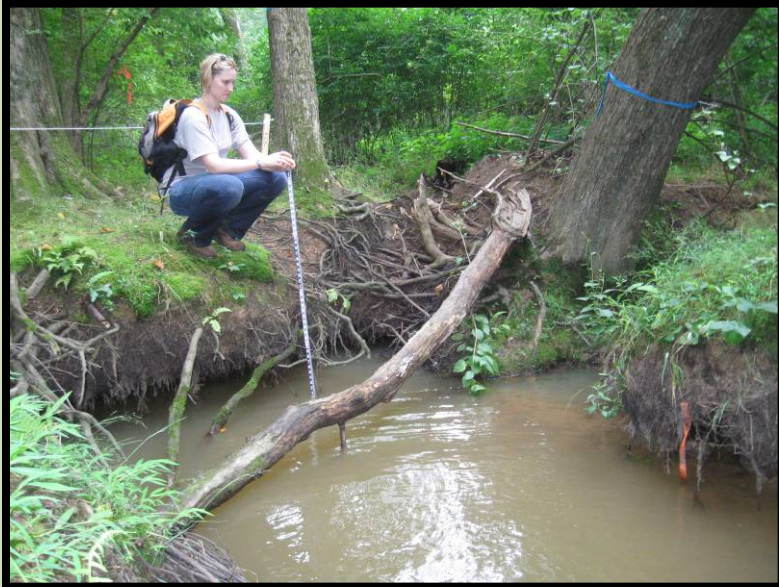
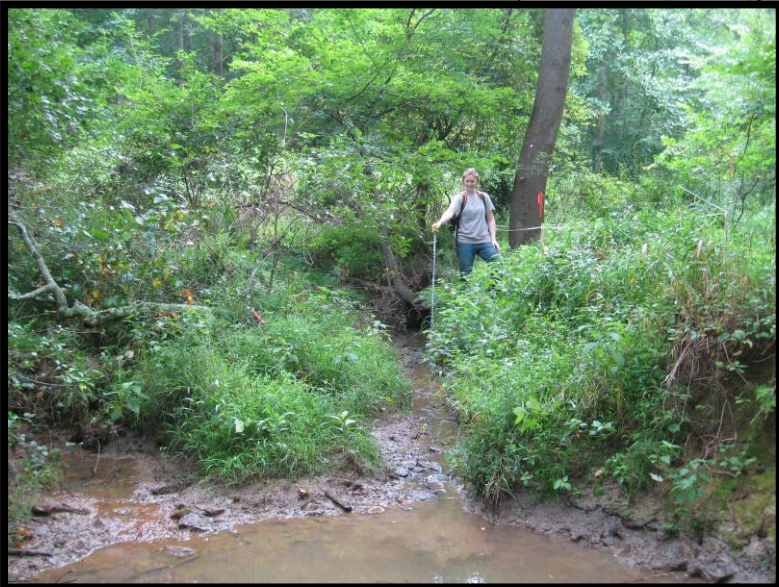
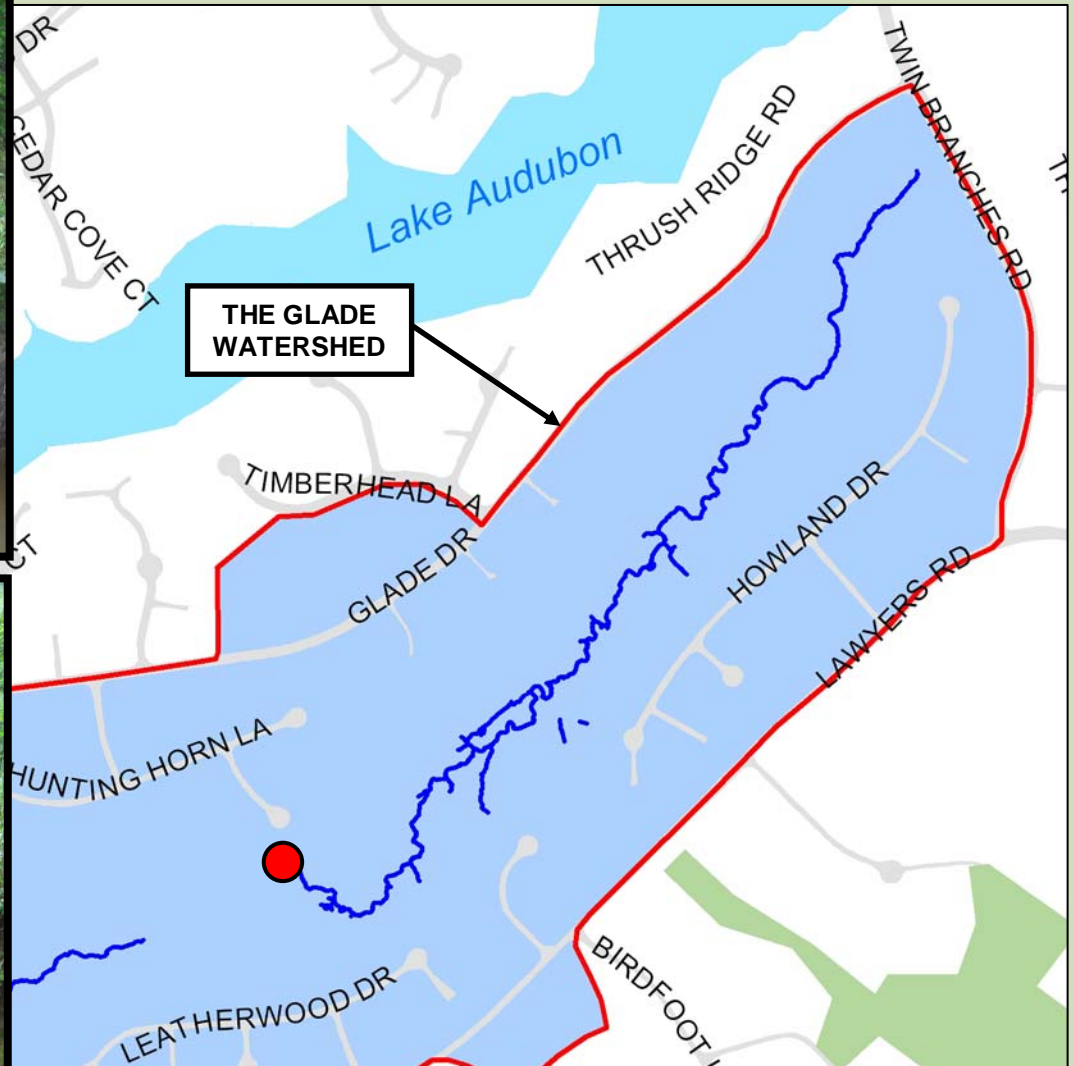
EXISTING CONDITIONS - THE GLADE REACH 6

*** Reach 6 Starts at 3 headcuts.**

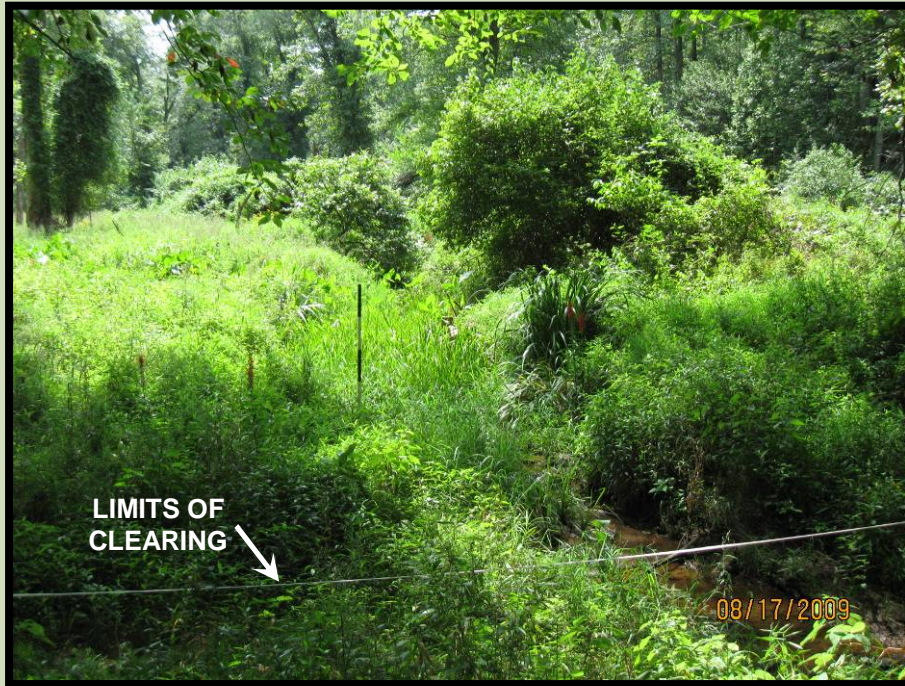
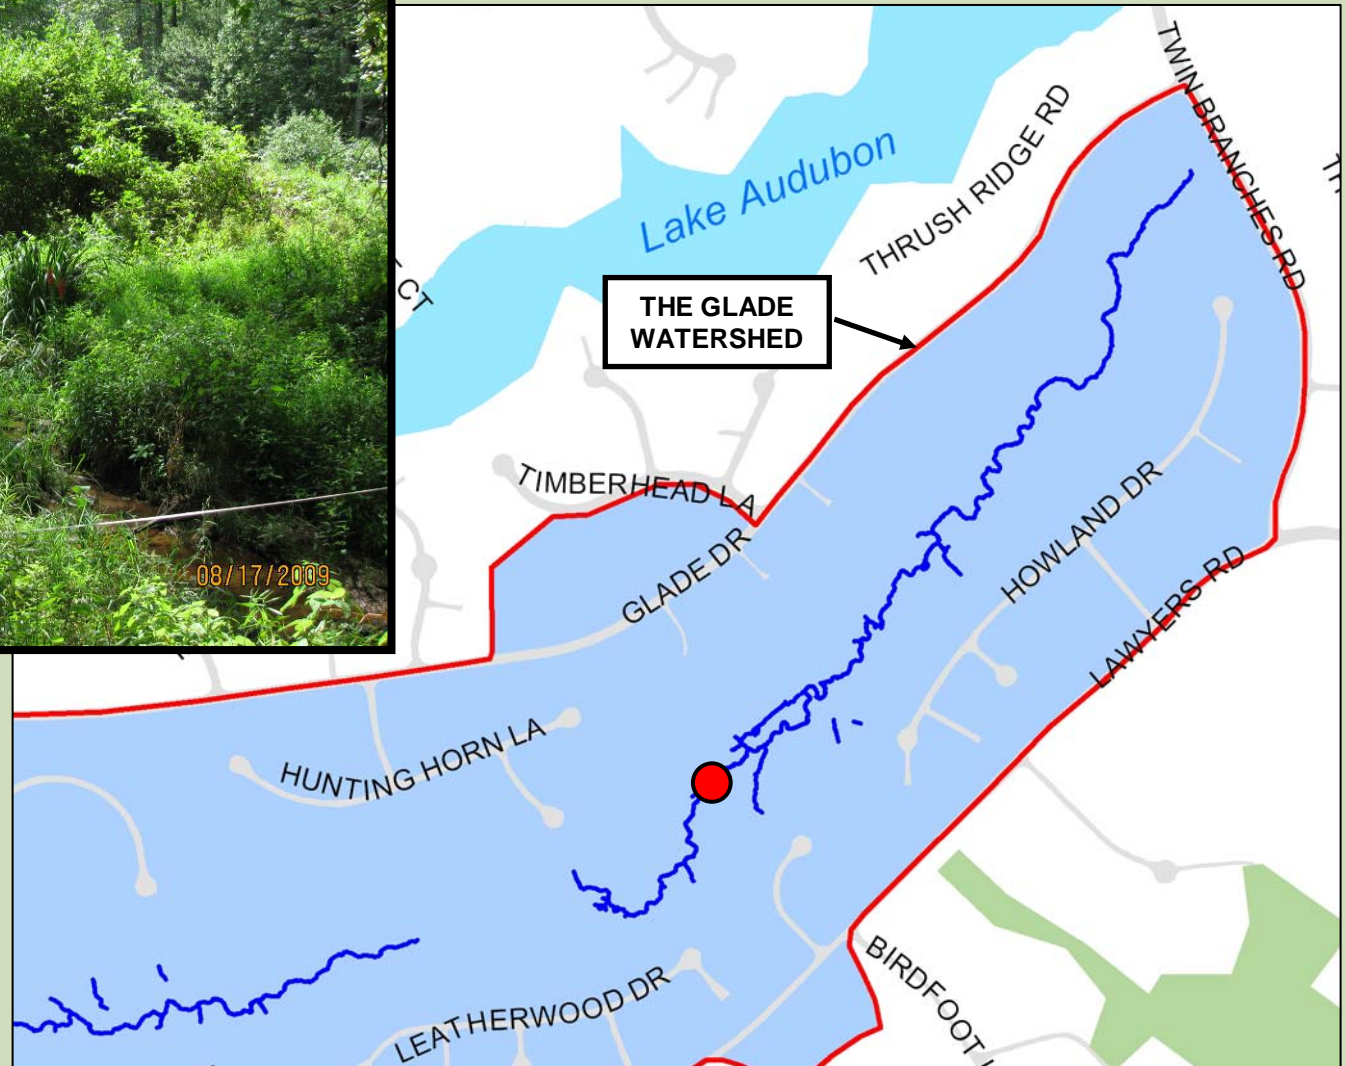
EXISTING CONDITIONS - THE GLADE REACH 6

Looking upstream into
stable area (± 50 ft) that
will not be disturbed

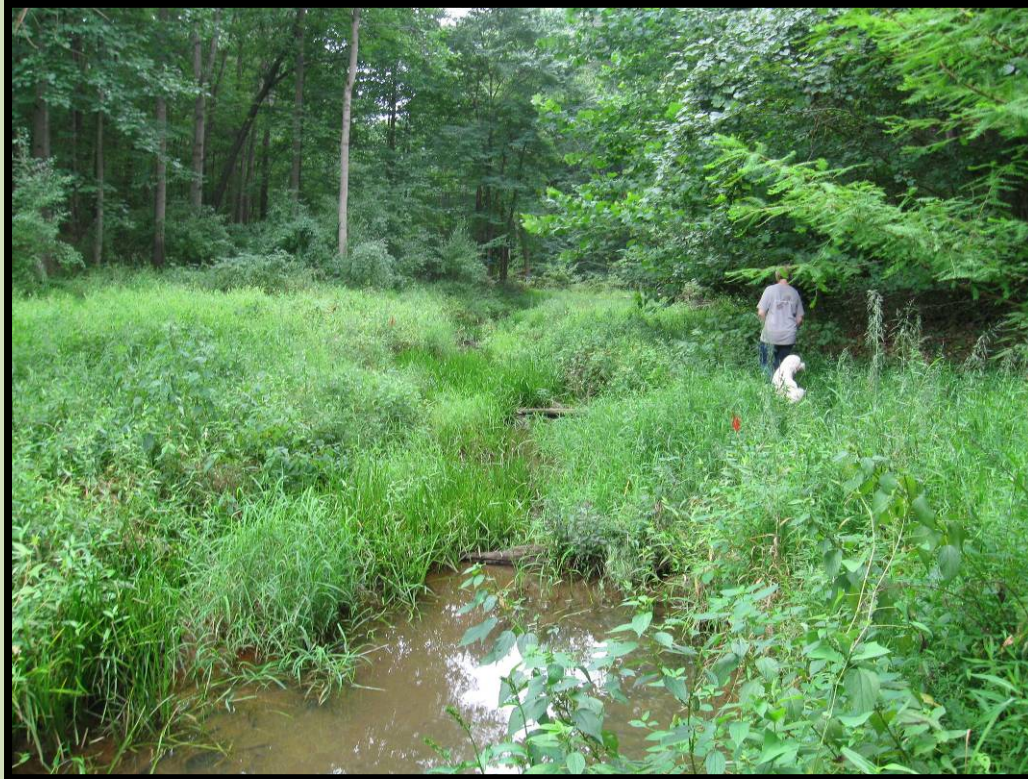
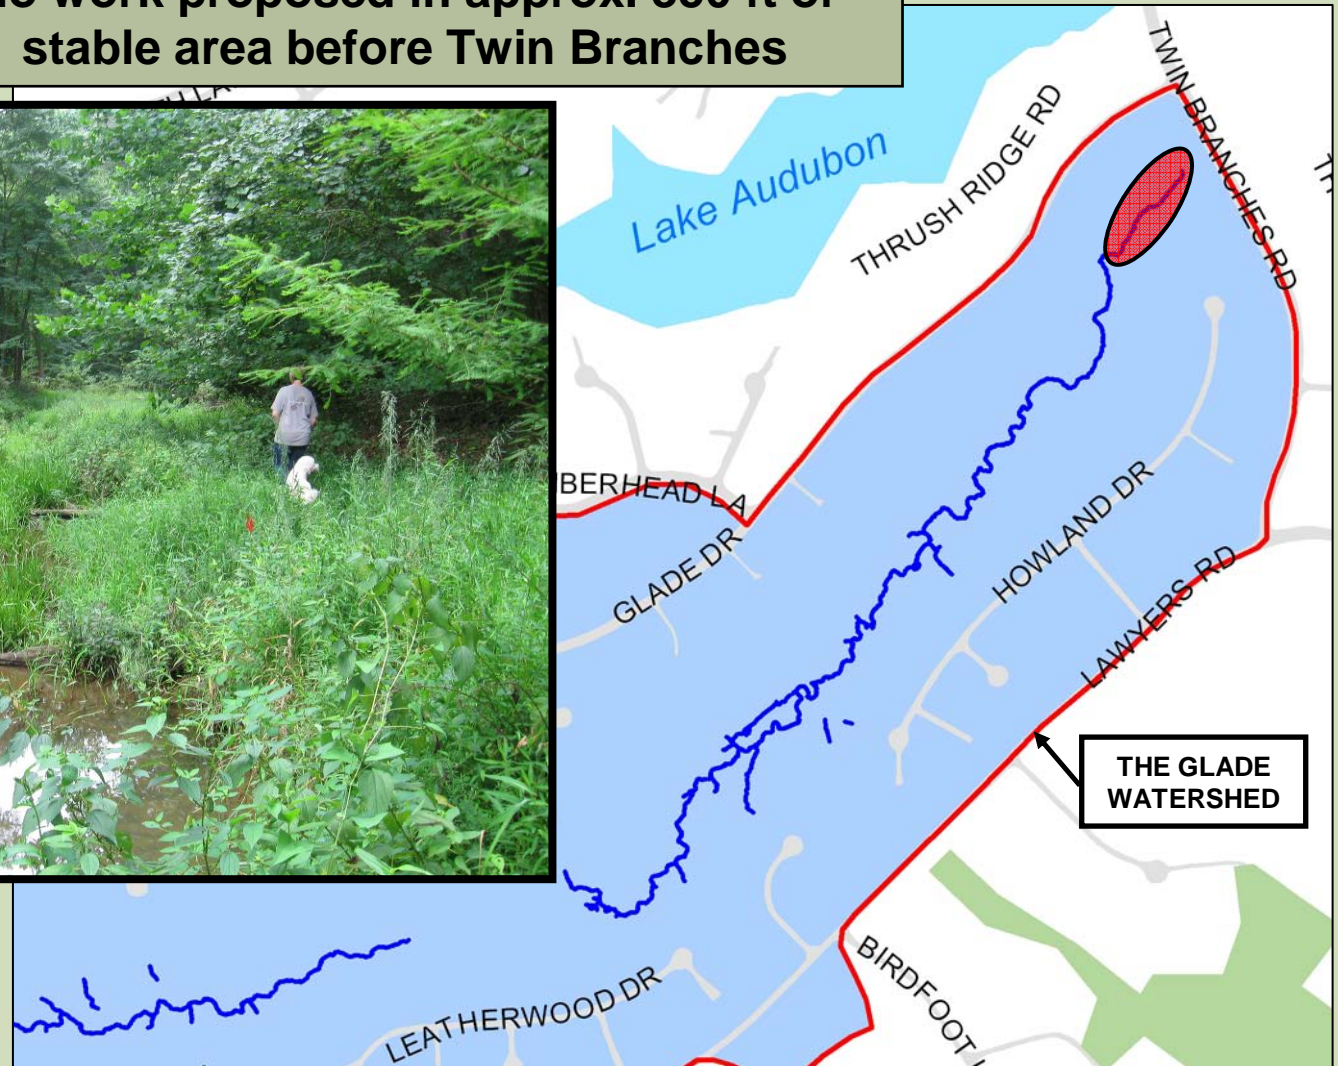
EXISTING CONDITIONS - THE GLADE REACH 6

No work proposed in approx. 350 ft of stable area before Twin Branches

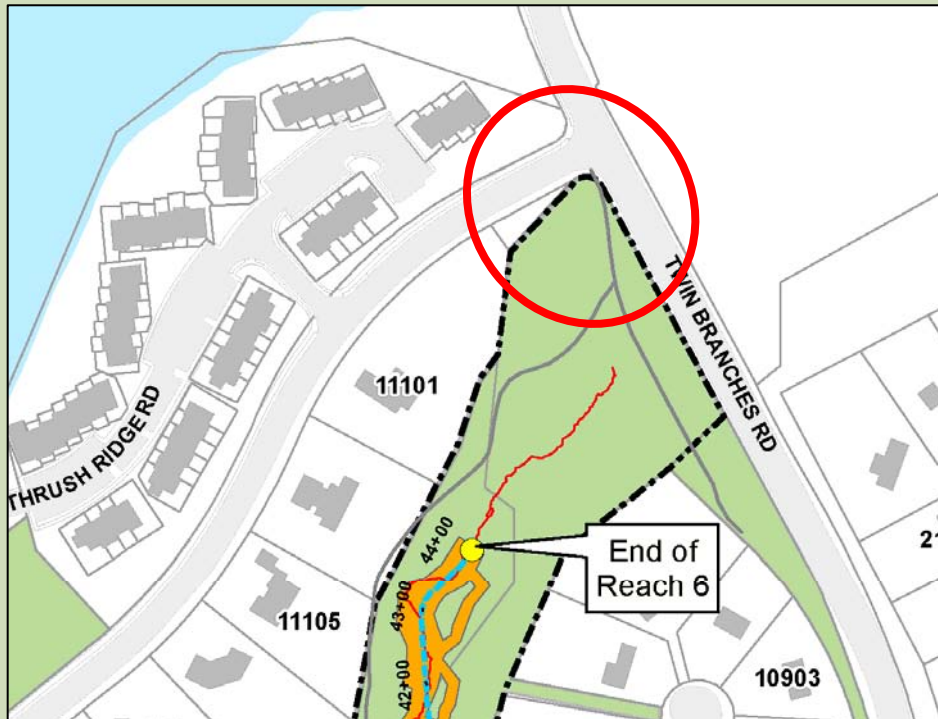
THE GLADE REACH 6 - ACCESS OPTIONS

Twin Branches Road and Glade Drive (removed after citizen vote 7/24/09)

- Busy intersection with odd approach angle
- Steep, narrow path
- Requires tree removal
- Stockpile near area not being restored
- No viable pedestrian access alternatives

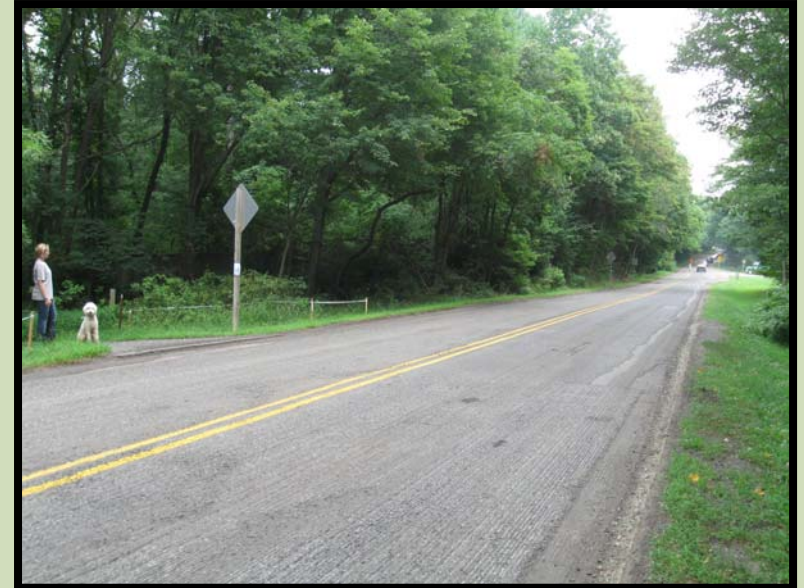
THE GLADE REACH 6 - ACCESS PLAN

Lawyers Road

- Less steep path
- Stockpile nearby with no tree removal
- Temporary pedestrian access for residents & C. C. Trail users

- This entrance has adequate sight distance per Minimum Standards of Entrances to State Highways, Table 1.
- There is not continuous traffic flow in and out of the construction entrance.
 - Construction Crew Vehicles: average 5 - 8
 - Material Deliveries: average 15 - 20 per week
- Construction Crew Parking provided for workers adjacent to stockpile area (not on Lawyers Road).
- Temporary pedestrian access trail provided (for November Lane and the Cross County Trail. Trail will be removed once construction is complete).

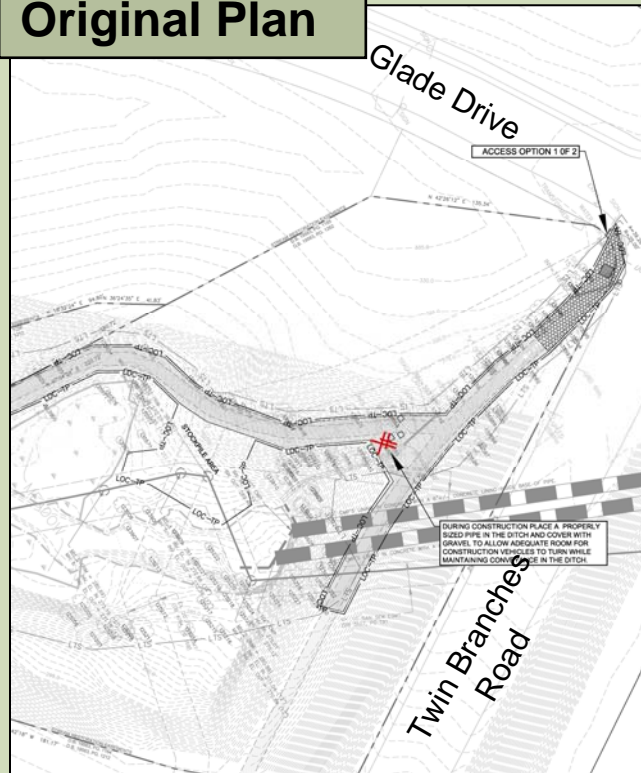
THE GLADE REACH 6 CONSTRUCTION ACCESS CHANGES

Original Plan

Glade / Twin Branches

Plan Change

Lawyers Road

WSSI to add split rail fence & landscaping at 2310 November Lane

November Lane Meeting (July 28, 2009):
Chose location of temporary pedestrian access trail.
