Northern Virginia Stream Restoration Bank

Snakeden Branch, Reach 3

What is Stream Restoration?

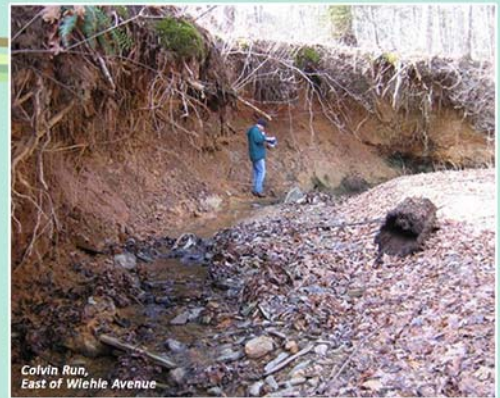
Streambank erosion threatens roads, trails, trees and utilities in Reston

Steep, actively eroding banks, caused by increased runoff from impervious surfaces, are prevalent through the stream channels in Reston. This bank erosion threatens adjacent trails, sanitary sewers, and trees. It also produces hundreds of tons of sediment that are deposited in Reston lakes and other receiving waters every year.

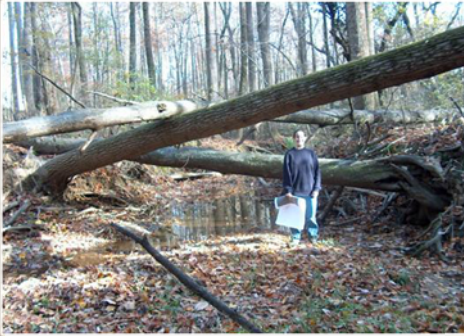
Snakeden Branch - Reach 3

Pre-Construction

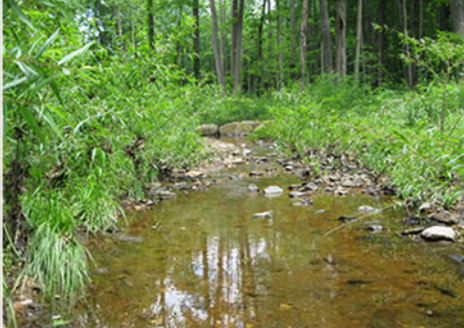
16 Months Post-Construction

The Reston streams are being restored using Natural Channel Design (NCD) techniques that include raising the bed to reconnect higher storm flows with the floodplain; placement of a reinforced bed comprised of crushed stone, sand, gravel, and topsoil; and placement of rock and log structures to direct flow away from channel banks and create riffle/pool features within the bed of the stream. These techniques help the stream bed and banks withstand the high urban flow rates.

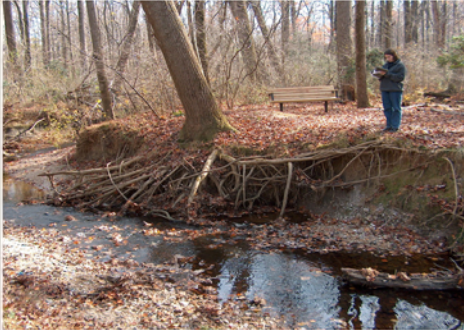
Snakeden Branch - Reach 17

Pre-Construction

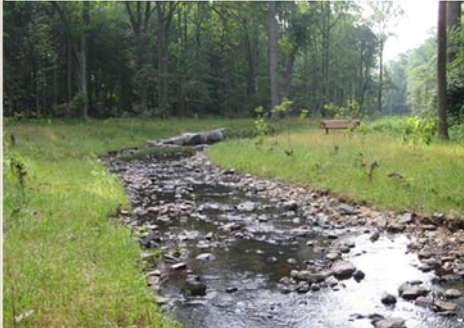
6 Months Post-Construction

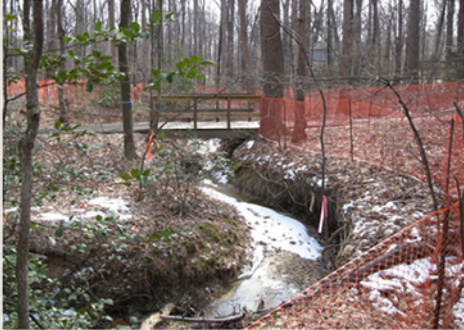
The Glade - Reach 1

Pre-Construction

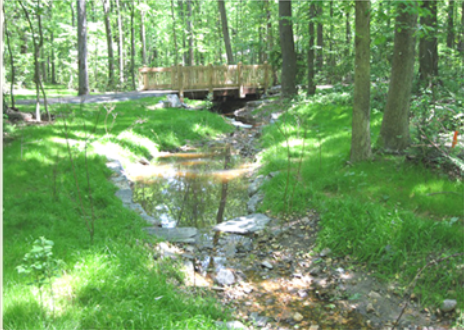
4 Months Post-Construction
