What is Stream Restoration?

The Northern Virginia Stream Restoration Bank (NVSRB) is a partnership between Wetland Studies and Solutions, Inc. (WSSI) and The Peterson Companies, working in concert with the Reston Association. The Phase 1 goal of NVSRB is to restore 14 miles of degraded streams in the Snakeden, Glade and Colvin Run Watersheds in Reston, Virginia.

Northern Virginia Stream Restoration Bank

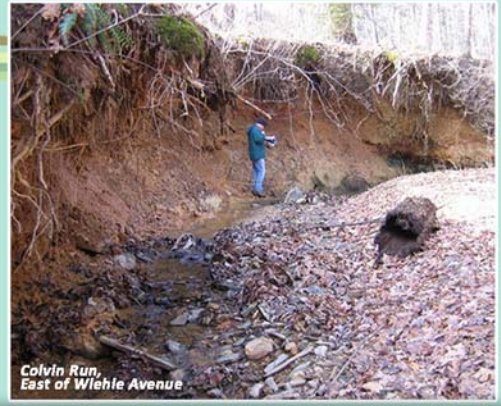
Streambank erosion threatens roads, trails, trees and utilities in Reston

Steep, actively eroding banks, caused by increased runoff from impervious surfaces, are prevalent through the stream channels in Reston. This bank erosion threatens adjacent trails, sanitary sewers, and trees. It also produces hundreds of tons of sediment that are deposited in Reston lakes and other receiving waters every year.

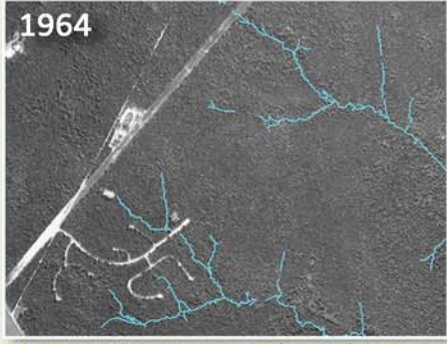
1964

Hunters Woods area in the early stages of development.

Development of Reston resulted in forested land being converted to buildings, roads, parking lots, driveways, sidewalks, and other impervious surfaces that prevent the infiltration of stormwater. The combination of higher runoff volume resulting from developed impervious surfaces and higher peak flows resulting from outdated management techniques increases the flow energy in Reston's streams. This increase in flow energy results in severe stream erosion and downstream sediment deposition.

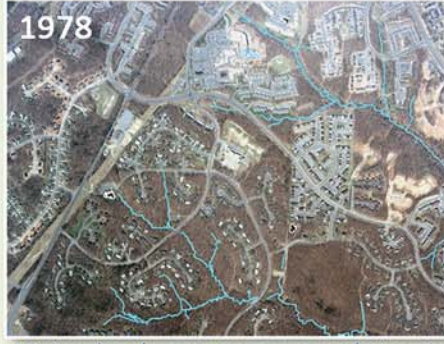
1978

Major development near completion in the late 1970's.

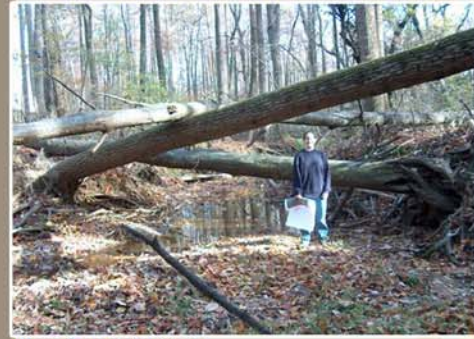
Snakeden Branch - Reach 3

Pre-Construction

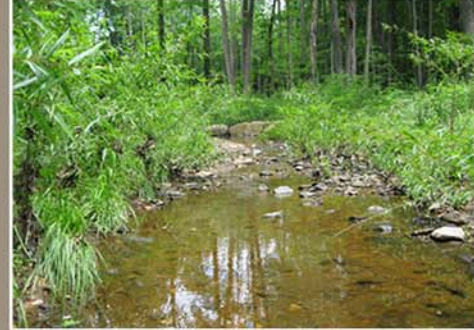
16 Months Post-Construction

The Reston streams are being restored using Natural Channel Design (NCD) techniques that include raising the bed to reconnect higher storm flows with the floodplain; placement of a reinforced bed comprised of crushed stone, sand, gravel, and topsoil; and placement of rock and log structures to direct flow away from channel banks and create riffle/pool features within the bed of the stream. These techniques help the stream bed and banks withstand the high urban flow rates.

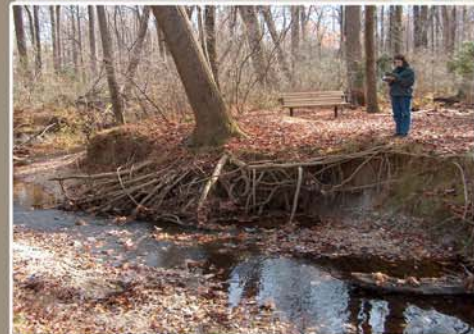
Snakeden Branch - Reach 17

Pre-Construction

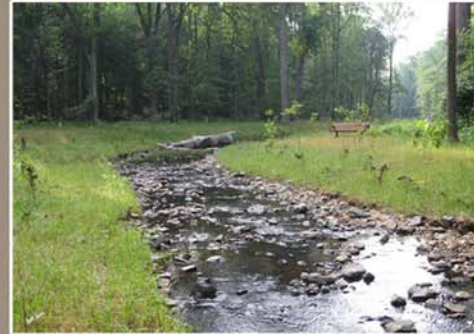
6 Months Post-Construction

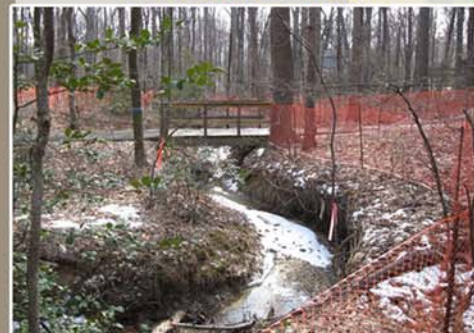
The Glade - Reach 1

Pre-Construction

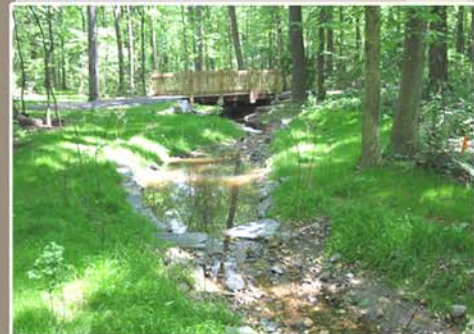
4 Months Post-Construction
