Northern Virginia Stream Restoration Bank Reston Status and Wiehle South Preliminary Plan

February 21, 2012

Wetland Studies and Solutions, Inc.

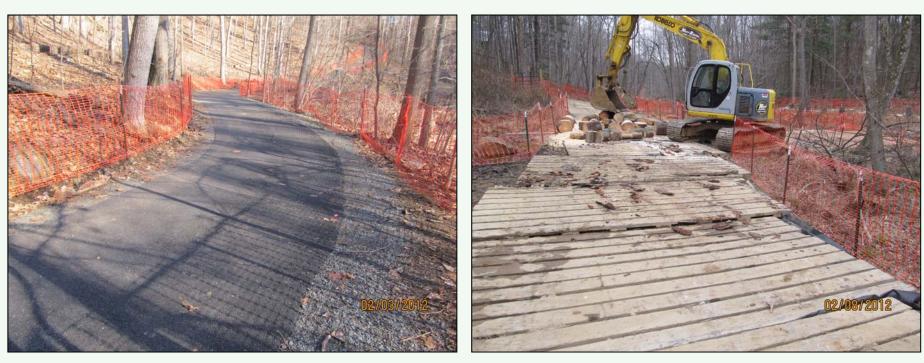
The Glade – Reach 6 Repairs

Tree protection fencing installed, early February

Deck Mats used in active cut-ins

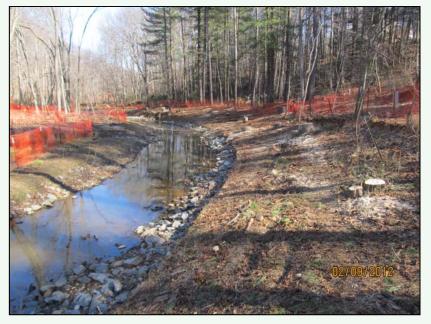
Tree clearing complete

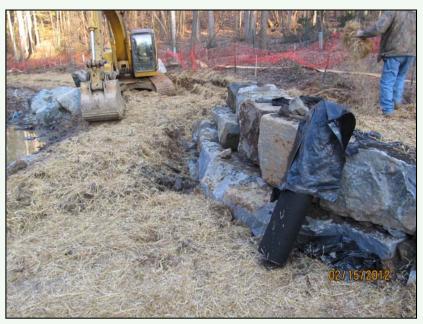
Rock wall and channel grading commenced

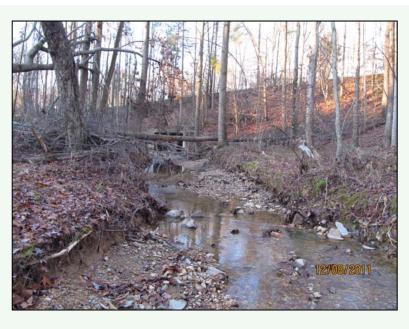
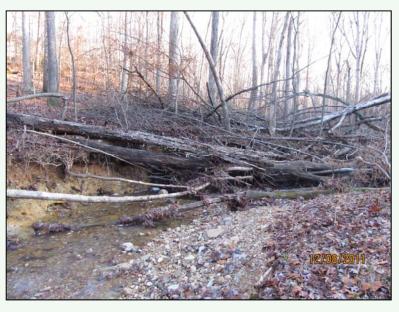
- Vertical banks typical throughout reach.
- Eroded bank at meander debris jam accumulated since tornado damage.

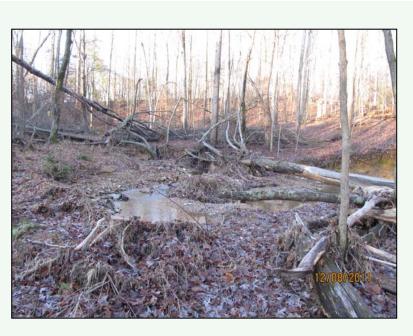
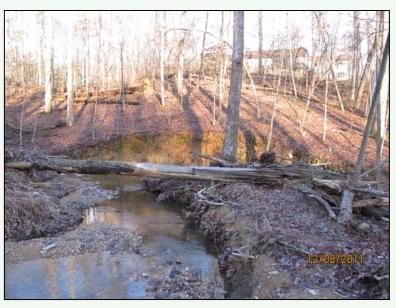
- Very tight meander and another tall, eroded bank.

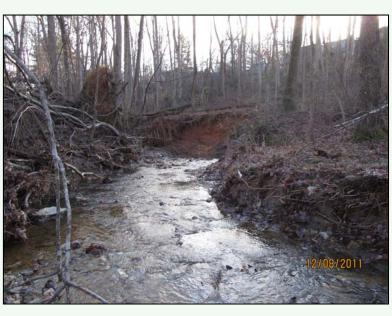
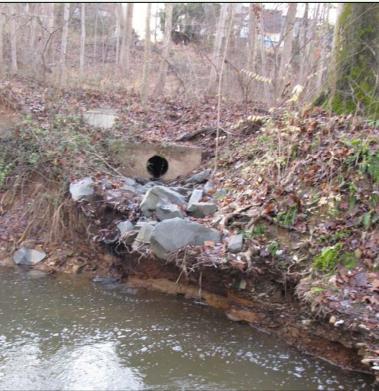
- Tree fall (left bank) at disconnected culvert outfall on the right bank.

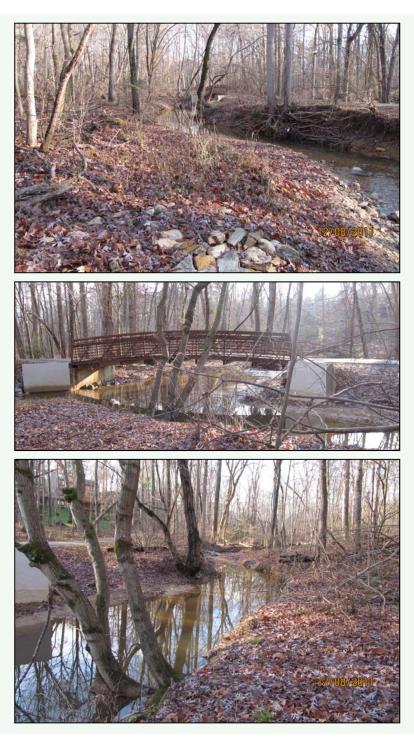
- Abrupt tie-in with Wiehle North at metal bridge.
- Bridge will not be replaced.
