NORTHERN VIRGINIA STREAM RESTORATION BANK

“EVERYTHING YOU WANT TO KNOW ABOUT
STREAM RESTORATION NORTH OF THE TOLL ROAD”

**NORTHERN VIRGINIA STREAM RESTORATION BANK
COLVIN RUN COMMUNITY MEETING
MARCH 27, 2010**

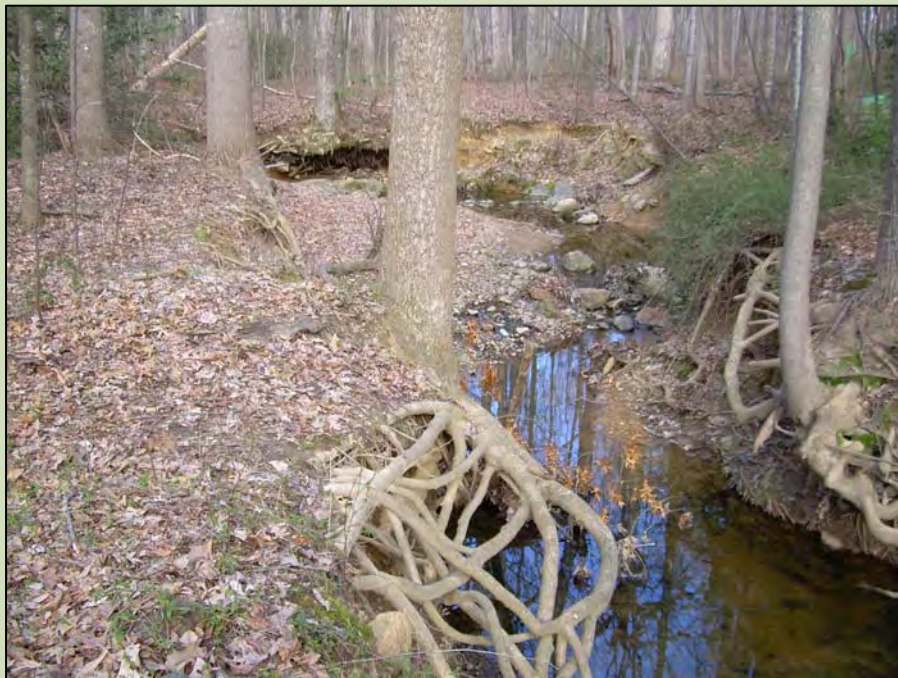
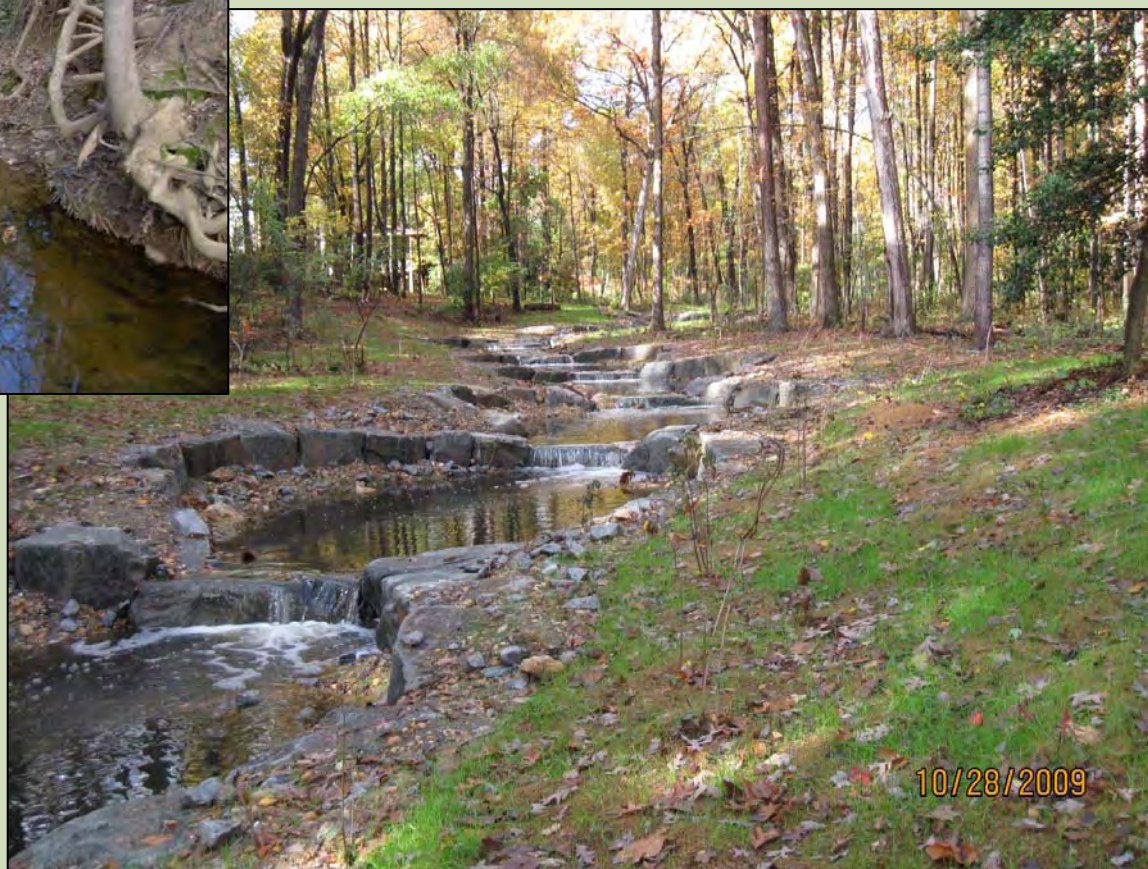
RESTORATION PROGRESS – REACH 13

Pre-Construction
(March 2008)

Post-Construction
(October 2009)

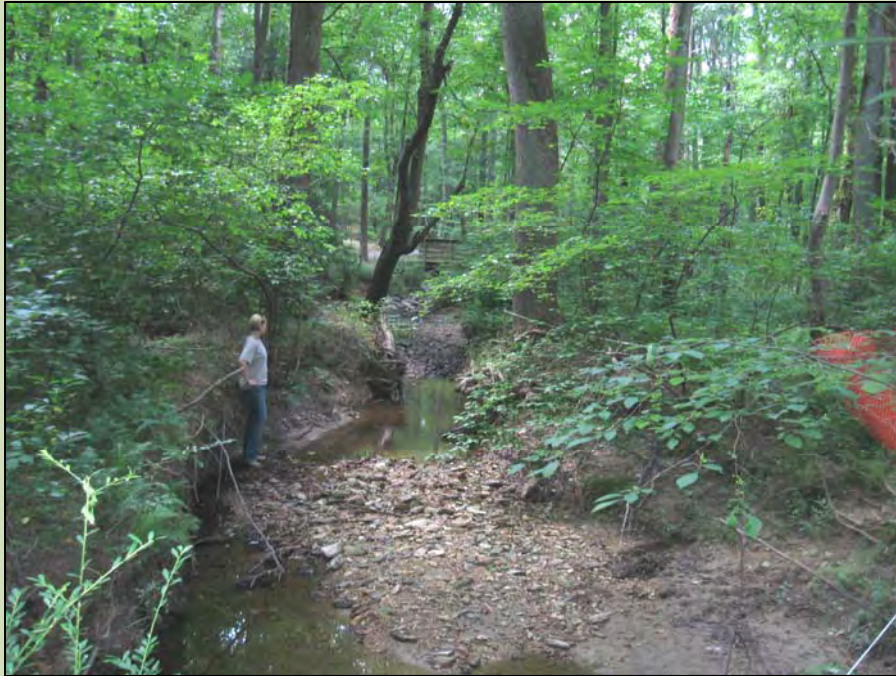
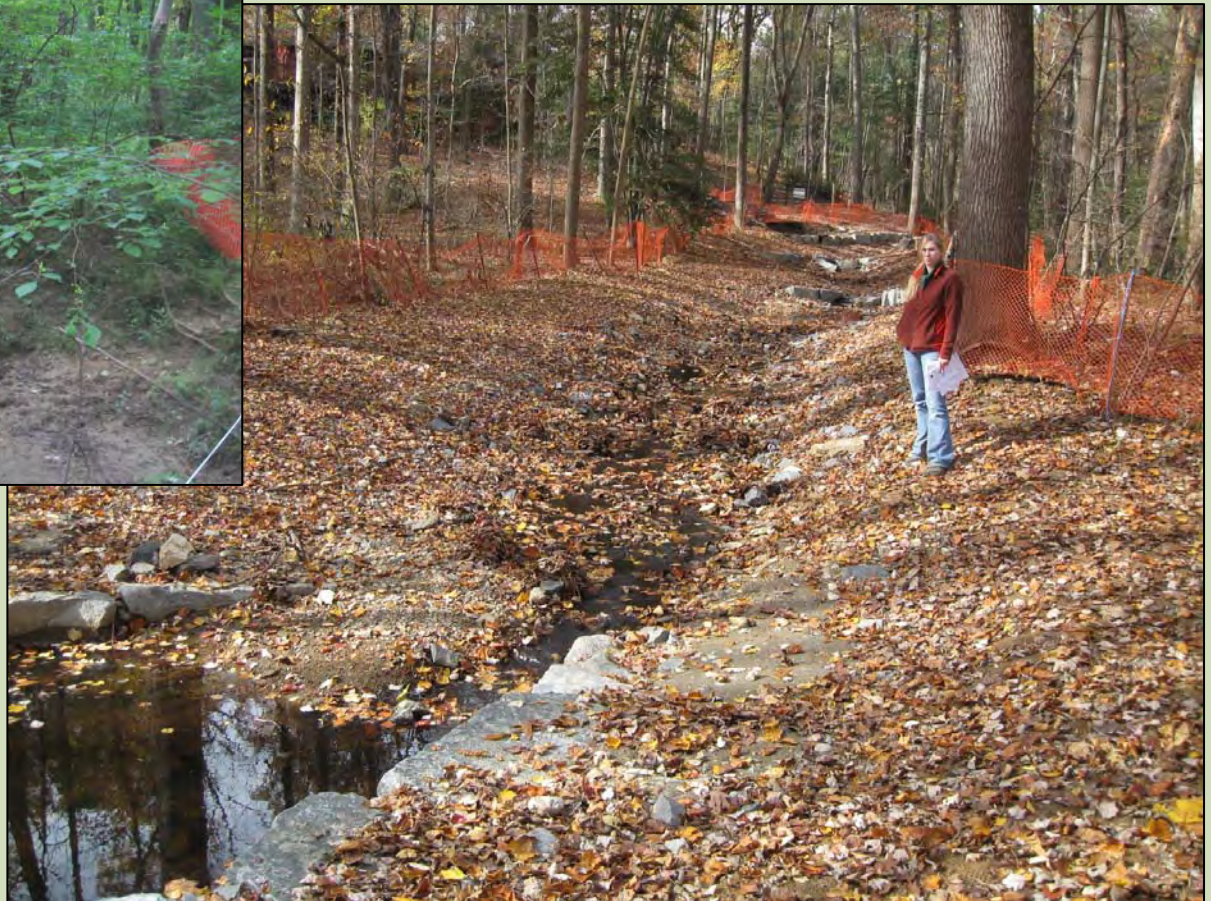
RESTORATION PROGRESS – REACH 4A

Pre-Construction
(September 2009)

Post-Construction
(November 2009)

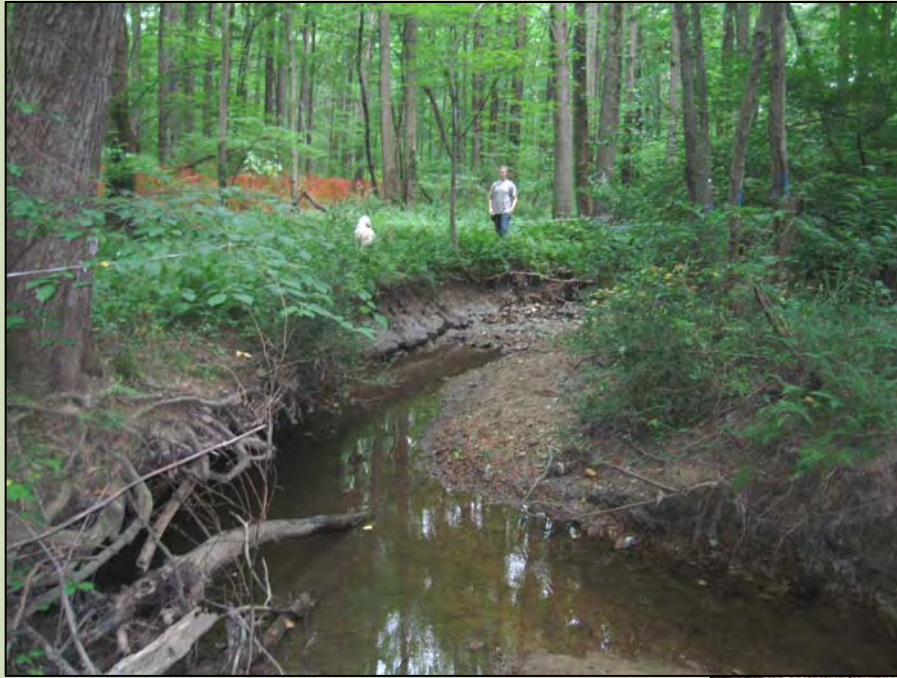
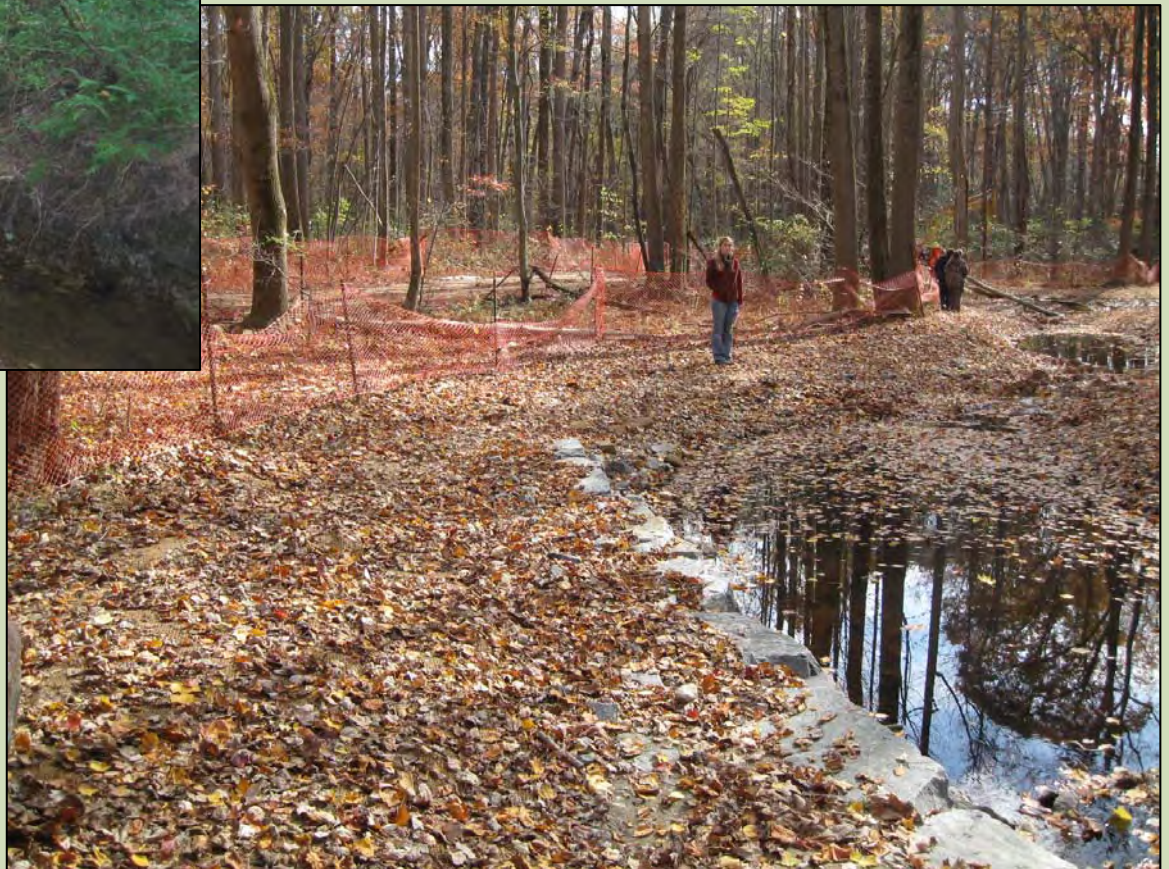
RESTORATION PROGRESS – REACH 4A

Pre-Construction
(September 2009)

Post-Construction
(November 2009)

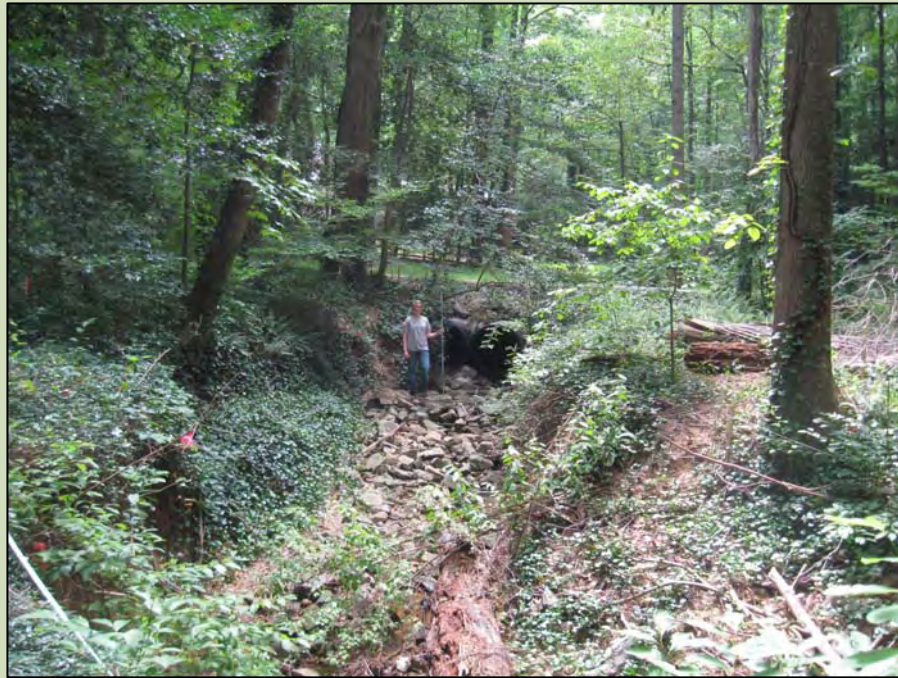
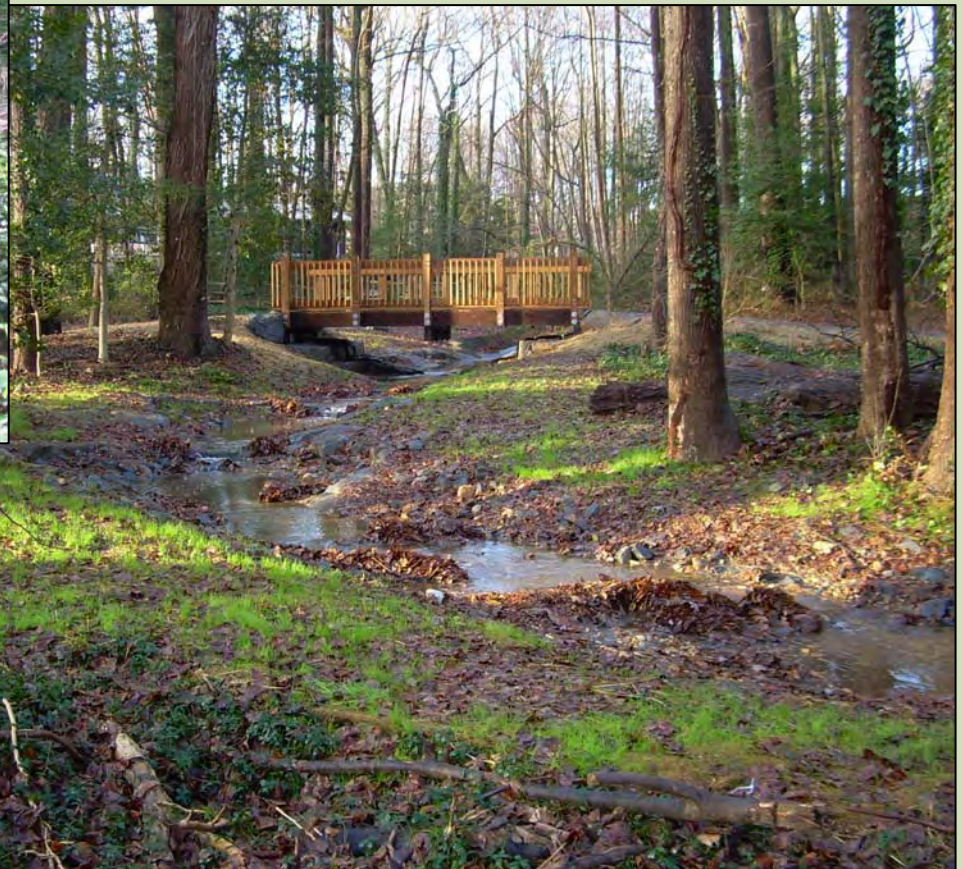
RESTORATION PROGRESS – TRIBUTARY TO REACH 4A

Pre-Construction
(September 2009)

Post-Construction
(December 2009)

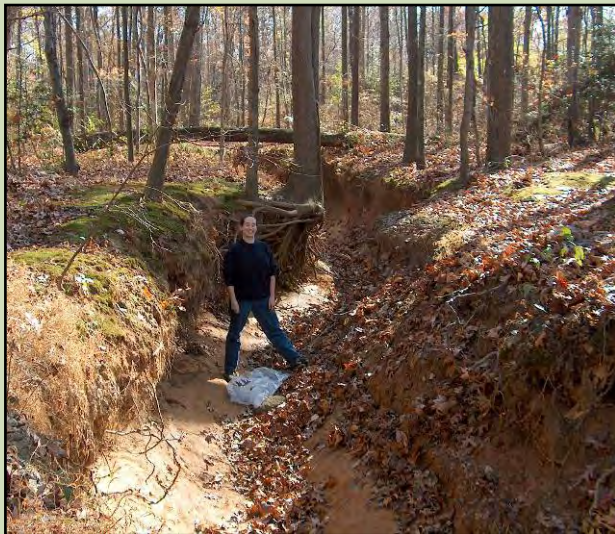
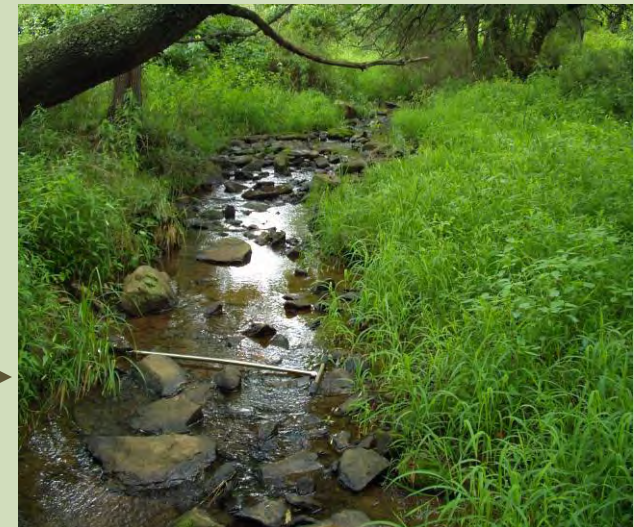
Evolutionary process considers the channel's incision, bank stability, & sedimentation load (aggrading or degrading)

Severe
Channel Condition

Optimal
Channel Condition

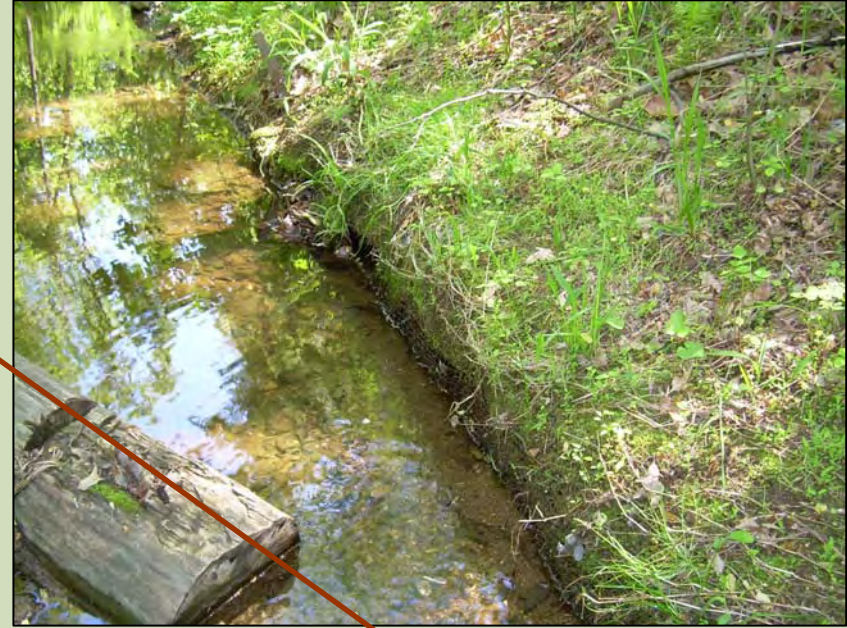
Priority 4 Restoration – Stabilize in-place

Snakeden Branch Reach 2
(2003, by others) –
Long-term stability not
achieved using this approach.

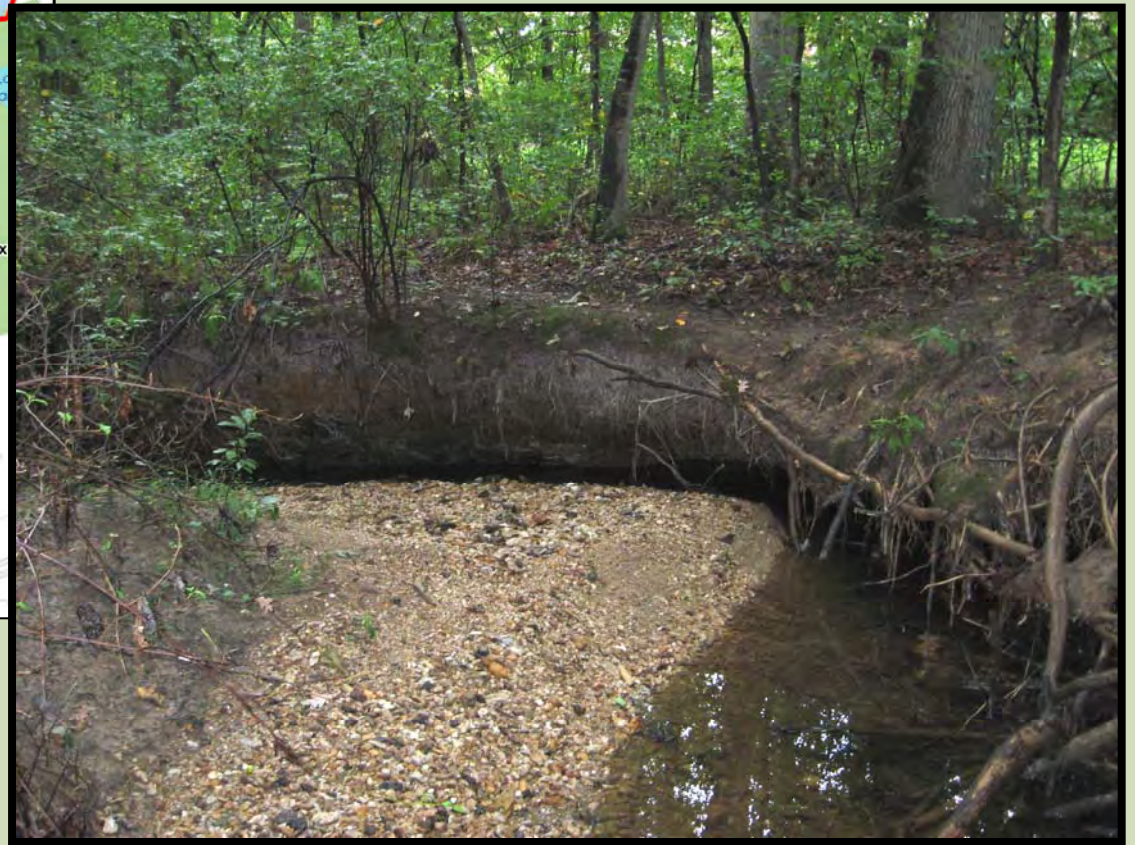
Bennington Woods South

EXISTING CONDITIONS IN COLVIN RUN

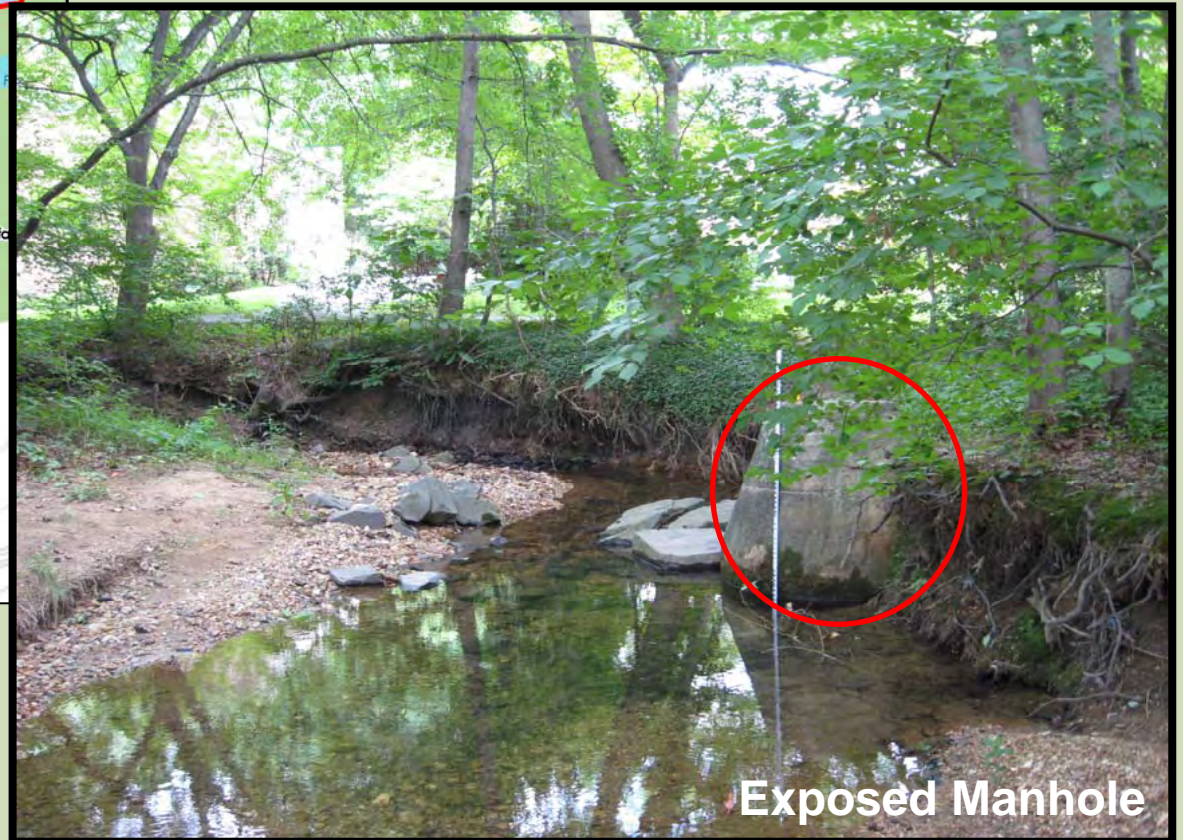
Vantage Hill

Exposed Manhole

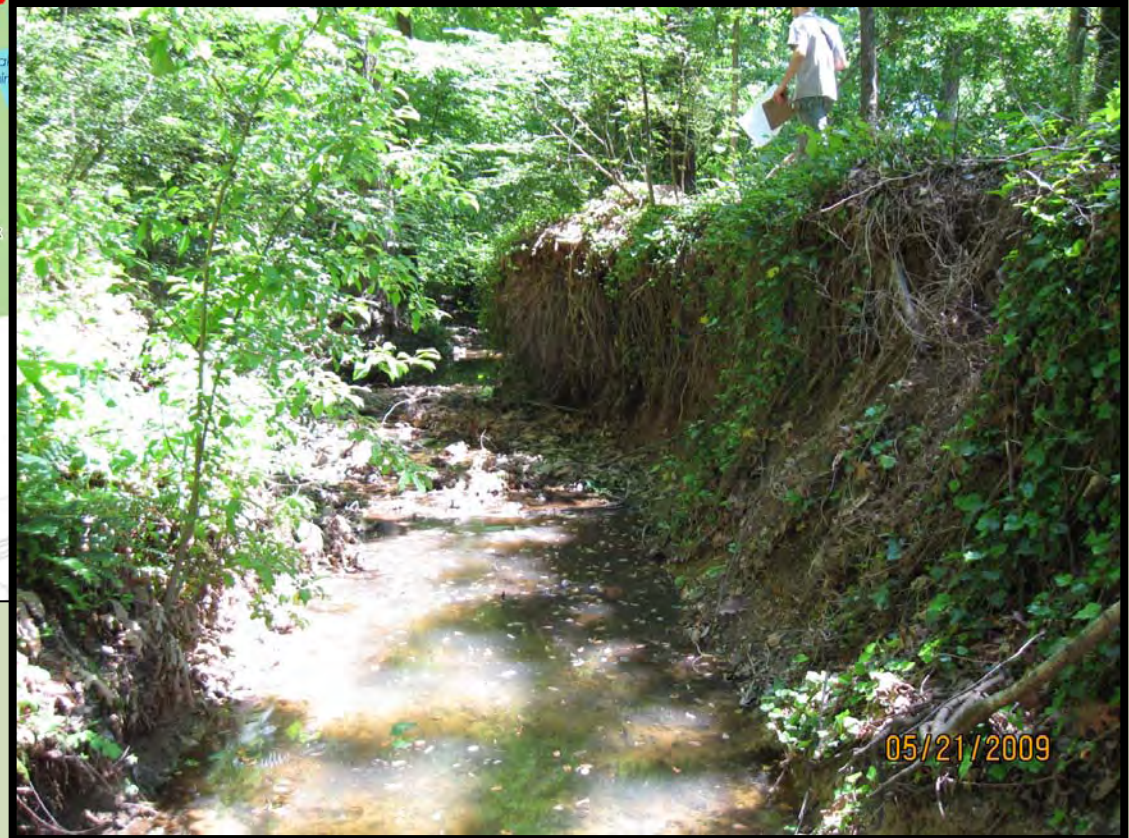
Forest Edge North

EXISTING CONDITIONS IN COLVIN RUN

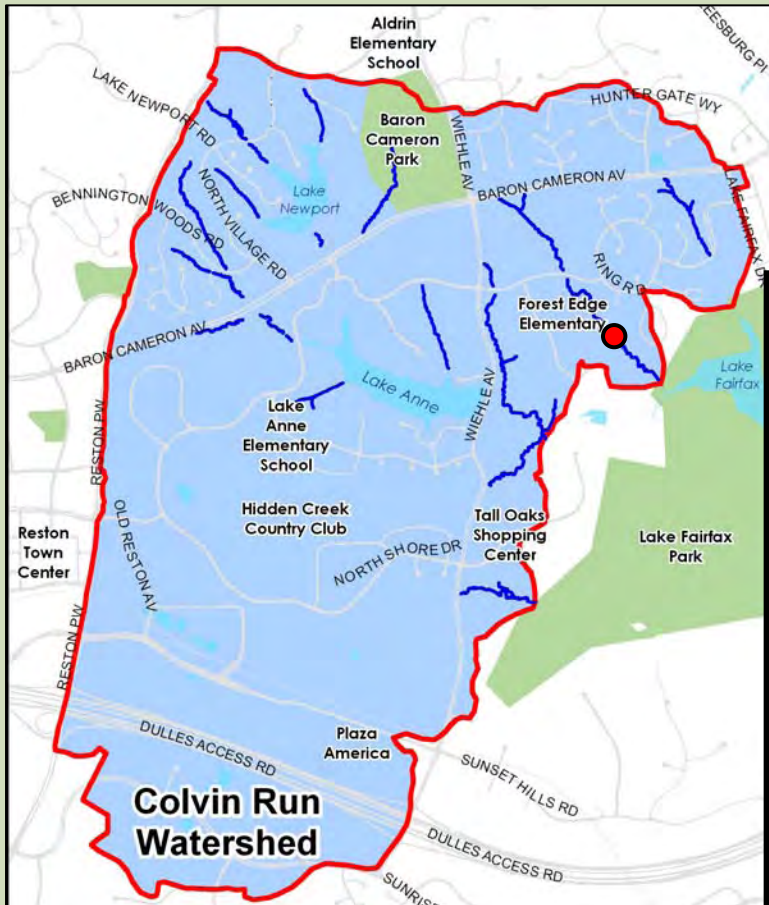
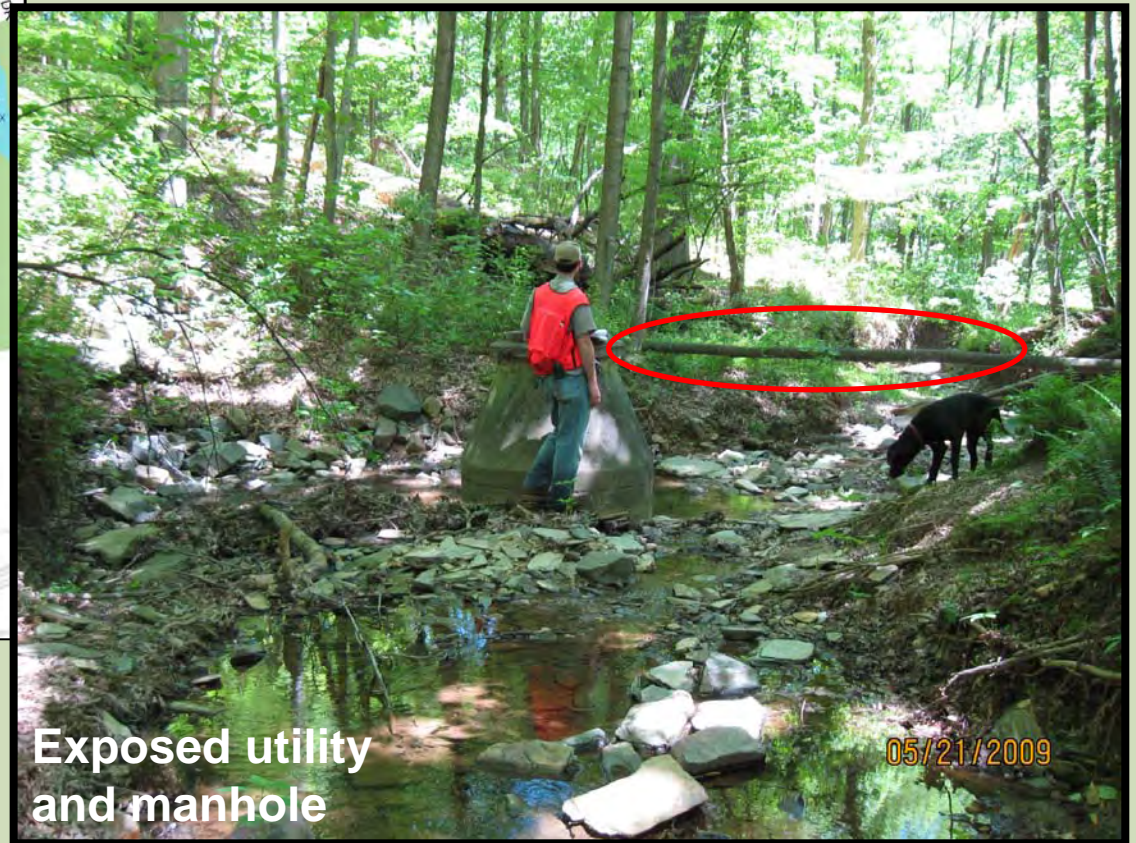
Forest Edge South

EXISTING CONDITIONS IN COLVIN RUN

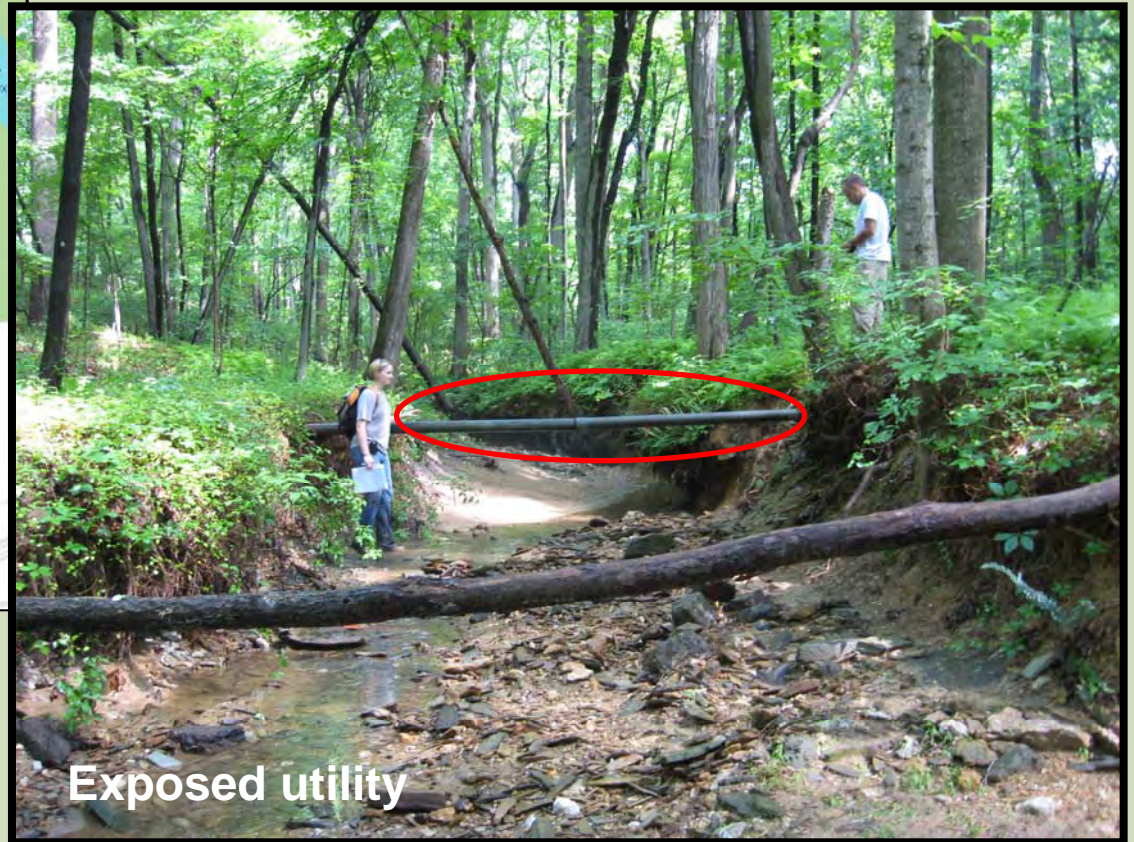
Wiehle North

Exposed utility

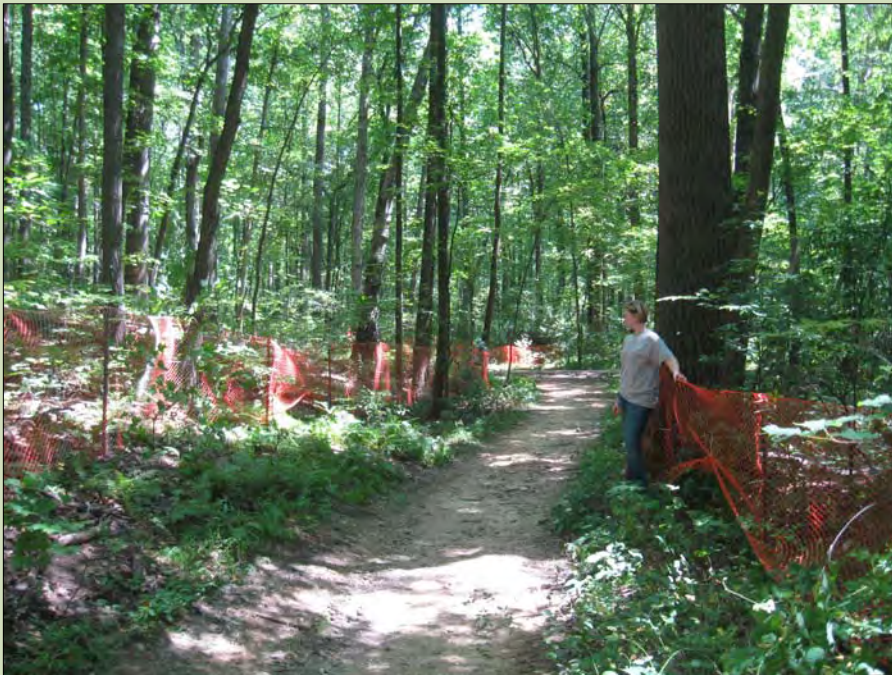
CONSTRUCTION – THE GLADE REACH 4A

Pre-Construction (August 2009)

Construction (October 2009)

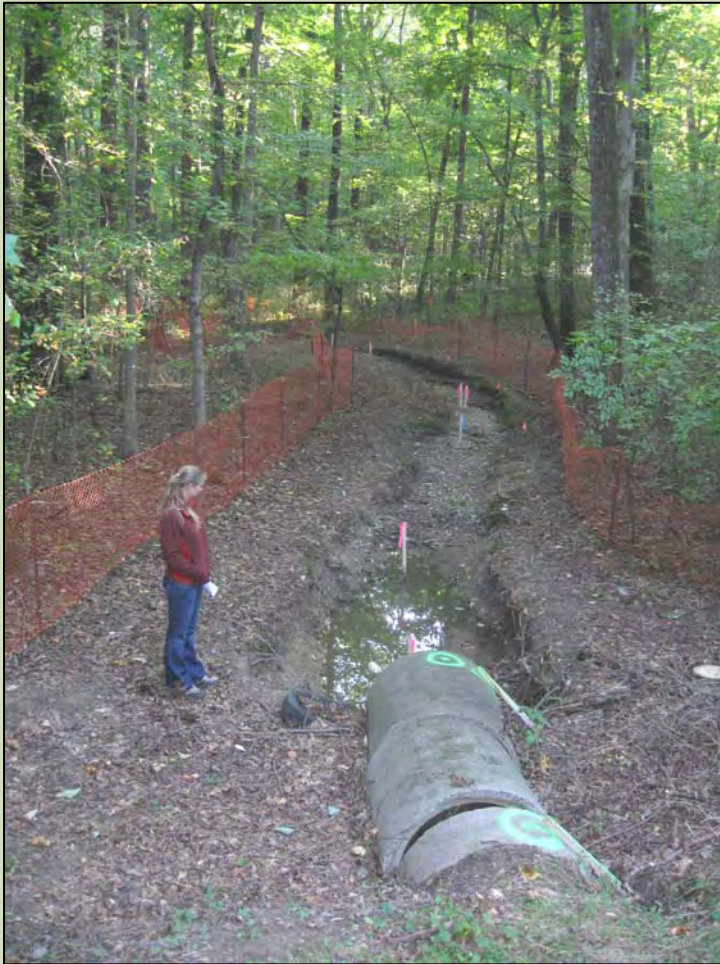
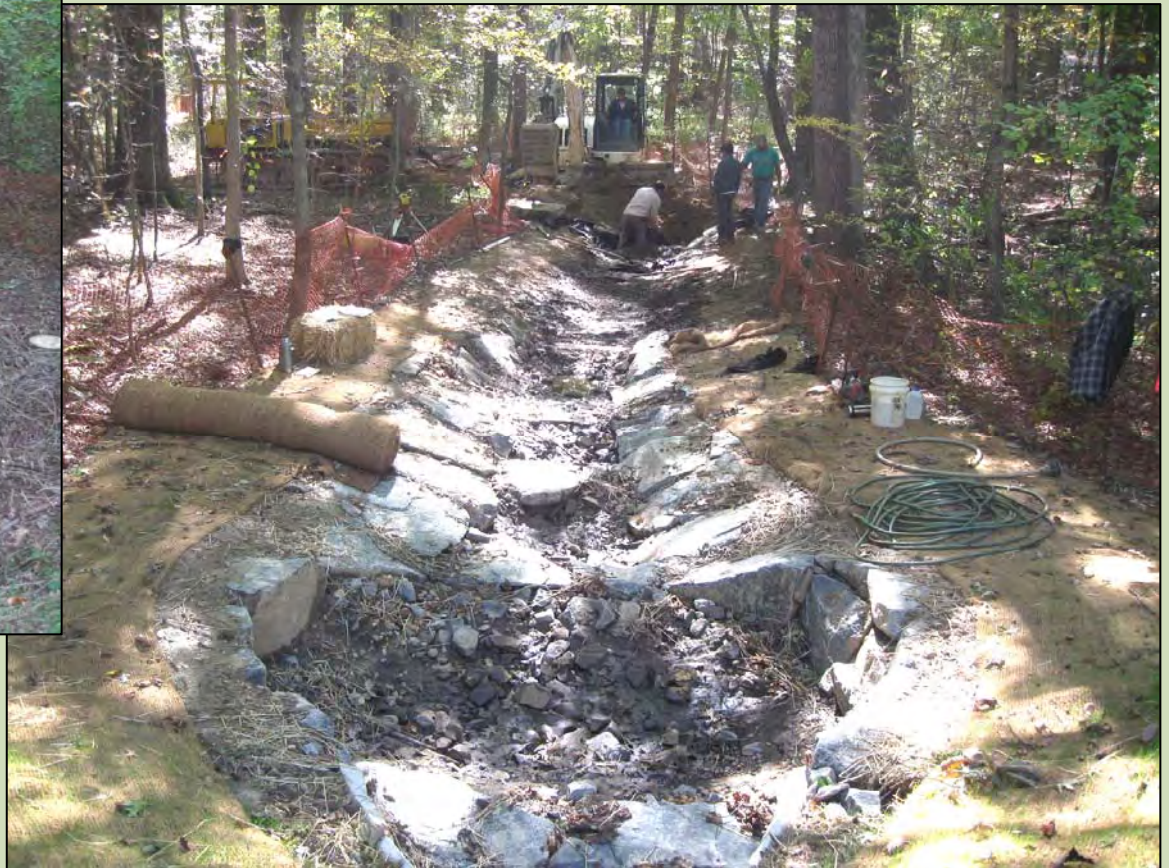
CONSTRUCTION – THE GLADE REACH 4A

Construction
(October 2009)

Pre-Construction
(September 2009)

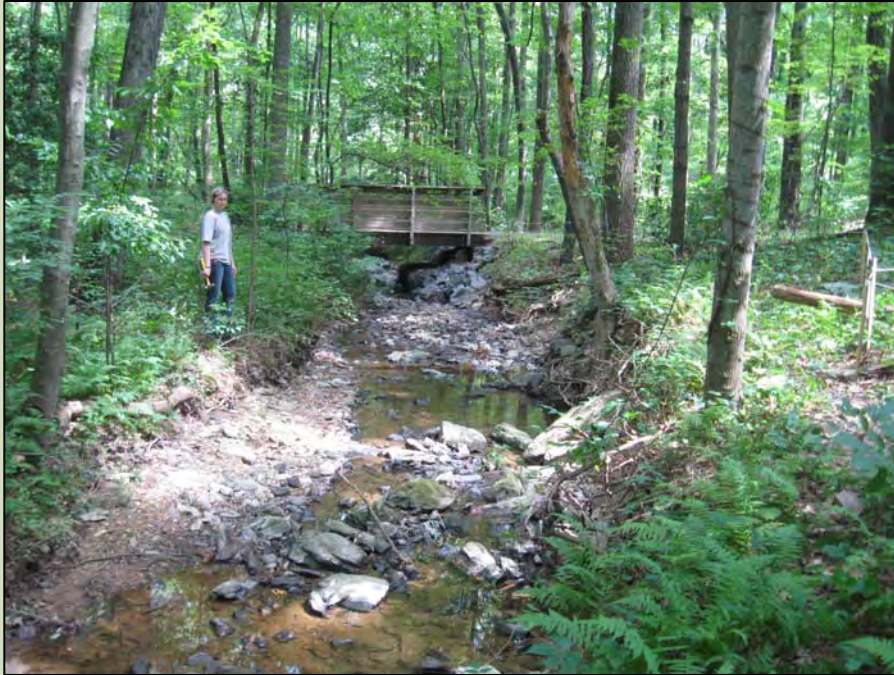
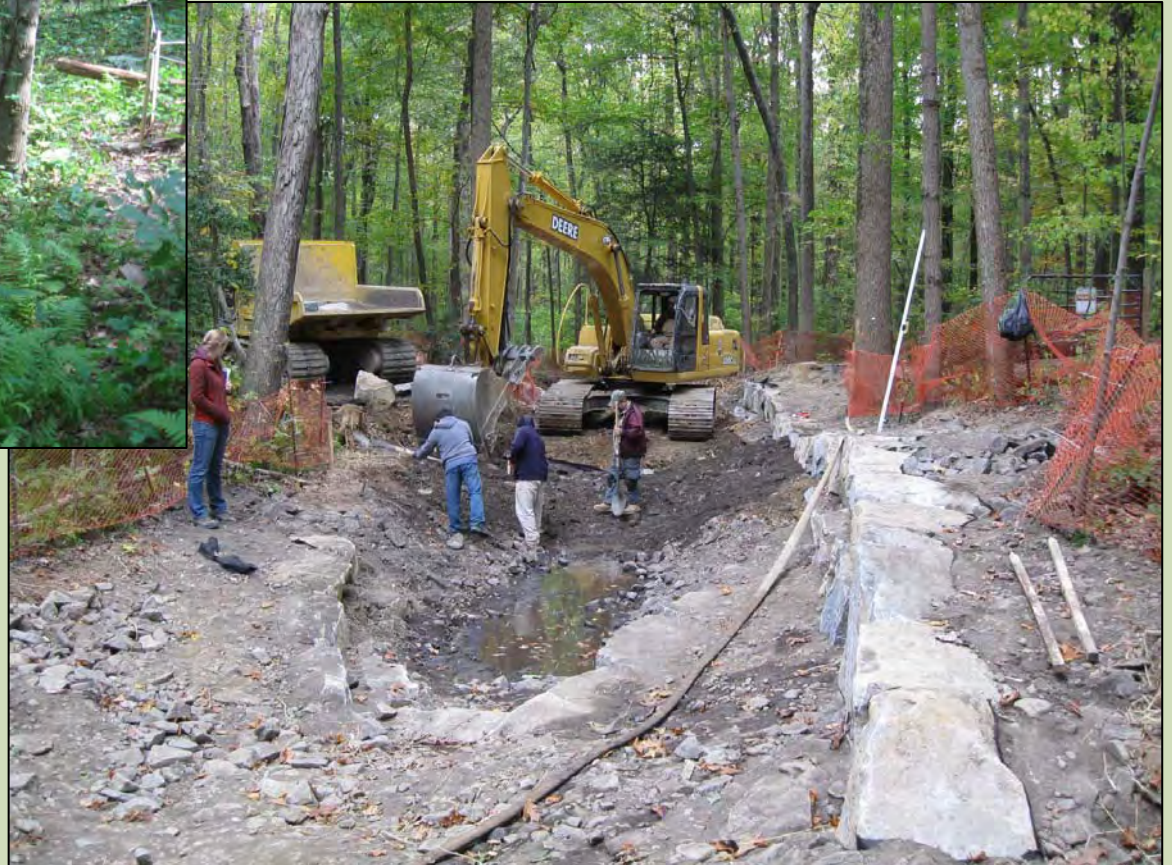
CONSTRUCTION – THE GLADE REACH 4A

Pre-Construction
(August 2009)

Construction
(October 2009)

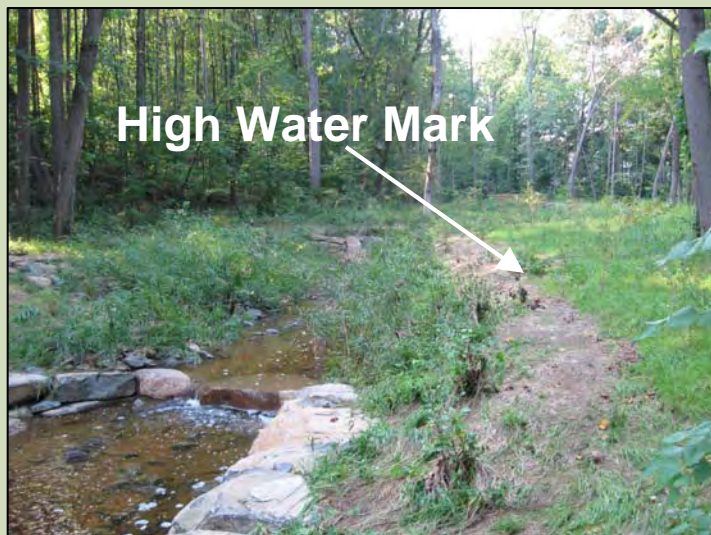
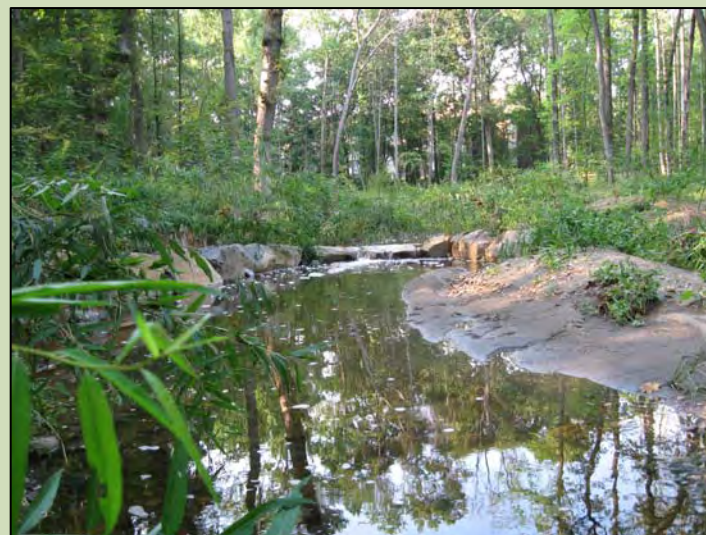
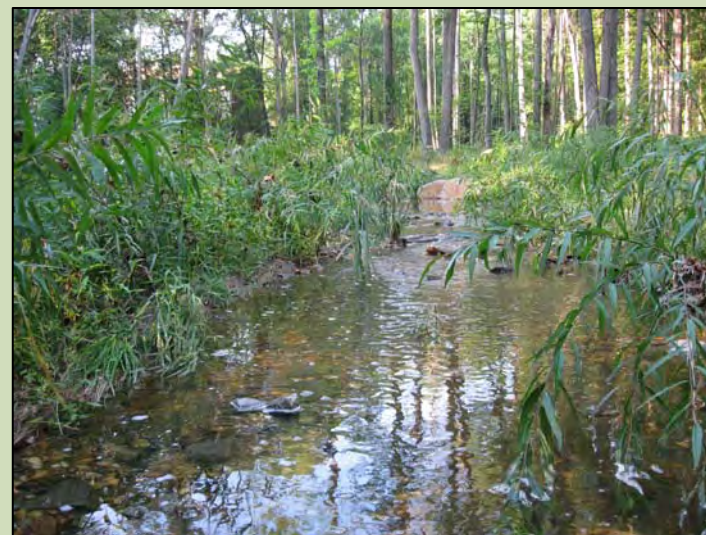
TROPICAL STORM HANNA (9/06/08)

100-YR EVENT (6.22" IN 9 HOURS)

TROPICAL STORM HANNA

2 - DAYS LATER
