## What is Stream Restoration?

# Northern Virginia Stream Restoration Bank

## Stream Restoration Progress Map

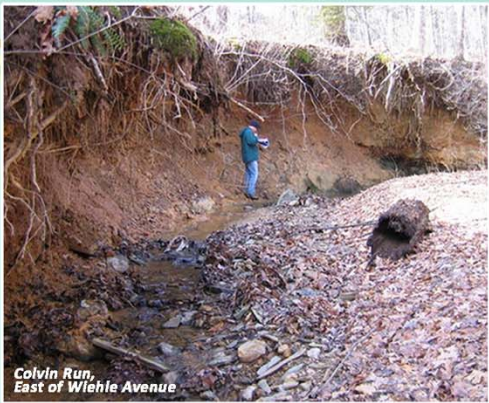
Colvin Run,  
East of Wiehle Avenue

**Streambank erosion threatens roads, trails, trees and utilities in Reston**

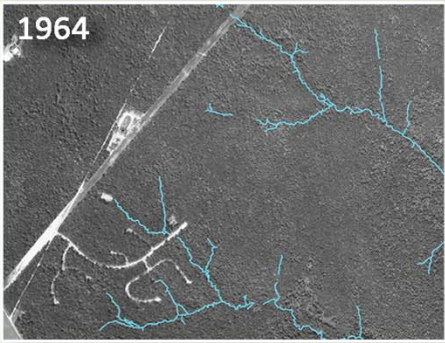
Hunters Woods area in the early stages of development.

Development of Reston resulted in forested land being converted to buildings, roads, parking lots, driveways, sidewalks, and other impervious surfaces that prevent the infiltration of stormwater. The combination of higher runoff volume resulting from developed impervious surfaces and higher peak flows resulting from outdated management techniques increases the flow energy in Reston's streams. This increase in flow energy results in severe stream erosion and downstream sediment deposition.

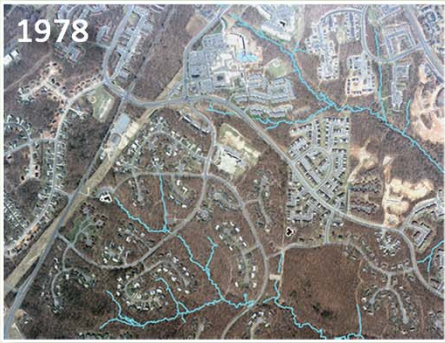
Major development near completion in the late 1970's.

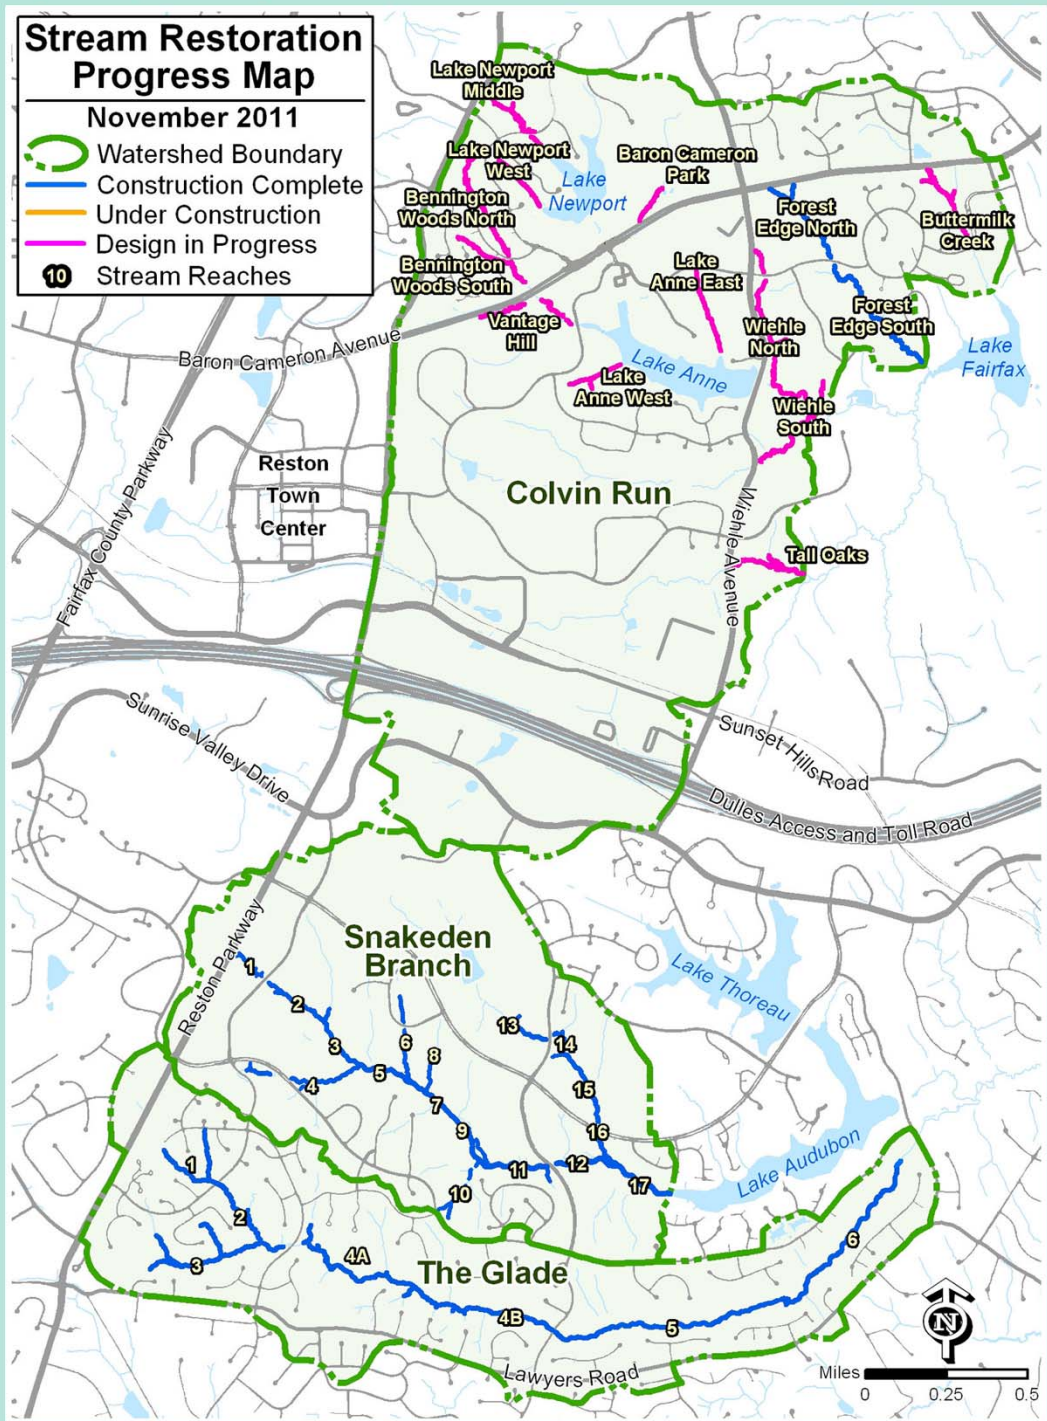
Construction of NVSRB began with the Snakeden Branch watershed in February, 2008. As of November 2011, over 45,000 linear feet have been completed - including all of the Snakeden Branch watershed, the neighboring Glade watershed, and Forest Edge North and South in the Colvin Run watershed. Design work on the remaining reaches in the Colvin Run watershed is in progress. Following construction of each reach, a 10-year monitoring and maintenance program begins that includes streambed, structure, vegetation, and biological surveys.

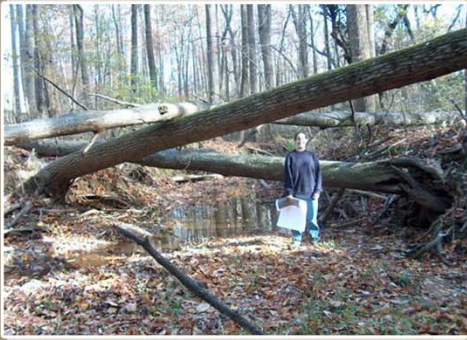
### Snakeden Branch - Reach 3

Pre-Construction

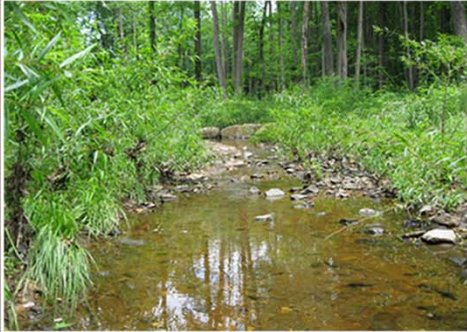
16 Months Post-Construction

The Reston streams are being restored using Natural Channel Design (NCD) techniques that include raising the bed to reconnect higher storm flows with the floodplain; placement of a reinforced bed comprised of crushed stone, sand, gravel, and topsoil; and placement of rock and log structures to direct flow away from channel banks and create riffle/pool features within the bed of the stream. These techniques help the stream bed and banks withstand the high urban flow rates.

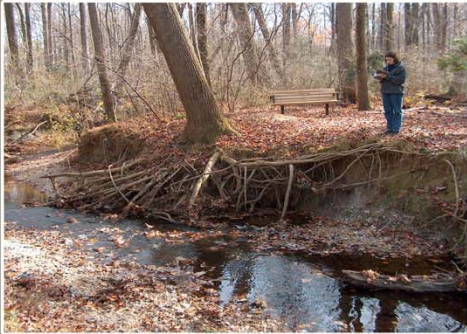
### Snakeden Branch - Reach 17

Pre-Construction

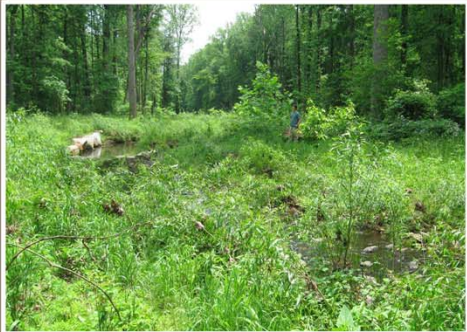
2.5 Years Post-Construction

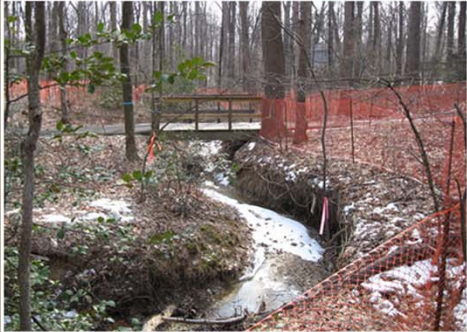
### The Glade - Reach 1

Pre-Construction

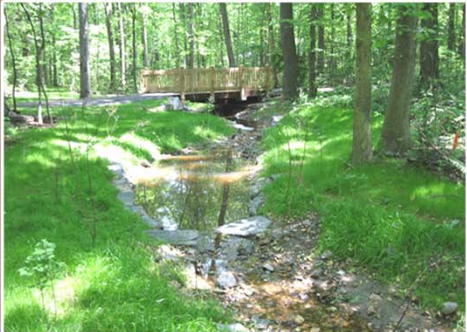
4 Months Post-Construction
