Post-Storm Inspections September 12, 2011

WSSI and RA Inspections

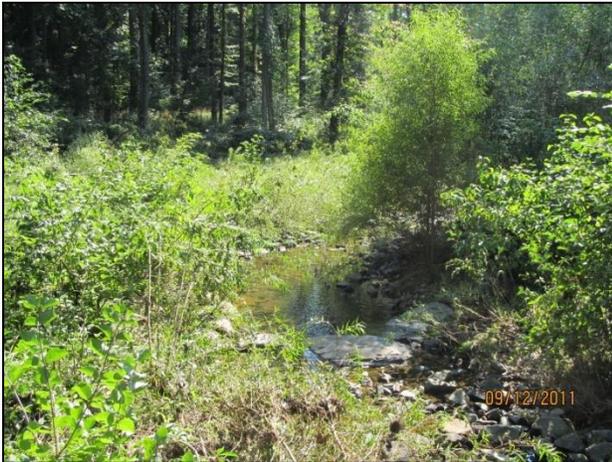
Photo 1: Snakeden Branch - Reach 3

Snakeden Branch. Most of the vegetation in Snakeden Branch is well established, and its fourth growing season. Beyond cleaning debris from bridges and culverts, no stream repairs are required.

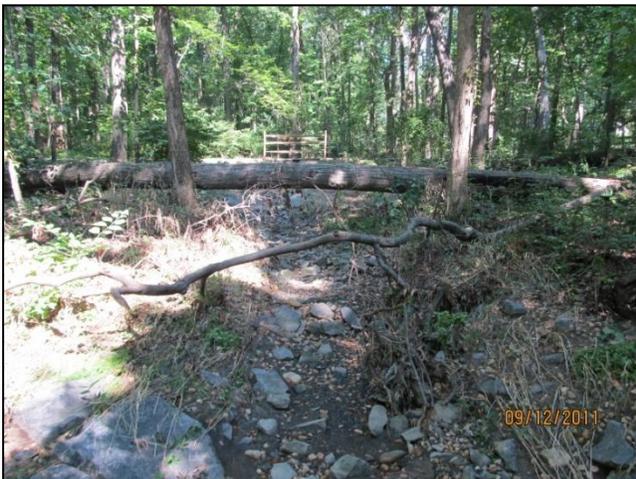
The Glade - Reaches 1 & 1A: No stream issues identified in these upper reaches of The Glade. However, in Reach 1A another tree (a smaller one fell earlier this spring). Neither are adversely affecting the stream at this time. WSSI and RA will continue to monitor. RA will be repairing the pedestrian path that crosses 1A.

Photo 3: The Glade - Reach 1A
Most recent tree fall.

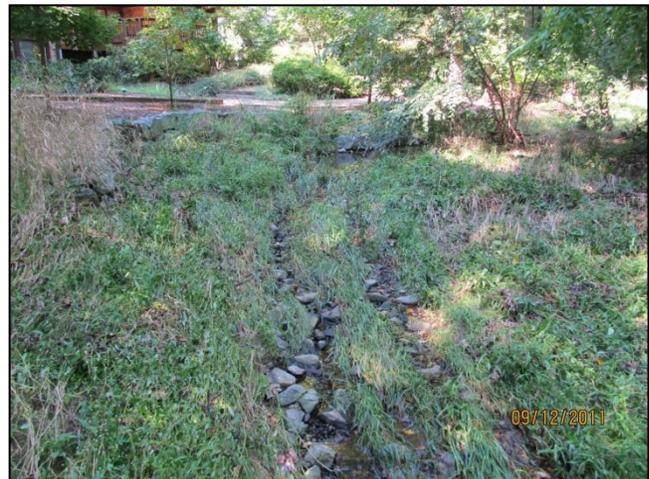
Photo 4: The Glade - Reach 1
No issues at rock wall installed where stream goes onto a private residence.

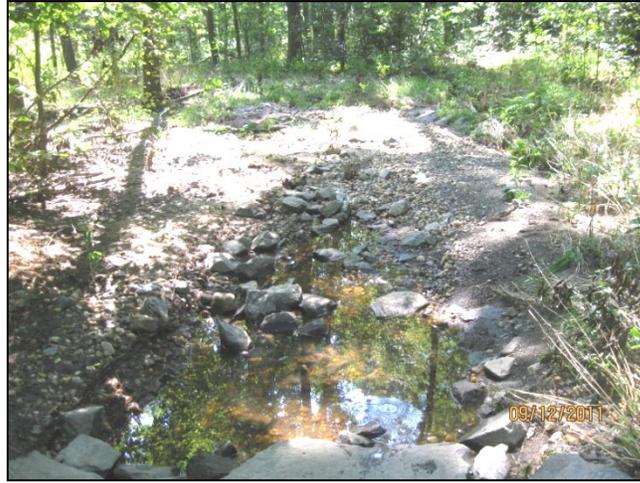
Photo 5: The Glade - Reach 3
Sediment Accumulation on the right bank will be redistributed and a rock wall installed.

The Glade - Reach 3: Sediment deposits immediately downstream of culvert (at the top of the reach) will be redistributed. A rock wall (approximately 6" above ground) will be installed to help prevent this accumulation in the future. Work will commence this month.

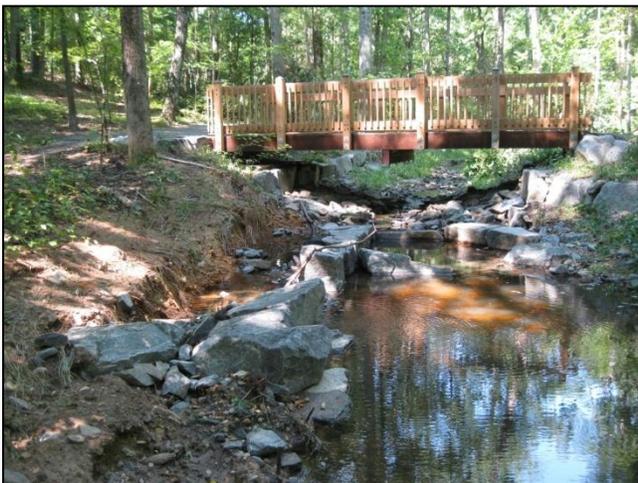
The Glade - Reach 4A: The only stream structure with a problem in the entire NVSRB stream network is the two-step cross vane immediately downstream of the first bridge. One rock in the vane was popped out of place allowing fill material behind the vane to wash downstream. The erosion is isolated around the structure itself and does not affect the bridge or wall immediately upstream. Crews have already mobilized and are scheduled to finish this week.

Photo 6: The Glade - Reach 4A
Crews already mobilized to repair vane

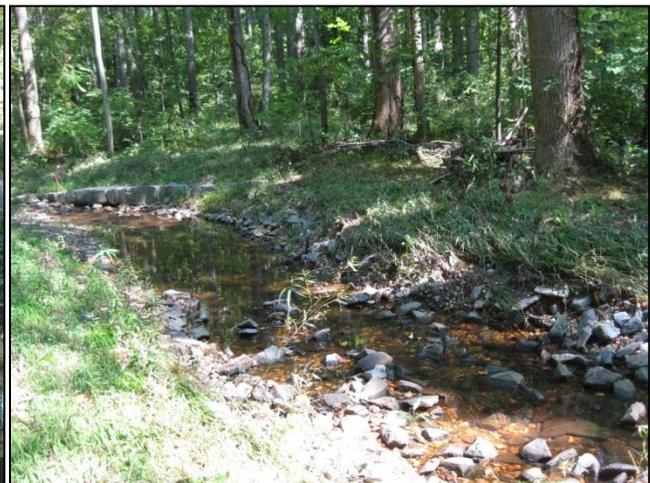
Photo 7: The Glade - Reach 4A
Rack line throughout floodplain shows depth of water during height of storm

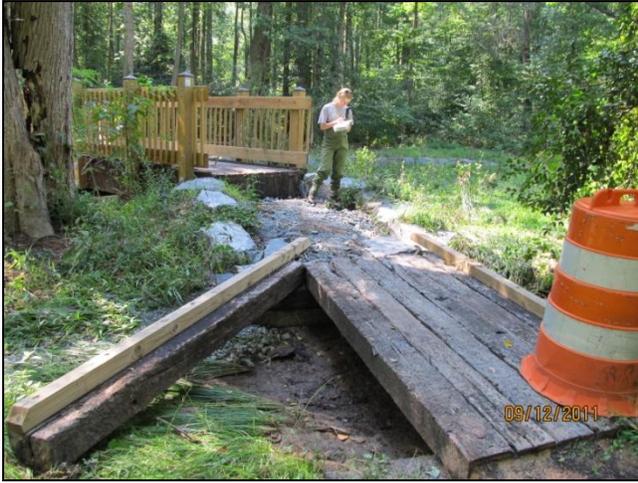
The Glade - Reach 5: Approaches to the pedestrian bridge immediately downstream of Soapstone Drive were washed away. Repairs should be complete this month.

Photo 8: The Glade - Reach 5
Pedestrian bridge approaches washed away

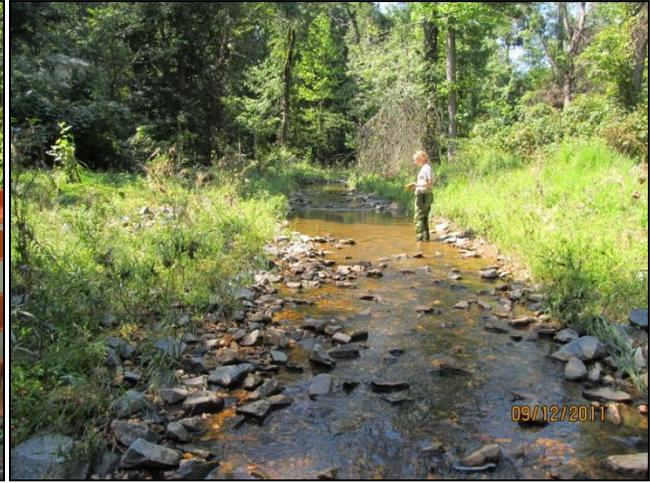
Photo 9: The Glade - Reach 5
Stream and vegetation recovered well

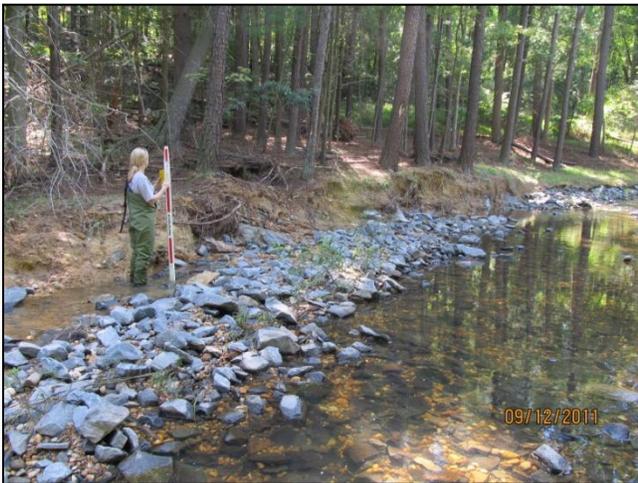
The Glade - Reach 6: The most downstream portion of this channel has eroded 200 feet along the right bank. This repair will potentially require installation of new structures and grading of a bankfull bench and, as such, will require some survey and engineering design work. Repairs are expected this fall/winter. For now, the damage does not pose an imminent risk but will be monitored until the required design and permits can be completed.

Photo 10: The Glade - Reach 6
Looking upstream at erosion along pine forest

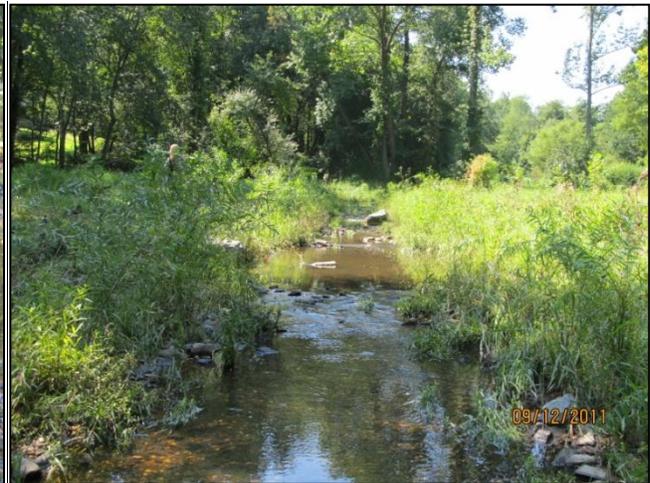
Photo 11: The Glade - Reach 6
Looking upstream immediately upstream of pine forest. No issues in floodplain or along restored channel.

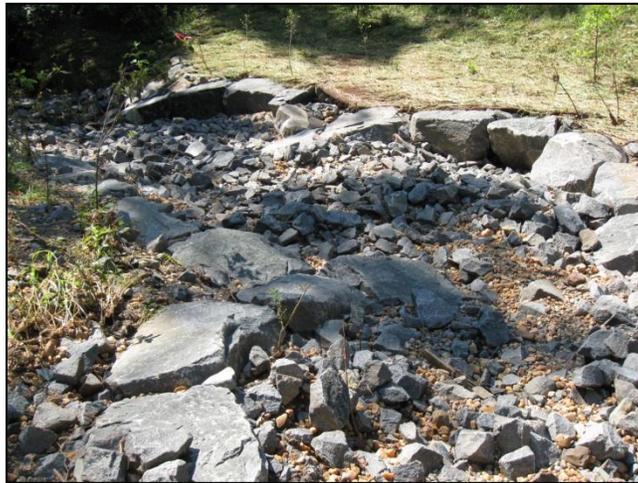
Colvin Run - Forest Edge North. The upper portion of this reach performed well. The area that will require some repair is located between the last bridge and the culvert that crosses under North Shore Drive. A wall and series of step pools were installed to drop the stream down into this existing culvert. The structures are stable, but bed material has been deposited in the step pools – this will be removed and re-distributed in the upstream channel. Additional planting and some top dressing with fines will also be performed within the coming months.

Photo 12: Colvin Run - Forest Edge North
Looking downstream at last step pool series where sediment deposits will be redistributed upstream.

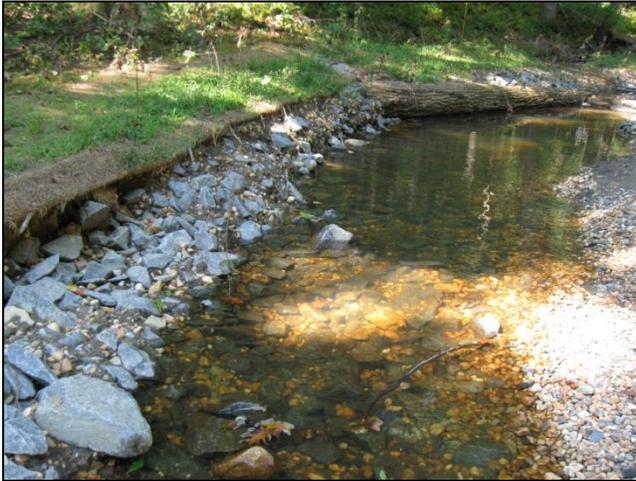
Colvin Run - Forest Edge South. All the structures held very well with no failures. However, bed material displacement (including washout of the fines within the bed mix) was prevalent throughout this reach and will be corrected within the coming months. This will also include some minor grading and top dressing with finer material and top soil, replacement of coir matting, and re-planting as most of the stream side plantings were washed away. Contractors will use small construction equipment to re-grade these areas and prepare the channel for replanting in the spring.

**Photo 13: Colvin Run - Forest Edge South
Looking upstream at bank erosion**

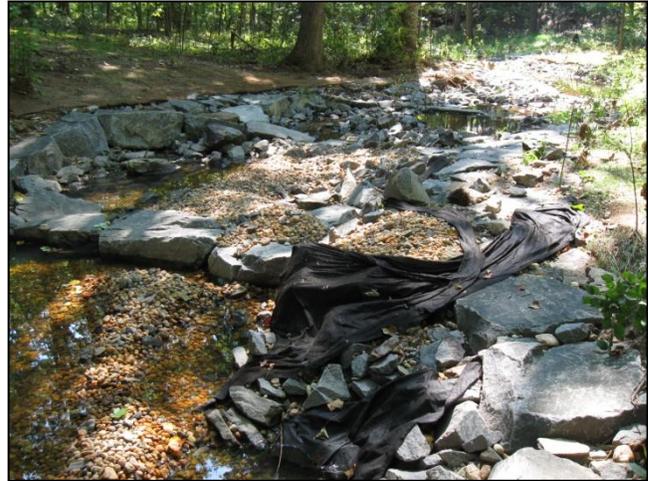
**Photo 14: Colvin Run - Forest Edge South
Looking upstream where fabric will be trimmed**

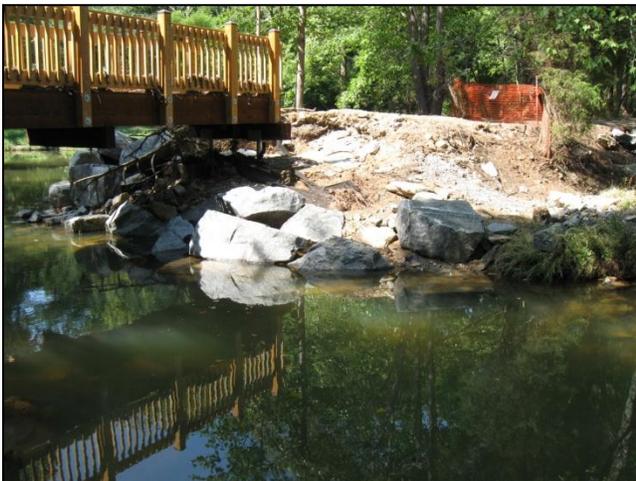
The pedestrian approaches washed away on both sides of the new bridge along the Cross-County Trail (CCT) that was installed just upstream of Lake Fairfax. The good news is that despite the fact that water was flowing over the top of the bridge itself, it did not sustain any damage. Work is expected to be completed in the coming weeks.

**Photo 15: CCT Bridge approaches washed away,
but bridge is unharmed**

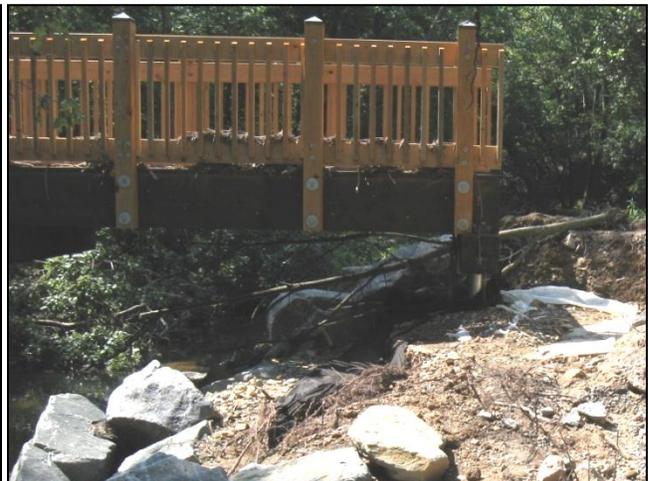
**Photo 16: CCT Bridge
Water was over the bridge as confirmed by debris
accumulation on bridge**

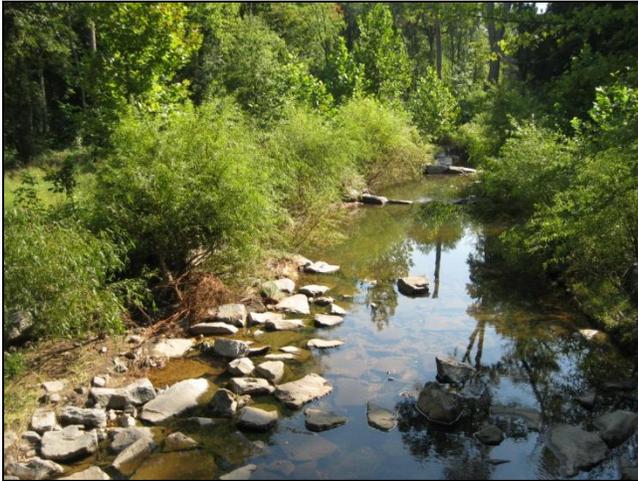
Photo 17: Snakeden Branch - Reach 12

Beyond these few problem spots, the streams handled the rain events extremely well with most areas already completely recovered. Below are a couple photos from our storm inspections showing how remarkable the streams looked only a couple days after the storm.
