Biological Monitoring Report – Year 1 (Post-Construction)

The Glade - Reaches 2, 3, 4A, and 4B

Fairfax County, Virginia
WSSI #20030, Task I2

October 29, 2010

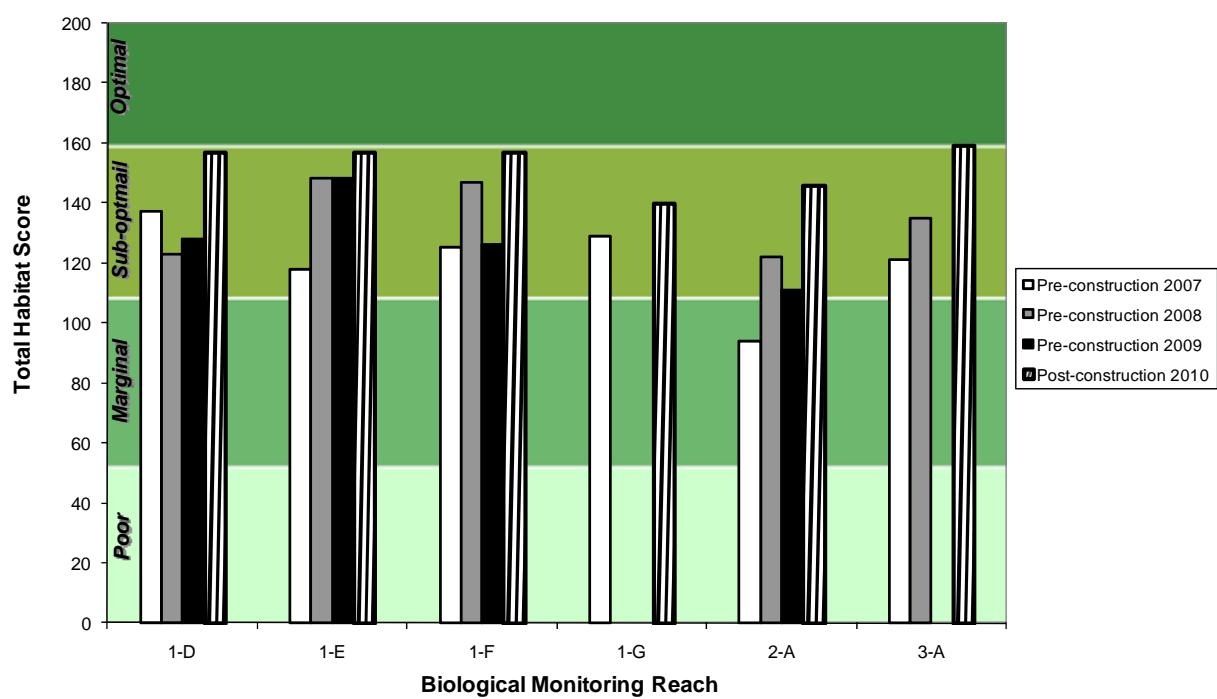
Figure 1. Comparison of Habitat Assessment Scores from 2007-2010 for The Glade Watershed

Biological Stream Monitoring Results and Discussion. Habitat results for Year 1 show that all stream reaches have “Sub-optimal” habitat conditions, though the reaches are generally at the high end of “Sub-optimal” (Table 1, Figure 1, and Exhibit 5 for each reach). The average habitat assessment score for all restored stream reaches assessed in 2010 is 153 out of 200 following restoration. These results show improved habitat conditions following restoration, with scores exceeding the pre-restoration scores. Improved habitat assessment scores relate to the success of the well vegetated and stabilized banks, with little erosion or depositional zones present throughout the restored reaches. It is expected that this trend will continue over time as the density of the reforested riparian zone increases.

*Note that biological monitoring reach 1-G was not assessed in 2008 and 2009 and biological monitoring reach 3-A was not assessed in 2009 due to the lack of flowing water during the time of the sampling fieldwork.

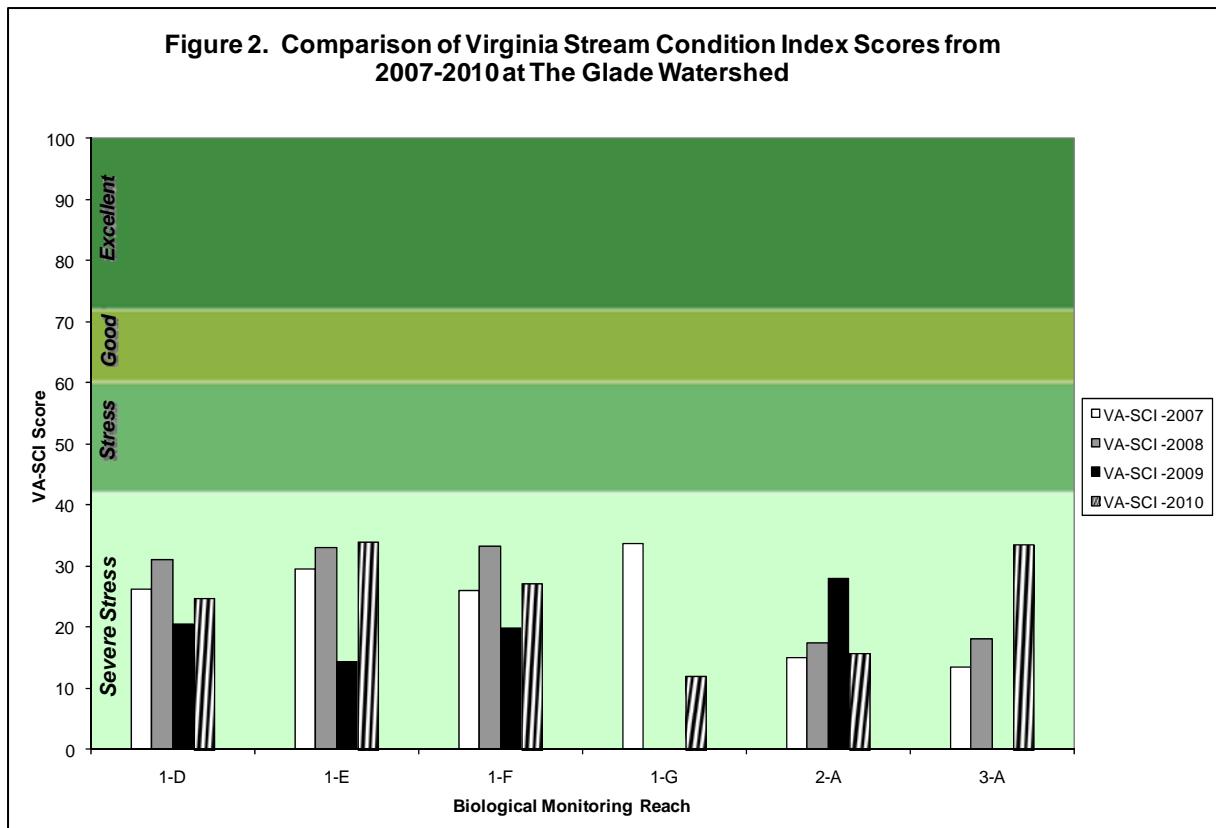
These results are similar to the 2007-2009 monitoring, where the benthic macroinvertebrate community at almost all reaches was also in “Severe Stress” (Figure 2). It is expected that the VA-SCI scores in 2010 would not improve immediately following restoration efforts due to disturbance from construction. Such disturbances can temporarily reduce benthic condition, and recovery of the benthic community can be slow (Muatka 2002).

*Note that biological monitoring reach 1-G was not sampled in 2008 and 2009 and biological monitoring reach 3-A was not sampled in 2009 due to the lack of flowing water during the time of the sampling fieldwork.

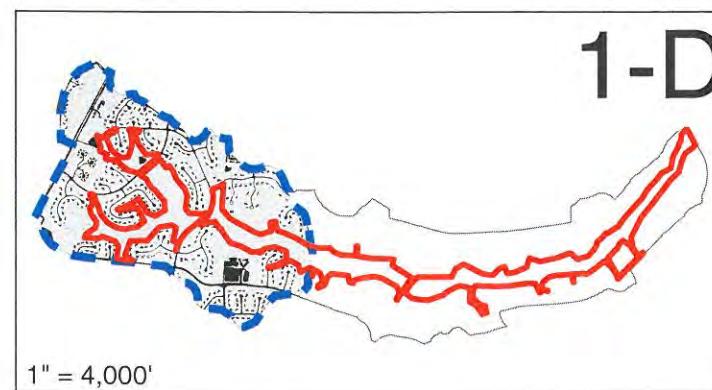
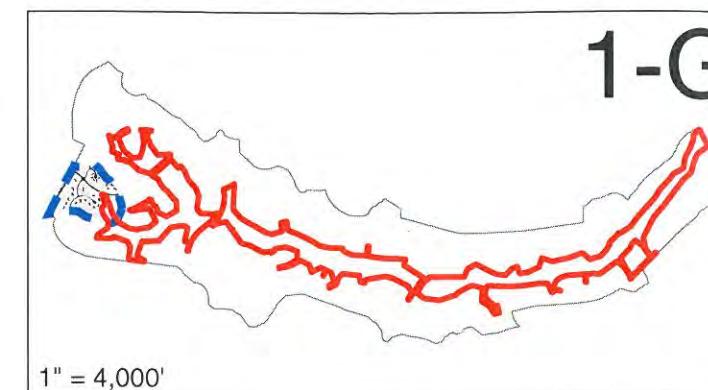
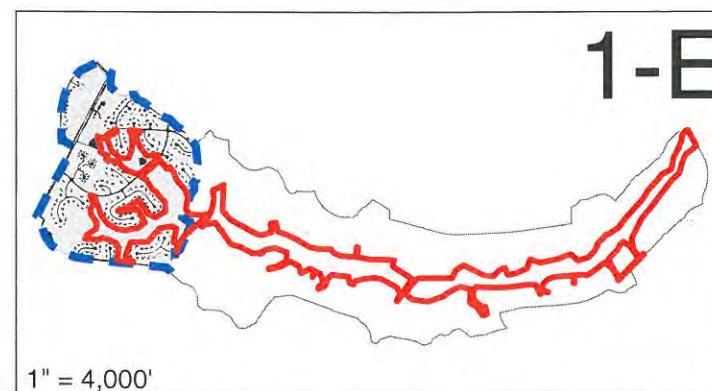
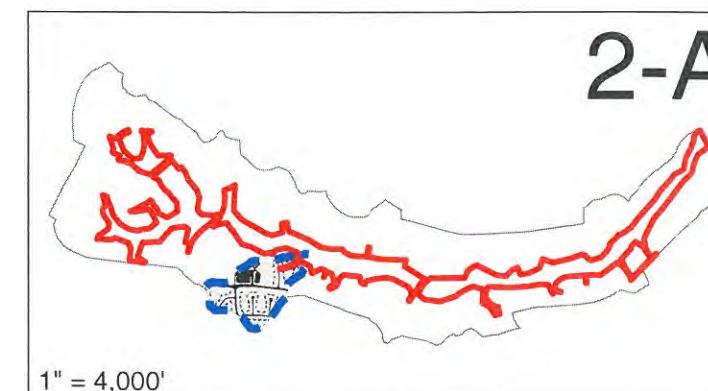
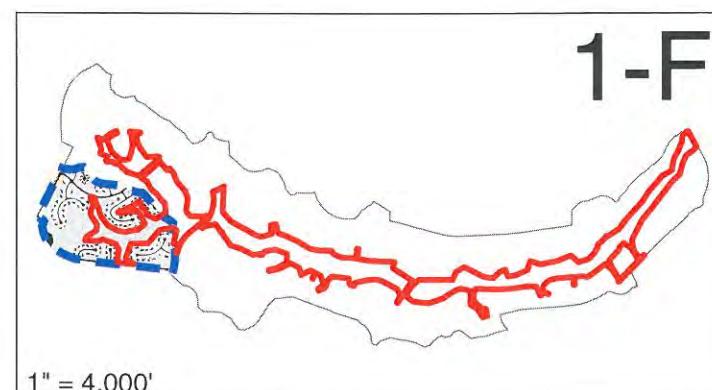
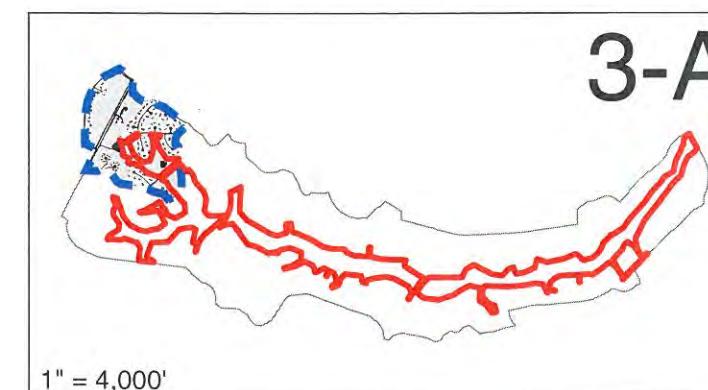
Land Cover Map
The Glade Reaches 2, 3, 4A, and 4B
WSSI #20030
Scale as Noted

An analysis of land use within the watershed of each stream reach indicates that each watershed is highly developed, with all reaches having at least 15 percent impervious land cover (with a weighted watershed average of 15 percent), as depicted in the Land Cover Map (Exhibit 4), and Table 5. It has been documented that increases in watershed imperviousness reduce macroinvertebrate diversity, such that when imperviousness exceeds 10 to 15 percent, macroinvertebrate diversity becomes low (Klein 1979). Runoff from the highly impervious land within these watersheds typically produces a high volume and velocity of flowing water and sediment in the stream channels during storm events. As a result, epifaunal substrate/available cover within these streams becomes highly mobile and benthic macrofauna could not easily colonize the available substrate (Debrey and Lockwood 1990) or they were buried and killed by high sediment deposition (Wood and Armitage 1997). However, because the restored streams within our study area have been engineered to accommodate high volume flows, future habitat degradation should be minimized.

Stream	Impervious	Total
	ID	Percent
1-D	16%	395
1-E	16%	221
1-F	15%	95
1-G	17%	27
2-A	28%	40
3-A	18%	91

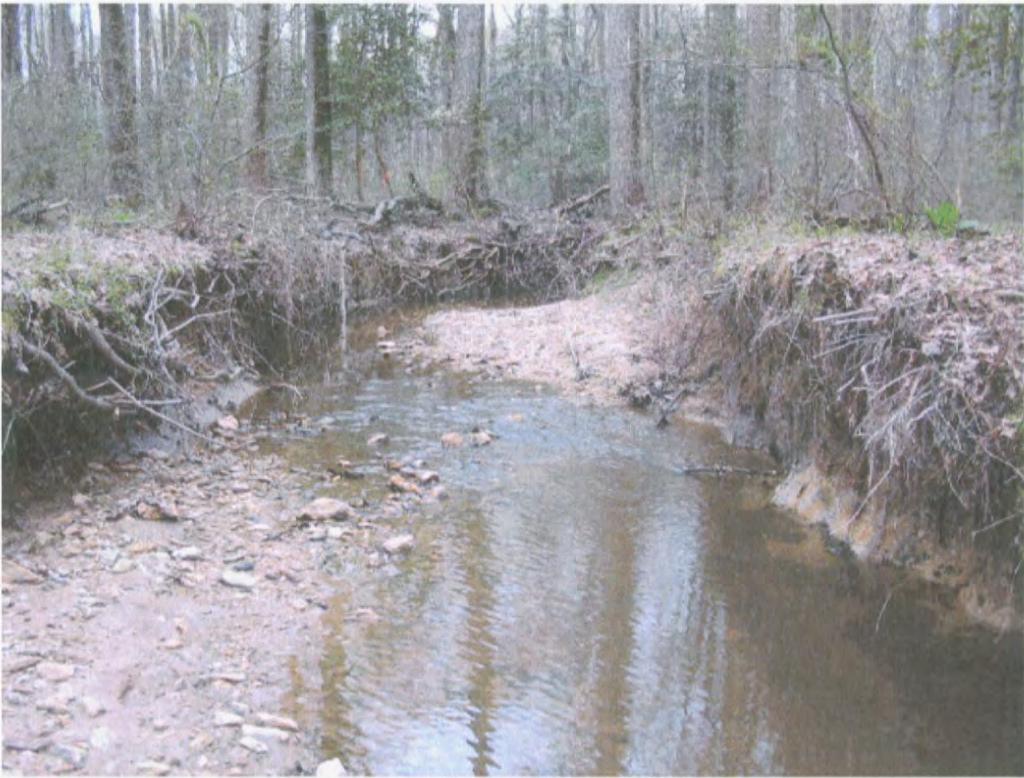
**REACH 1-D
BIOLOGICAL STREAM ASSESSMENT PHOTOGRAPHS
THE GLADE WATERSHED
WSSI #20030**

1. Looking northwest (upstream) at Reach 1-D of The Glade in the eastern portion of the study area. Photo taken March 2007, prior to construction.

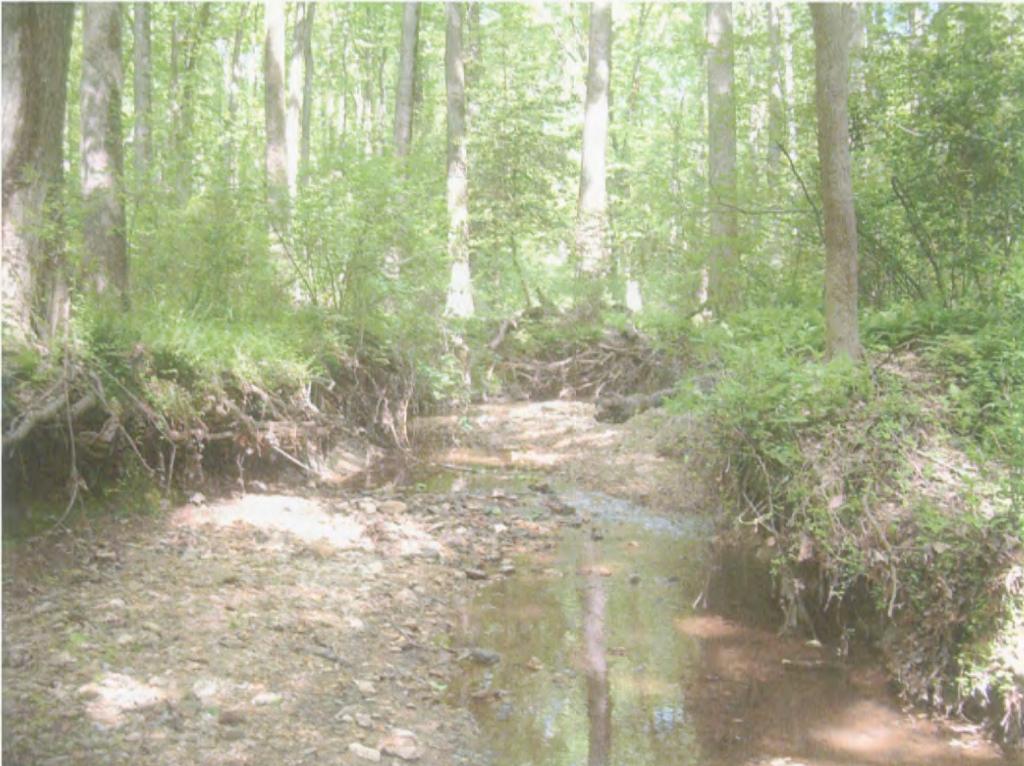
2. Looking northwest (upstream) at Reach 1-D of The Glade in the eastern portion of the study area. Photo taken May 2008, prior to construction.

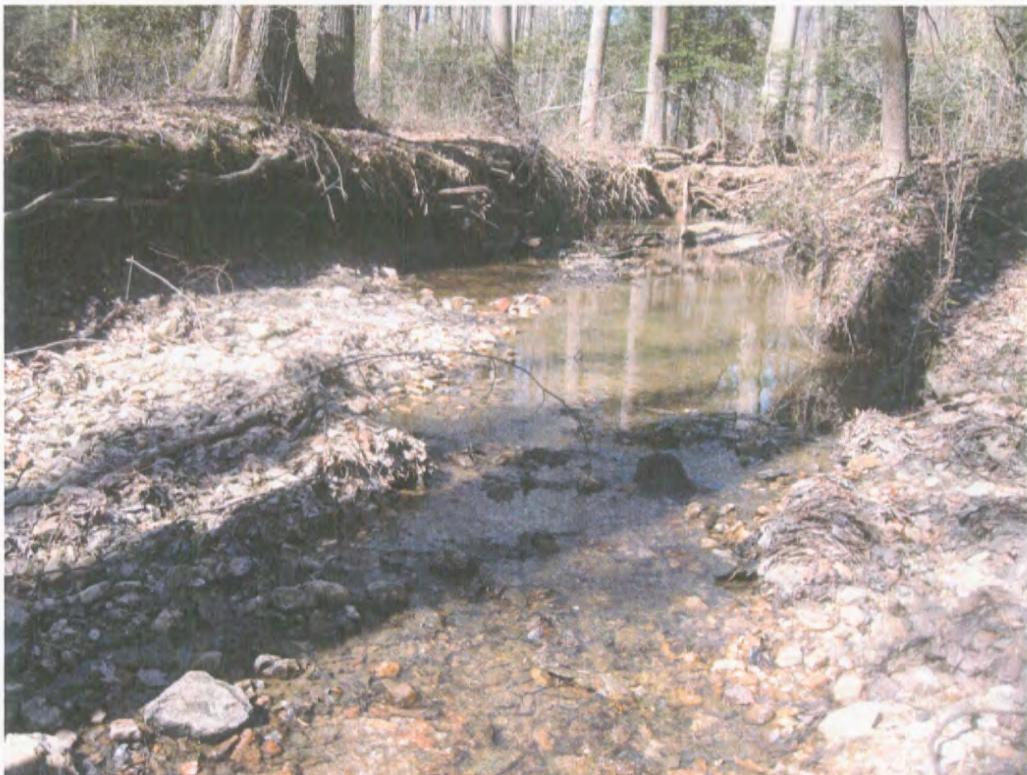
**REACH 1-D
BIOLOGICAL STREAM ASSESSMENT PHOTOGRAPHS
THE GLADE WATERSHED
WSSI #20030**

3. Looking northwest (upstream) at Reach 1-D of The Glade in the eastern portion of the study area. Photo taken March 2009, prior to construction.

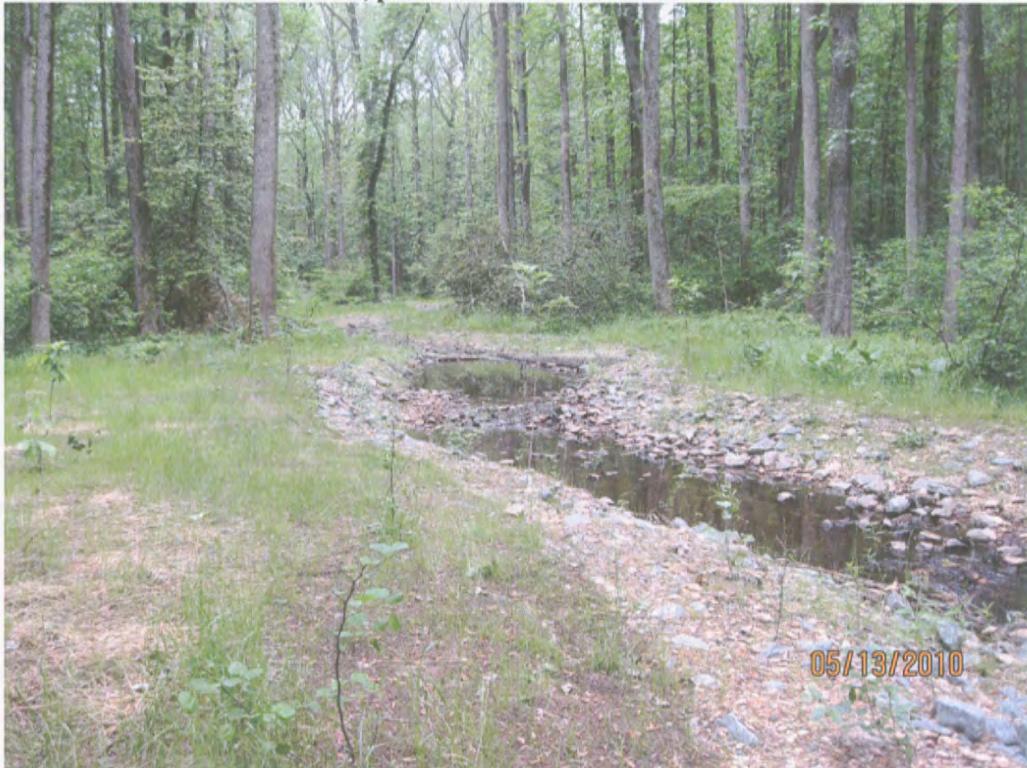
4. Looking northwest (upstream) at Reach 1-D of The Glade in the eastern portion of the study area. Photo taken May 2010, during Year 1.

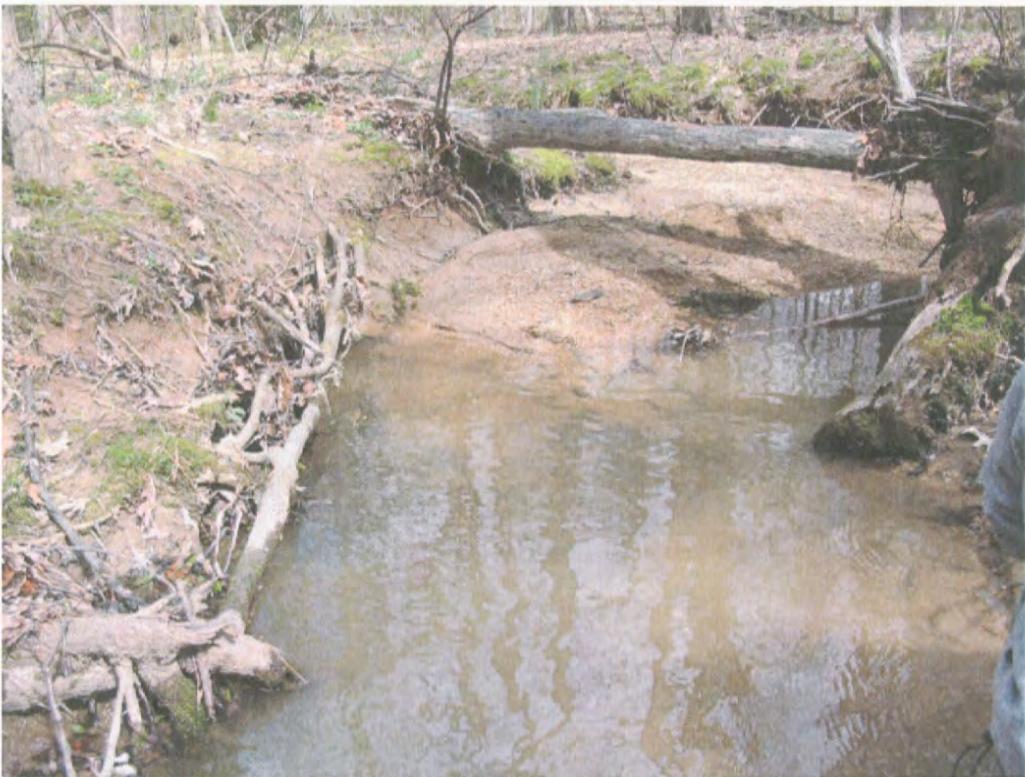
**REACH 1-E
BIOLOGICAL STREAM ASSESSMENT PHOTOGRAPHS
THE GLADE WATERSHED
WSSI #20030**

1. Looking west (upstream) at Reach 1-E of The Glade in the eastern portion of the study area.
Photo taken March 2007, prior to construction.

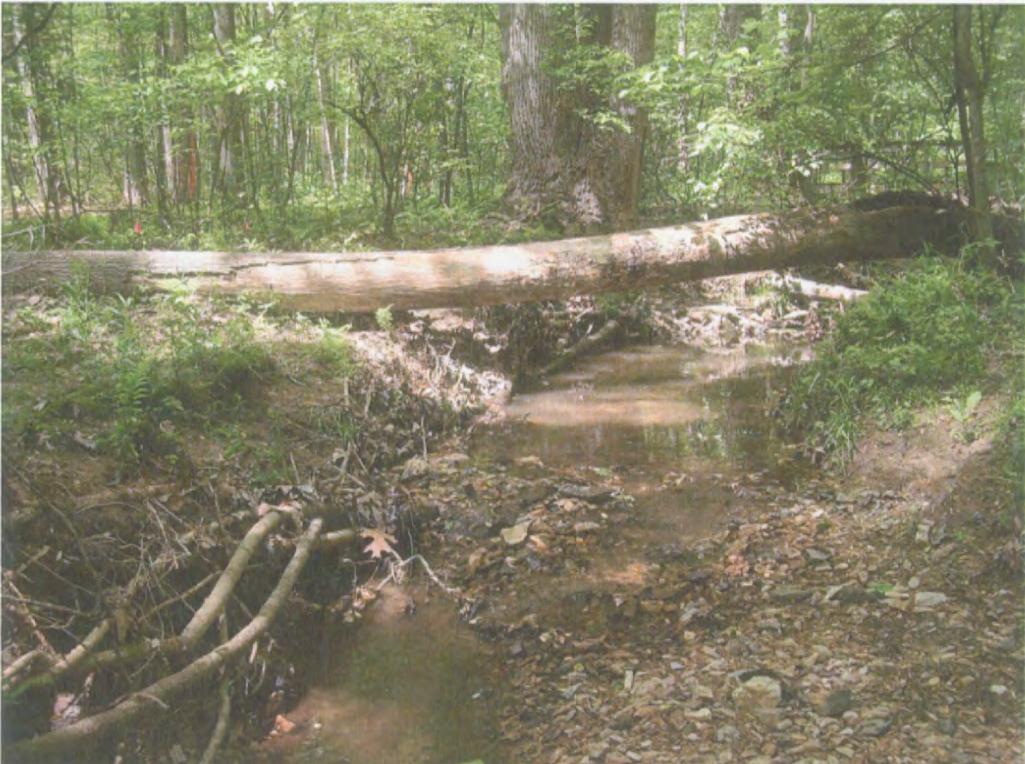
2. Looking west (upstream) at Reach 1-E of The Glade in the eastern portion of the study area.
Photo taken May 2008, prior to construction.

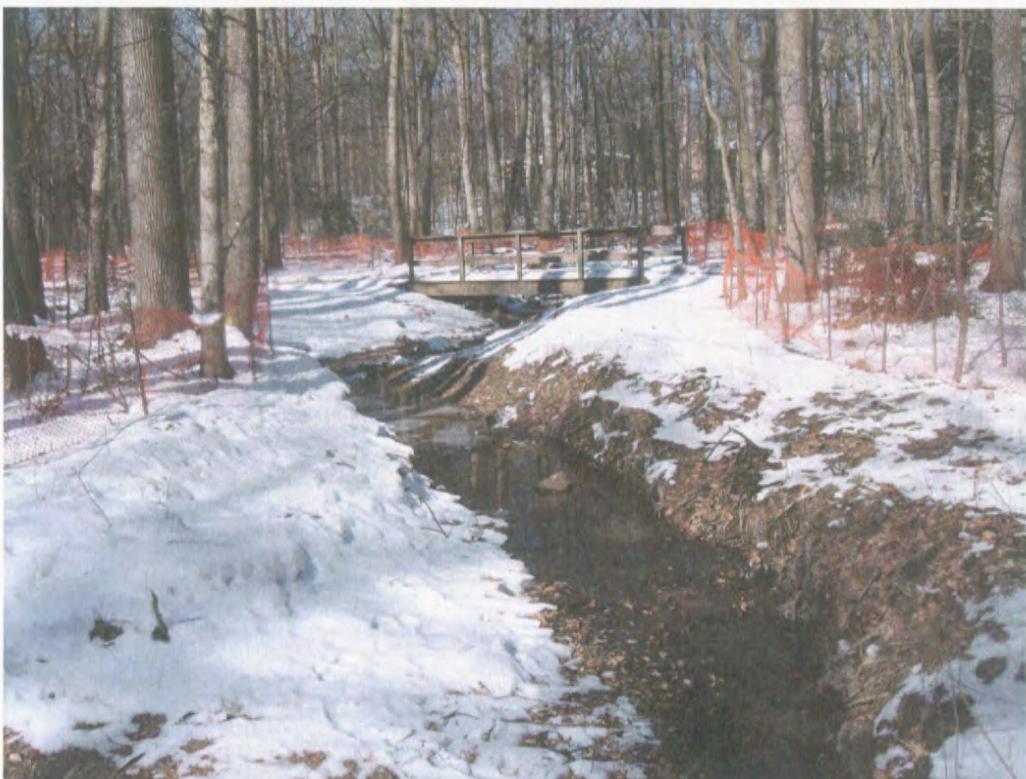
**REACH 1-E
BIOLOGICAL STREAM ASSESSMENT PHOTOGRAPHS
THE GLADE WATERSHED
WSSI #20030**

3. Looking west (upstream) at Reach 1-E of The Glade in the eastern portion of the study area. Photo taken March 2009, prior to construction.

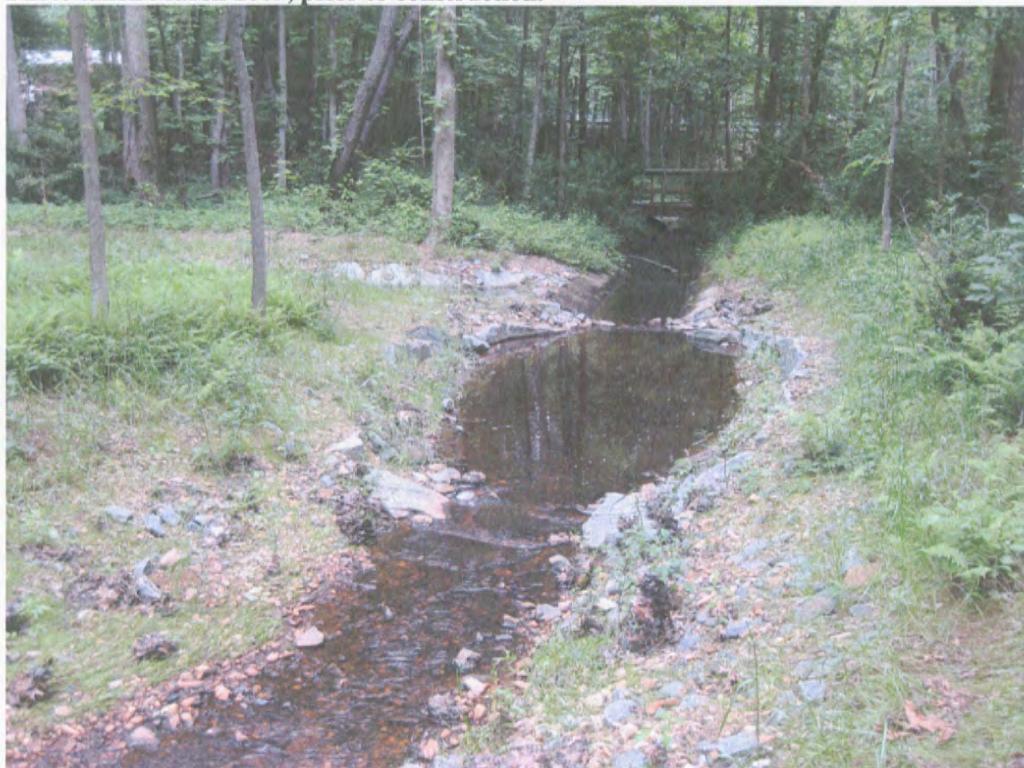
4. Looking west (upstream) at Reach 1-E of The Glade in the eastern portion of the study area. Photo taken May 2010, during Year 1.

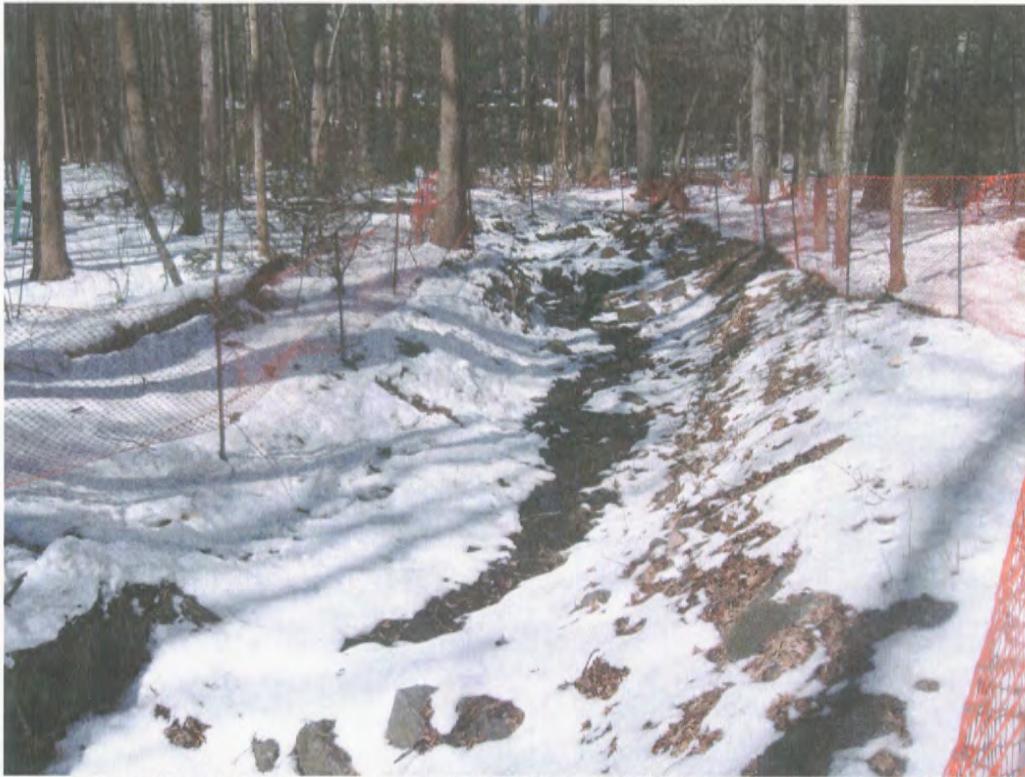
**REACH 1-F
BIOLOGICAL STREAM ASSESSMENT PHOTOGRAPHS
THE GLADE WATERSHED
WSSI #20030**

3. Looking southwest (upstream) at Reach 1-F of The Glade in the eastern portion of the study area. Photo taken March 2009, prior to construction.

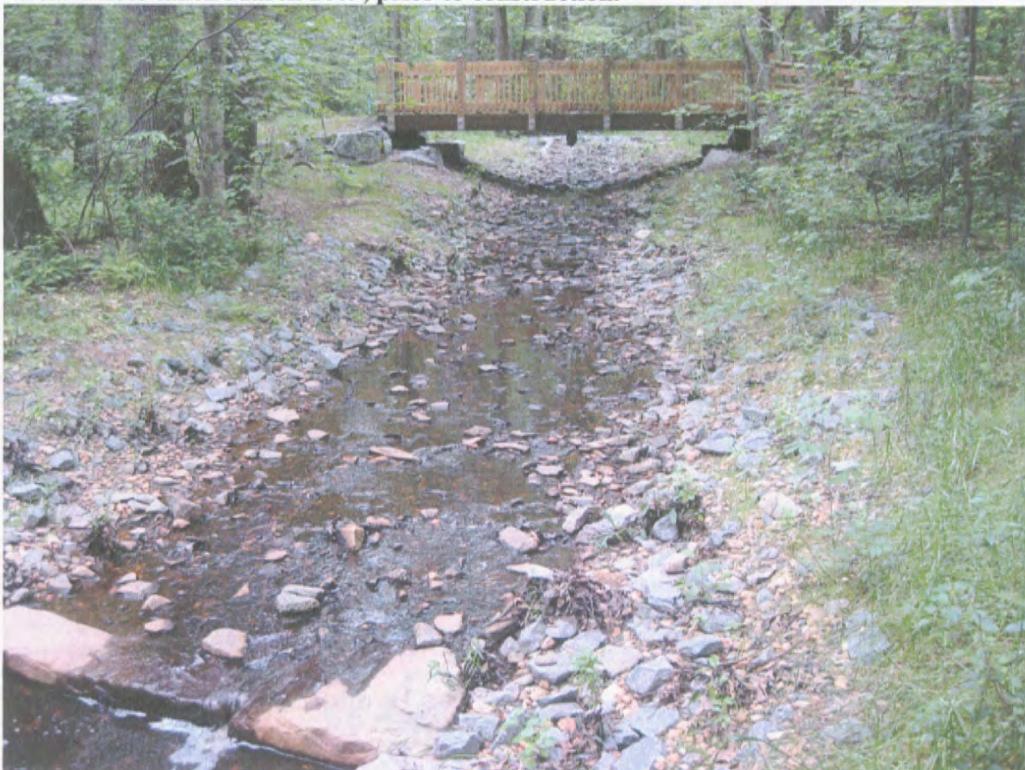
4. Looking southwest (upstream) at Reach 1-F of The Glade in the eastern portion of the study area. Photo taken May 2010, during Year 1.

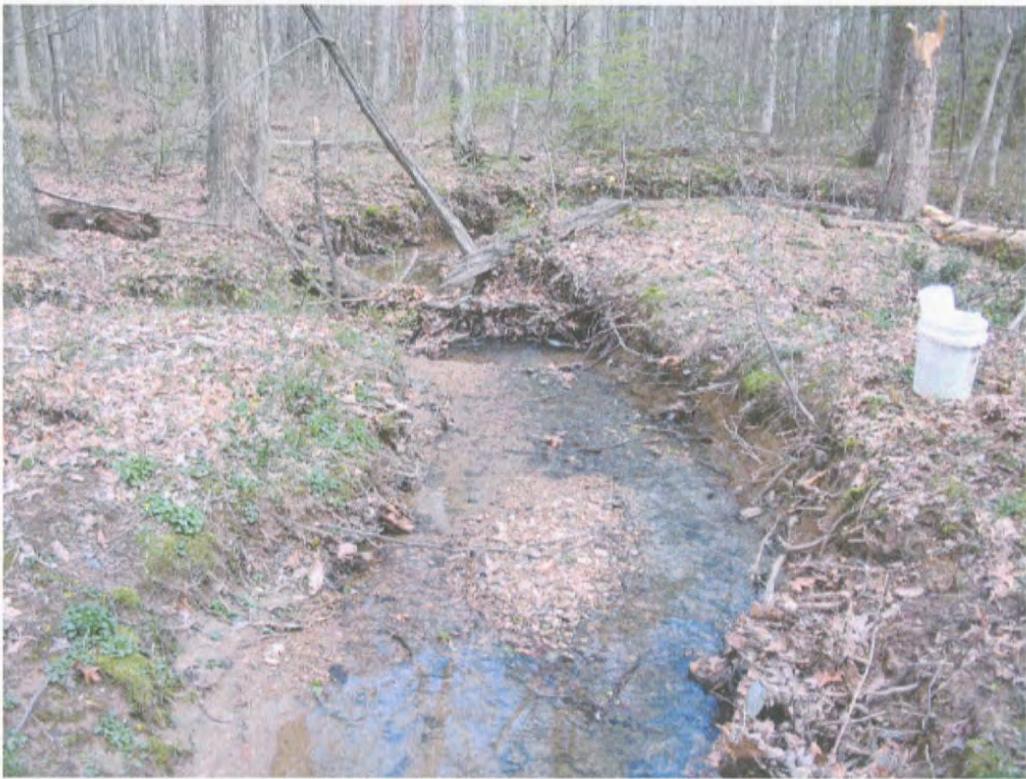
**REACH 1-F
BIOLOGICAL STREAM ASSESSMENT PHOTOGRAPHS
THE GLADE WATERSHED
WSSI #20030**

1. Looking southwest (upstream) at Reach 1-F of The Glade in the eastern portion of the study area. Photo taken March 2007, prior to construction.

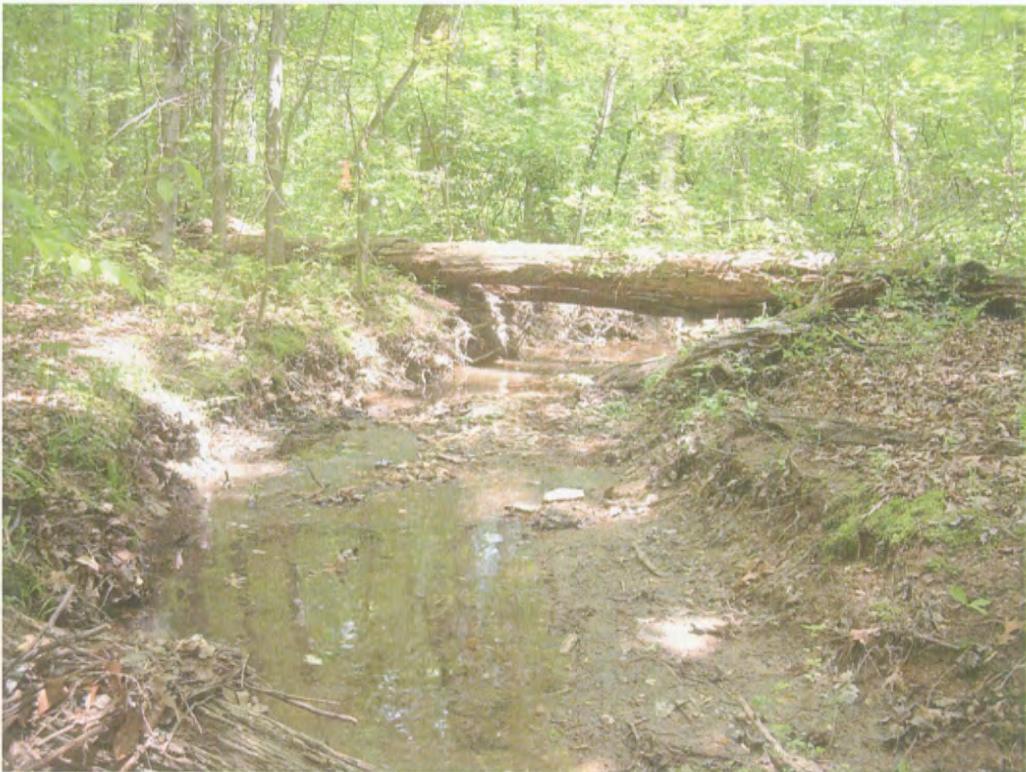
2. Looking southwest (upstream) at Reach 1-F of The Glade in the eastern portion of the study area. Photo taken May 2008, prior to construction.

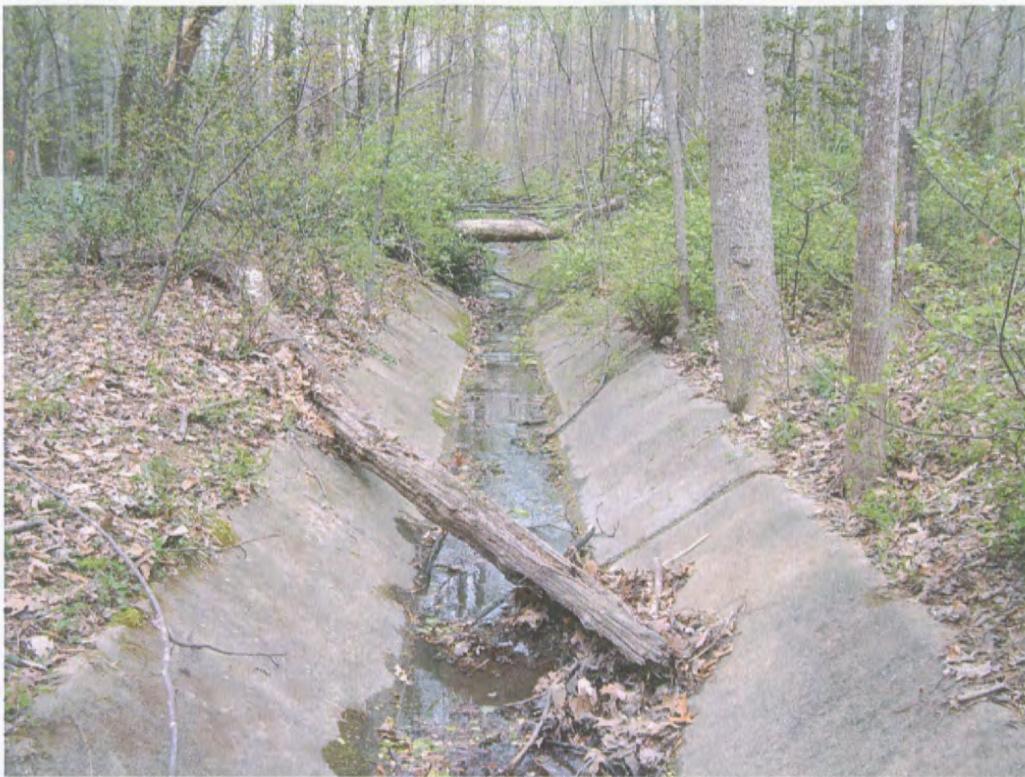
**REACH 1-G
BIOLOGICAL STREAM ASSESSMENT PHOTOGRAPHS
THE GLADE WATERSHED
WSSI #20030**

1. Looking northwest (upstream) at Reach 1-G of The Glade in the western portion of the study area. Photo taken April 2007, prior to construction.

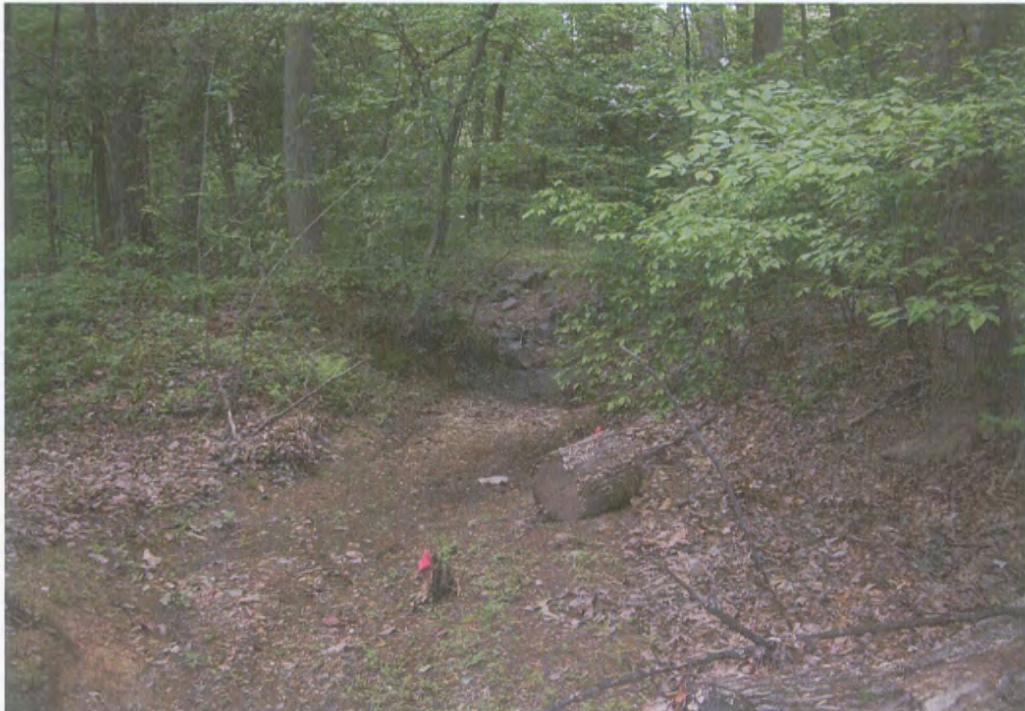
2. Looking northwest (upstream), just downstream of Reach 1-G of The Glade in the western portion of the study area. Reach 1-G had no flow during the 2008 sampling fieldwork and this photo depicts the lack of flow downstream of the reach. Due to the lack of flow within and just downstream of Reach 1-G, this area was not samplable in 2008. Photo taken May 2008, prior to construction.

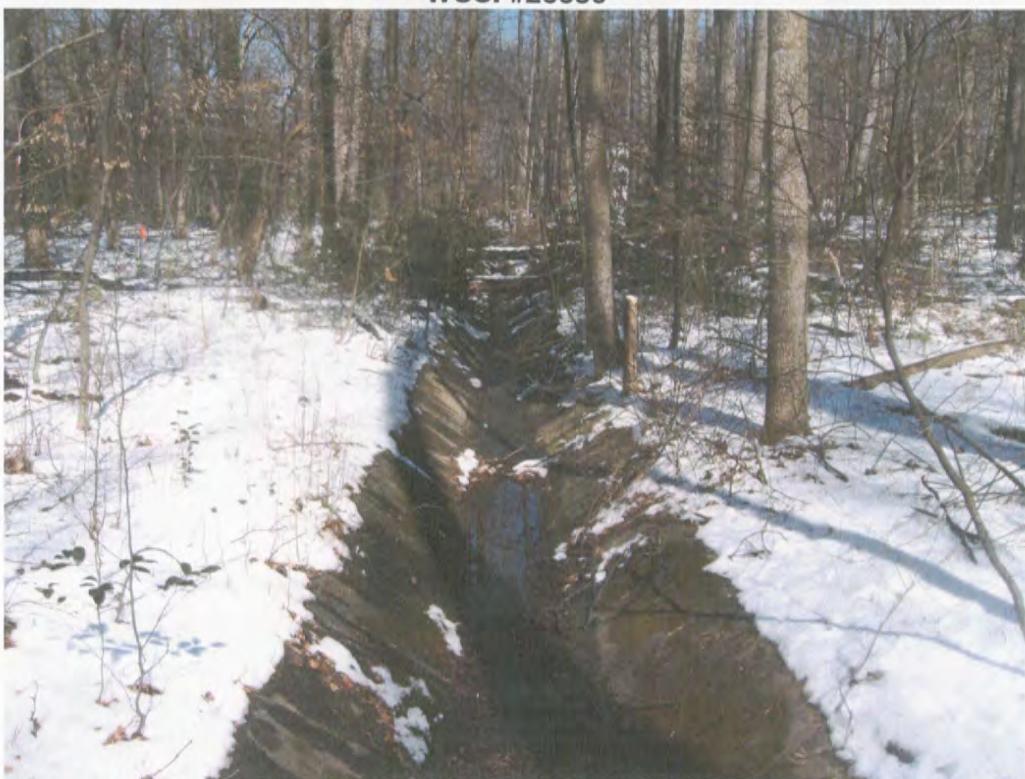
3. Photo taken northwest (upstream) at Reach 1-G of The Glade in the western portion of the study area. This reach did not have continuous flow and was therefore not sampleable at the time of field work in 2009. Photo taken March 2009, prior to construction.

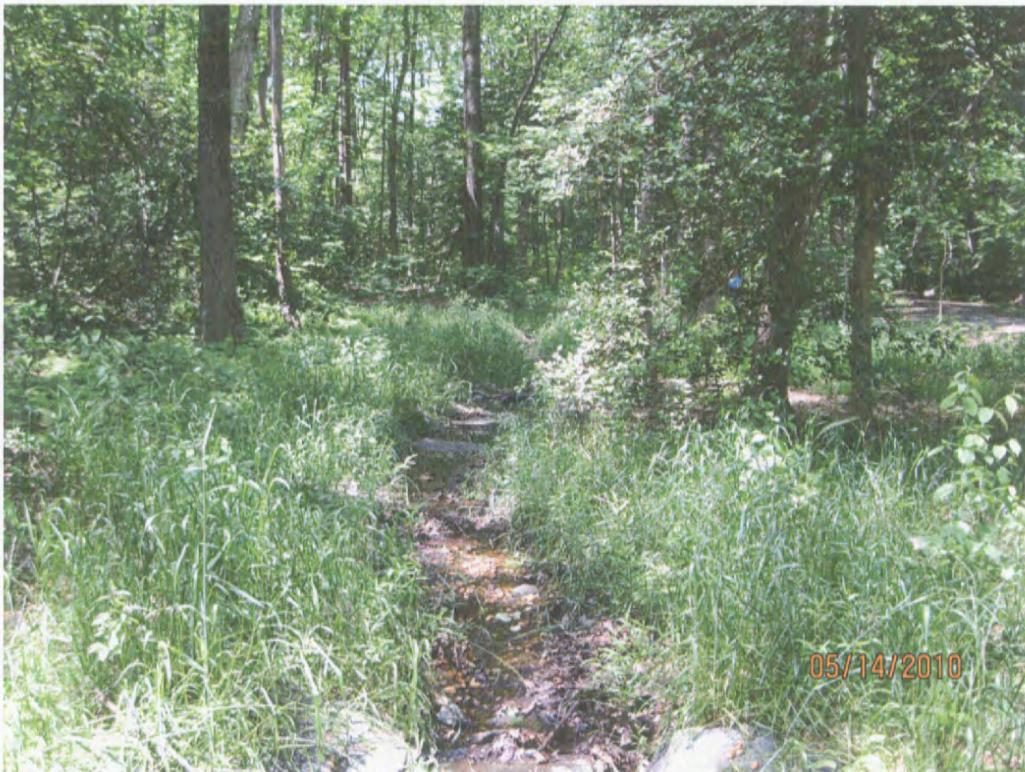
4. Looking northwest (upstream), just downstream of original Reach 1-G in the western portion of the study area. Because the area containing concrete was not restored, Reach 1-G has been moved just downstream of the original reach. This area depicts the new location of Reach 1-G during Year 1 following restoration. Photo taken May 2010, during Year 1.

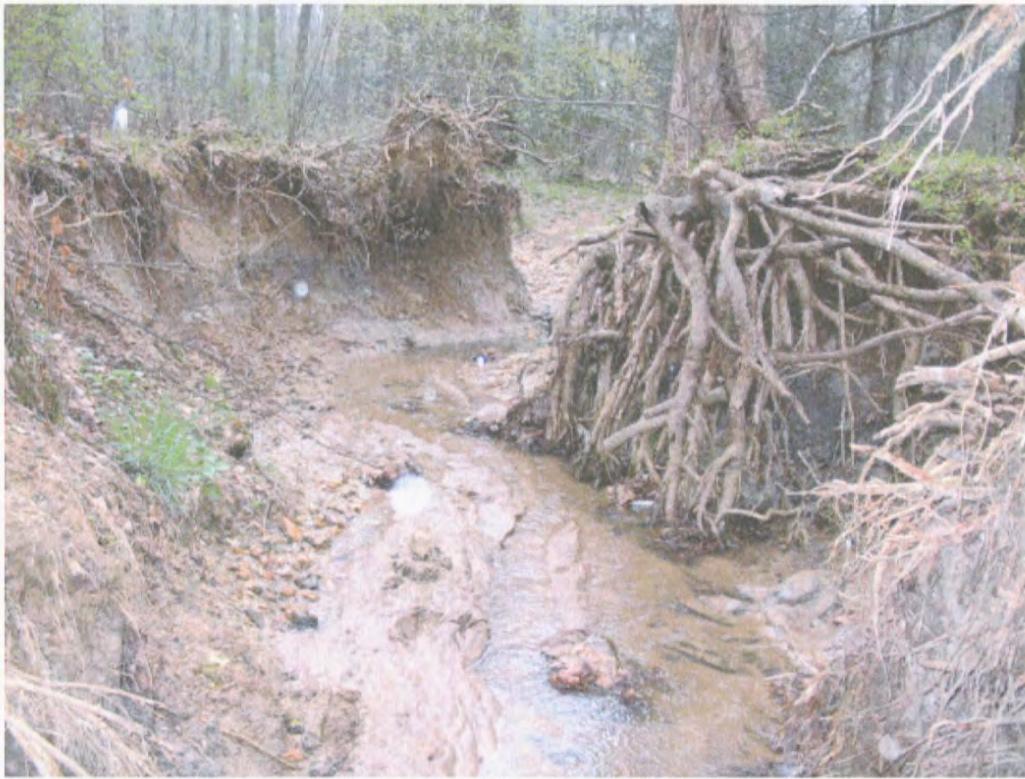
**REACH 2-A
BIOLOGICAL STREAM ASSESSMENT PHOTOGRAPHS
THE GLADE WATERSHED
WSSI #20030**

1. Looking northeast (downstream) at Reach 2-A of The Glade in the eastern portion of the study area. Photo taken March 2007, prior to construction.

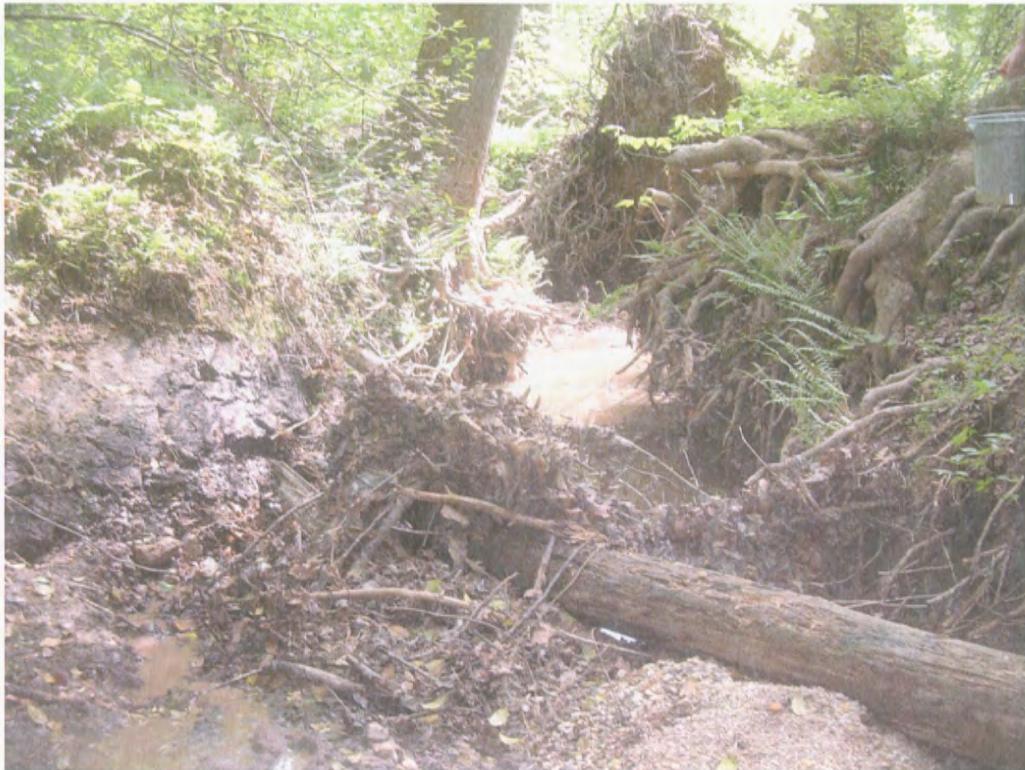
2. Looking northeast (downstream) at Reach 2-A of The Glade in the eastern portion of the study area. Photo taken May 2008, prior to construction.

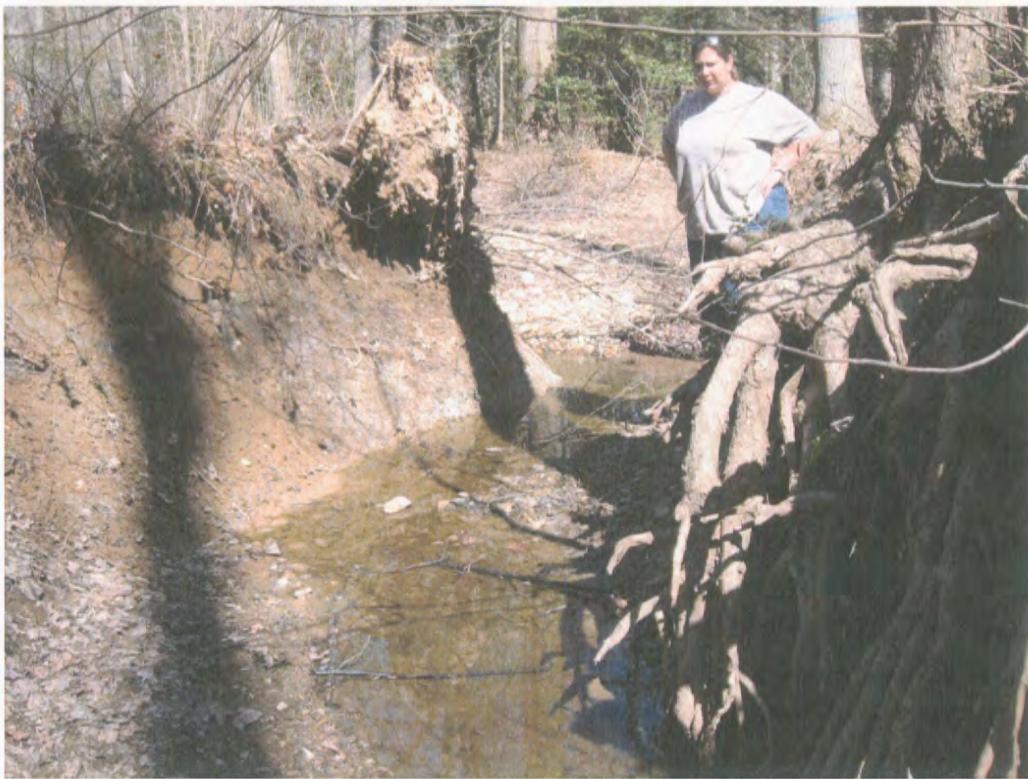
**REACH 2-A
BIOLOGICAL STREAM ASSESSMENT PHOTOGRAPHS
THE GLADE WATERSHED
WSSI #20030**

3. Looking northeast (downstream) at Reach 2-A of The Glade in the eastern portion of the study area. Photo taken March 2009, prior to construction.

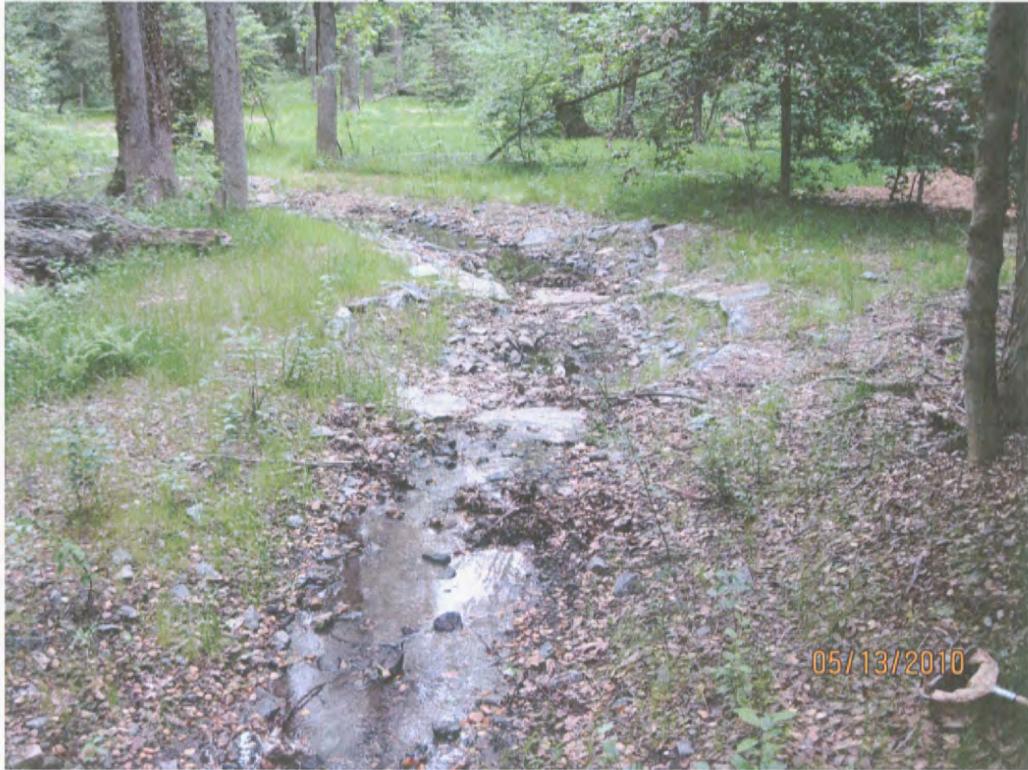
4. Looking northeast (downstream) at Reach 2-A of The Glade in the eastern portion of the study area. Photo taken May 2010, during Year 1.

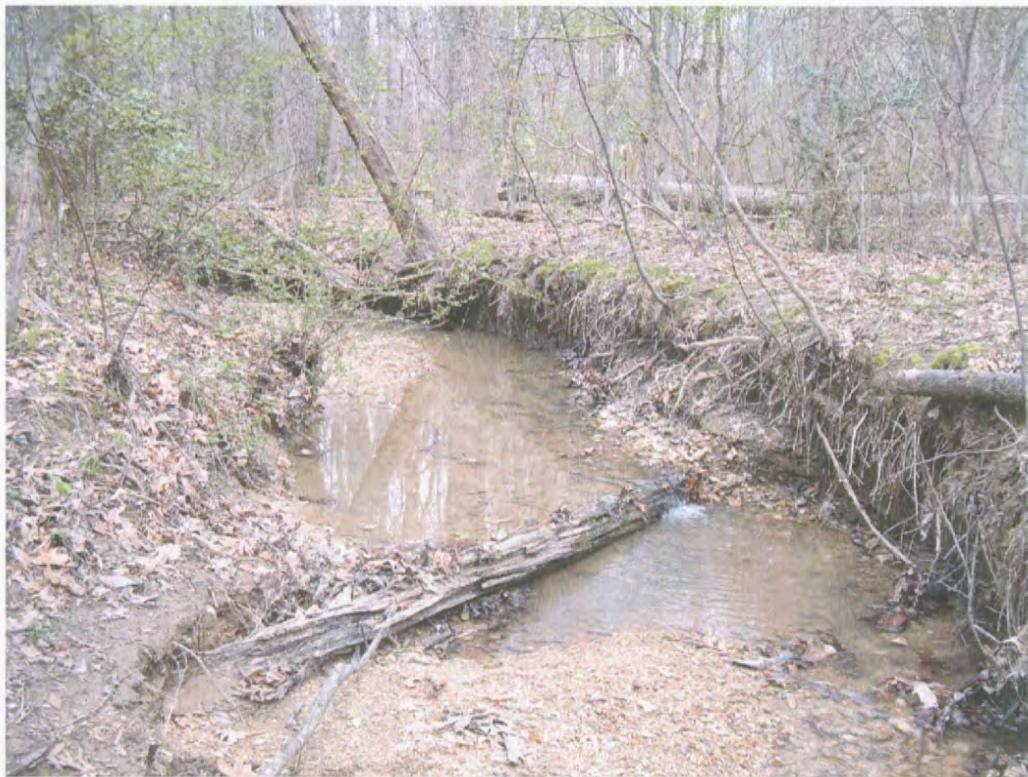
**REACH 3-A
BIOLOGICAL STREAM ASSESSMENT PHOTOGRAPHS
THE GLADE WATERSHED
WSSI #20030**

1. Looking northwest (upstream) at Reach 3-A, an unnamed tributary of The Glade in the western portion of the study area. Photo taken March 2007, prior to construction.

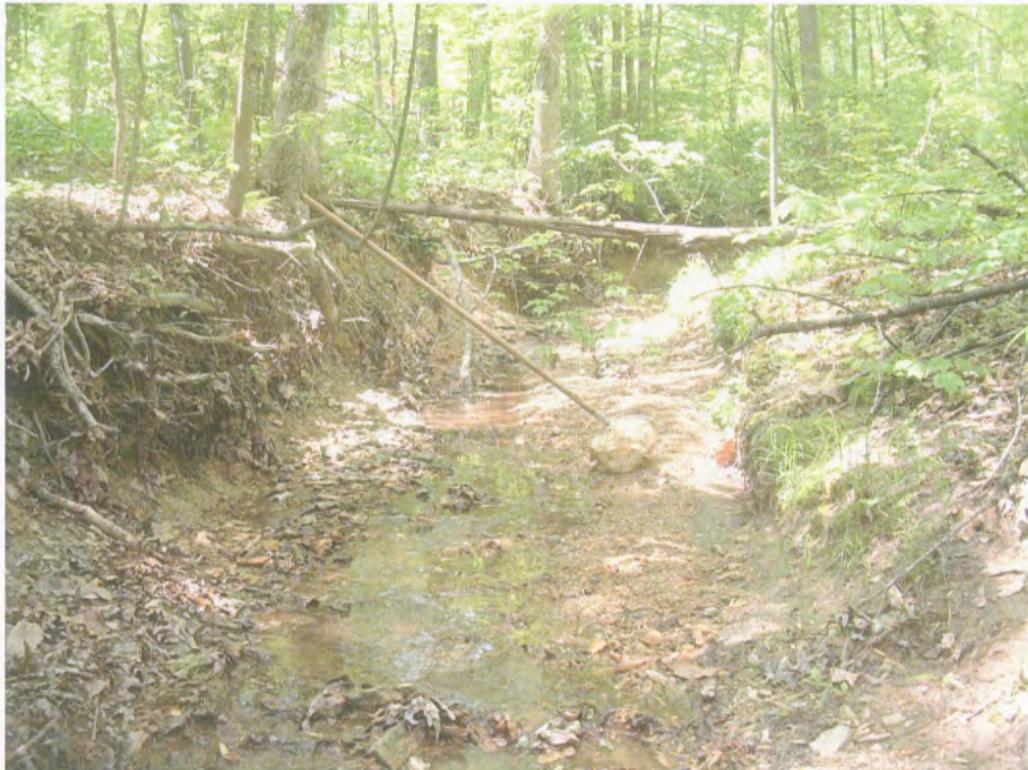
2. Looking northwest (upstream) at Reach 3-A, an unnamed tributary of The Glade in the western portion of the study area. Photo taken April 2008, prior to construction.
