Biological Monitoring Report – Year 1 (Post-Construction)

The Glade - Reaches 2, 3, 4A, and 4B

Fairfax County, Virginia
WSSI #20030, Task I2

October 29, 2010

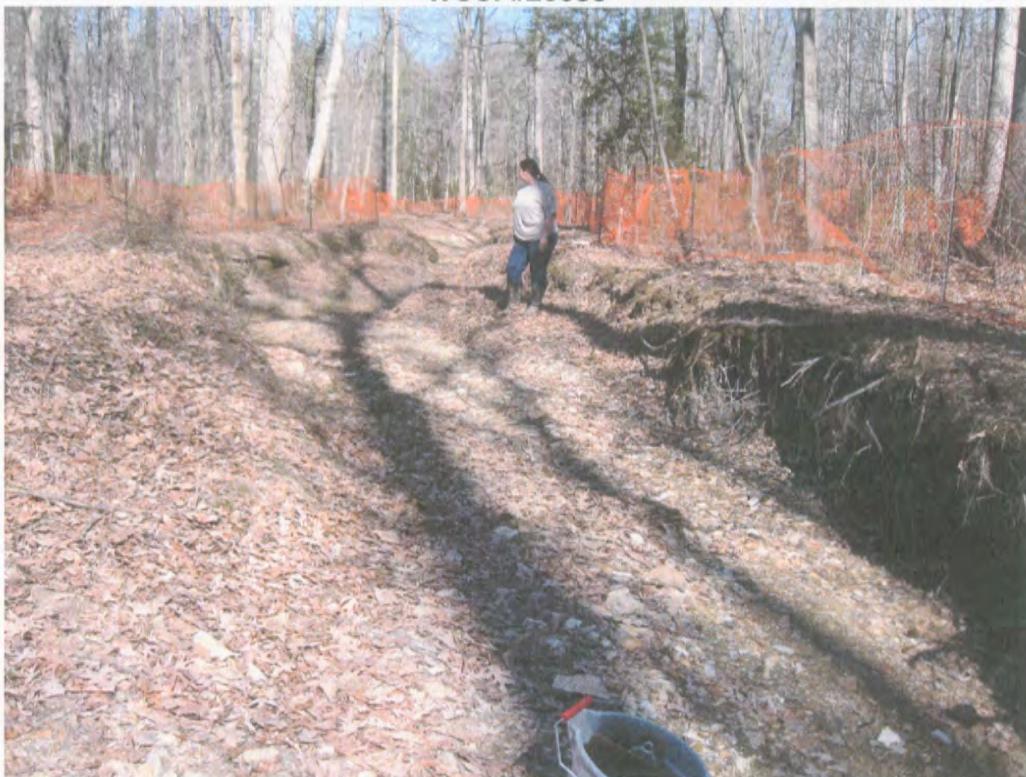
3. Looking northwest (upstream) at Reach 3-A, an unnamed tributary of The Glade in the western portion of the study area. The stream did not have continuous flow and was therefore not sampleable at the time of field work. Photo taken March 2009, prior to construction.

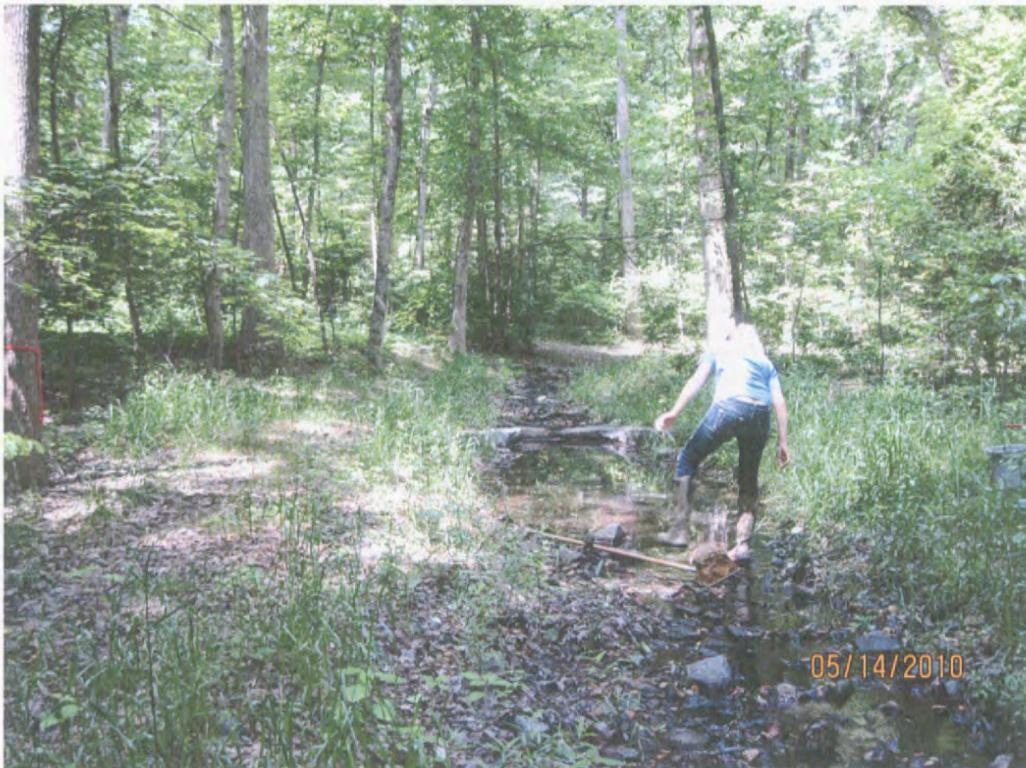
4. Looking northwest (upstream) at Reach 3-A, an unnamed tributary of The Glade in the western portion of the study area. Photo taken May 2010, during Year 1.
