# The Glade – Reaches 5 and 6

Fairfax County, Virginia WSSI #20030, Task I5b

# Biological Monitoring Report- Year 5 (Post-Construction)

April 27, 2015

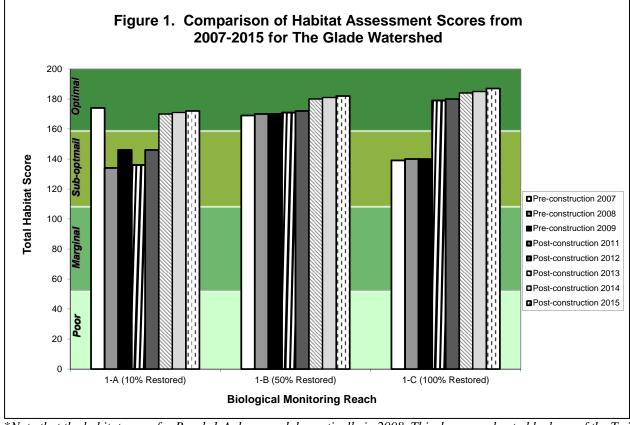
<u>Biological Stream Monitoring Results and Discussion.</u> Habitat results for Year 5 show that Reach 1-A, 90% of which was not restored, scored an "Optimal" habitat condition rating. Reach 1-B is 50% restored, with the upstream portion within the non-restored beaver save area, and scored in the "Optimal" category. Reach 1-C was the only fully restored reach in Design Reaches 5 and 6 and scored in the "Optimal" category (Table 1, Figure 1 and Exhibit 4 for each reach). The average habitat assessment score for all restored stream reaches assessed in 2015 is 180 out of 200 following restoration which falls in the "Optimal" category. These results show improved habitat conditions following restoration, with scores exceeding the pre-restoration scores with the exception of Reach 1-A which was not fully restored. Improved habitat assessment scores relate to the success of the well vegetated and stabilized banks, with little erosion or depositional zones present throughout the restored reaches. It is expected that this trend will continue and stabilize over time.

\*Note that the habitat score for Reach 1-A decreased dramatically in 2008. This drop was due to blockage of the Twin Branches culvert, located at the downstream end of the Glade, which caused sediment deposition and increased embeddedness of the substrate, a decrease in the velocity and depth regime, and a decrease in the frequency of riffles within Reach 1-A. This blockage has since been removed.

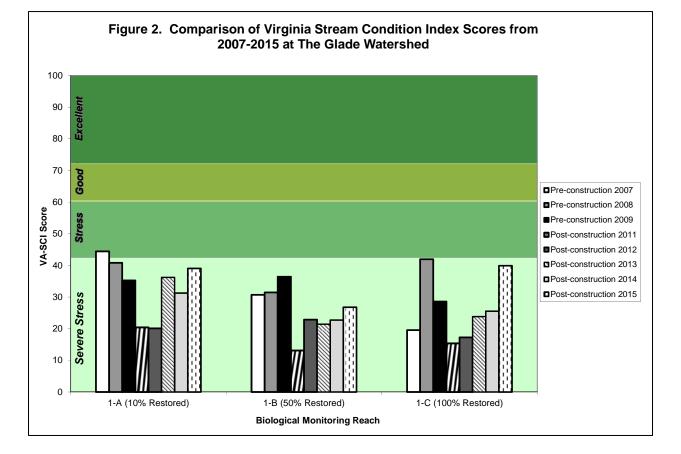
The Year 5 results show an overall increase in SCI figures since the restoration. However, the benthic community within all of the sampled reaches is still in "Severe Stress" (<u>Figure 2</u>). It was expected that the VA-SCI scores immediately following construction would not improve due to disturbance from construction. Such disturbances can temporarily reduce benthic condition, and recovery of the benthic community can be slow (Muatka 2002). WSSI noticed a similar decrease in the benthic community in the Snakeden Watershed immediately following restoration. However, given the factors discussed above, it is WSSI's opinion that the VA-SCI will remain low and pollution-tolerant taxa, such as non-biting midges and aquatic worms, will remain the dominant taxa. However, restoration has improved in-stream habitat, thus providing a stable substrate for colonization by benthic macroinvertebrates and it may be possible that an increase in benthic condition may occur over time through colonization. Note that in order to accomplish a significant improvement of the benthic community within these streams, water quality enhancements will need to be undertaken within the watershed by others (i.e. residents, Reston Association, or Fairfax County).

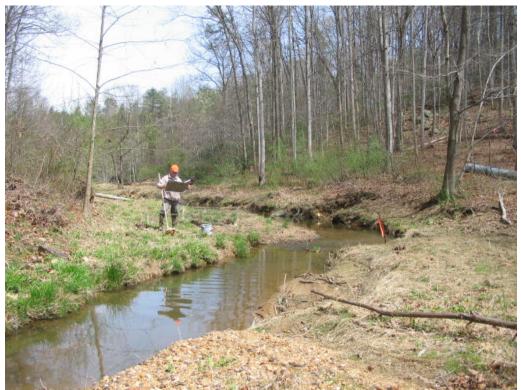
1. Looking south-southwest (upstream) at Reach 1-A of The Glade in the eastern portion of the study area. Photo taken April, 2007.

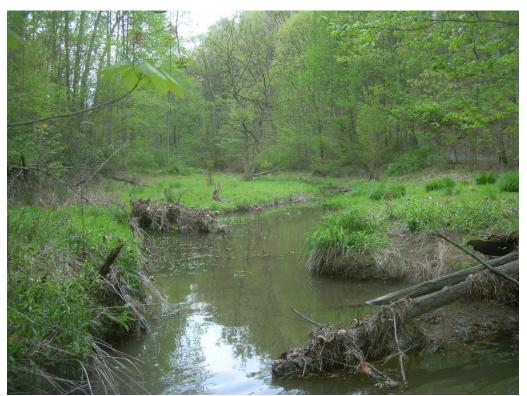
2. Looking south-southwest (upstream) at Reach 1-A of The Glade in the eastern portion of the study area. Photo taken May, 2008.

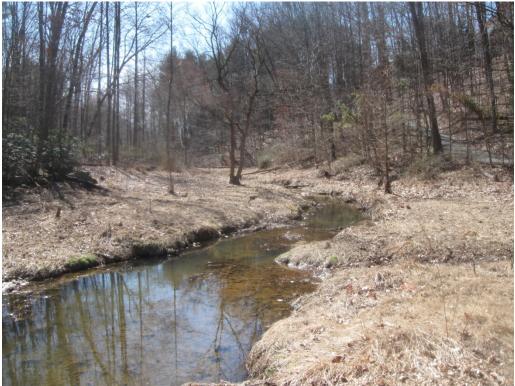
3. Looking south-southwest (upstream) at Reach 1-A of The Glade in the eastern portion of the study area. Photo taken March, 2009.

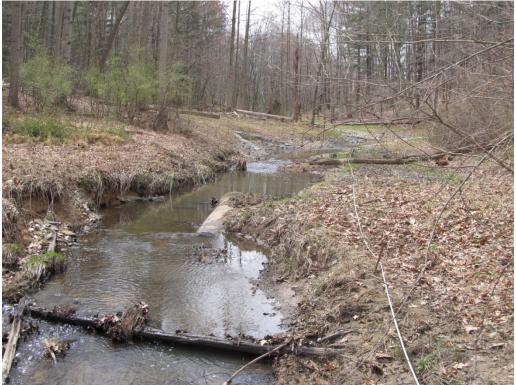
4. Looking south (upstream) at Reach 1-A of The Glade in the eastern portion of the study area. Photo taken March, 2011.

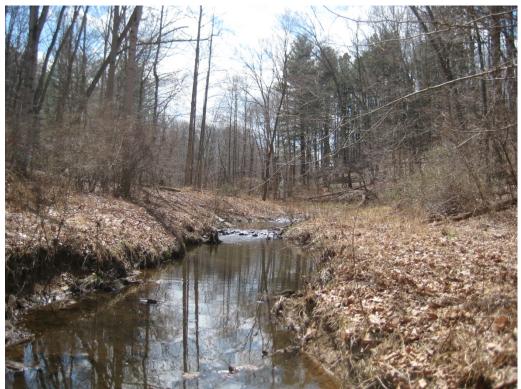
5. Looking south (upstream) at Reach 1-A of The Glade in the eastern portion of the study area. Photo taken March, 2015.

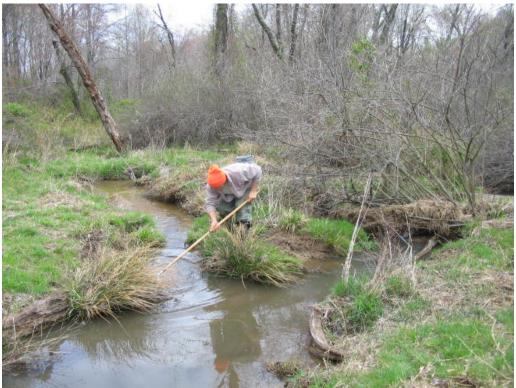
1. Looking northeast (downstream) at Reach 1-B of The Glade in the eastern portion of the study area. Photo taken March, 2007.

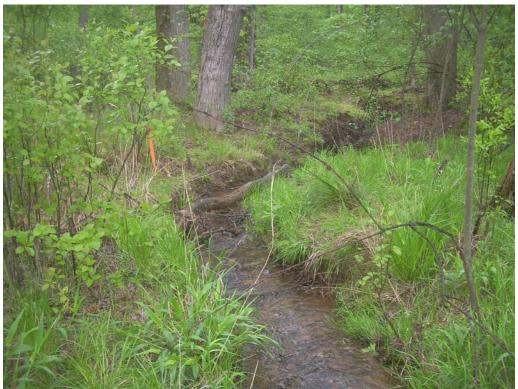
2. Looking northeast (downstream) at Reach 1-B of The Glade in the eastern portion of the study area. Photo taken May, 2008.

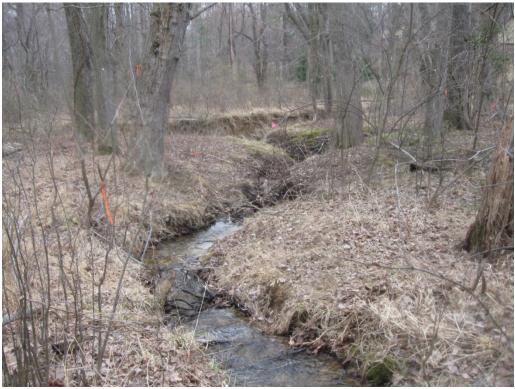
**3.** Looking northeast (downstream) at Reach 1-B of The Glade in the eastern portion of the study area. Photo taken March, 2009.

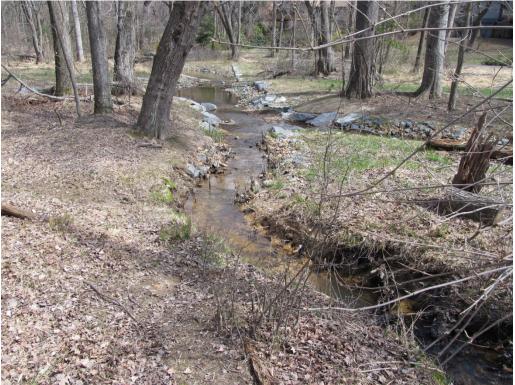
4. Looking east (downstream) at Reach 1-B of The Glade in the eastern portion of the study area. Photo taken March, 2011.

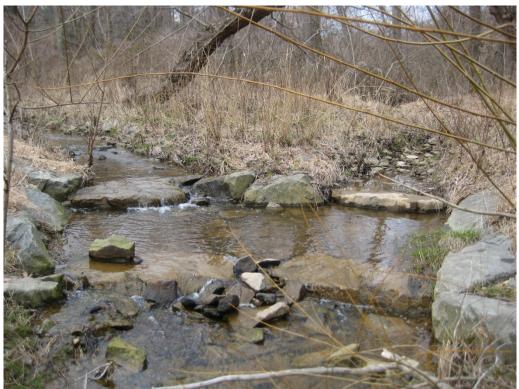
5. Looking west (upstream) at Reach 1-B of The Glade in the eastern portion of the study area. Photo taken March, 2015.

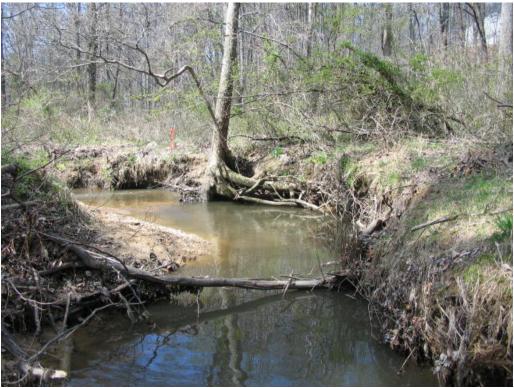
1. Looking southwest (upstream) at Reach 1-C of The Glade in the eastern portion of the study area. Photo taken March, 2007.

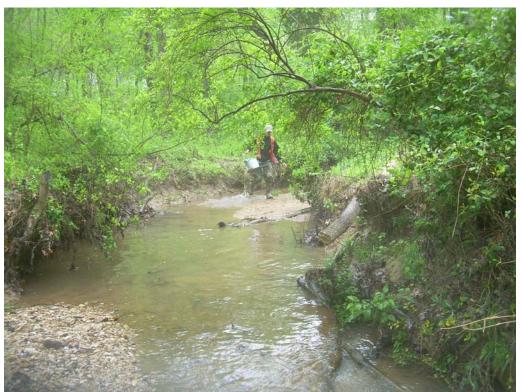
2. Looking southwest (upstream) at Reach 1-C of The Glade in the eastern portion of the study area. Photo taken May, 2008.

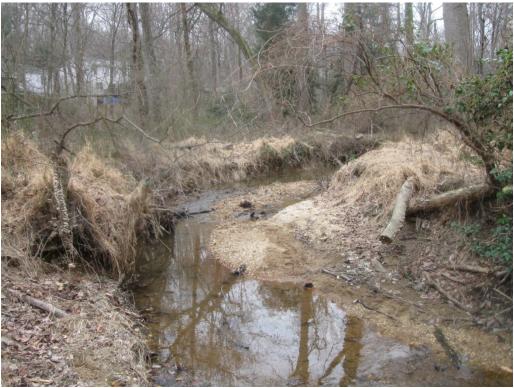
**3.** Looking southwest (upstream) at Reach 1-C of The Glade in the eastern portion of the study area. Photo taken March, 2009.

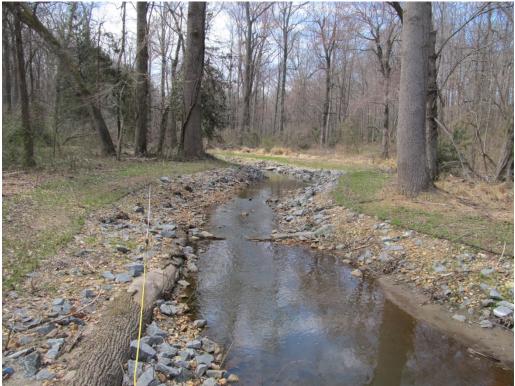
4. Looking west (upstream) at Reach 1-C of The Glade in the eastern portion of the study area. Photo taken March, 2011.

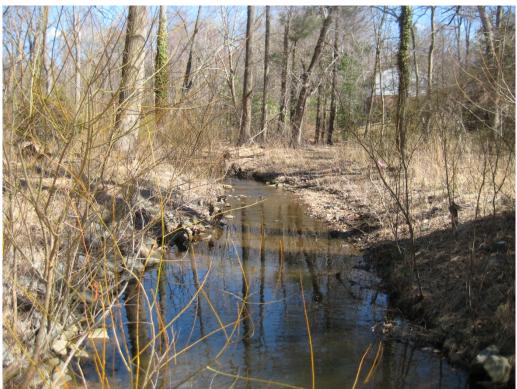
5. Looking east (downstream) at Reach 1-C of The Glade in the eastern portion of the study area. Photo taken March, 2015.

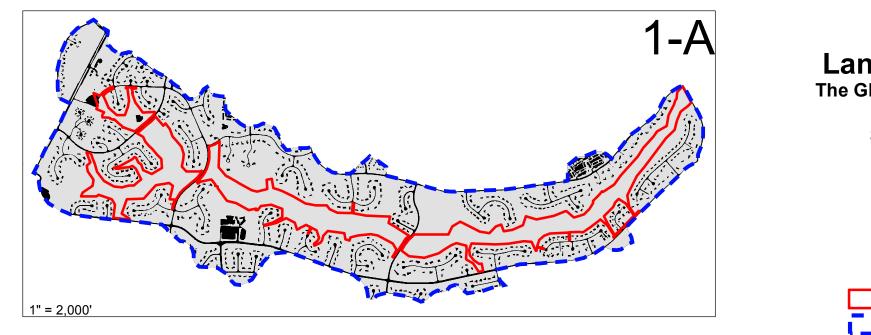
# Land Cover Map The Glade Reaches 5 and 6 WSSI #20030 Scale as Noted

An analysis of land use within the watershed of each stream reach indicates that each watershed is highly developed, with all reaches having 15 percent impervious land cover as depicted in the Land Cover Map (Exhibit 5), and Table 5. It has been documented that even at low levels of imperviousness (~5-10%), stream degradation can begin to occur, which includes macroinvertebrate diversity (Schueler, Fraley-McNeal, and Cappiella, 2009). Runoff from the highly impervious land within these watersheds typically produces a high volume and velocity of flowing water and sediment in the stream channels during storm events. As a result, epifaunal substrate/available cover within these streams becomes highly mobile and benthic macrofauna cannot easily colonize the available substrate (Debrey and Lockwood 1990) or they can be buried and killed by high sediment deposition (Wood and Armitage 1997). However, because the restored streams within our study area have been engineered to accommodate high volume flows, future habitat degradation should be minimized in the areas that were restored and it is anticipated that benthic condition could increase overtime if water quality enhancing measures were undertaken in the watershed by others.
