NORTHERN VIRGINIA STREAM RESTORATION BANK
THE GLADE – REACHES 1 AND 1A

MITIGATION MONITORING REPORT

FIRST GROWING SEASON (2009)

FAIRFAX COUNTY, VIRGINIA

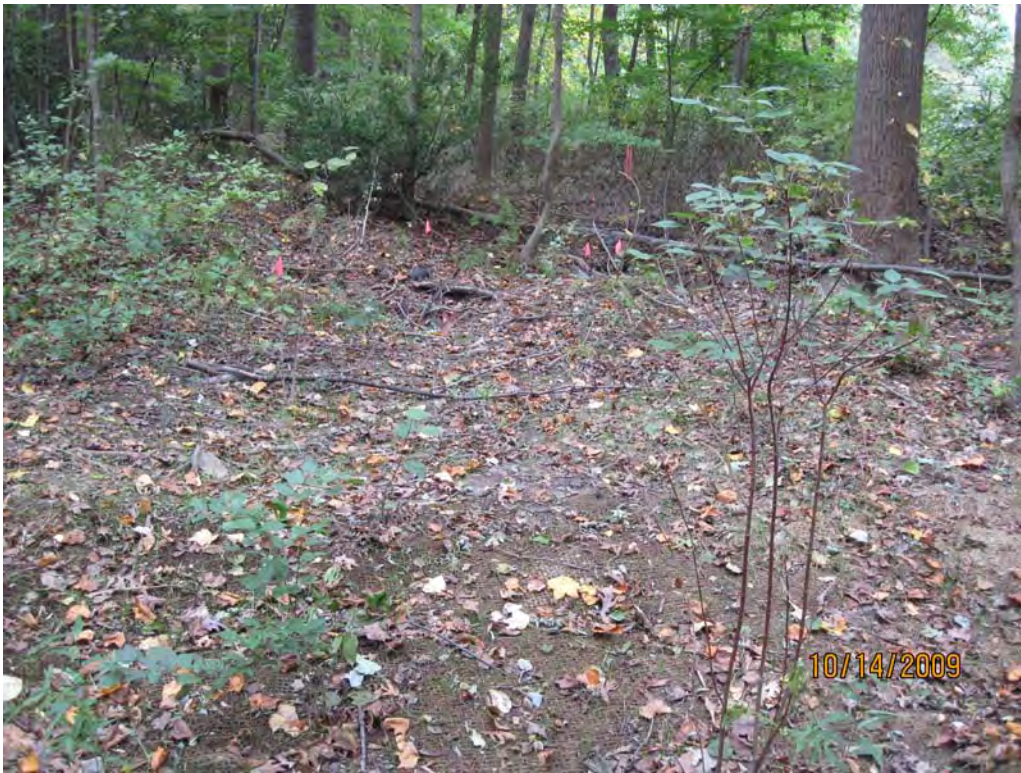
1. Looking west at Temporary Impact #1, in Reach 1 of the Glade. This impact area is becoming re-vegetated with a hydrophytic plant community.

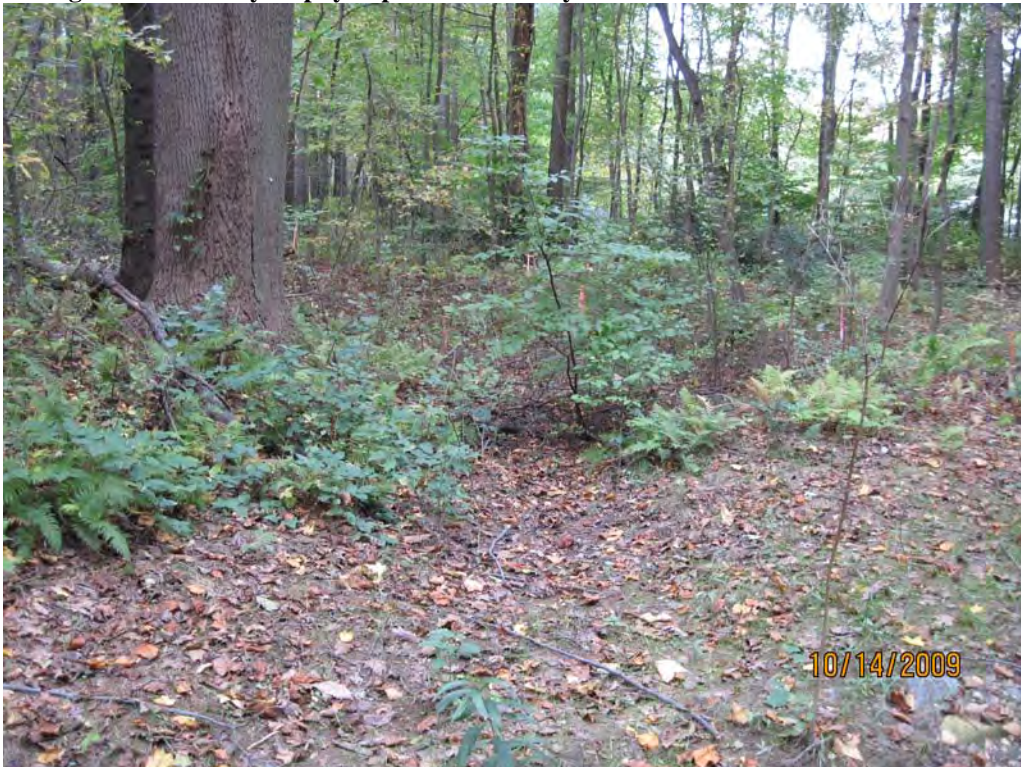
2. Looking southwest Temporary Impact #2, in Reach 1 of the Glade. Although vegetation is sparse within the impact area, the area is becoming re-vegetated with a hydrophytic plant community.

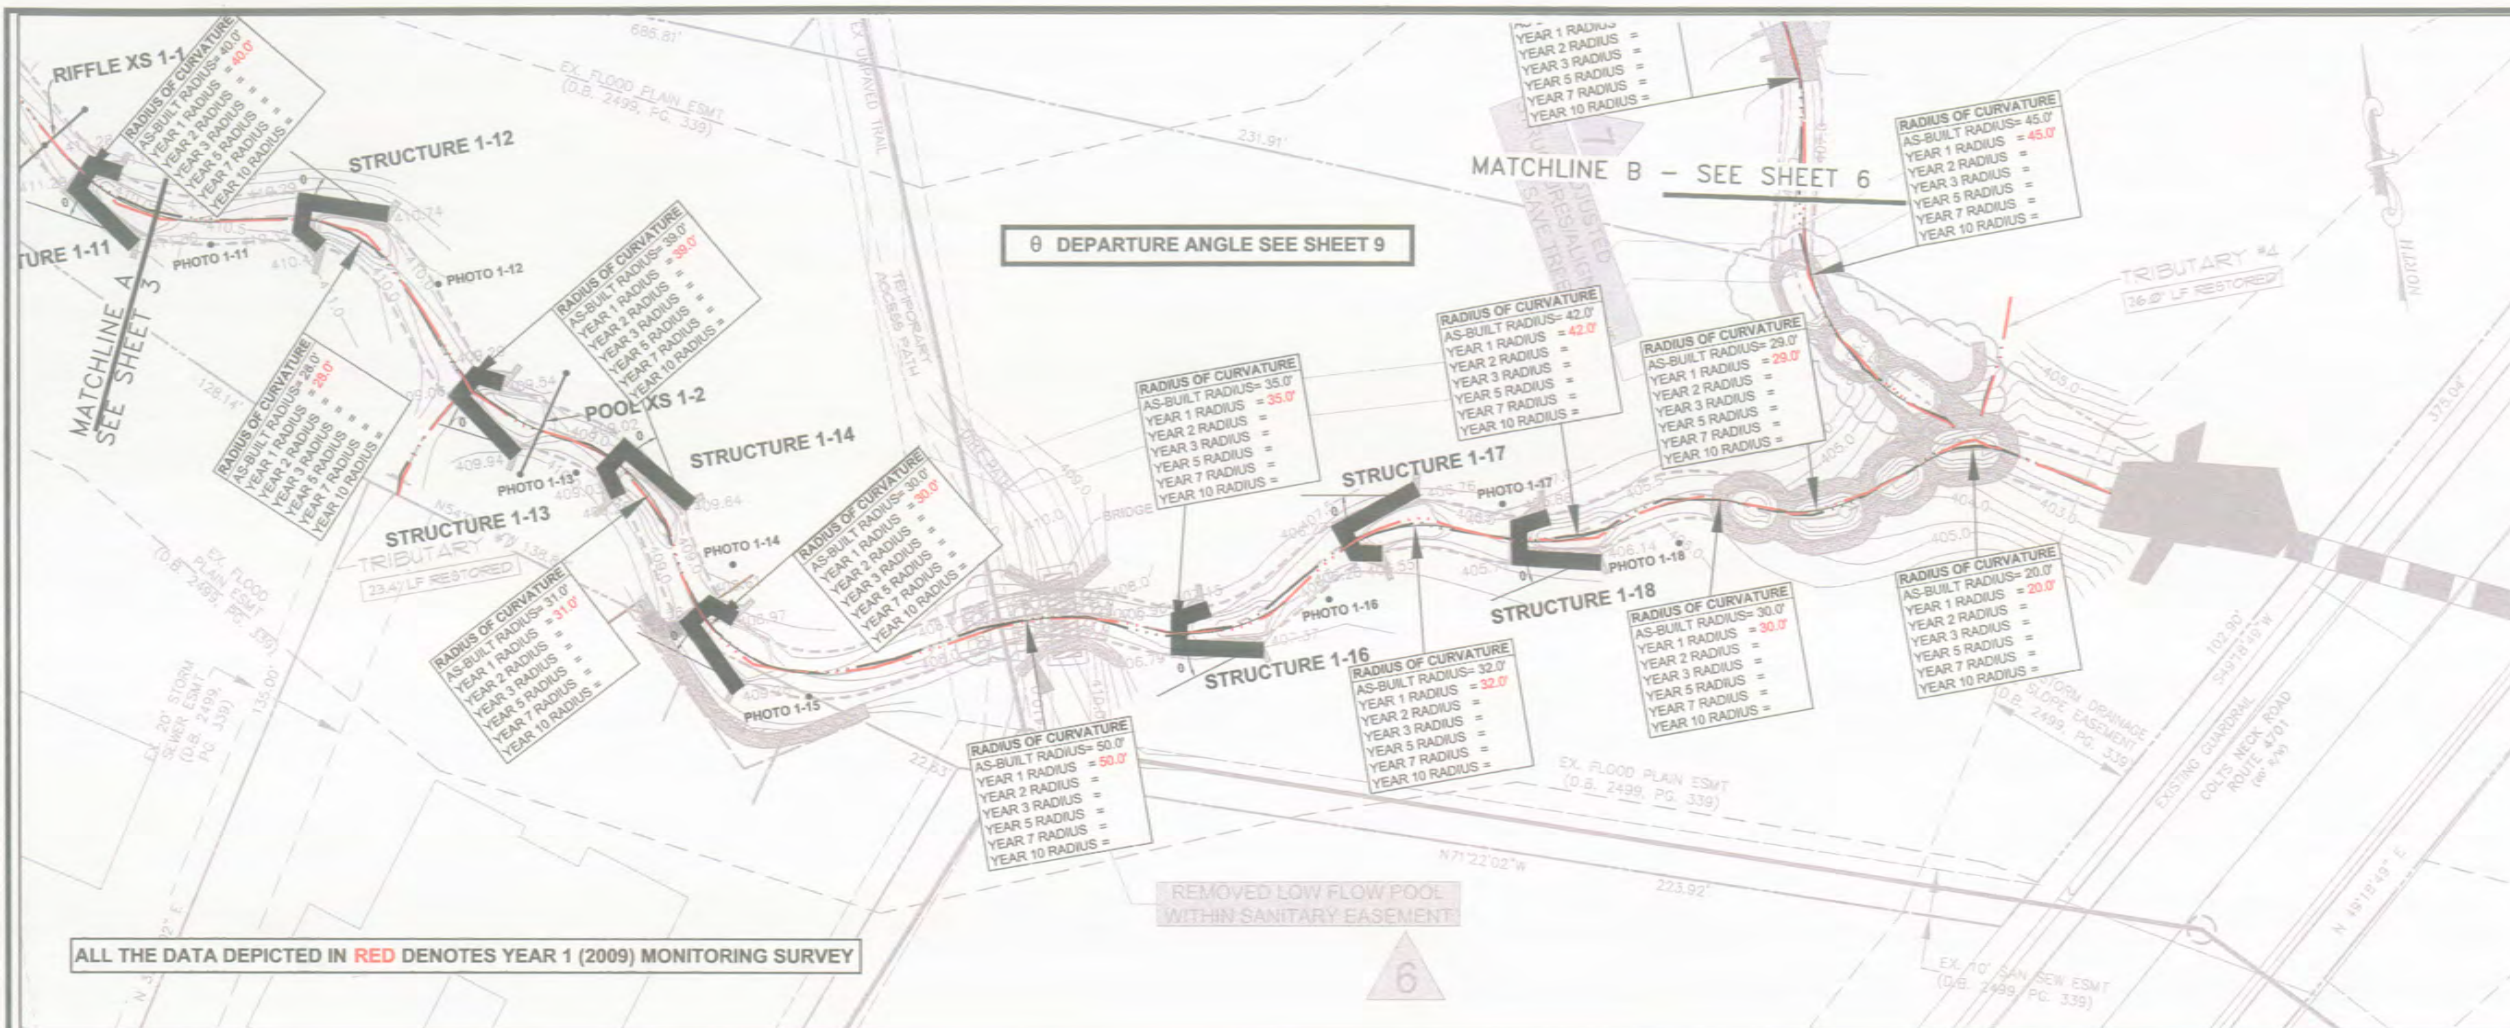
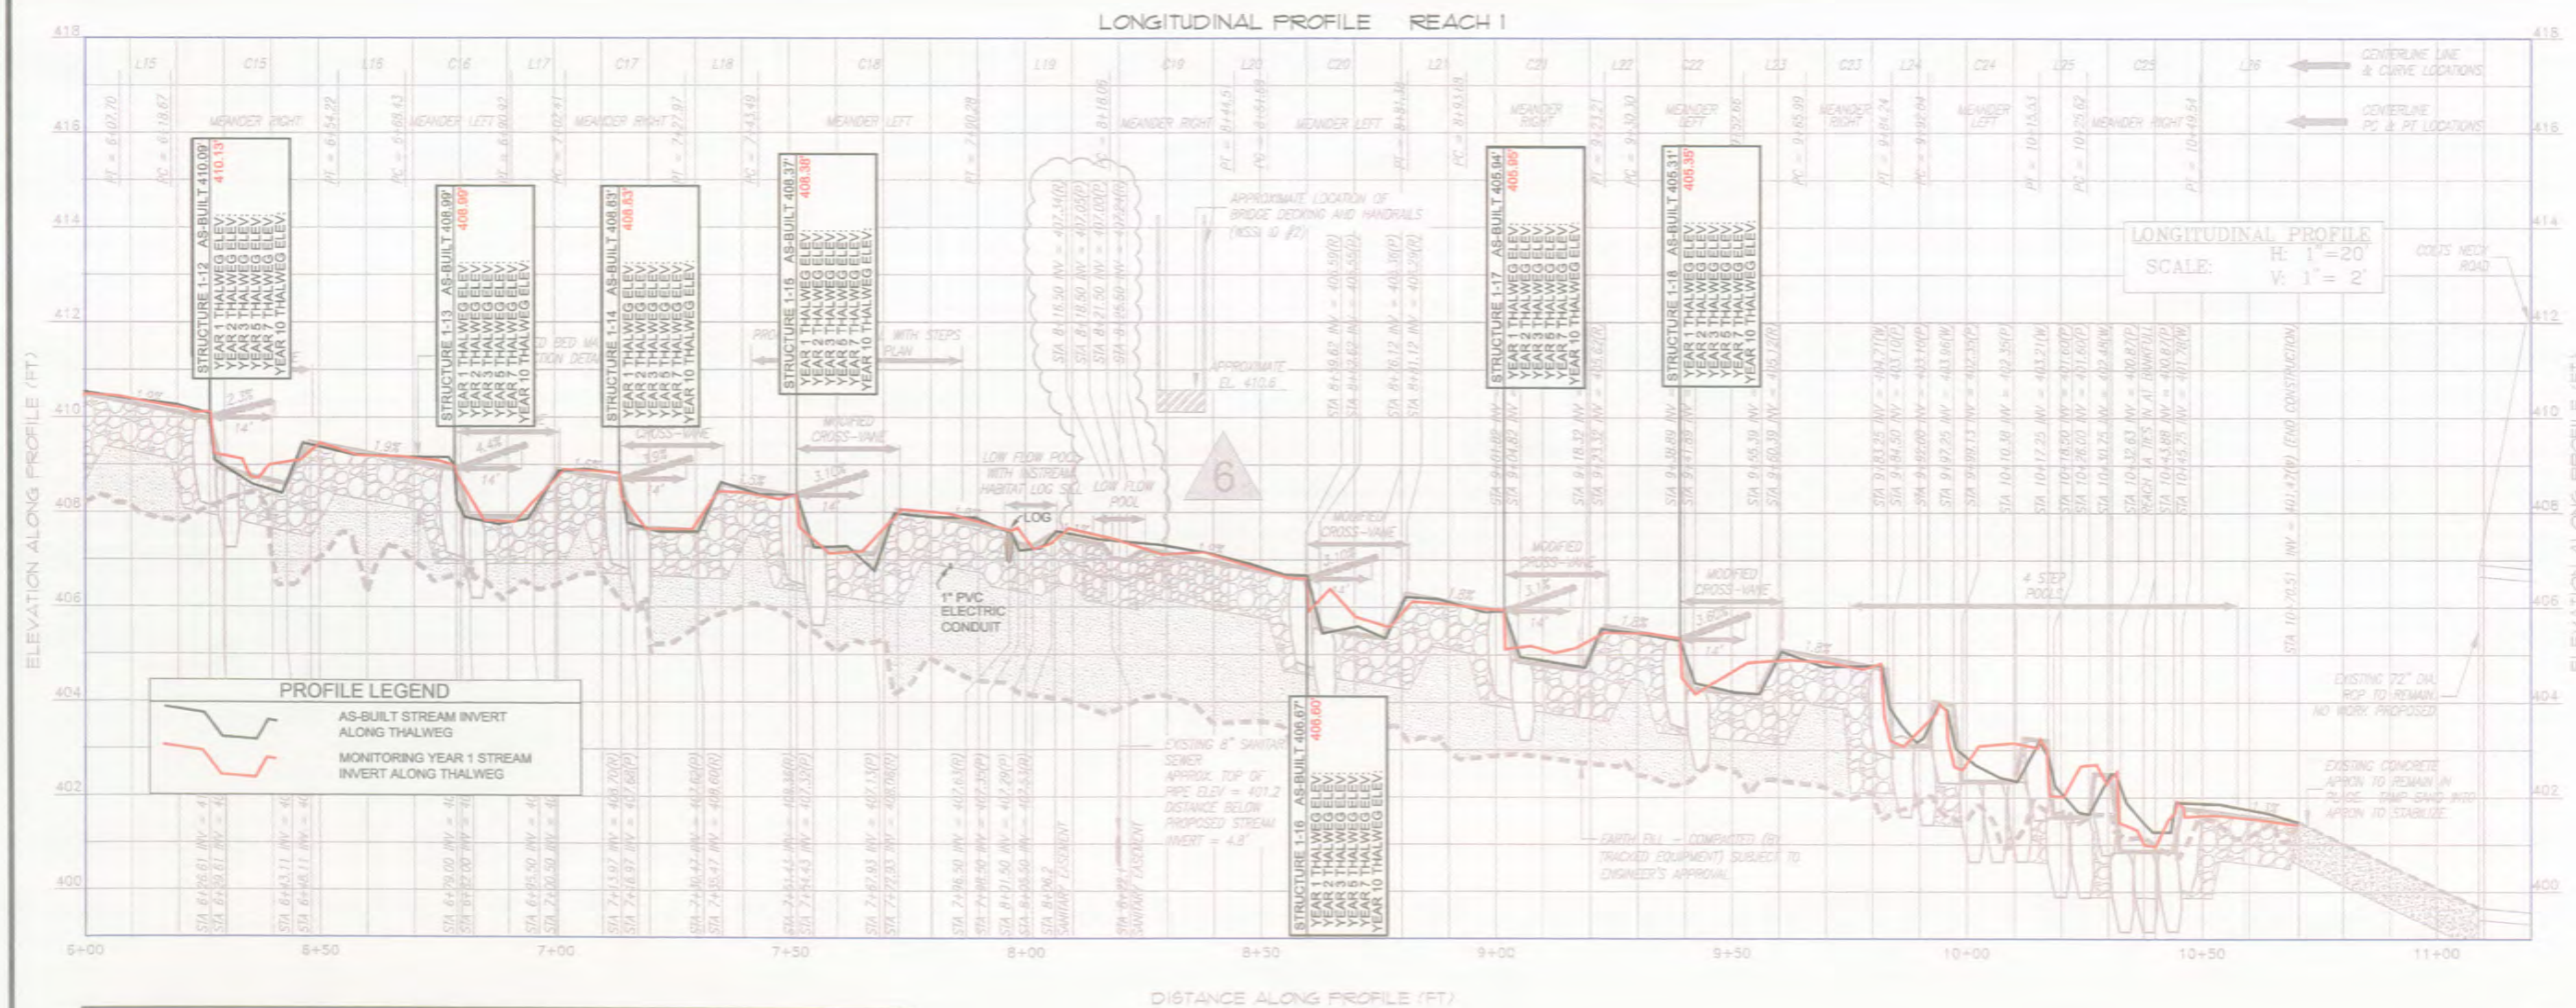
STATIONS AND ELEVATIONS OF THE AS-BUILT AND MONITORING ALIGNMENTS ARE RE-PROJECTED TO THE DESIGN ALIGNMENT FOR COMPARISON PURPOSES ONLY.

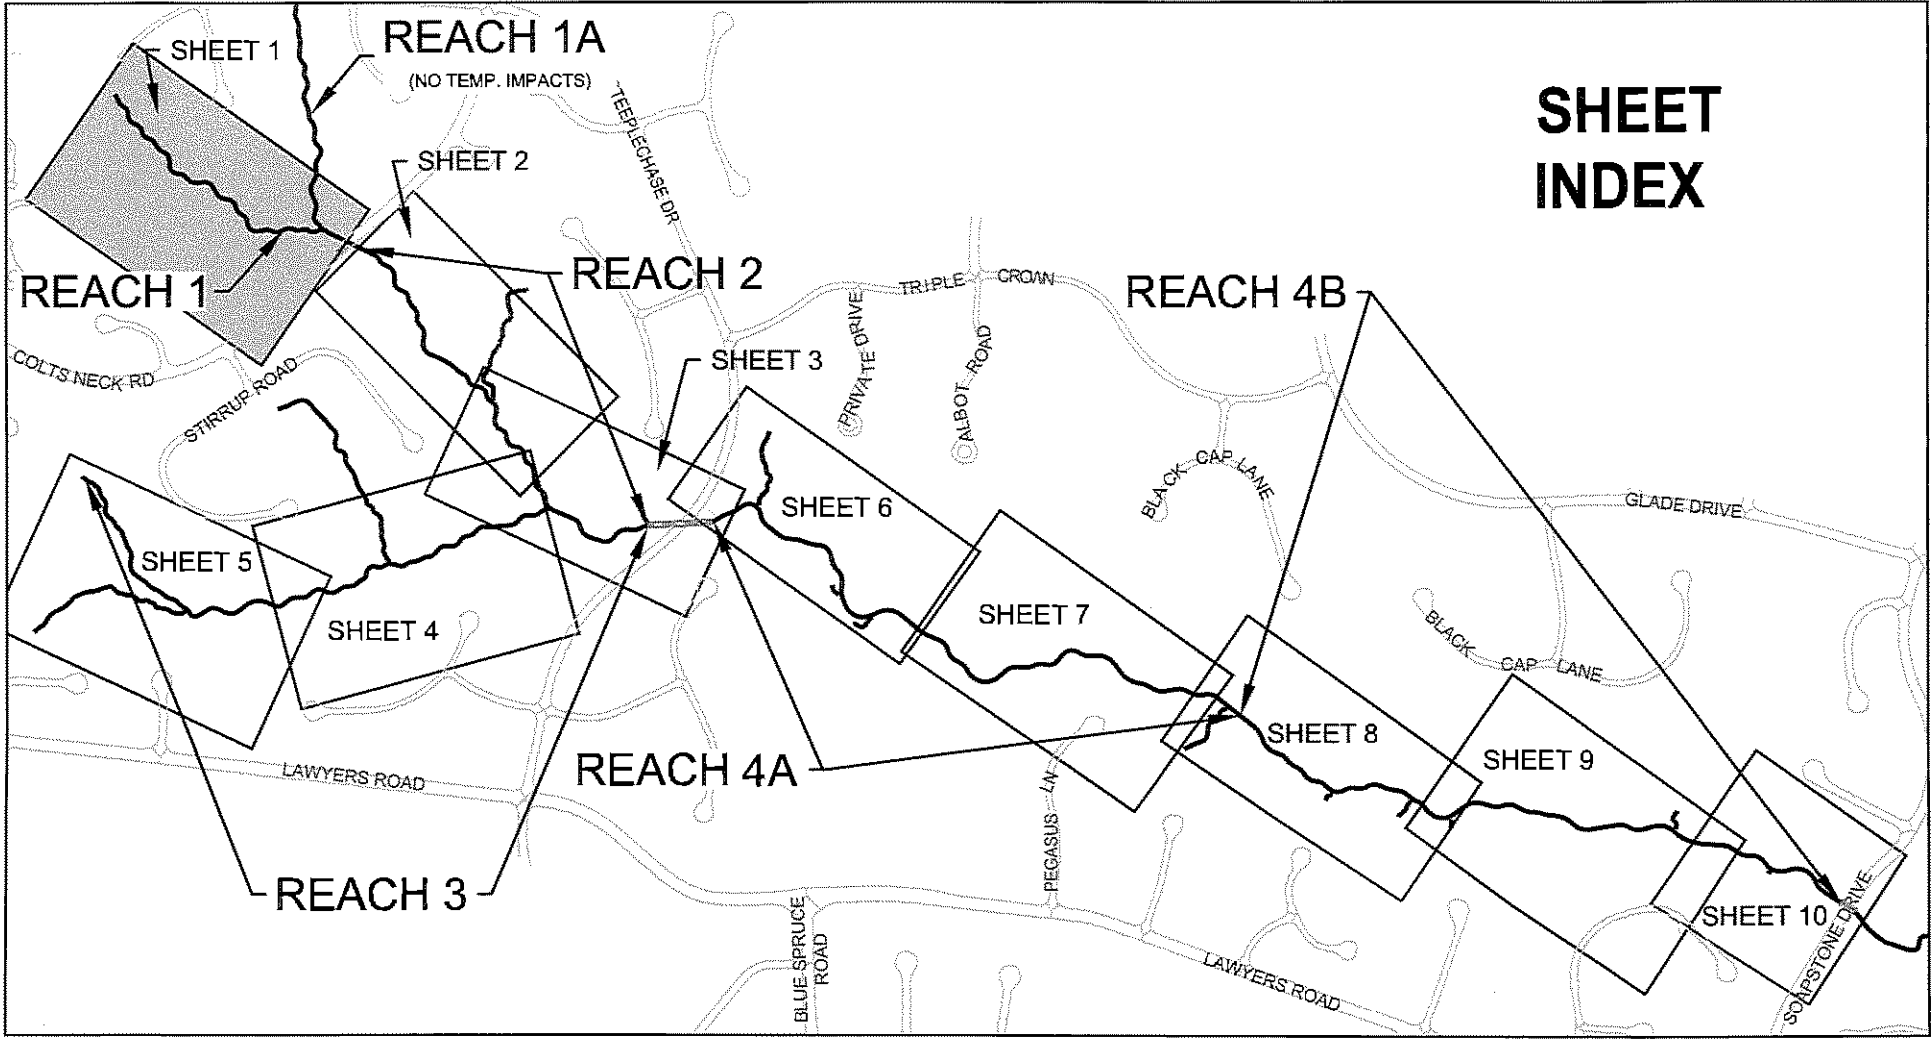
TEMPORARY WETLANDS IMPACT LOCATIONS

REACH NAME	IMPACT #	IMPACT (SF)
REACH 1 & 1A	1	55
	2	28
TOTAL		83
