Mitigation Monitoring Report

Northern Virginia Stream Restoration Bank The Glade- Reaches 1 and 1A Second Growing Season (2010)

Fairfax, Virginia
WSSI #20030, Task I3

October 18, 2010

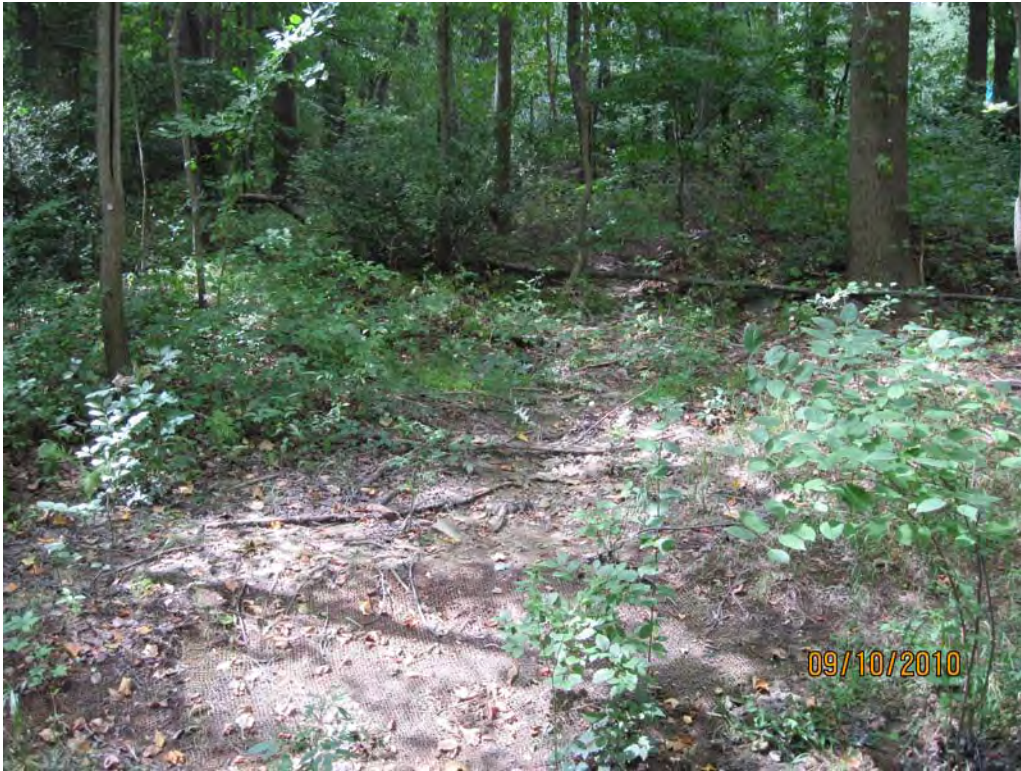
In accordance with the accepted conditions of DEQ's §401 certification for the Nationwide Permit 27 issued for Reaches 1 and 1A ([Appendix E](#)), the temporary wetland impacts were photographically monitored. Photographs provided within [Exhibit 4](#) depict the condition of the two temporary wetland impacts following the restoration activities, and show that these areas have become re-vegetated.

1. Looking west at Temporary Impact #1, in Reach 1 of The Glade. The vegetation has grown within the impact area, becoming re-vegetated with a hydrophytic plant community.

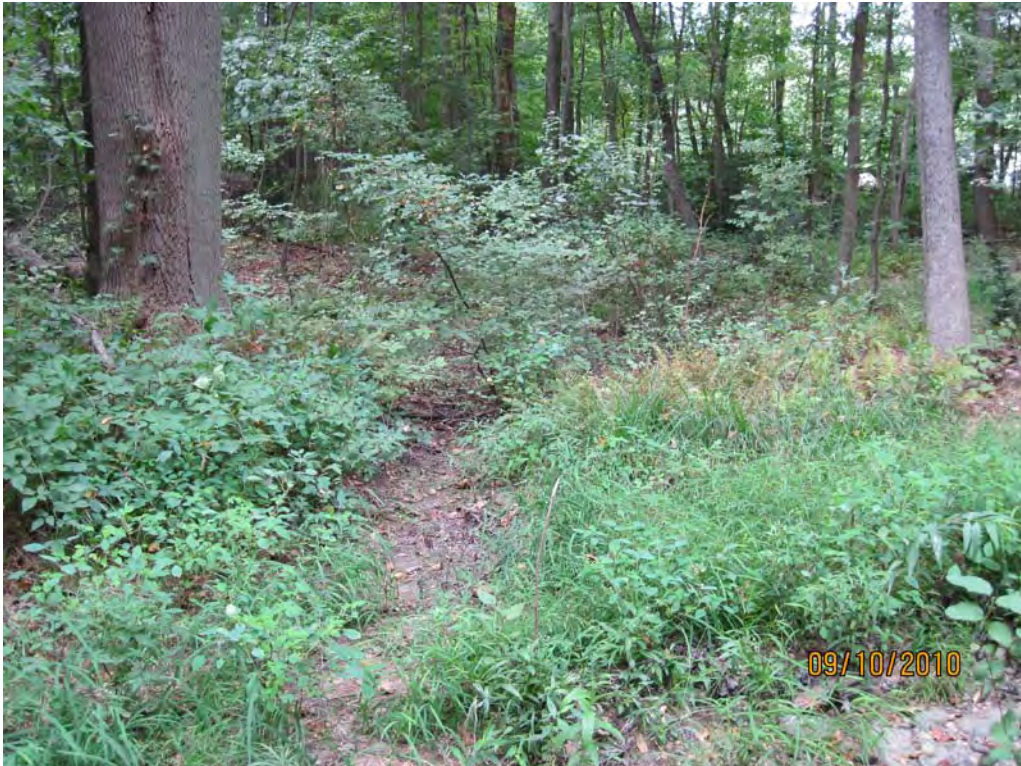
2. Looking southwest at Temporary Impact #2, in Reach 1 of The Glade. This impact area has been successfully re-vegetated with a hydrophytic plant community.

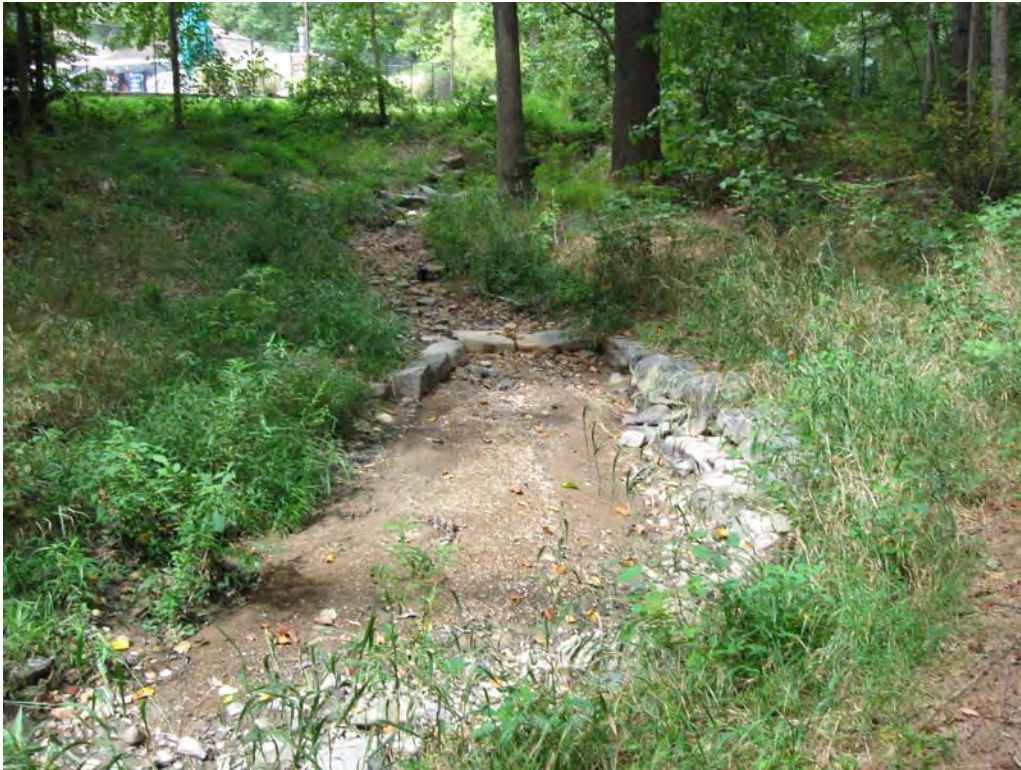
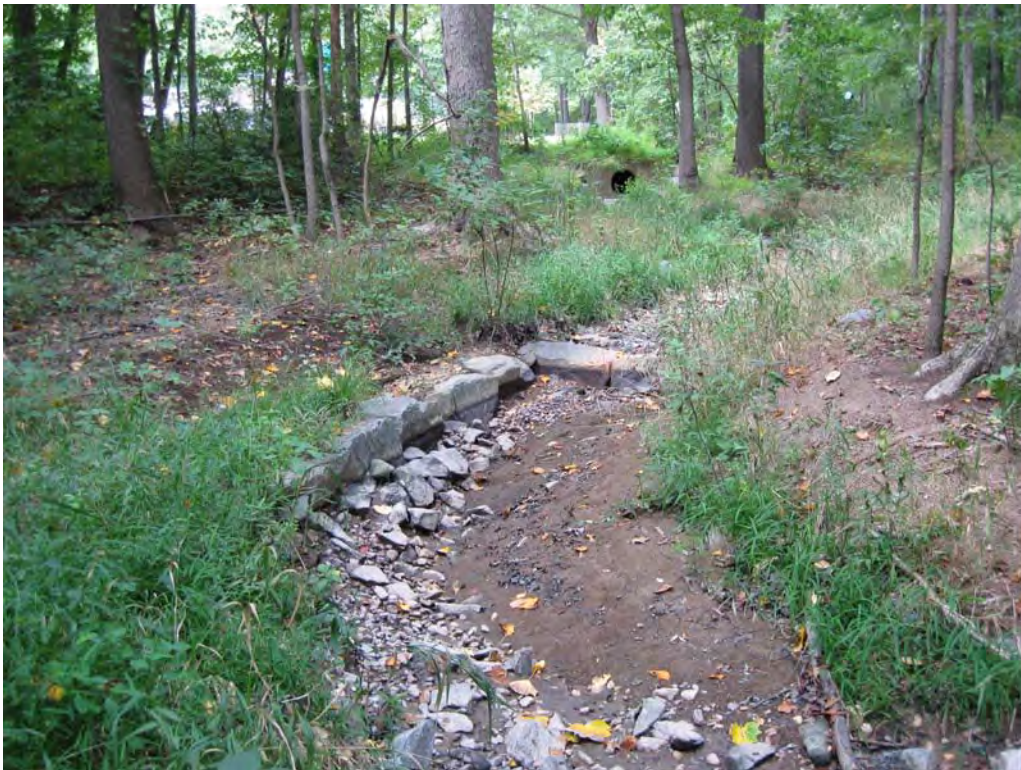
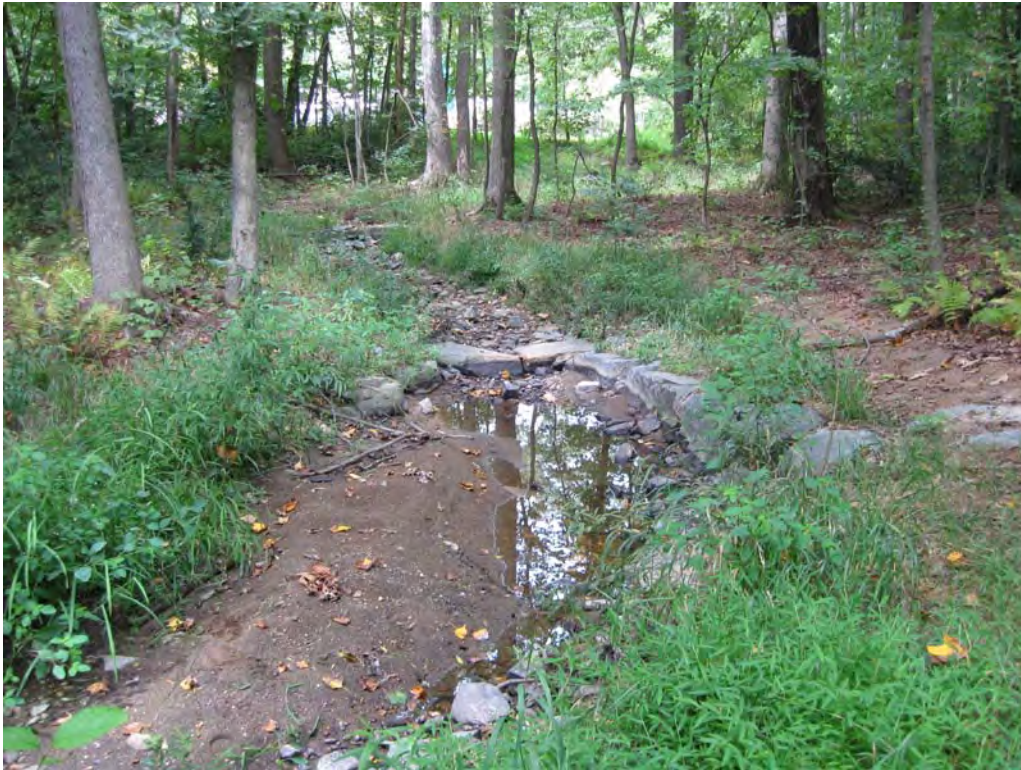
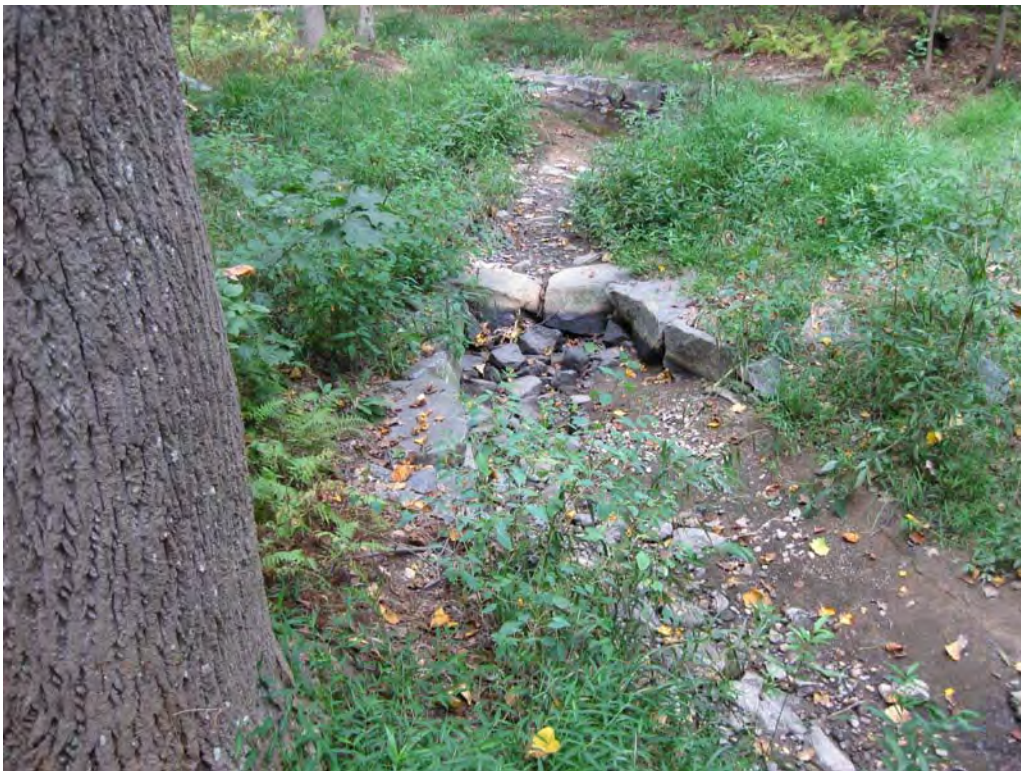
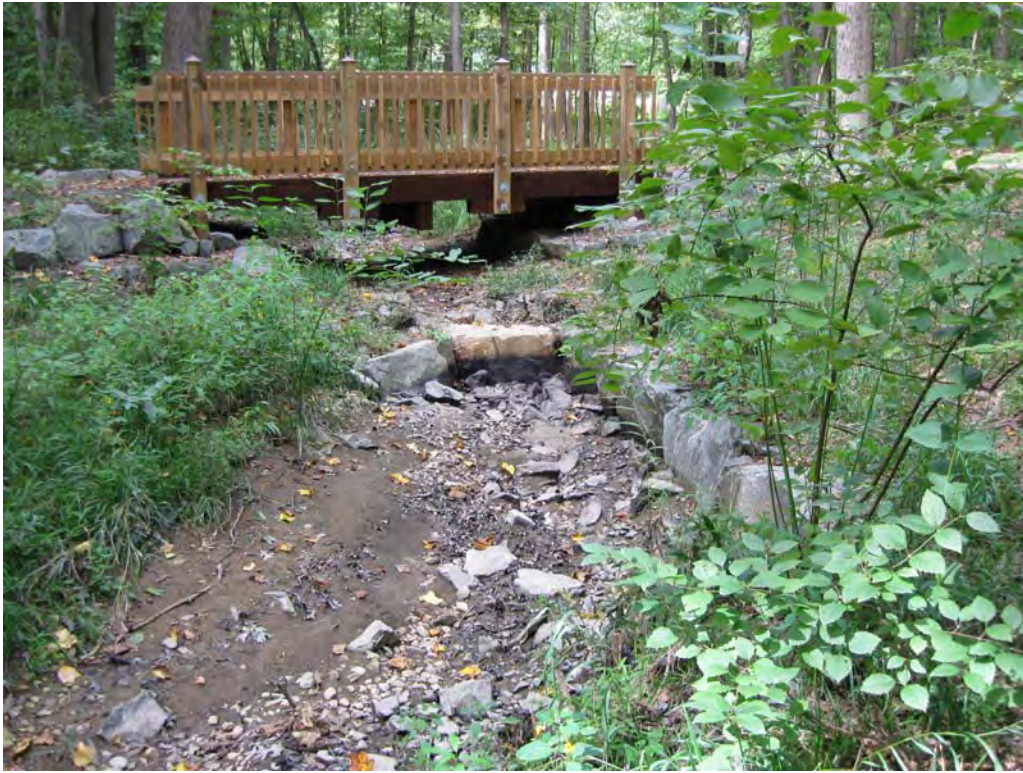
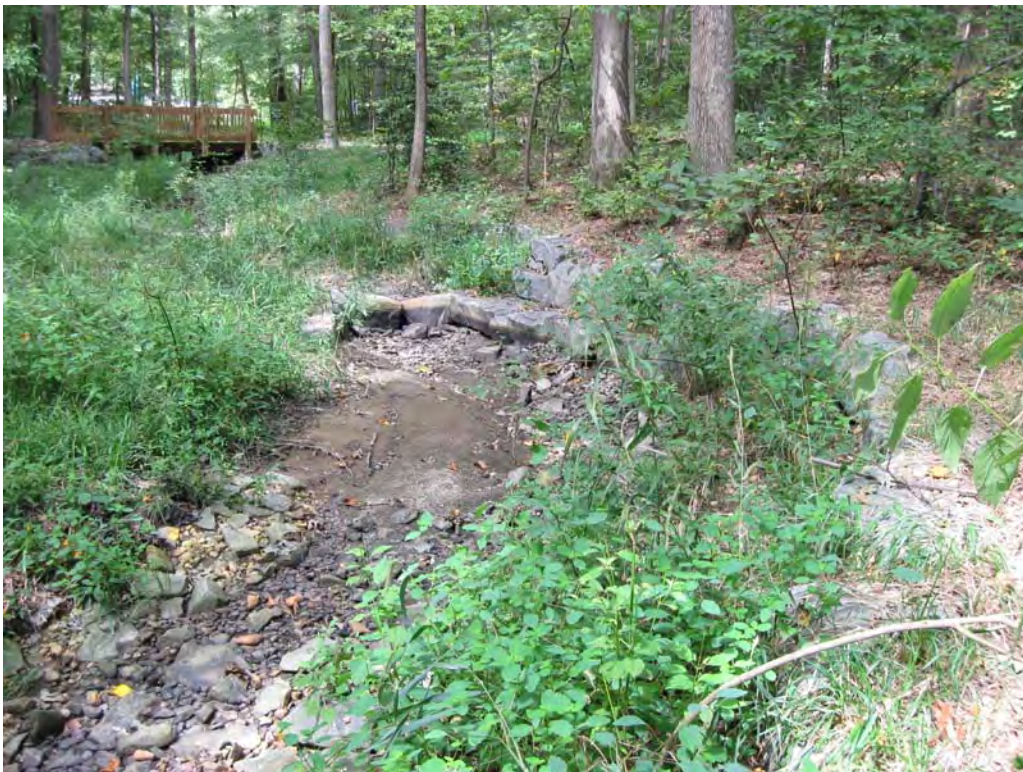
Structure photographs for 2010 indicate no erosion or stability issues. Photographs of all structures are included in Appendix D.

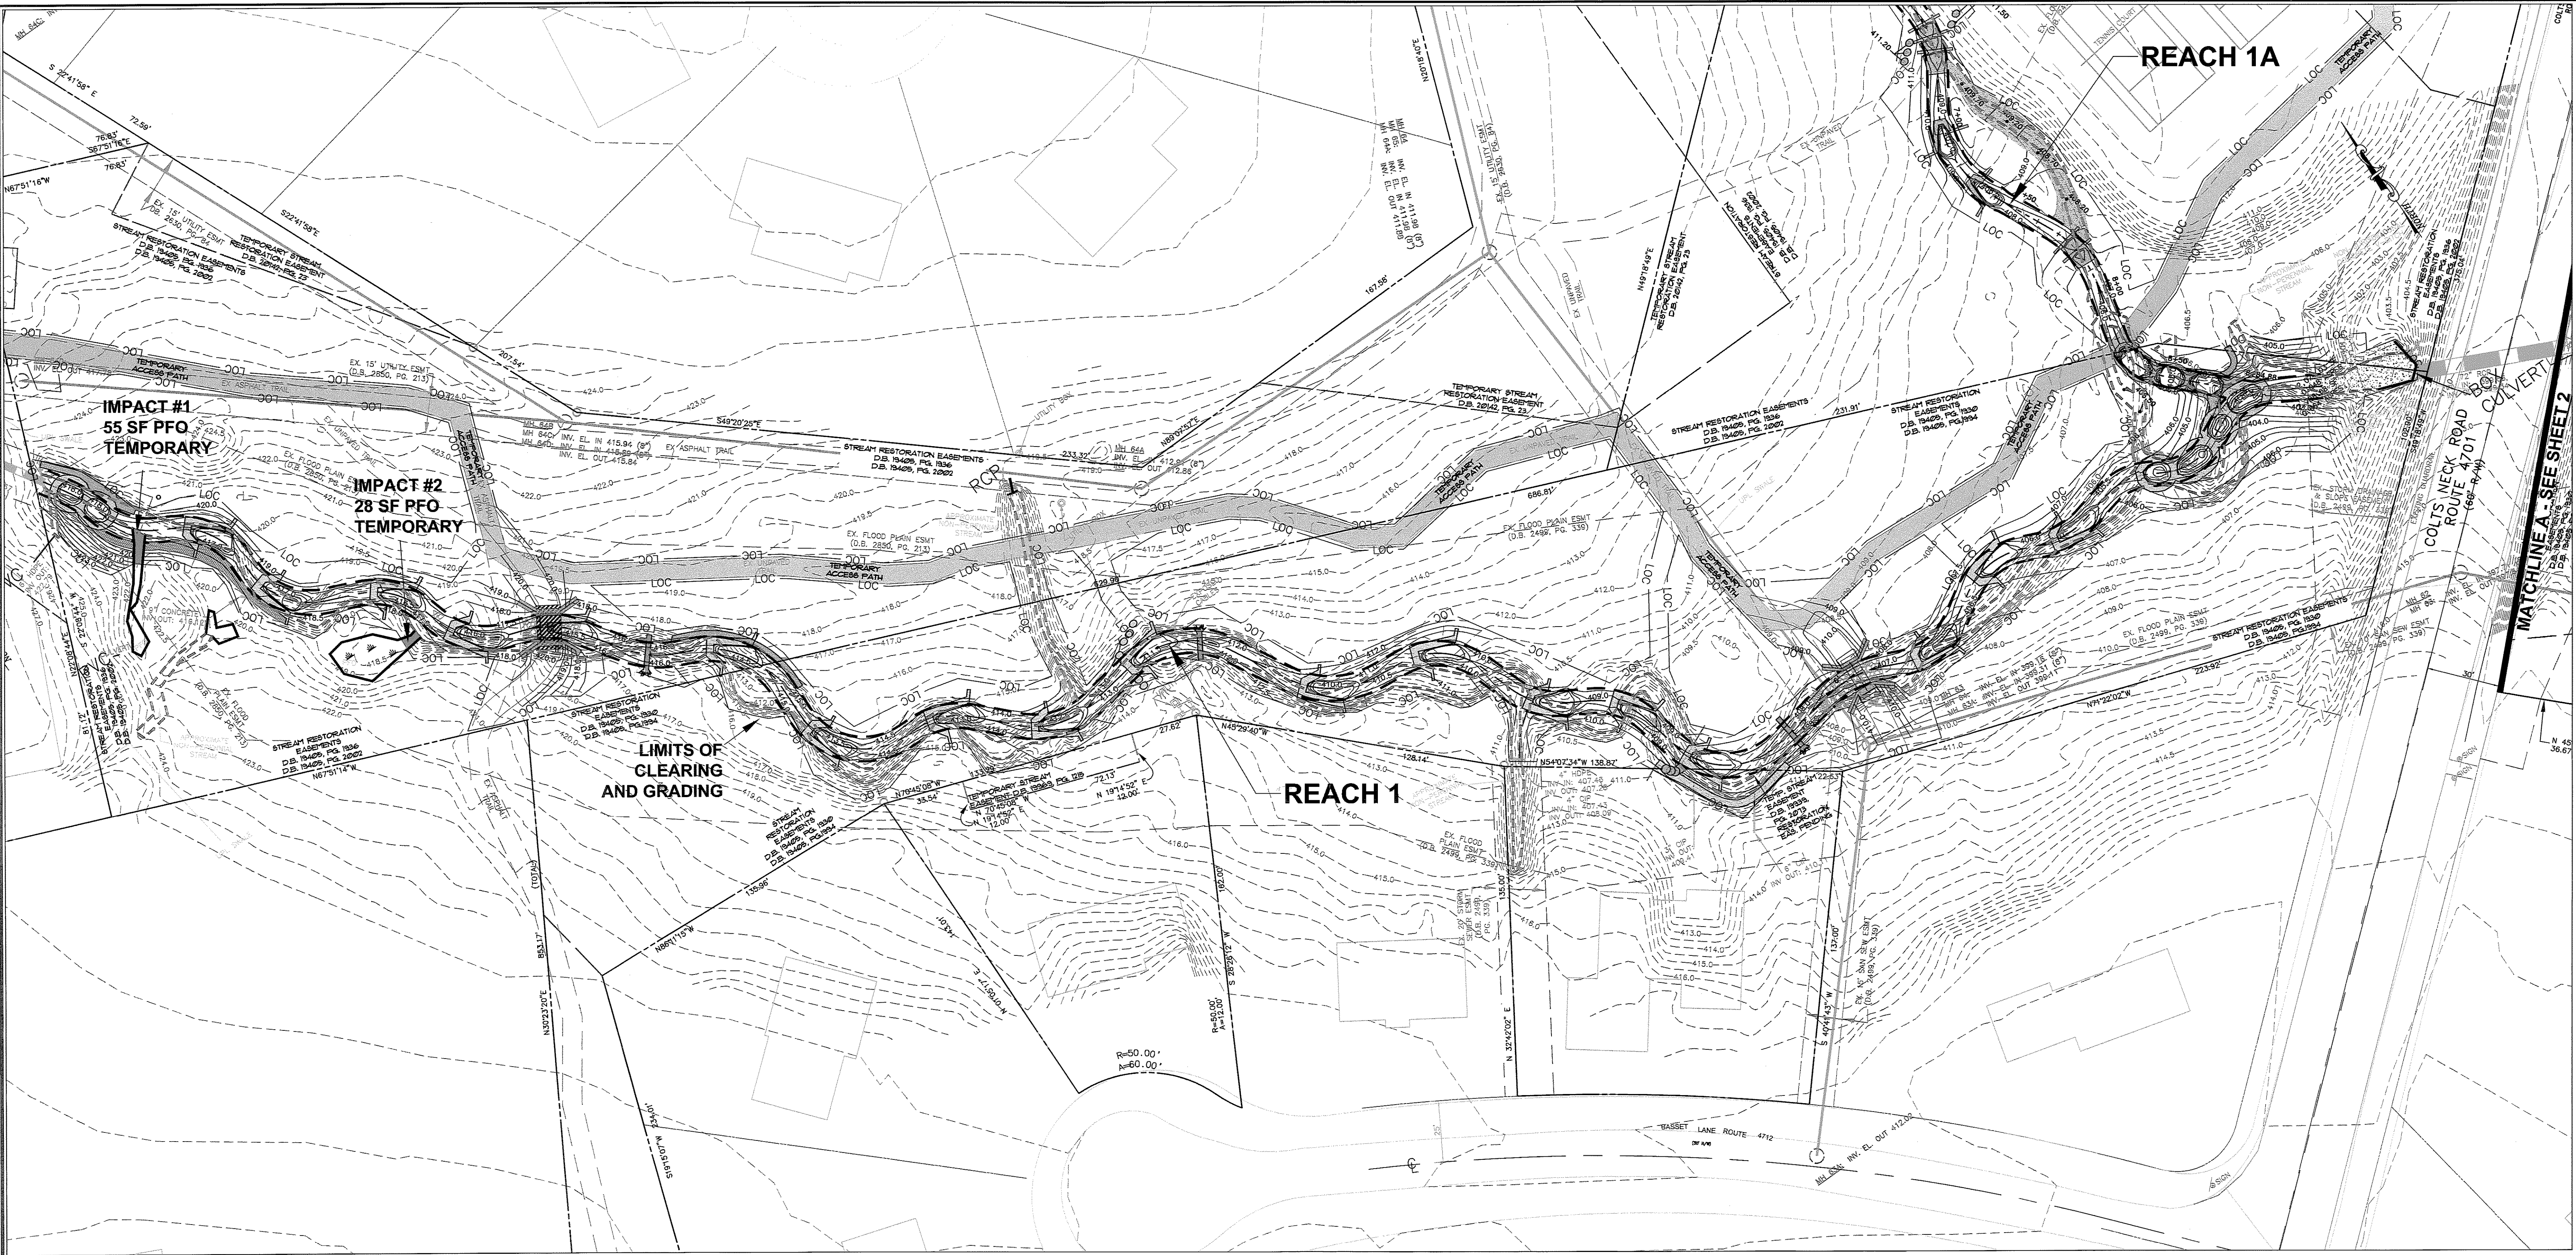
REACH NAME	IMPACT #	IMPACT (SF)
REACH 1 & 1A	1	55
	2	28
TOTAL		83
