NORTHERN VIRGINIA STREAM RESTORATION BANK- BACKGROUND AND STATUS REPORT

Presented by Michael S. Rolband
P.E., P.W.S., P.W.D.

Wetland Studies and Solutions, Inc.
5300 Wellington Branch Drive · Suite 100 · Gainesville · Virginia 20155
www.wetlandstudies.com

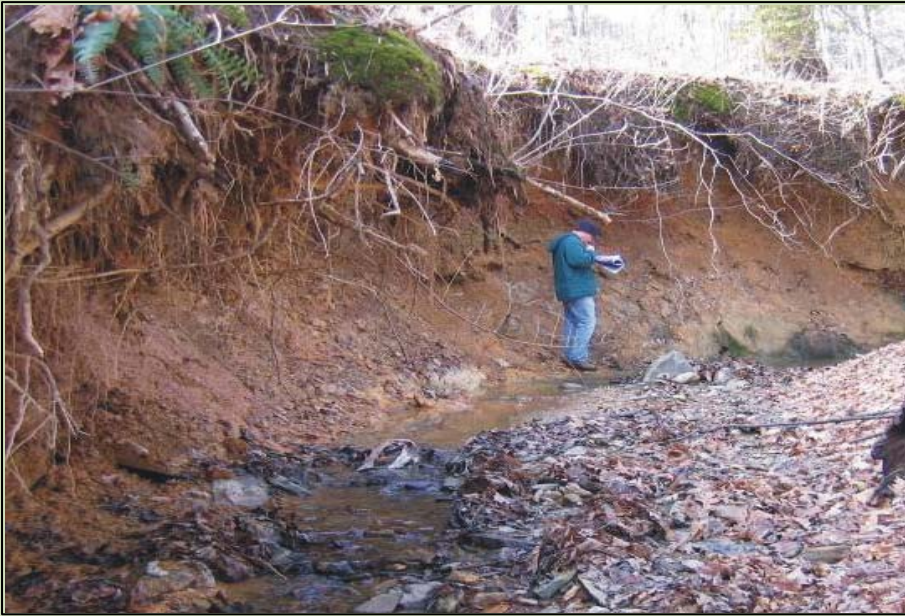
Eroding meander bend adjacent to Wiehle Ave in Reston

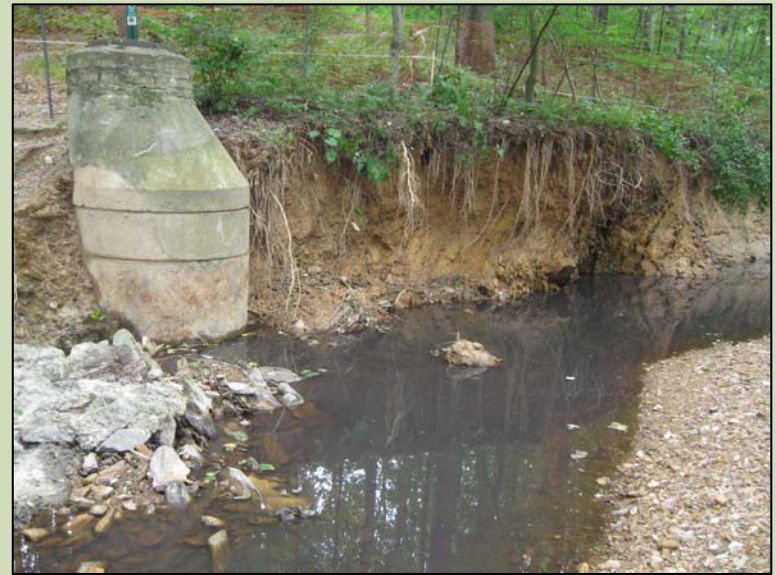
Exposed sewer manhole – Reach 12 in Snakeden

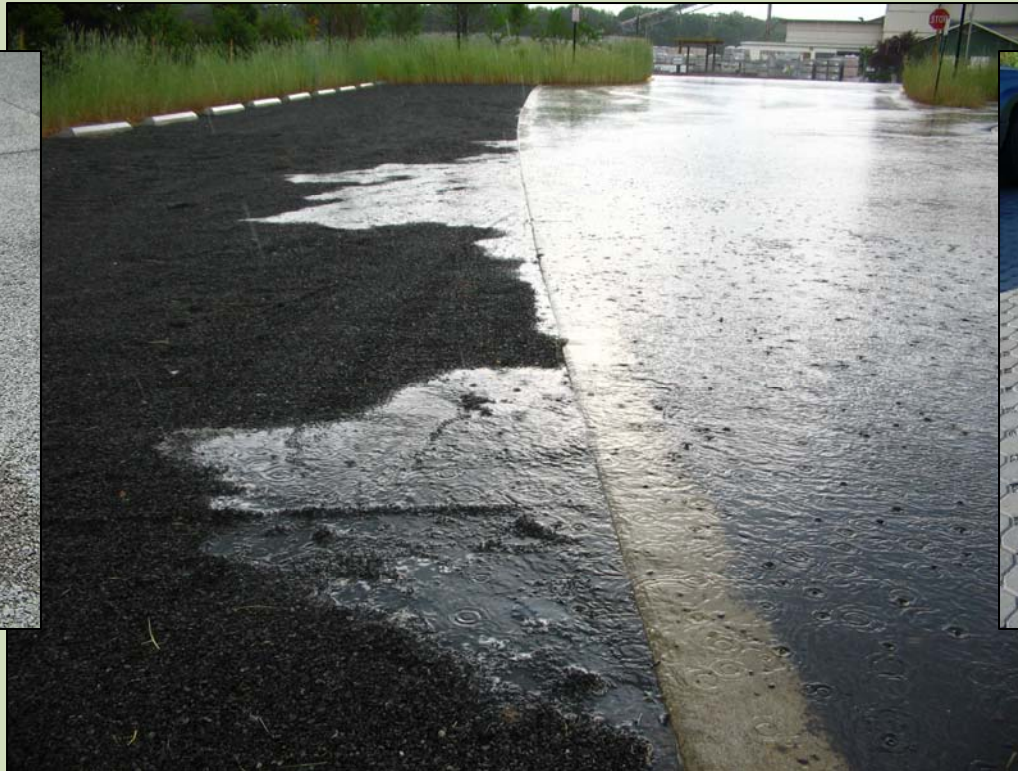
GravelPave2 infiltrating a large rainstorm at WSSI

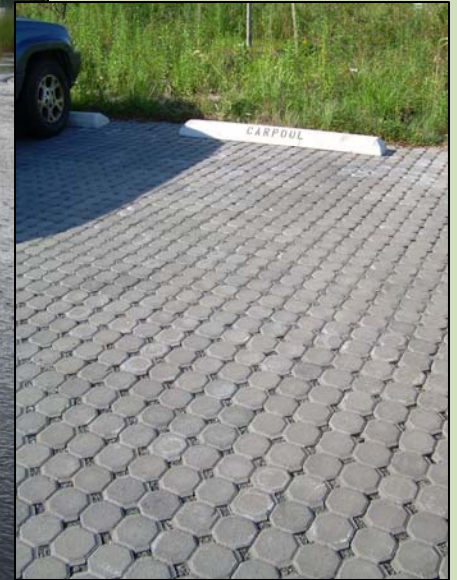
**Pervious pavers
at WSSI**

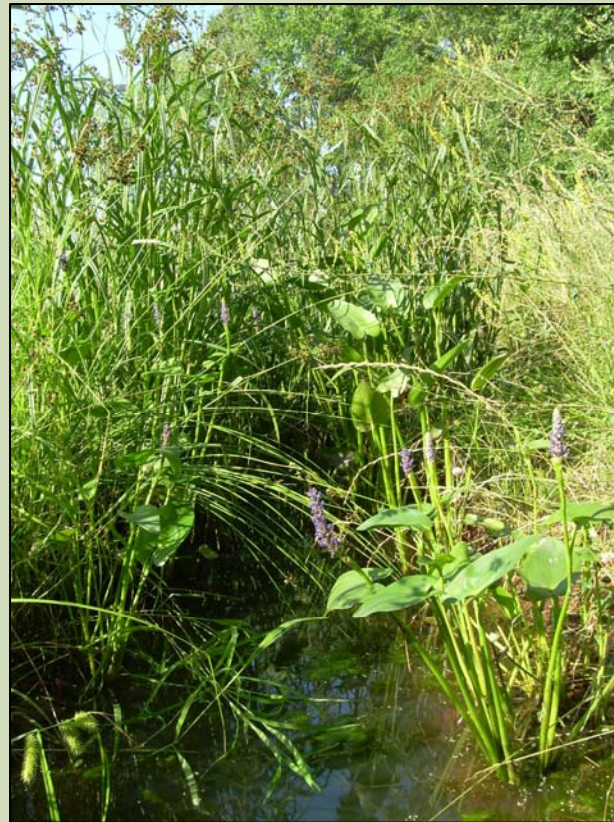
Water quality swale at WSSI

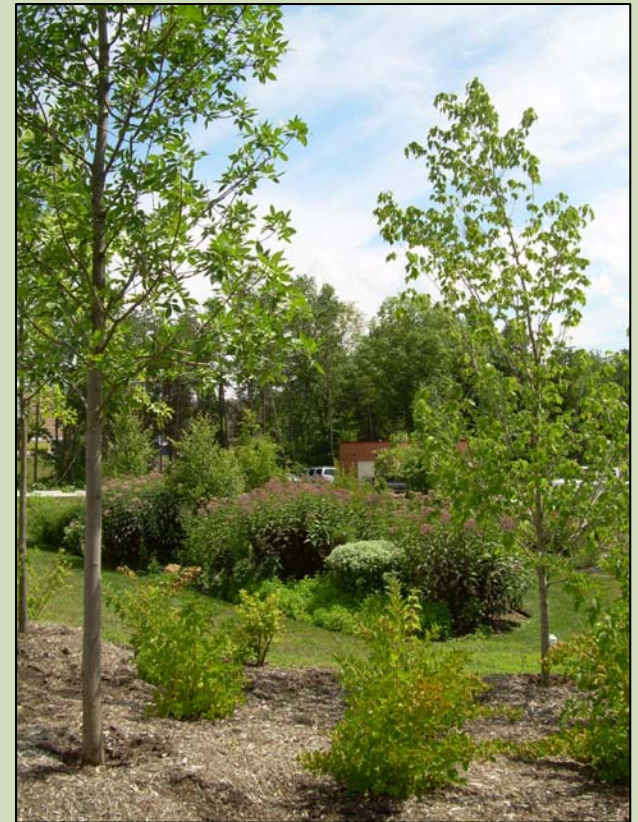
Rain Garden at WSSI

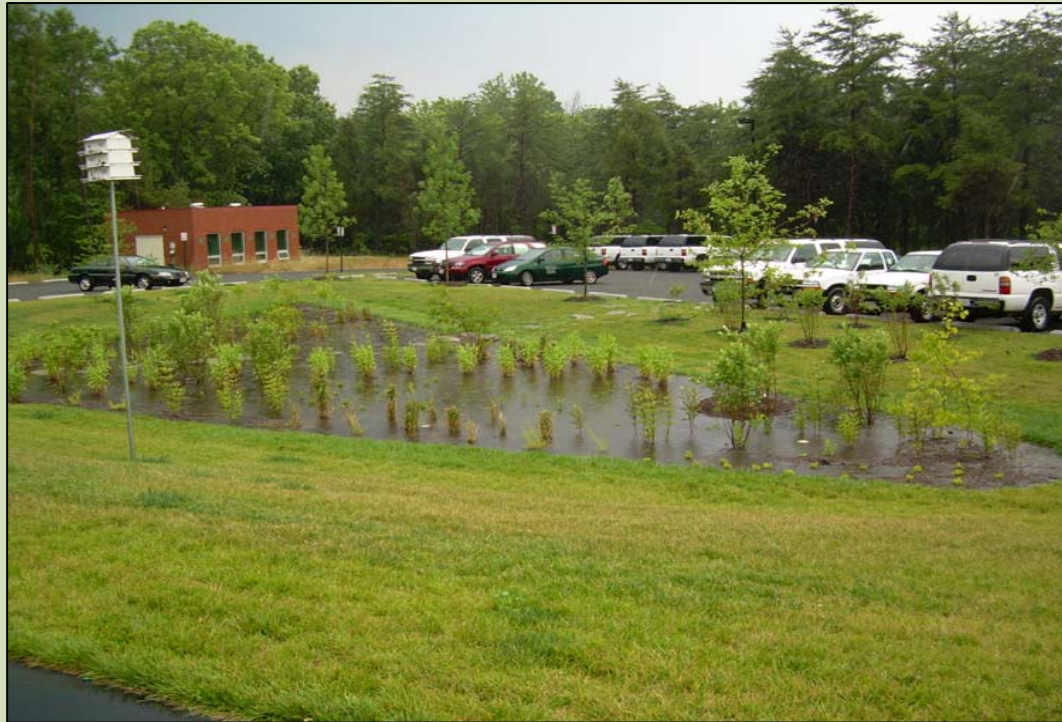
BIO-RETENTION SCENARIO

- 830 Bio-retention facilities
- 36.7 acres disturbance from grading

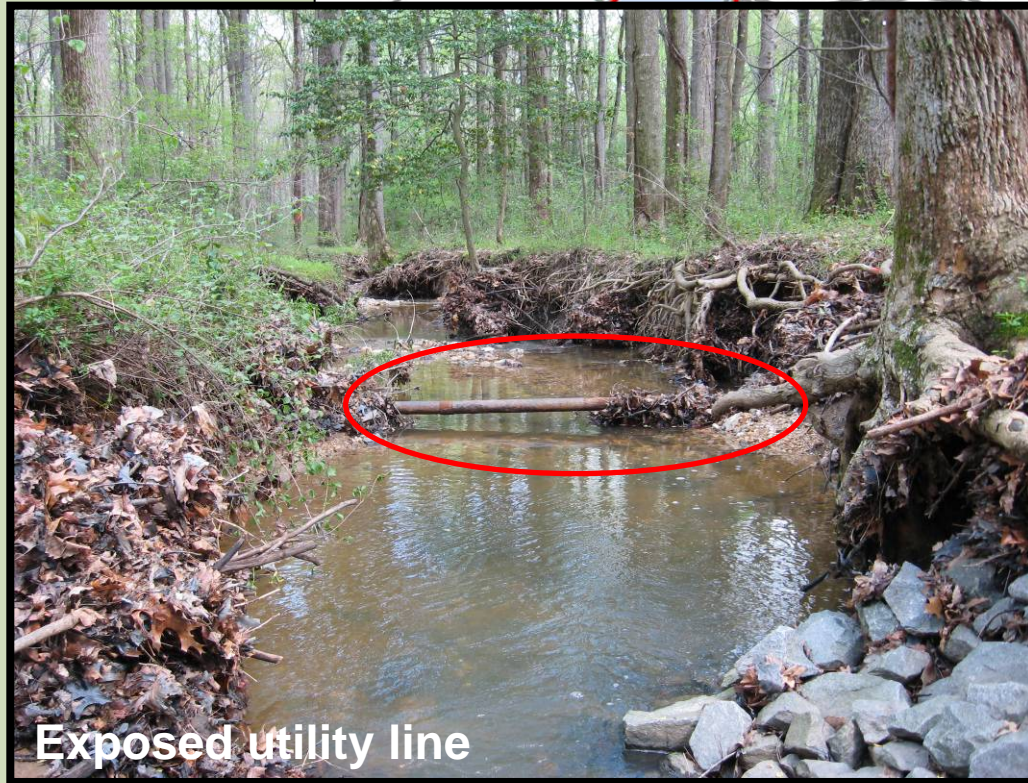
Reach 4A

Exposed utility line

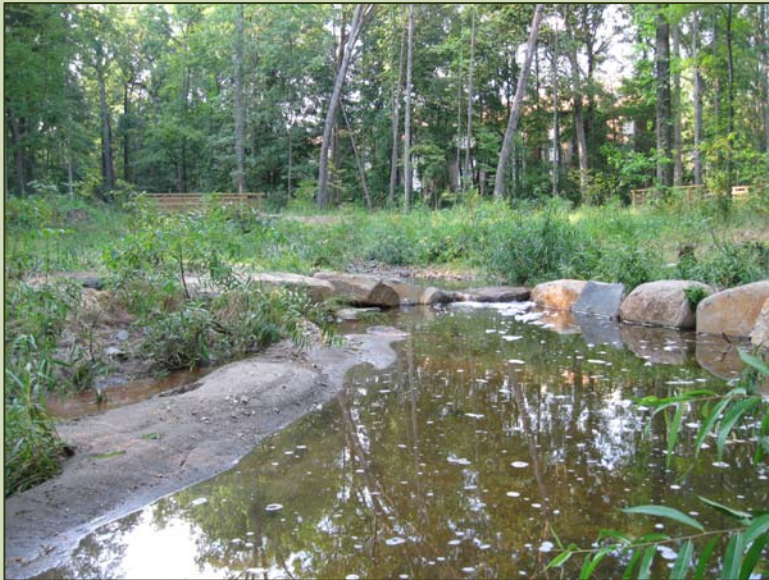
Snakeden Branch – Reach 3 (after 6 months)

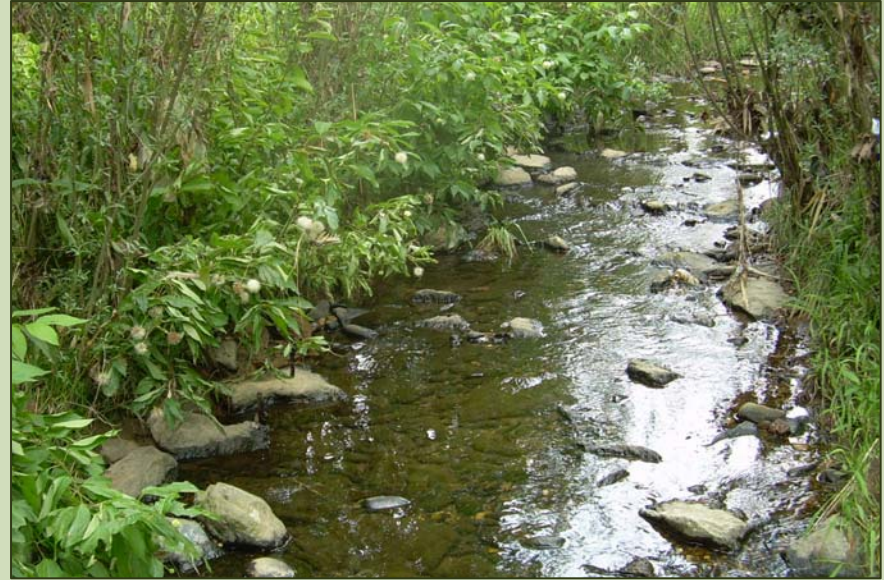
McLean Place (after 4.5 yrs)

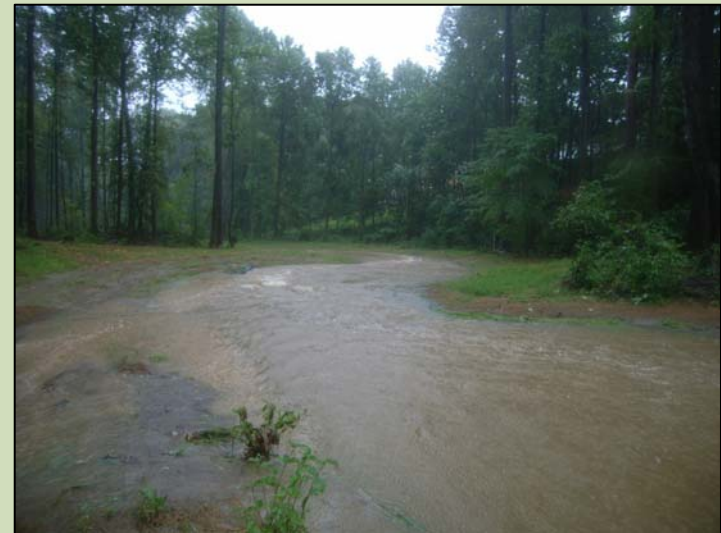
TROPICAL STORM HANNA (9/06/08)

100-YR EVENT (6.22" IN 9 HOURS)

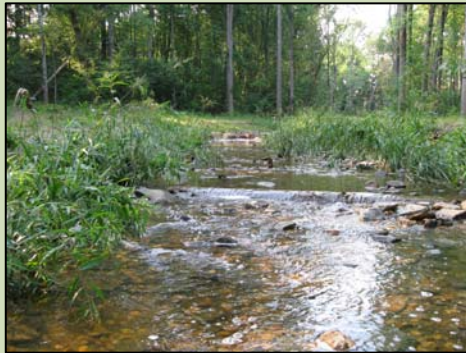
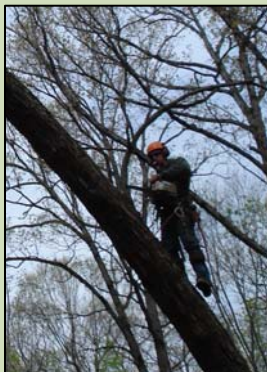
Incised stream

Lower water table

Restored (raised) stream

Higher water table

- **Cleared trees “recycled”** as in-stream habitat, grade control, wood-chip trails, habitat “brush” piles, timber products
- **Restoration raises the water table**, (raises stream bed) which increases stream access to floodplain and nutrient delivery to roots.
- **Healthier ecosystem will develop** with the density and species variety of replacement plantings
 - Mosquito population control via predator habitat
 - Dense streambank planting will provide shade, reduce water temperatures, increase oxygenation, increase fish survivability
 - Dragonfly larva molting access via heavily planted streambank with shallower slope
- **Canopy loss will close** as remaining trees adjust and react to increased sunlight, growing to fill in openings
