Northern Virginia Stream Restoration Bank Annual Status Report

December 15, 2011

Wetland Studies and Solutions, Inc.
5300 Wellington Branch Drive · Suite 100 · Gainesville · Virginia 20155
www.wetlandstudies.com

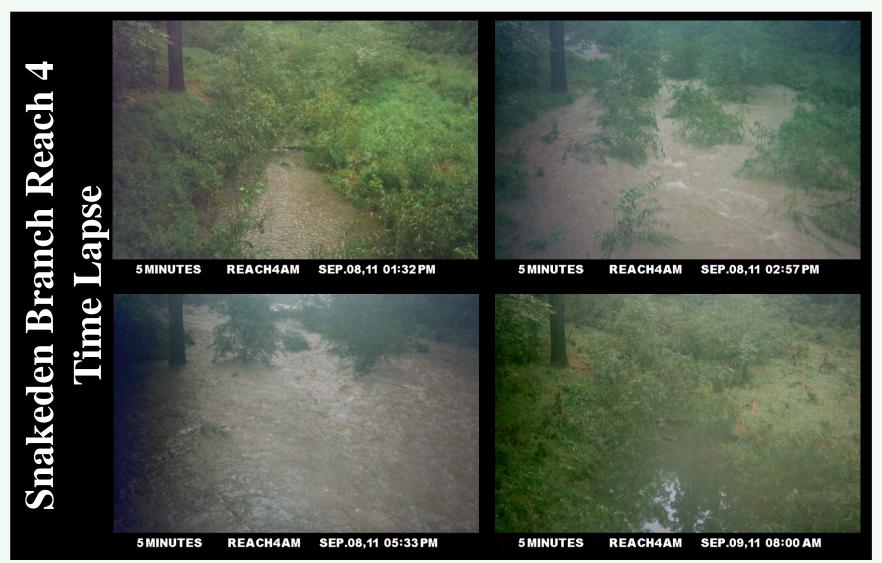
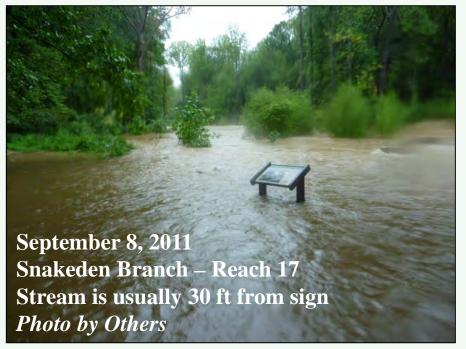
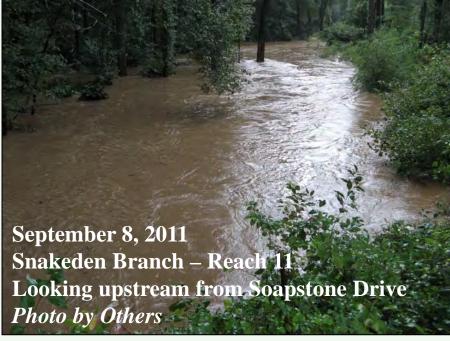
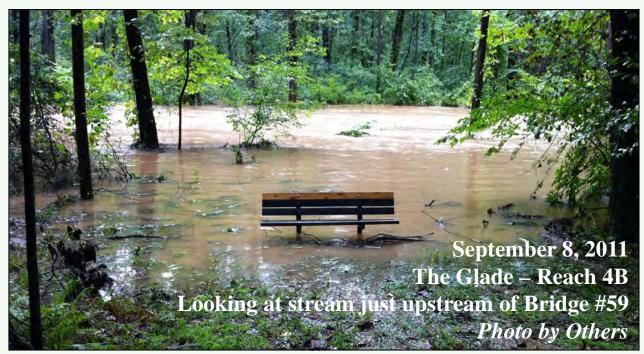
Catastrophic Storm Event: September 5-8, 2011

- 9.65 inches in 3 days with 5.4 inches falling in 3 hours
- Qualifies as 200-500 yr storm (per NOAA Atlas 14) for 3- & 6-hr storms

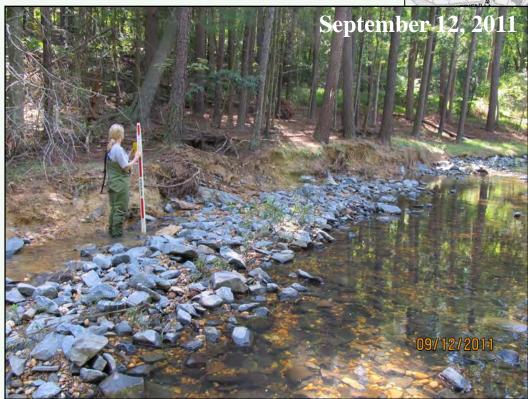
The Glade – Reach 6 Meander

- Design Plan Complete
- DRB Approved: 10/2011
- *Under Review with County and Agencies*

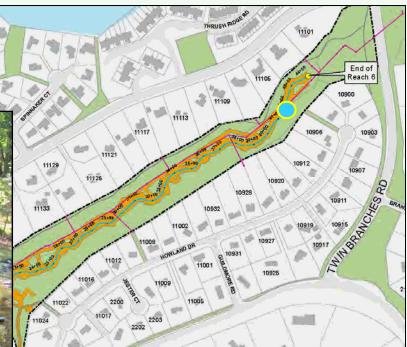
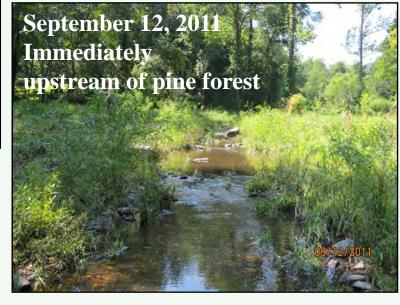
The Glade – Reach 6 (cont'd)

- Damage sustained in The Glade Reach 6
 - Approx. 200' of outside meander bend eroded (right bank)
 - Loss of vegetation on eroded bank
 - Reinforced bed deposited along right bank downstream of erosion
- Why the damage here?
 - Per citizen request, meander was not shifted toward the left bank, and the right bank was previously not protected by in-stream structures in an effort to protect:
 - Two (2) existing vernal pool wetland features (left bank), and
 - Mixed stand of primarily Eastern White Pine, Virginia Pine, and Red Maple trees (right bank)
 - No damage upstream or downstream of meander
