Northern Virginia Stream Restoration Bank – Snakeden Branch Watershed

WSSI #20003, Task L3

Biological Monitoring Report #5 – Post Construction Monitoring Year 7

Northern Virginia Stream Restoration Bank Snakeden Branch Watershed (20,068 Linear Feet) WSSI #20003

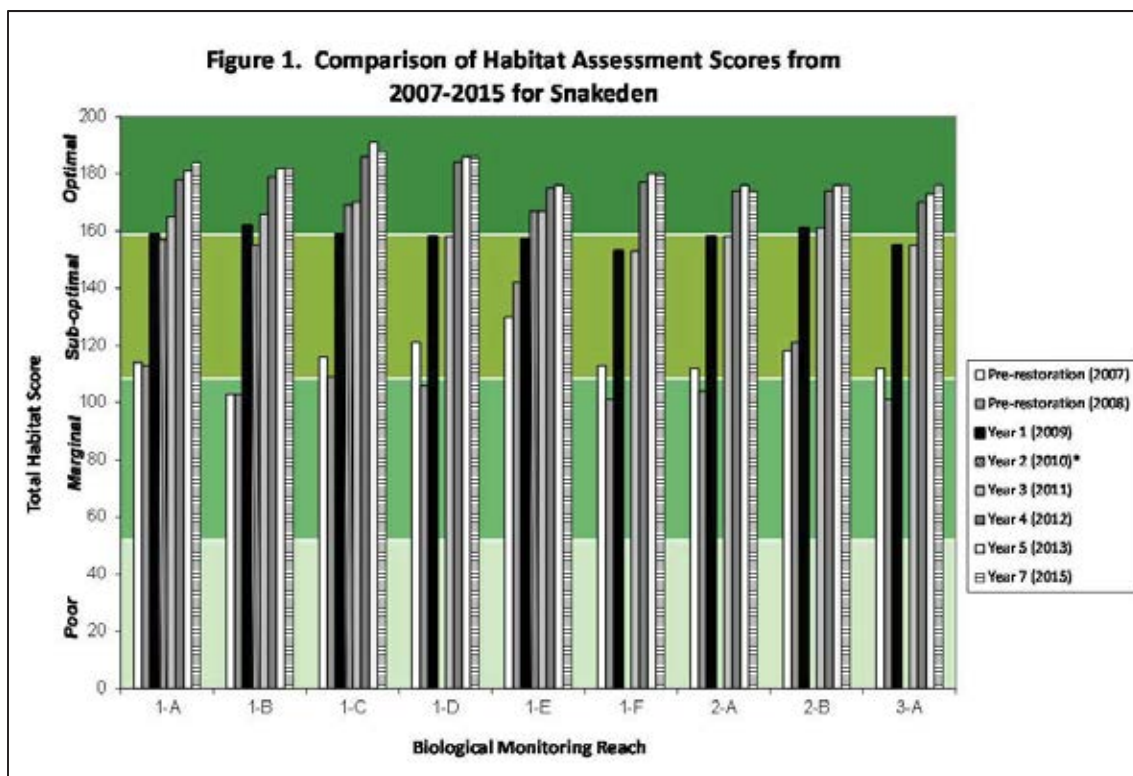
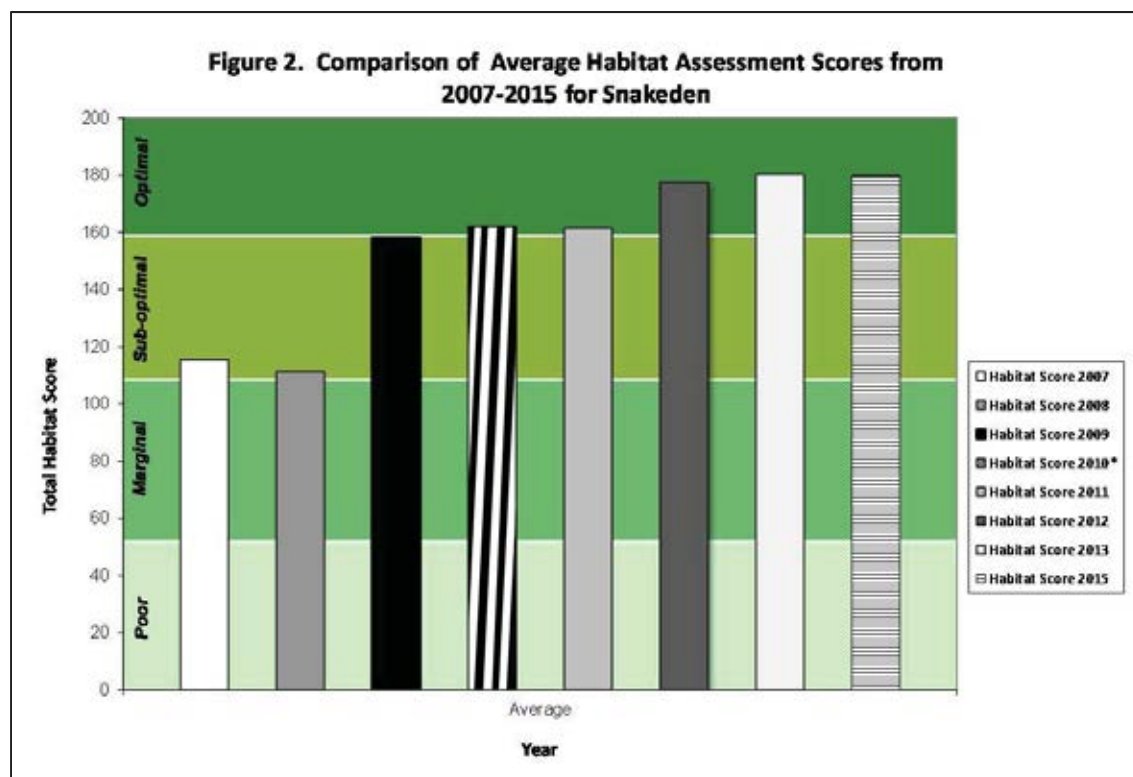
**In supplemental Year 2 (2010) only reaches 1-A, 1-B, 1-C, and 1-E were sampled.*

Biological Stream Monitoring Results and Discussion. Habitat results for 2015 show that all restored biological monitoring stream reaches (Reaches 1-A through 1-F, 2-A, 2-B and 3-A) have “Optimal” habitat condition (Table 1, Figure 1) following restoration. The average habitat assessment score for all restored streams assessed within the Snakeden Branch Watershed portion of the NVSRB in 2015 is 180 (“Optimal”). These results show improved habitat conditions following restoration, with average scores well exceeding the pre-restoration scores and early post-restoration scores (Figure 1 and Figure 2). The habitat conditions appear to have stabilized since the Year 4 monitoring was conducted potentially due to the maturation of the riparian vegetation which further stabilized the banks, with little evidence of erosion or depositional zones present throughout the restored reaches.

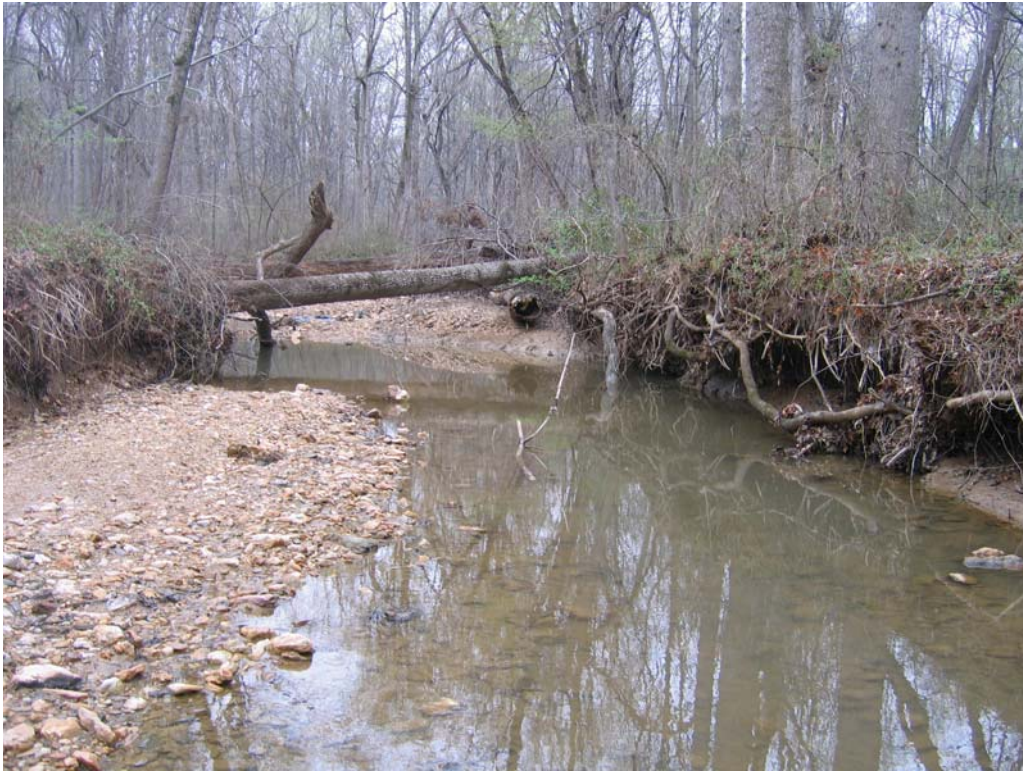
1. Looking northwest (upstream) at Reach 1-A of Snakeden Branch on the eastern portion of the study area during the 2007 preconstruction fieldwork. Photograph taken April 2007.

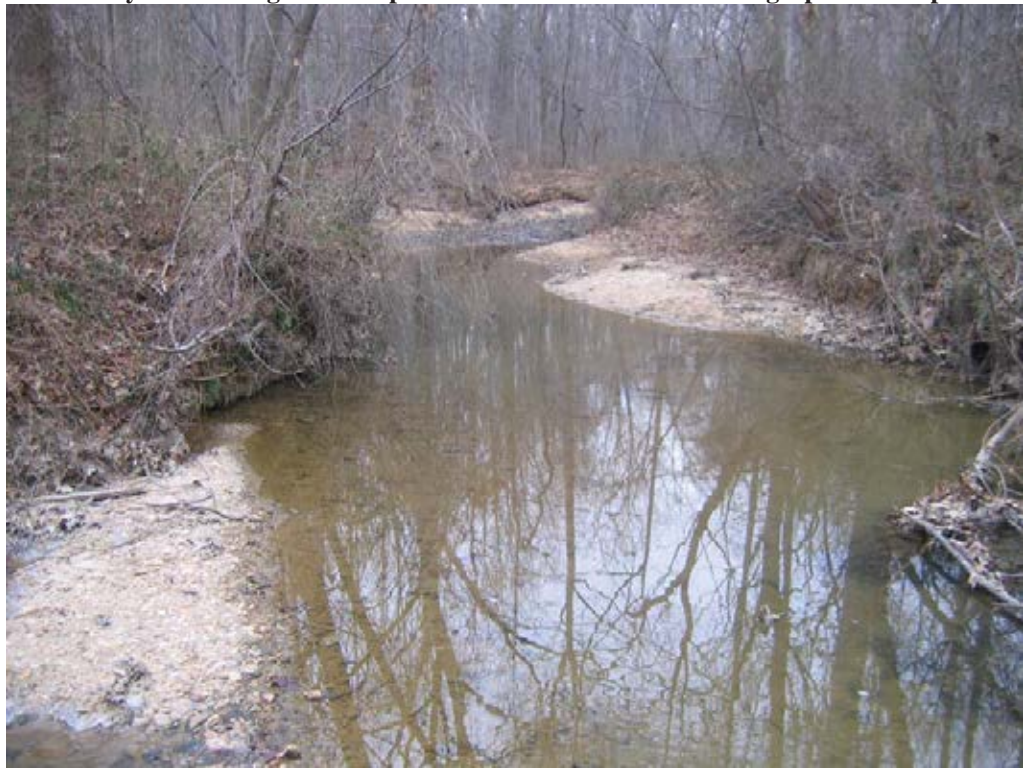
2. Looking northwest (upstream) at Reach 1-A of Snakeden Branch on the eastern portion of the study area during the 2008 preconstruction fieldwork. Photograph taken February 2008.

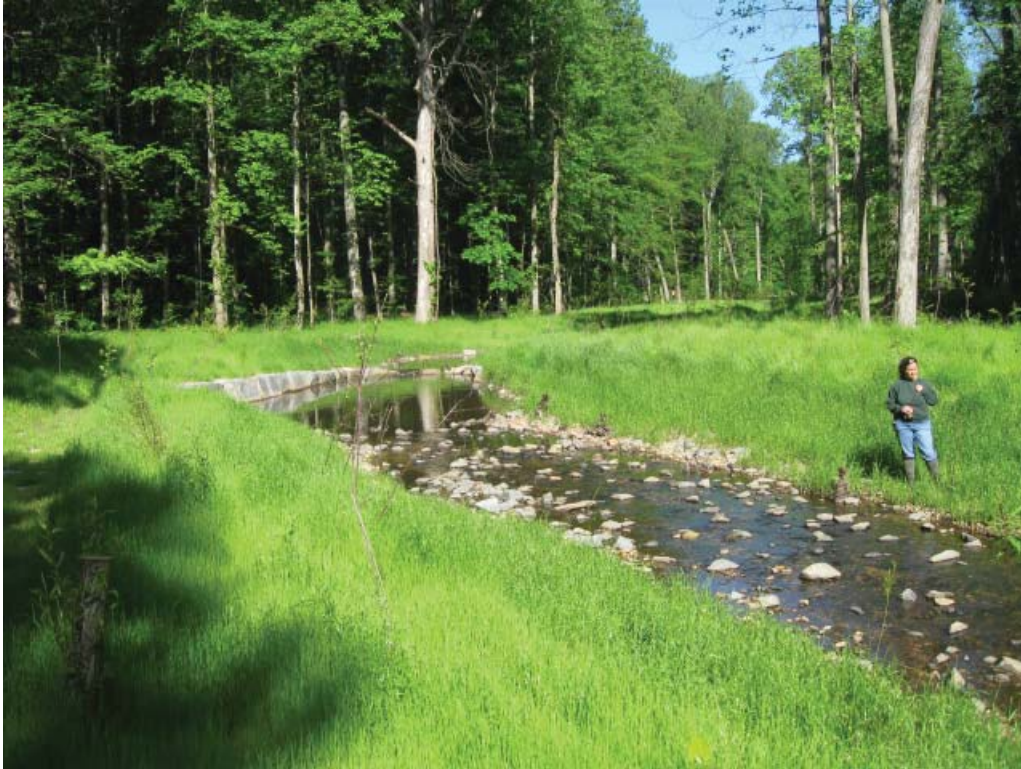
3. Looking northwest (upstream) at Reach 1-A of Snakeden Branch on the eastern portion of the study area during the 2009 post construction, Year 1, fieldwork. Photograph taken May 2009.

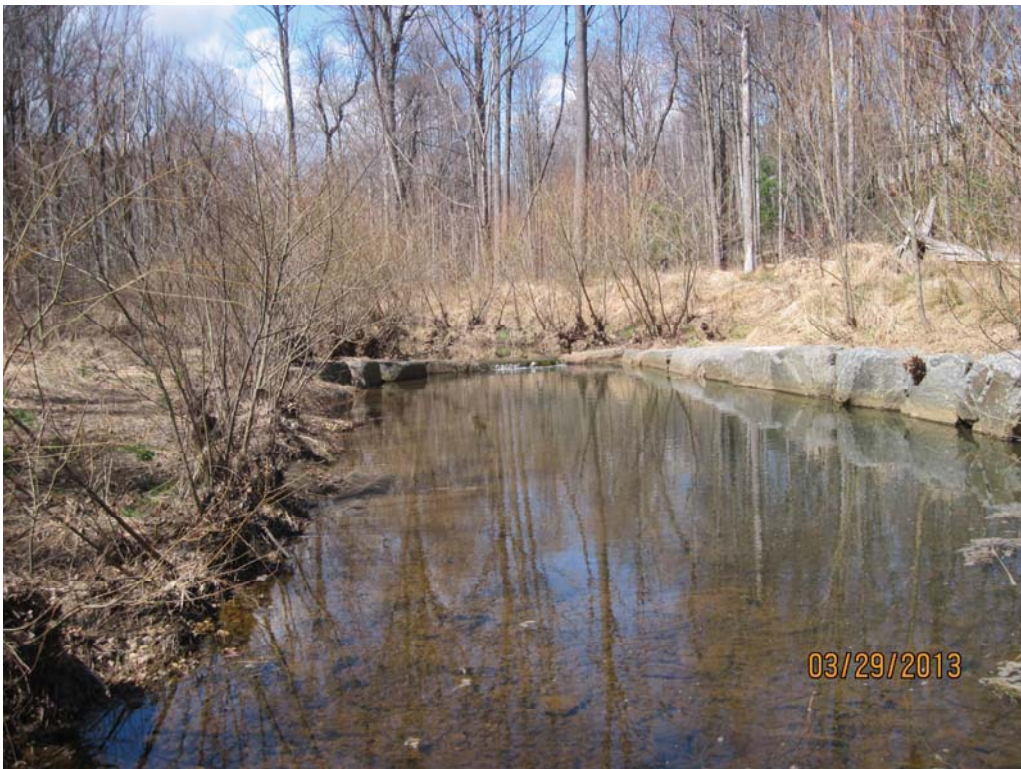
4. Looking northwest (upstream) at Reach 1-A of Snakeden Branch on the eastern portion of the study area during the 2013 post construction, Year 5, fieldwork. Photograph taken March 2013.

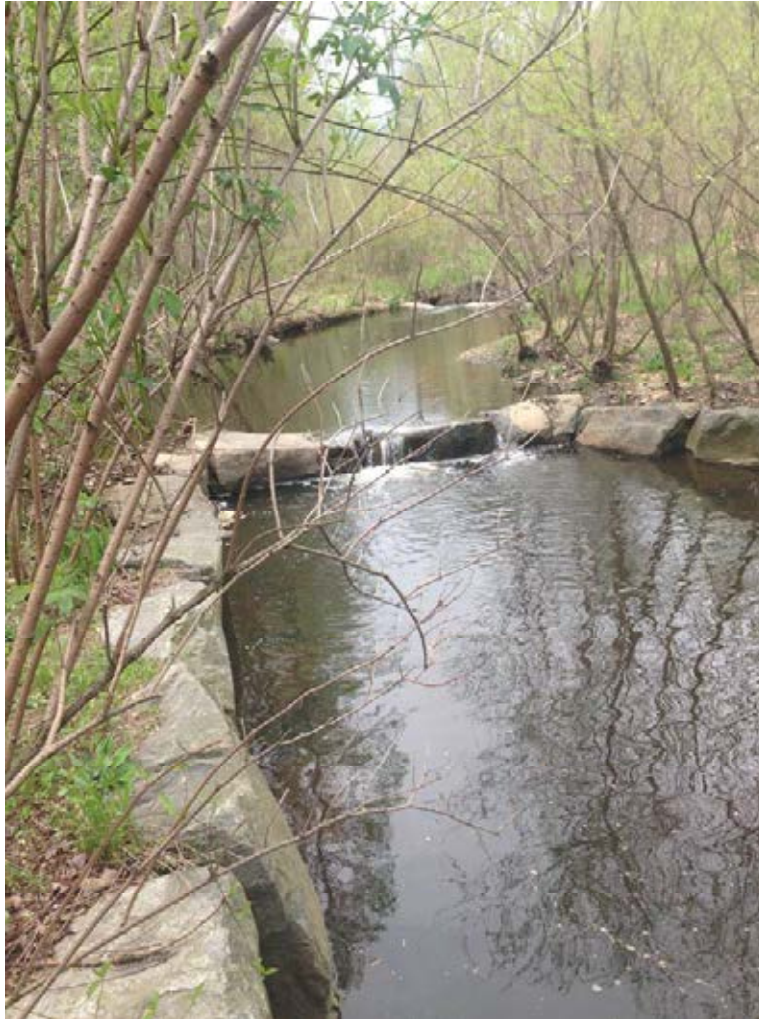
5. Looking northwest (upstream) at Reach 1-A of Snakeden Branch on the eastern portion of the study area during the 2015 post construction, Year 7, fieldwork. Photograph taken April 2015.

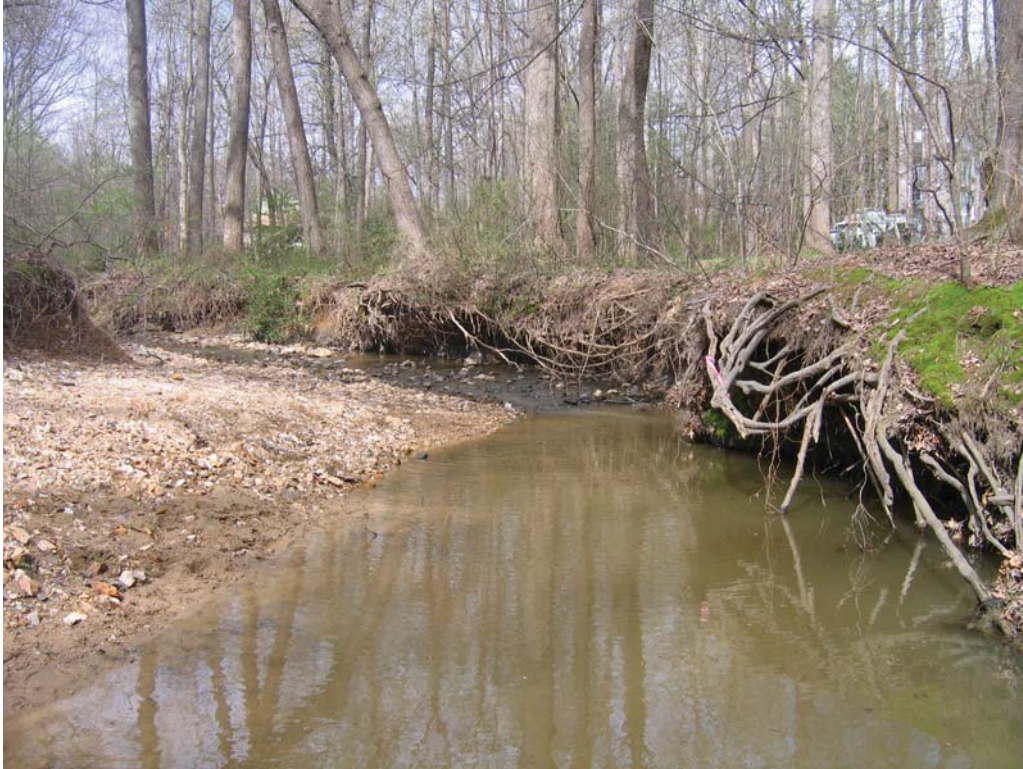
1. Looking west (upstream) at Reach 1-B of Snakeden Branch on the eastern portion of the study area during the 2007 preconstruction fieldwork. Photograph taken April 2007.

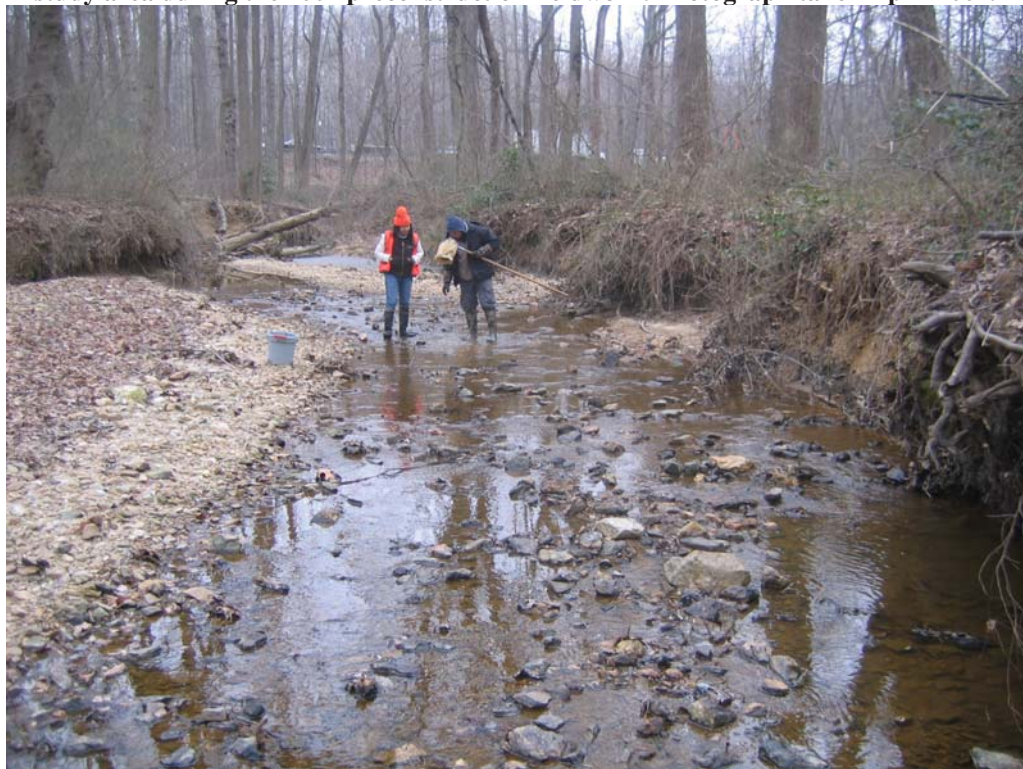
2. Looking west (upstream) at Reach 1-B of Snakeden Branch on the eastern portion of the study area during the 2008 preconstruction fieldwork. Photograph taken February 2008.

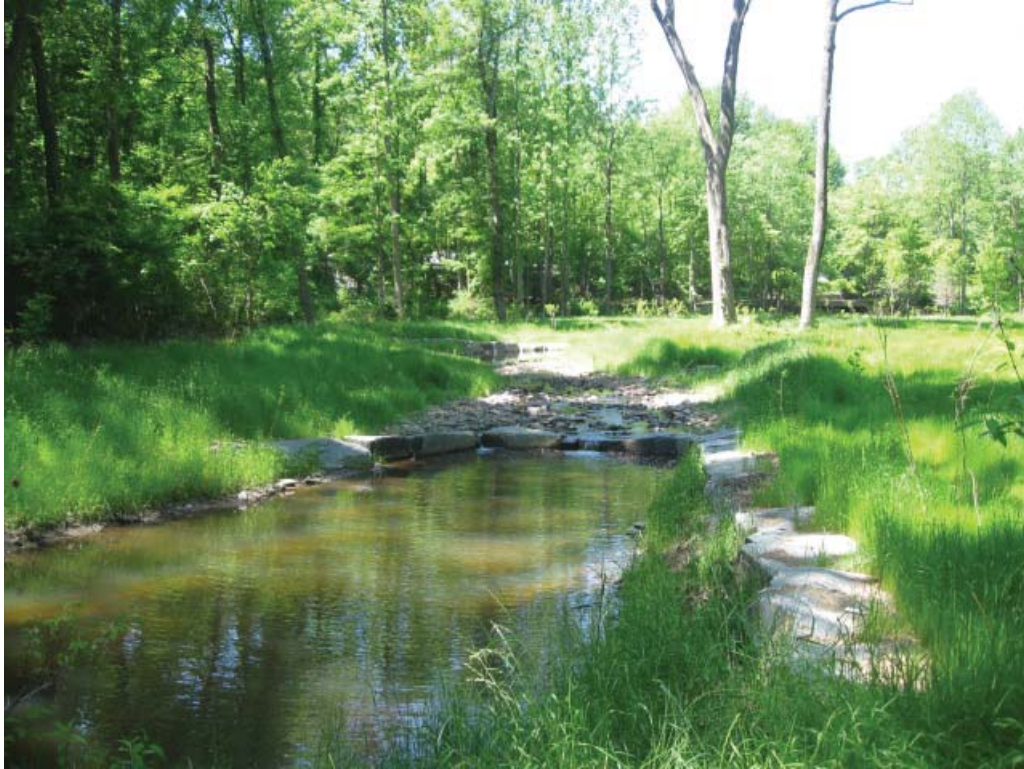
3. Looking west (upstream) at Reach 1-B of Snakeden Branch on the eastern portion of the study area during the 2009 post construction, Year 1, fieldwork. Photograph taken May 2009.

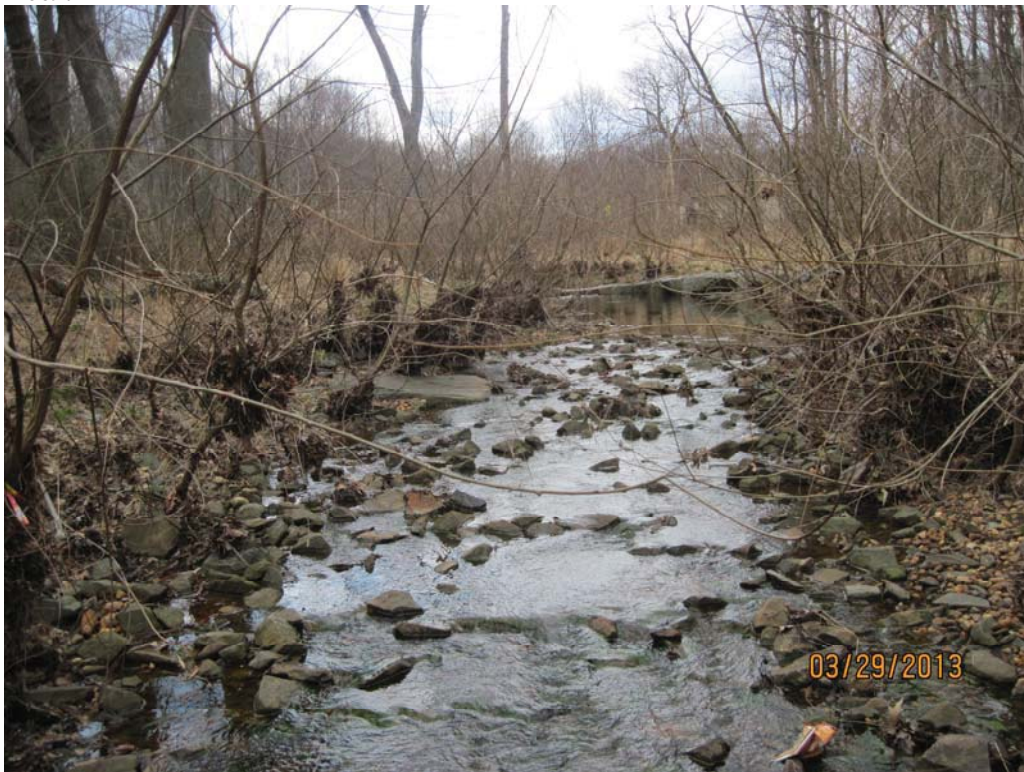
4. Looking west (upstream) at Reach 1-B of Snakeden Branch on the eastern portion of the study area during the 2013 post construction, Year 5, fieldwork. Photograph taken March 2013.

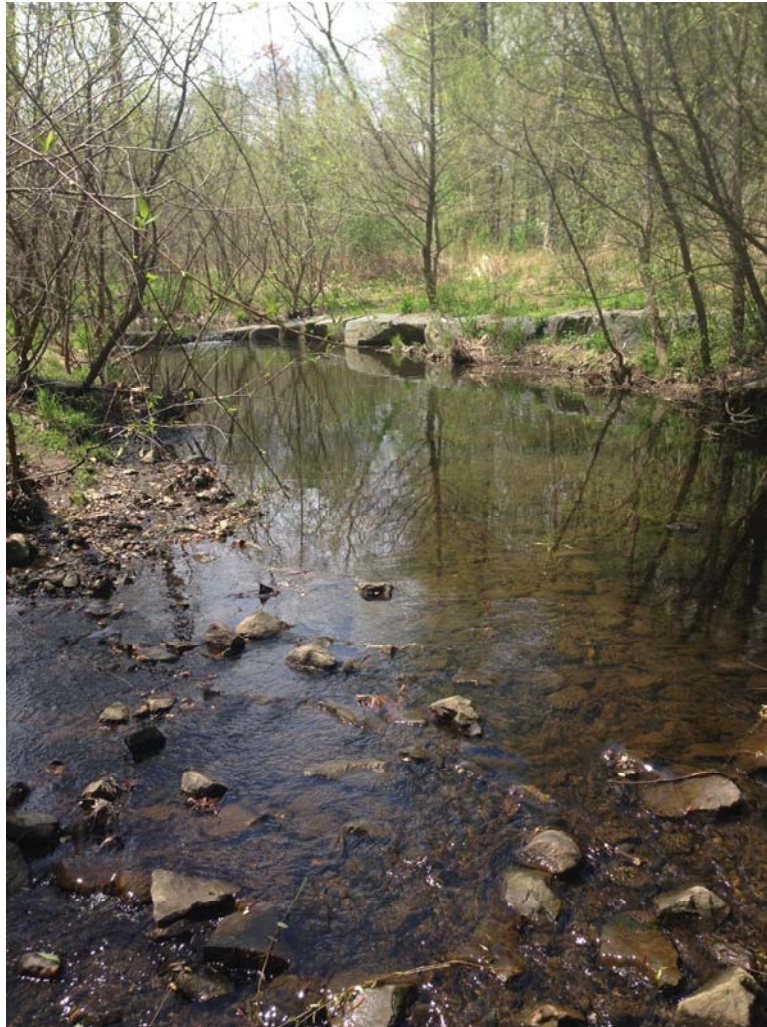
5. Looking west (upstream) at Reach 1-B of Snakeden Branch on the eastern portion of the study area during the 2015 post construction, Year 7, fieldwork. Photograph taken April 2015.

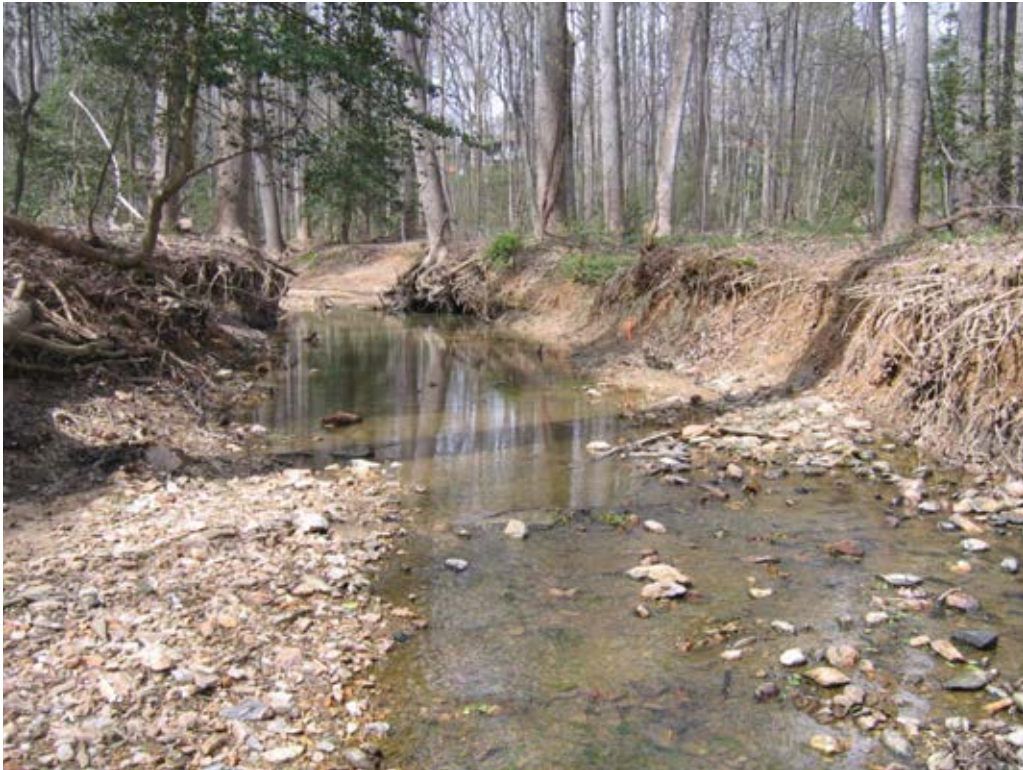
1. Looking northwest (upstream) at Reach 1-C of Snakeden Branch on the central portion of the study area during the 2007 preconstruction fieldwork. Photograph taken April 2007.

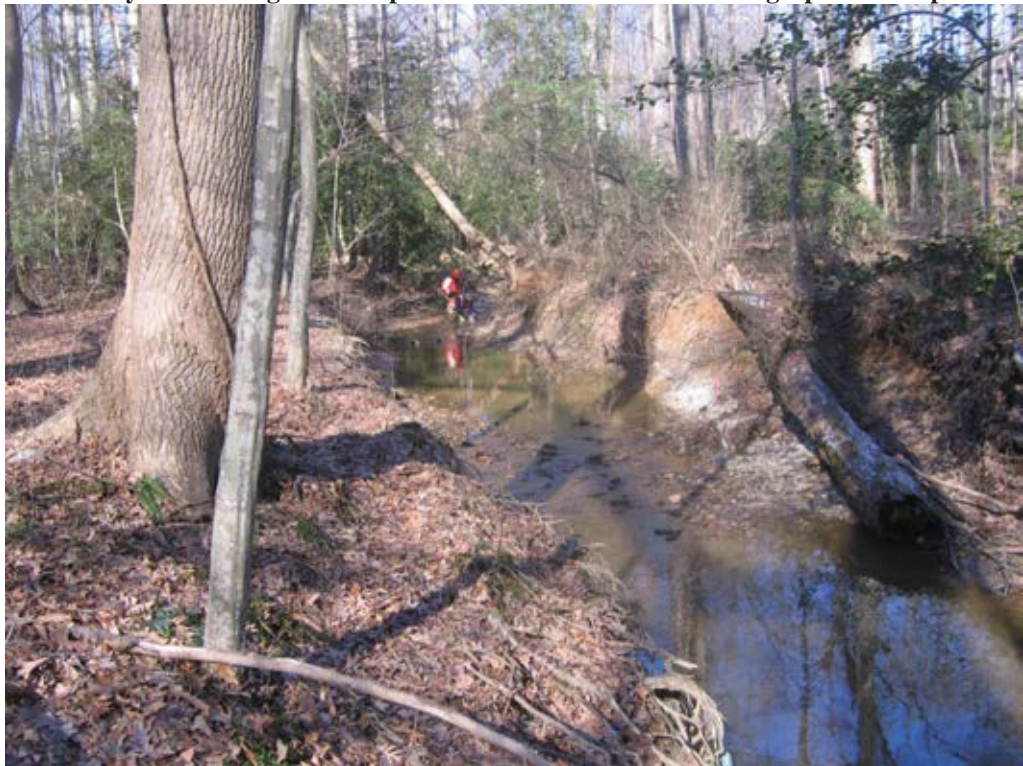
2. Looking northwest (upstream) at Reach 1-C of Snakeden Branch on the central portion of the study area during the 2008 preconstruction fieldwork. Photograph taken February 2008.

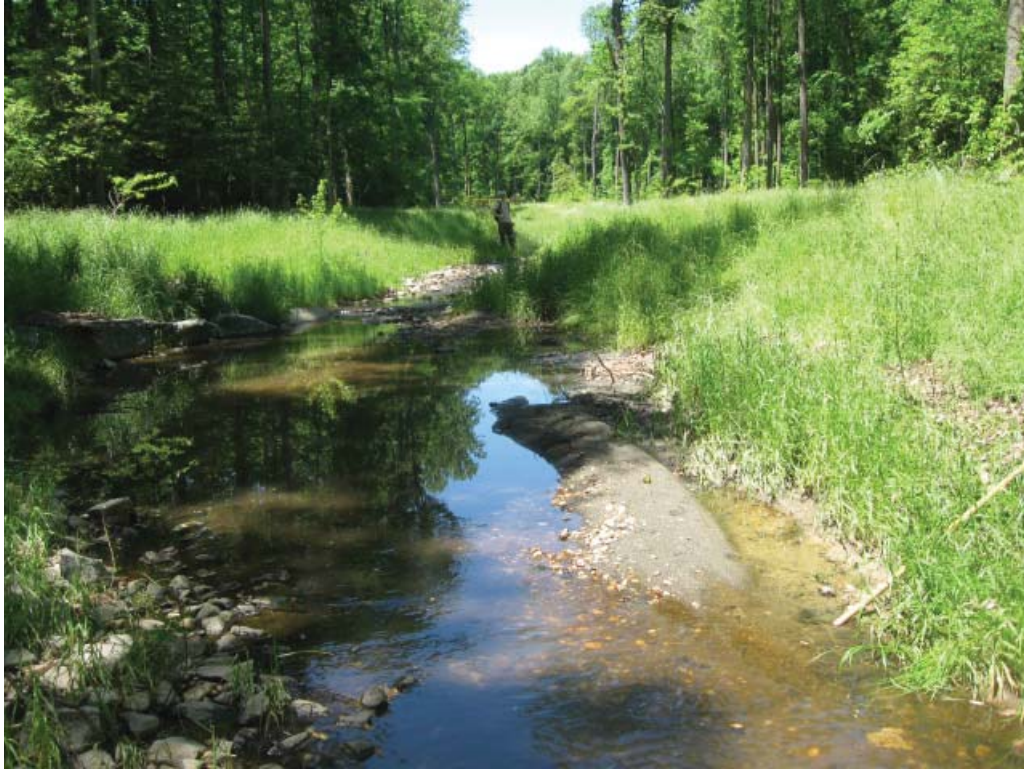
3. Looking northwest (upstream) at Reach 1-C of Snakeden Branch on the central portion of the study area during the 2009 post construction, Year 1, fieldwork. Photograph taken May 2009.

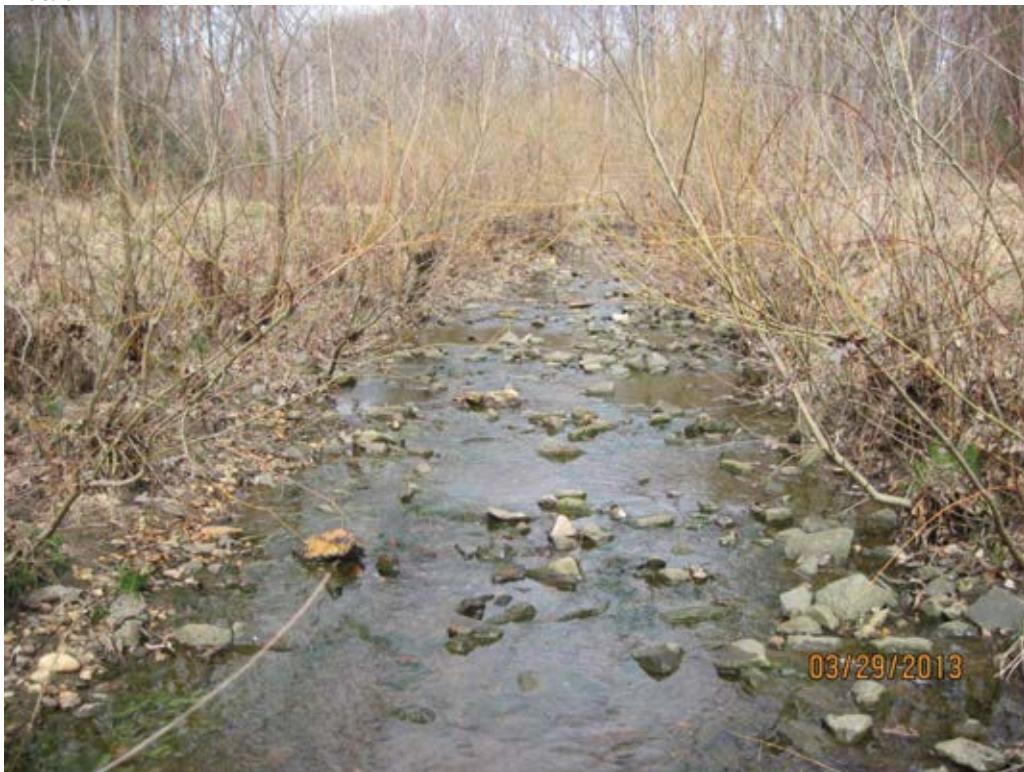
4. Looking northwest (upstream) at Reach 1-C of Snakeden Branch on the central portion of the study area during the 2013 post construction, Year 5, fieldwork. Photograph taken March 2013.

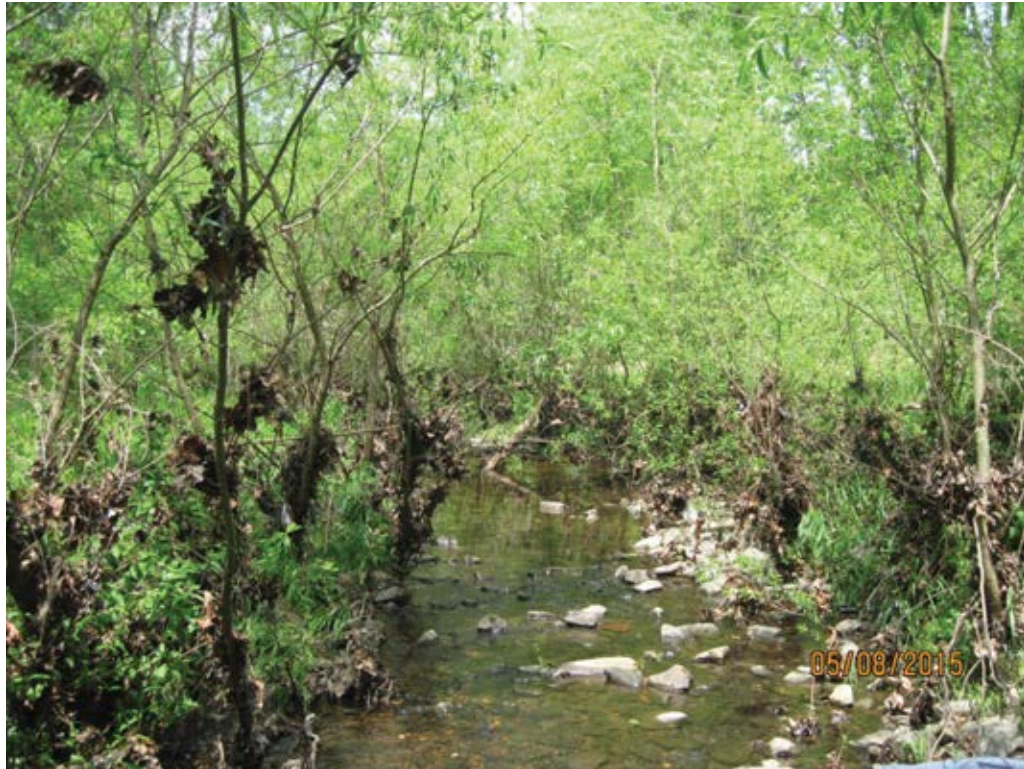
5. Looking northwest (upstream) at Reach 1-C of Snakeden Branch on the central portion of the study area during the 2015 post construction, Year 7, fieldwork. Photograph taken May 2015.

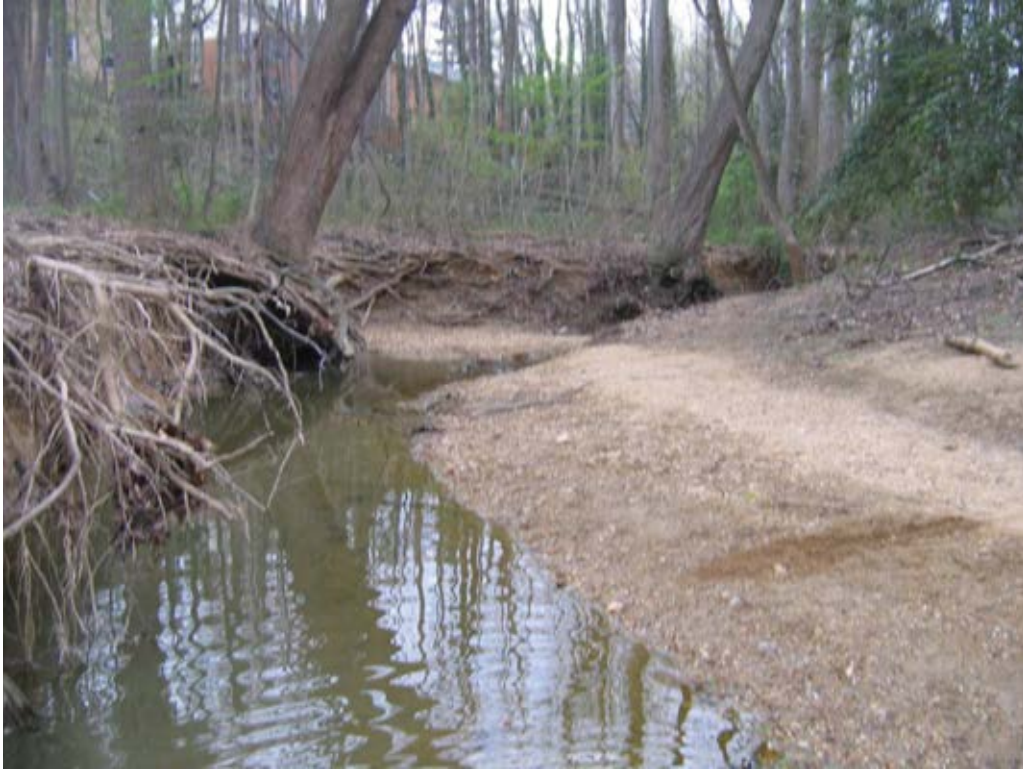
1. Looking southwest (upstream) at Reach 1-D of Snakeden Branch on the central portion of the study area during the 2007 preconstruction fieldwork. Photograph taken April 2007.

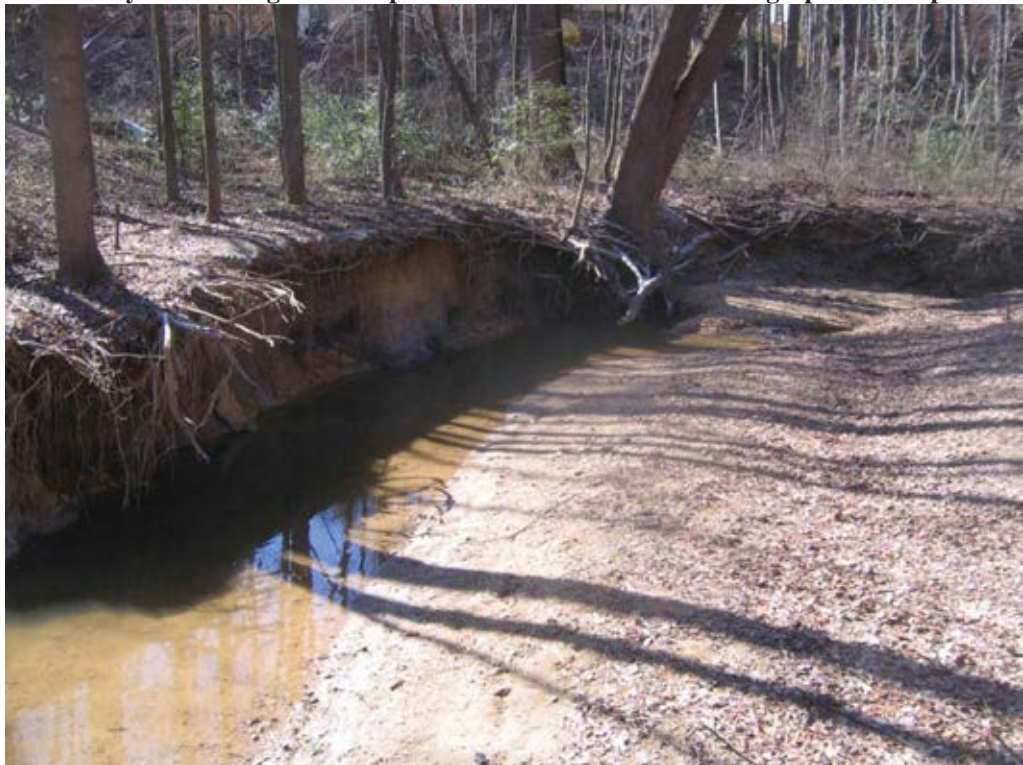
2. Looking southwest (upstream) at Reach 1-D of Snakeden Branch on the central portion of the study area during the 2008 preconstruction fieldwork. Photograph taken February 2008.

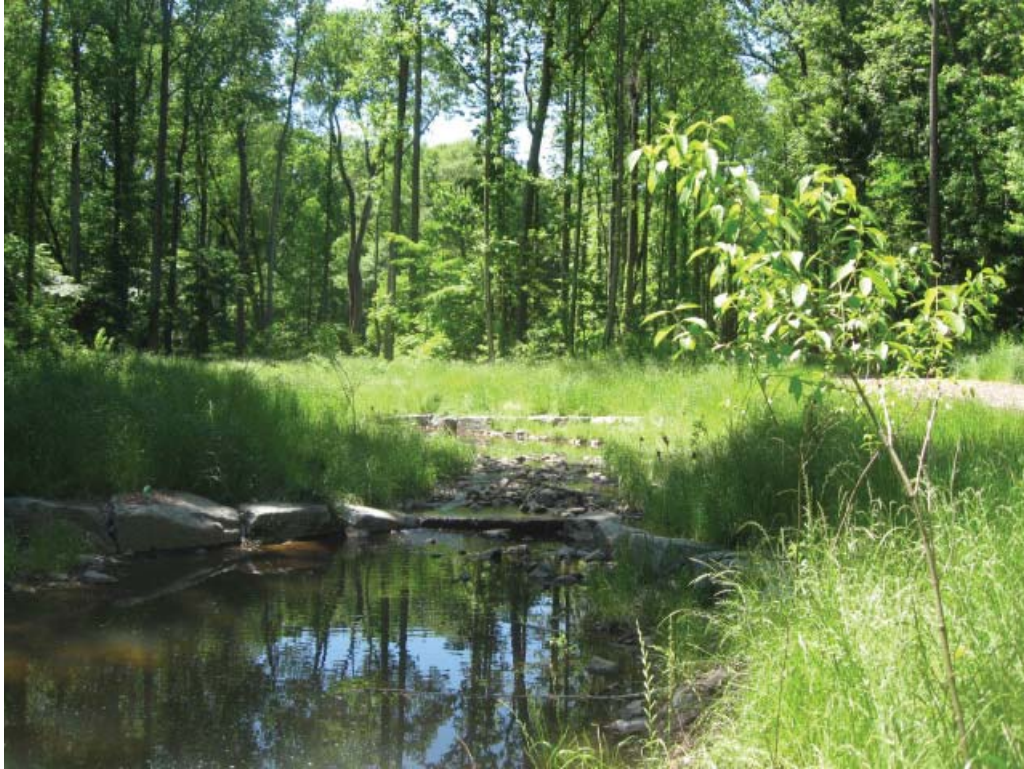
3. Looking southwest (upstream) at Reach 1-D of Snakeden Branch on the central portion of the study area during the 2009 post construction, Year 1, fieldwork. Photograph taken May 2009.

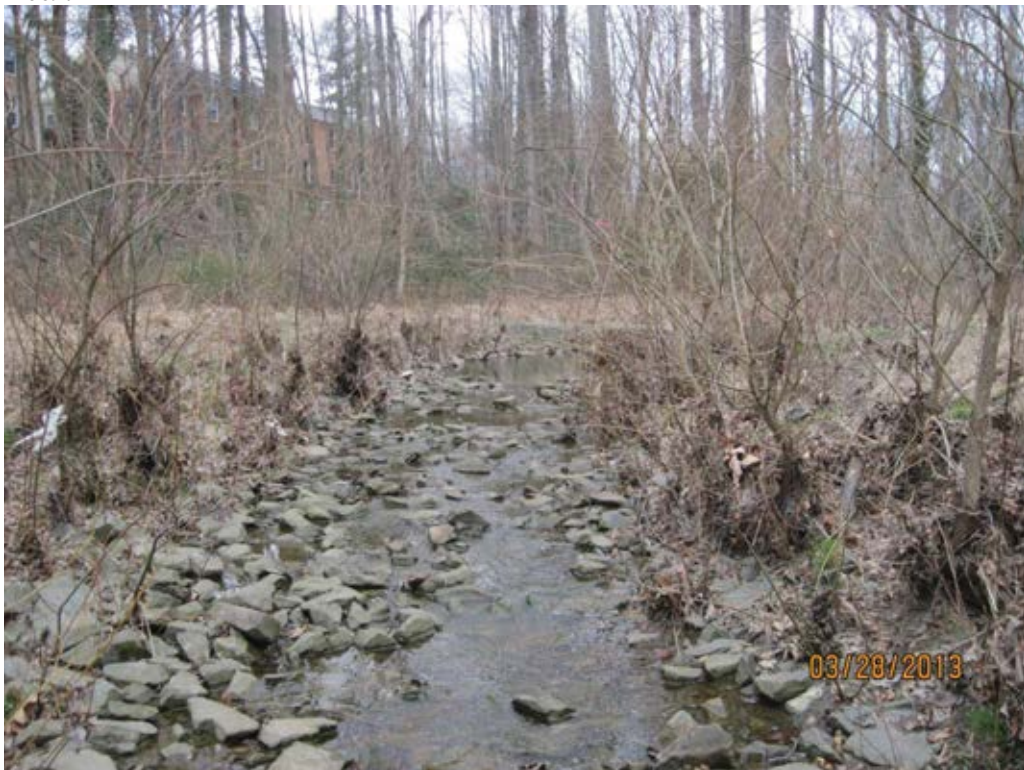
4. Looking southwest (upstream) at Reach 1-D of Snakeden Branch on the central portion of the study area during the 2013 post construction, Year 5, fieldwork. Photograph taken March 2013.

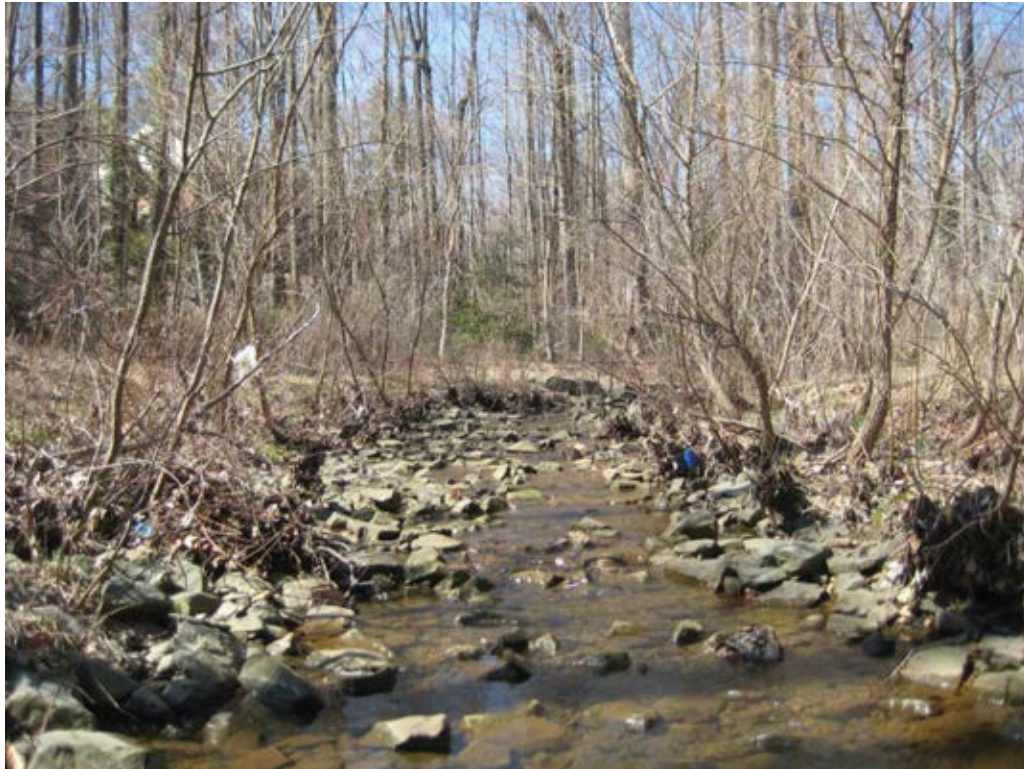
5. **Looking southwest (upstream) at Reach 1-D of Snakeden Branch on the central portion of the study area during the 2015 post construction, Year 7, fieldwork. Photograph taken April 2015.**

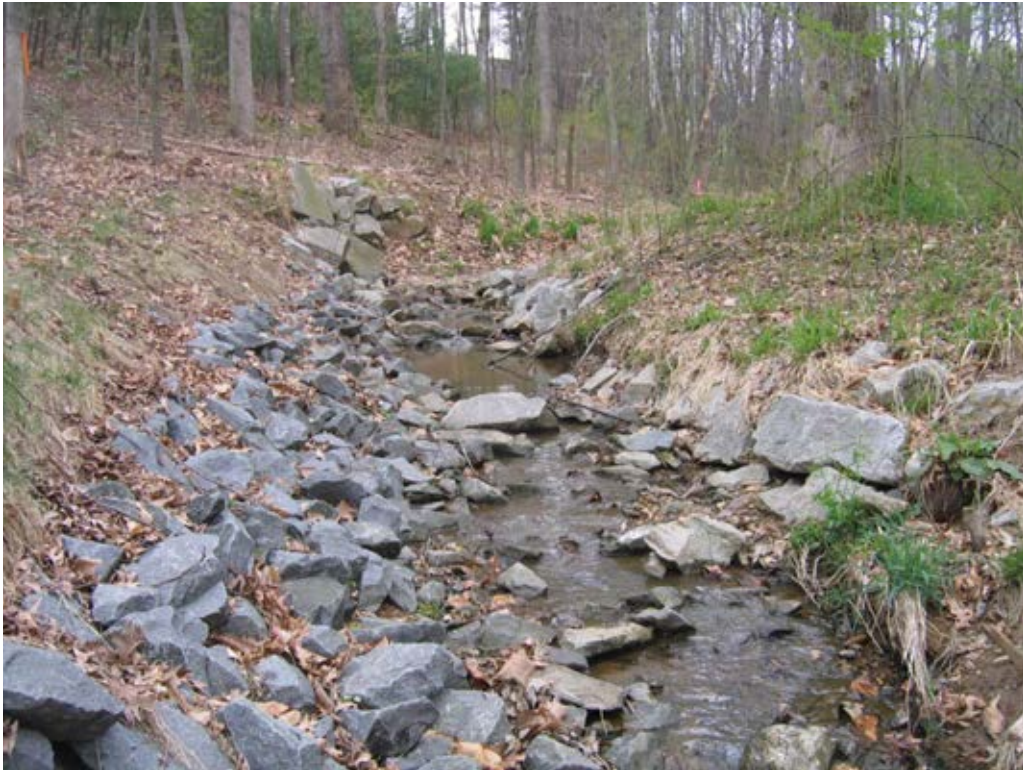
1. Looking northwest (upstream) at Reach 1-E of Snakeden Branch on the western portion of the study area during the 2007 preconstruction fieldwork. Photographs taken April 2007.

In addition, in September 2009, both a waste cooking oil spill and a continuous diesel fuel leak were discovered just above biomonitoring Reach 1-E in two separate incidents. The incidents are since being remediated by the Reston Association and Fairfax County (Bellezza, 2013). High amounts of such pollutants entering streams inevitably results in a shift in macroinvertebrate community composition, where pollution tolerant taxa such as non-biting midges and oligochaete worms out-compete pollution sensitive taxa such as EPT (Shueler 1994).

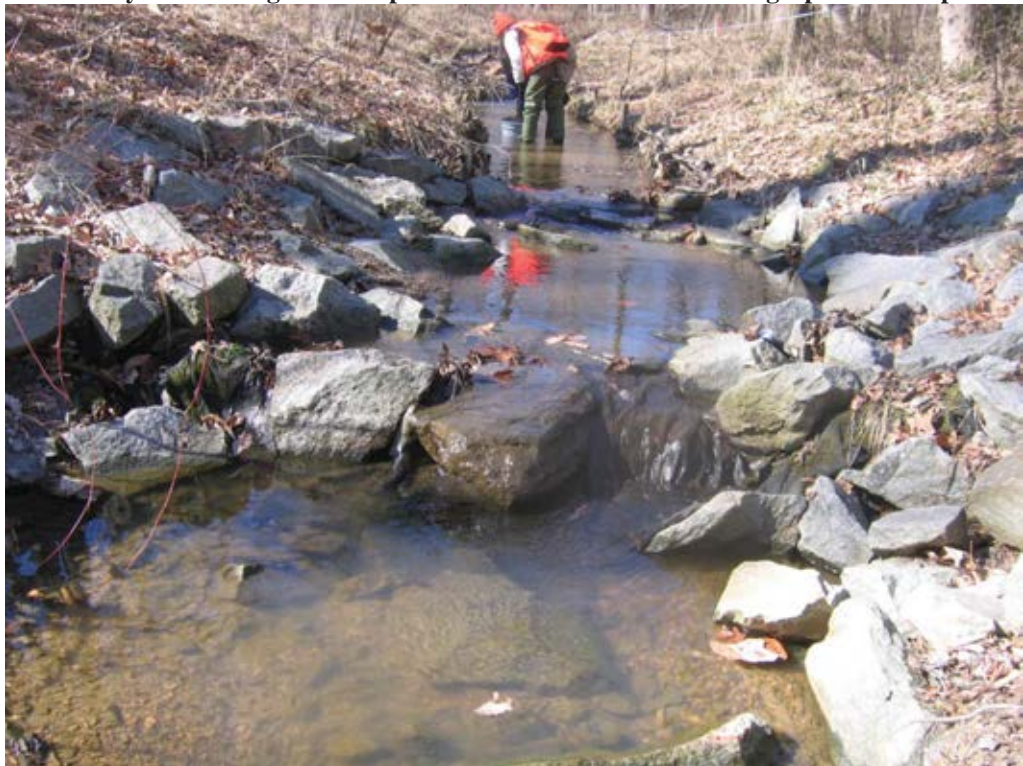
2. Looking northwest (upstream) at Reach 1-E of Snakeden Branch on the western portion of the study area during the 2008 preconstruction fieldwork. Photograph taken February 2008.

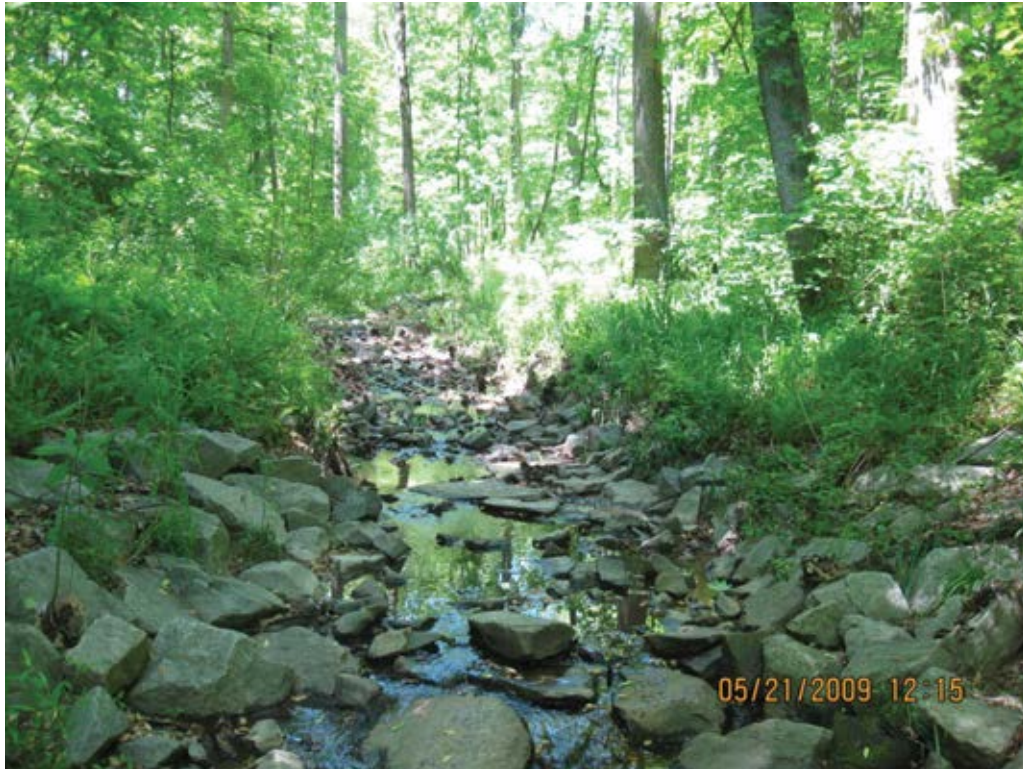
3. Looking northwest (upstream) at Reach 1-E of Snakeden Branch on the western portion of the study area during the 2009 post construction, Year 1, fieldwork. Photograph taken May 2009.

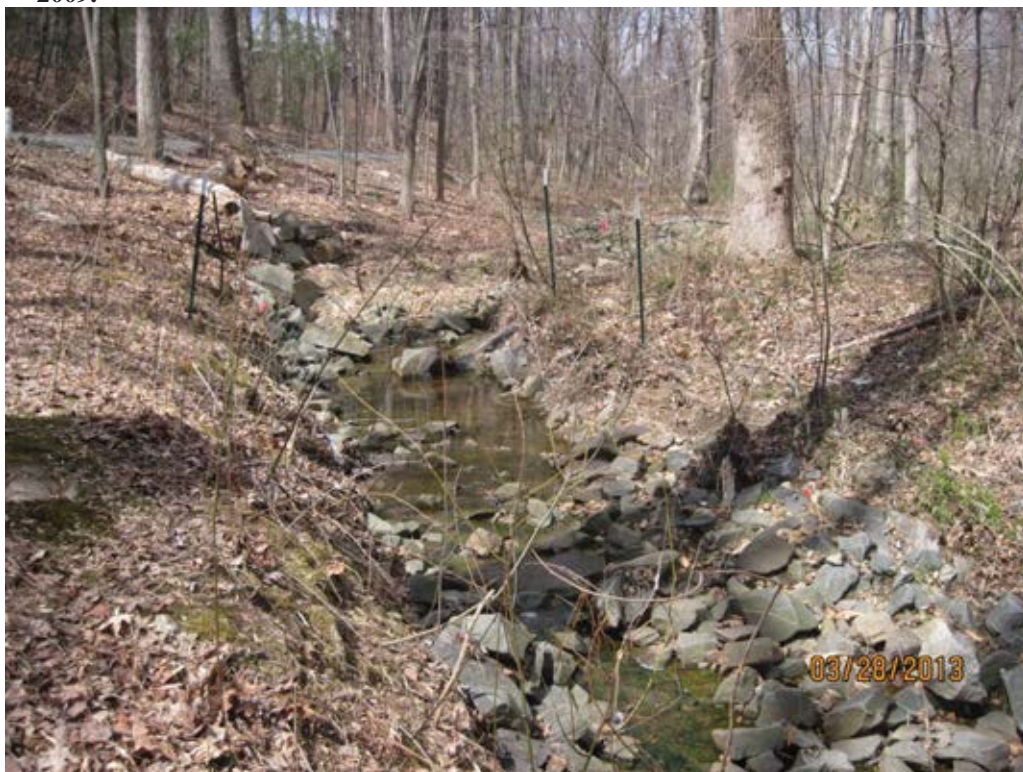
4. Looking northwest (upstream) at Reach 1-E of Snakeden Branch on the western portion of the study area during the 2013 post construction, Year 5, fieldwork. Photograph taken March 2013.

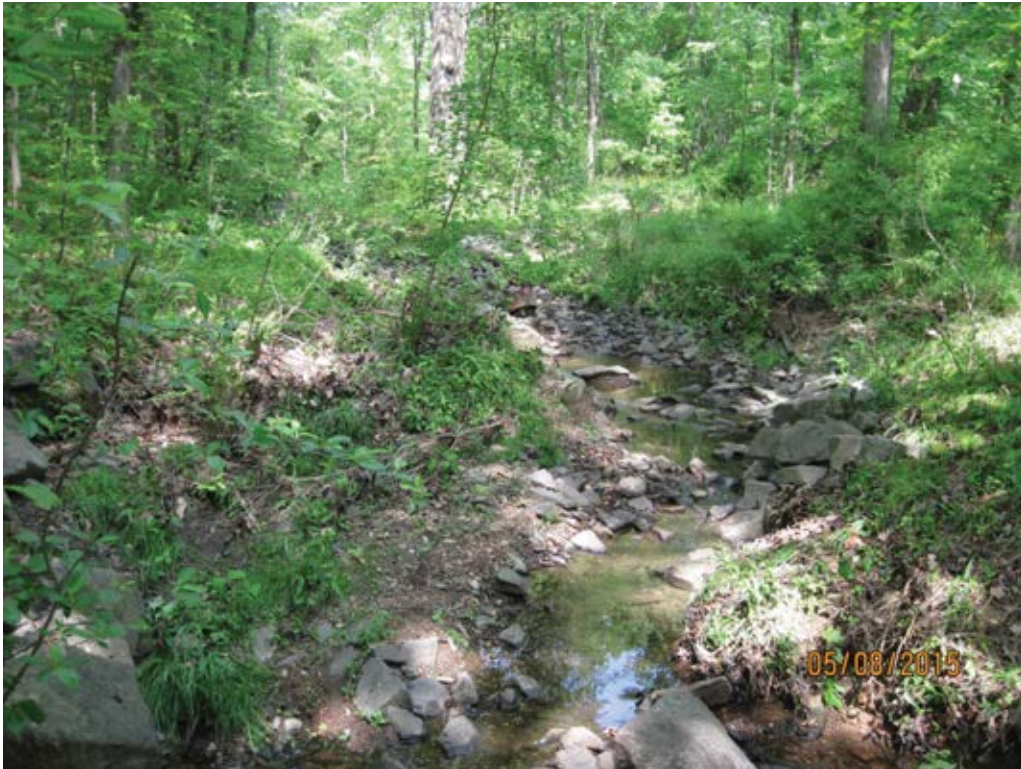
5. Looking northwest (upstream) at Reach 1-E of Snakeden Branch on the western portion of the study area during the 2015 post construction, Year 7, fieldwork. Photograph taken May 2015.
