Northern Virginia Stream Restoration Bank – Snakeden Branch Watershed

WSSI #20003, Task L3

Biological Monitoring Report #5 – Post Construction Monitoring Year 7

Northern Virginia Stream Restoration Bank Snakeden Branch Watershed (20,068 Linear Feet) WSSI #20003

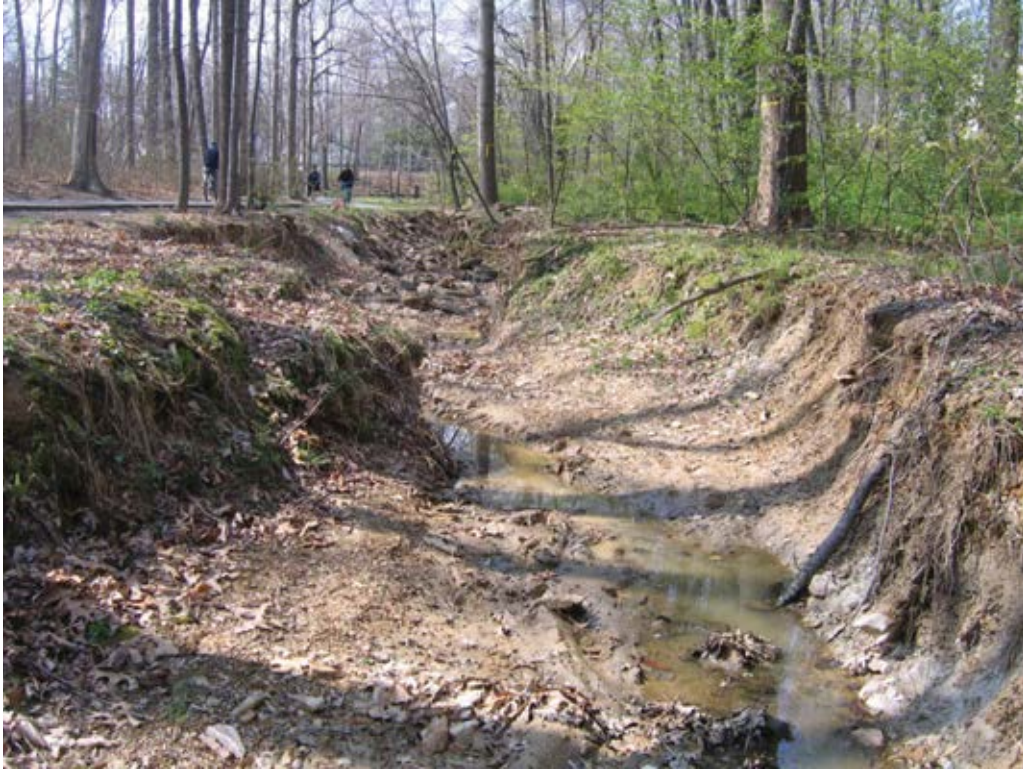
1. Looking northwest (upstream) at Reach 1-F of Snakeden Branch on the western portion of the study area during the 2007 preconstruction fieldwork. Photograph taken April 2007.

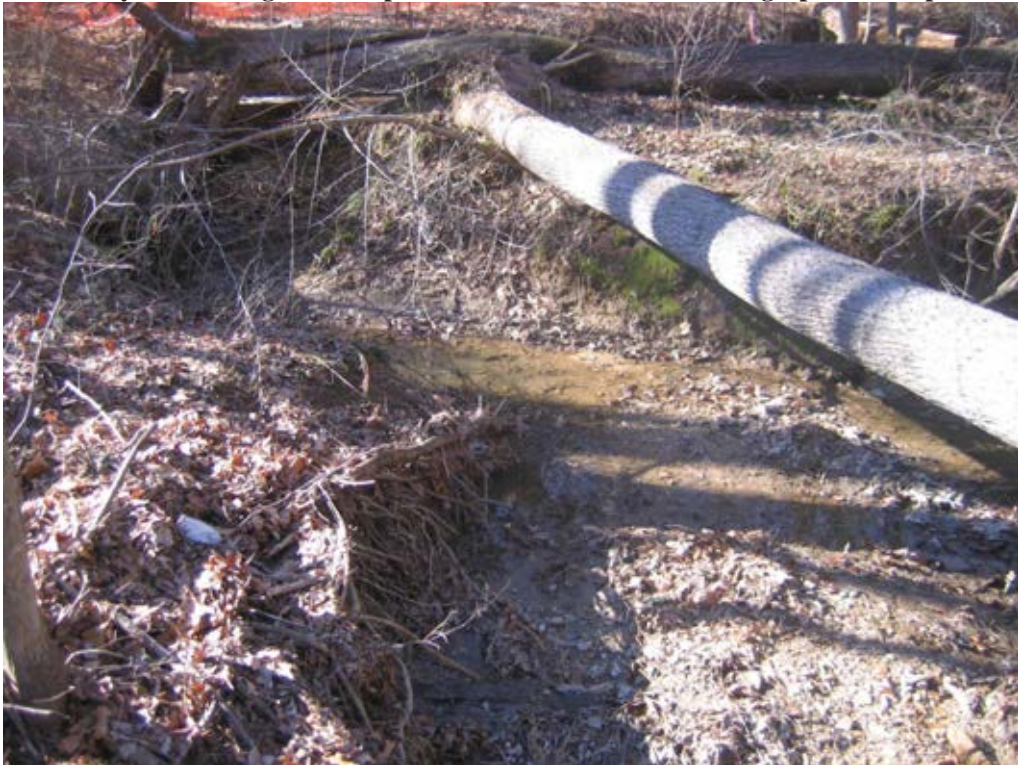
2. Looking northwest (upstream) at Reach 1-F of Snakeden Branch on the western portion of the study area during the 2008 preconstruction fieldwork. Photograph taken February 2008.

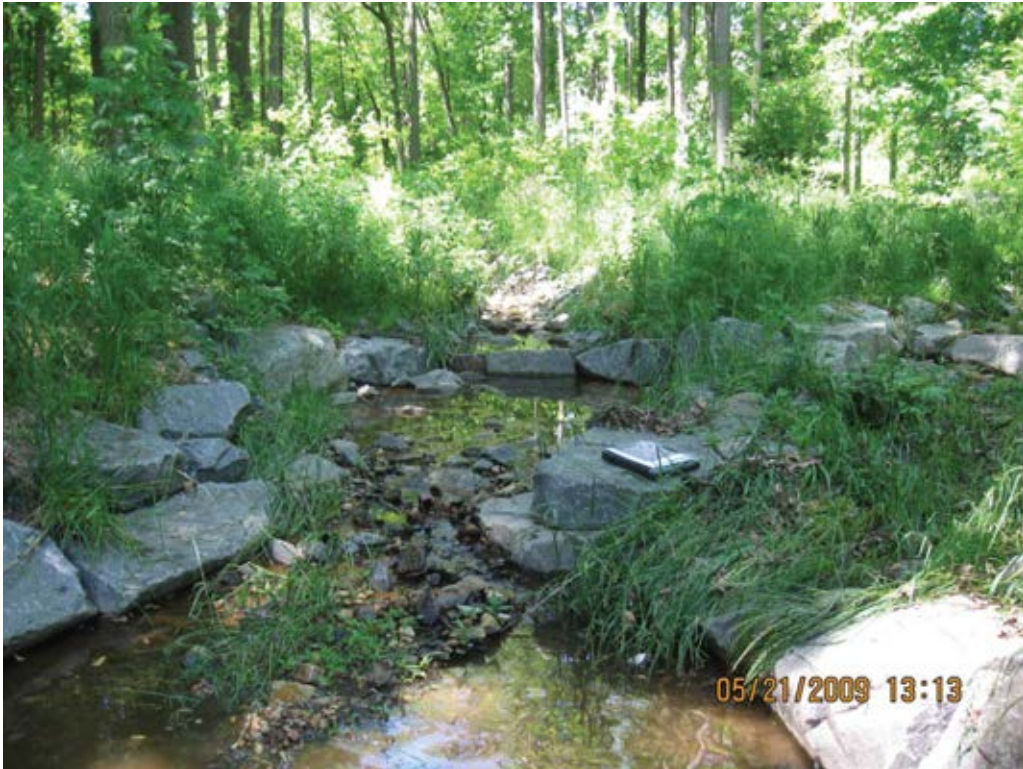
3. Looking northwest (upstream) at Reach 1-F of Snakeden Branch on the western portion of the study area during the 2009 post construction, Year 1, fieldwork. Photograph taken May 2009.

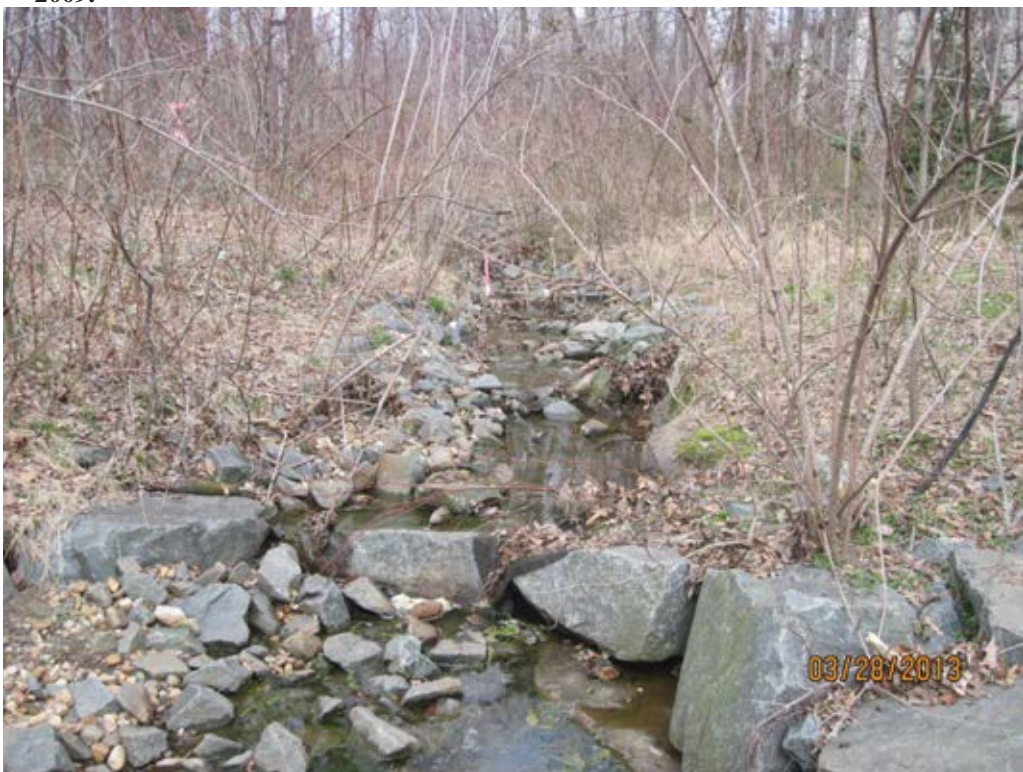
4. Looking northwest (upstream) at Reach 1-F of Snakeden Branch on the western portion of the study area during the 2013 post construction, Year 5, fieldwork. Photograph taken March 2013.

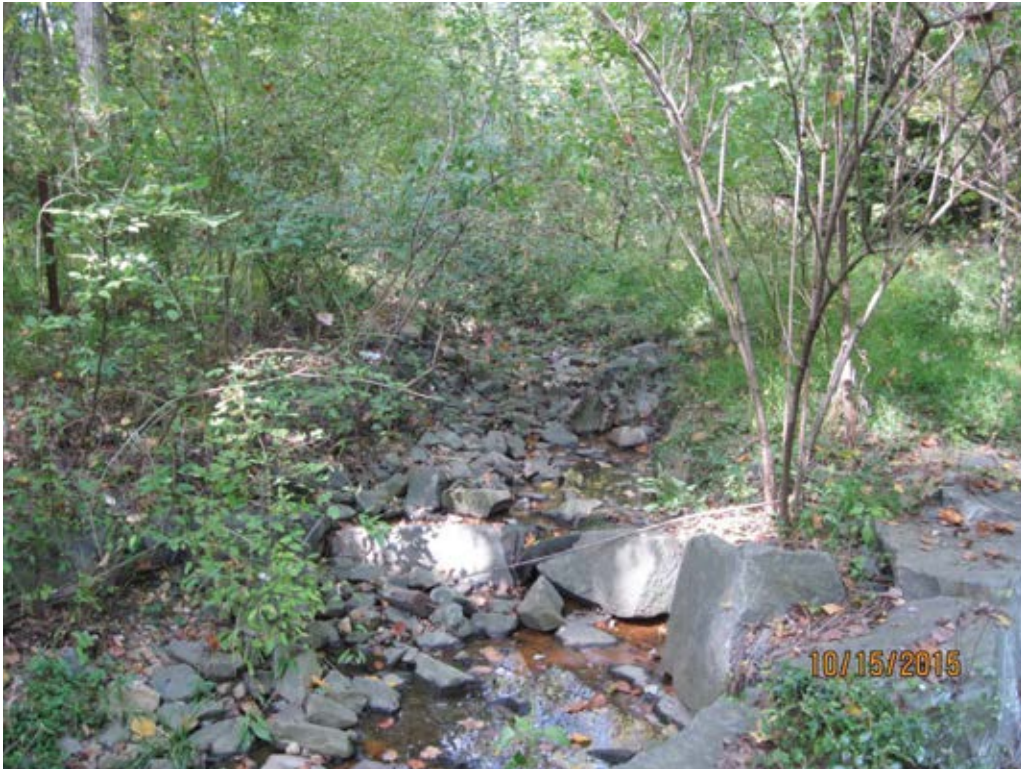
5. Looking northwest (upstream) at Reach 1-F of Snakeden Branch on the western portion of the study area during the 2015 post construction, Year 7, fieldwork. Photograph taken October 2015.

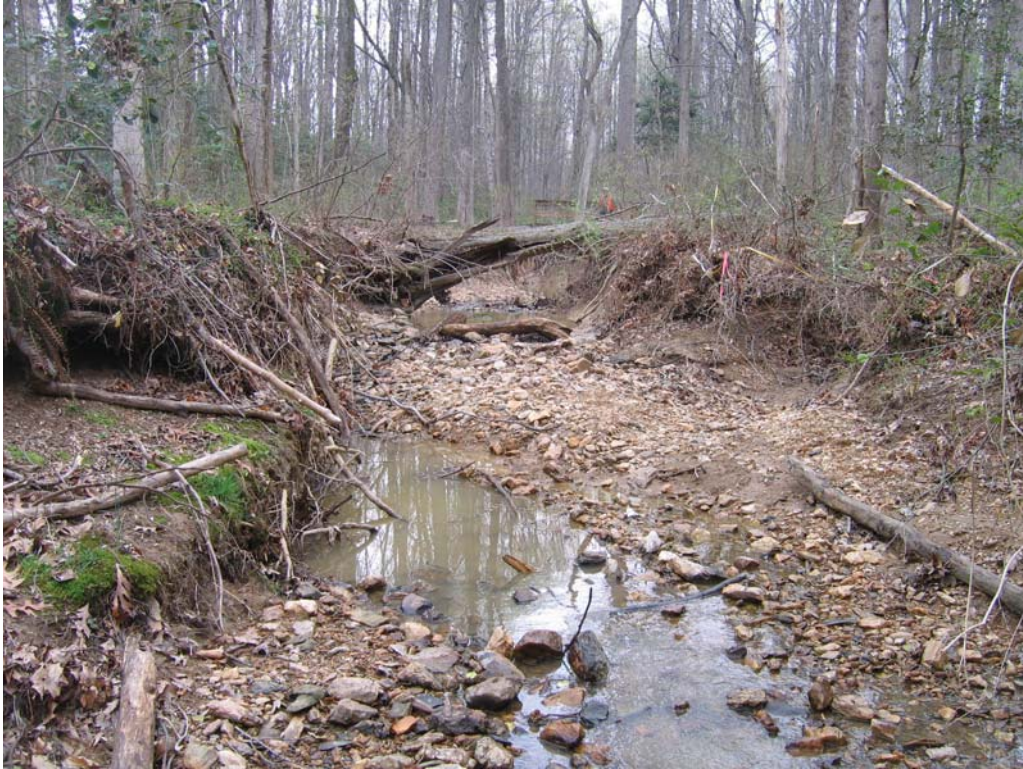
1. Looking northwest (upstream) at Reach 2-A of an unnamed tributary of Snakeden Branch on the eastern portion of the study area during the 2007 preconstruction fieldwork. Photograph taken April 2007.

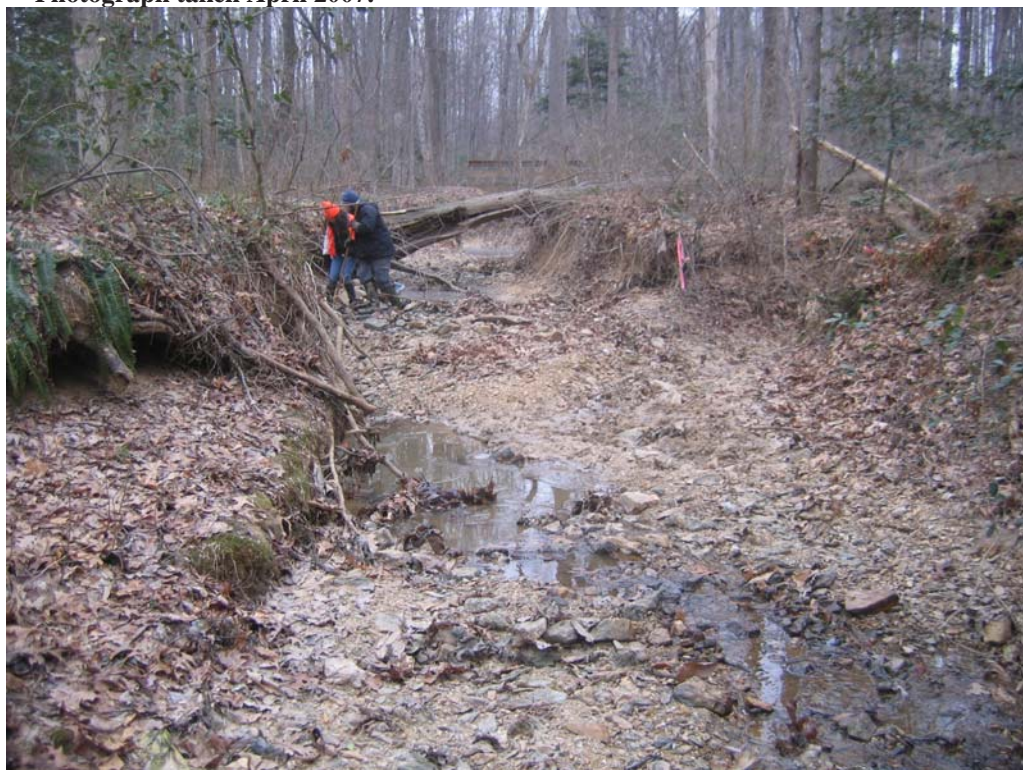
2. Looking northwest (upstream) at Reach 2-A of an unnamed tributary of Snakeden Branch on the eastern portion of the study area during the 2008 preconstruction fieldwork. Photograph taken February 2008.

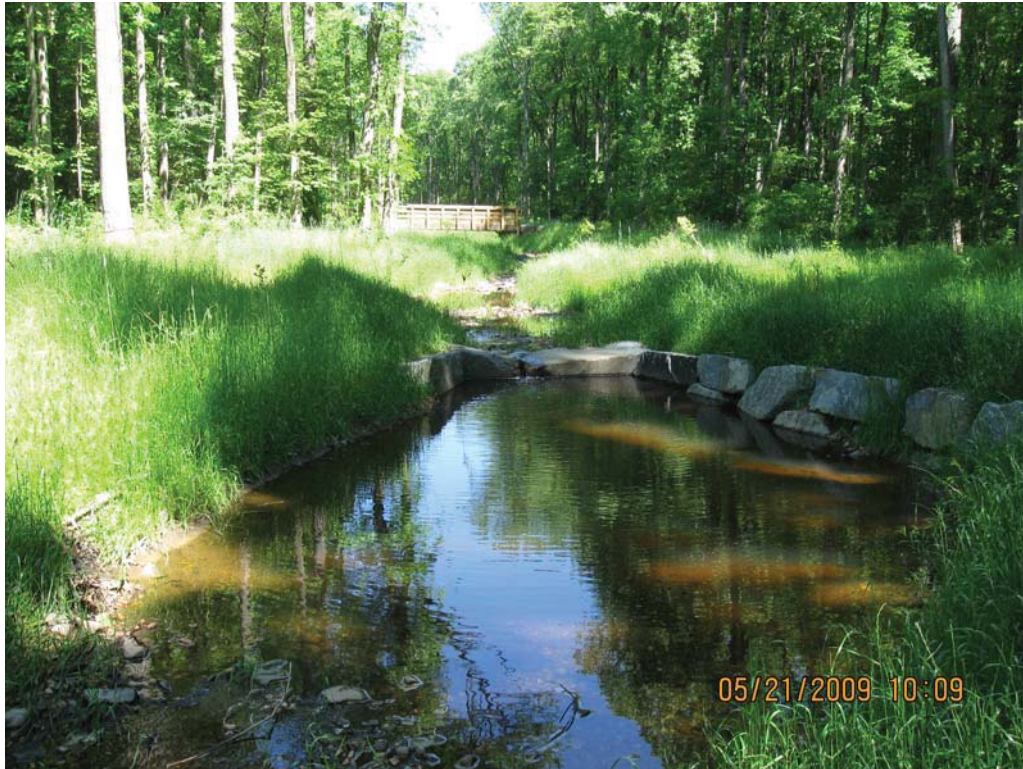
3. Looking northwest (upstream) at Reach 2-A of an unnamed tributary of Snakeden Branch on the eastern portion of the study area during the 2009 post construction, Year 1, fieldwork. Photograph taken May 2009.

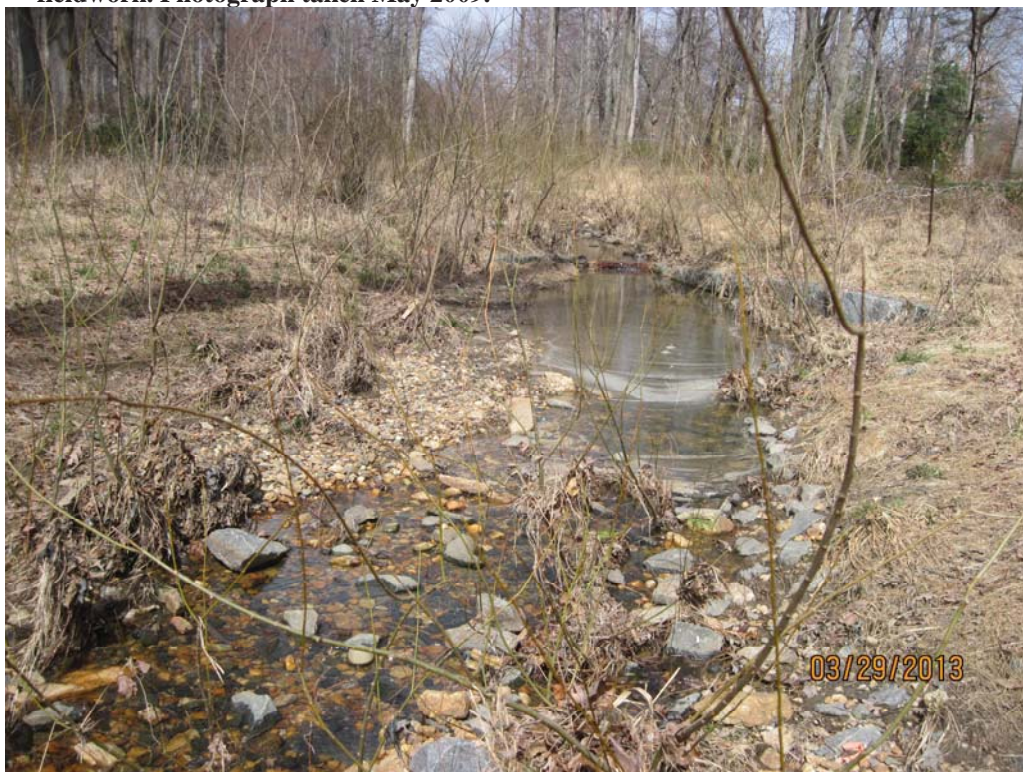
4. Looking northwest (upstream) at Reach 2-A of an unnamed tributary of Snakeden Branch on the eastern portion of the study area during the 2013 post construction, Year 5, fieldwork. Photograph taken March 2013.

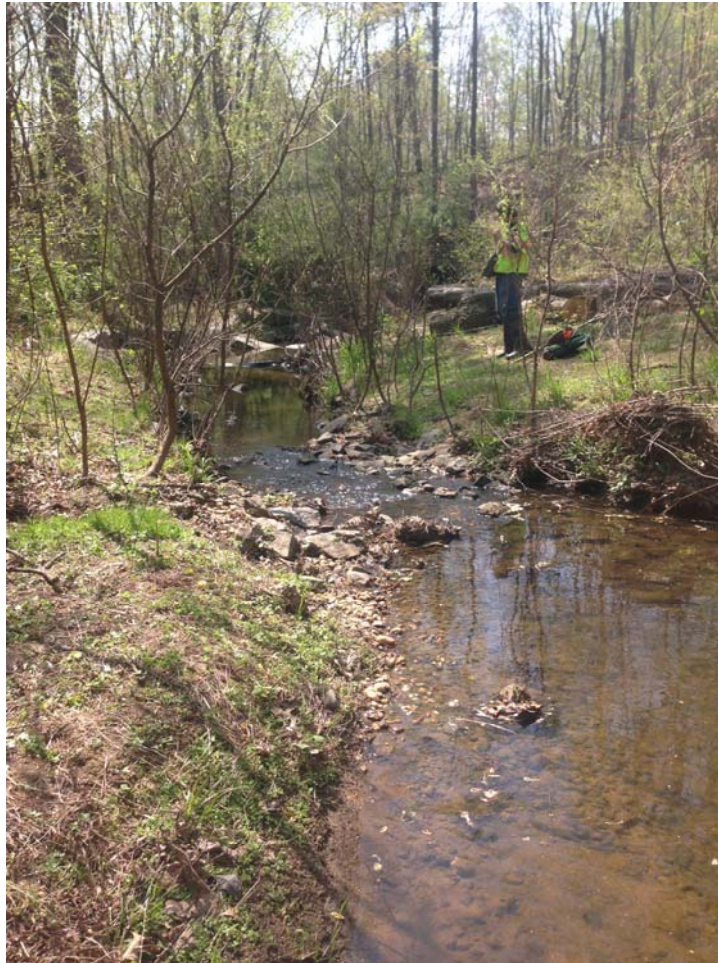
5. Looking northwest (downstream) at Reach 2-A of an unnamed tributary of Snakeden Branch on the eastern portion of the study area during the 2015 post construction, Year 7, fieldwork. Photograph taken April 2015.

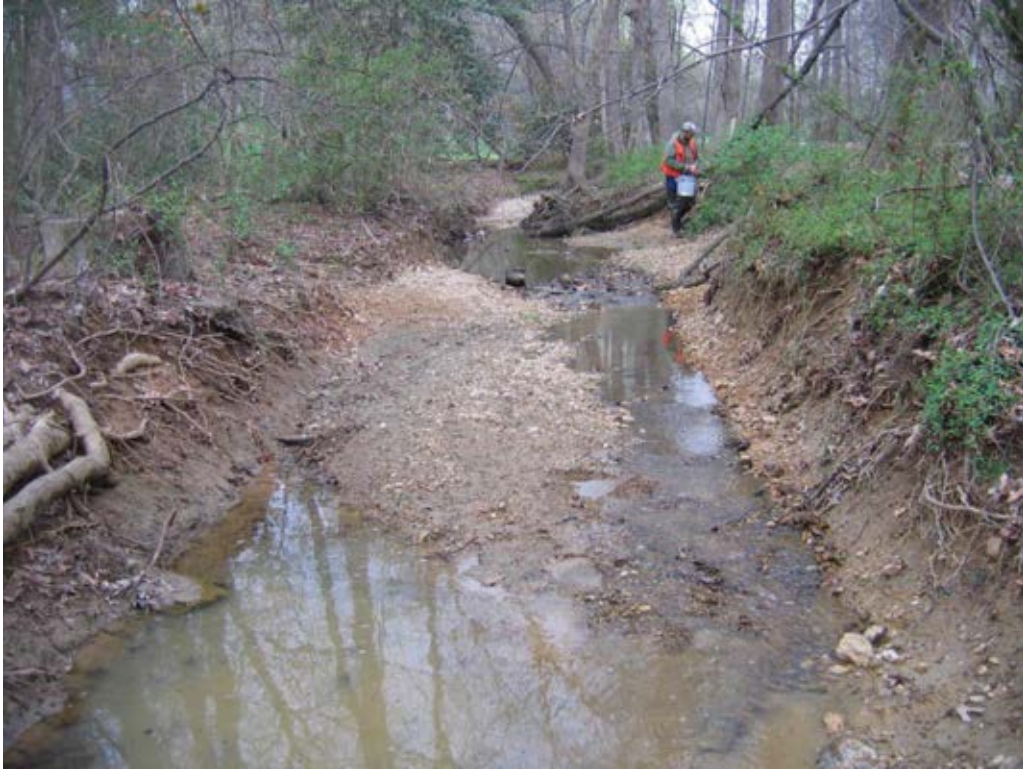
1. Looking northwest (upstream) at Reach 2-B of an unnamed tributary of Snakeden Branch on the eastern portion of the study area during the 2007 preconstruction fieldwork. Photograph taken April 2007.

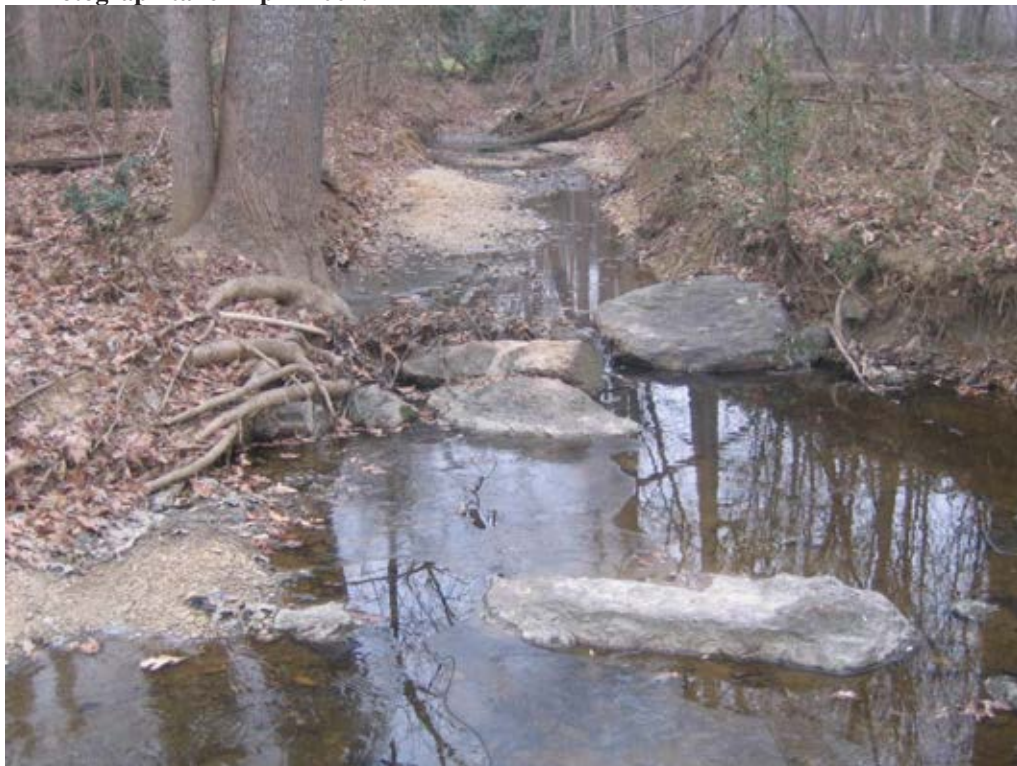
2. Looking northwest (upstream) at Reach 2-B of an unnamed tributary of Snakeden Branch on the eastern portion of the study area during the 2008 preconstruction fieldwork. Photograph taken February 2008.

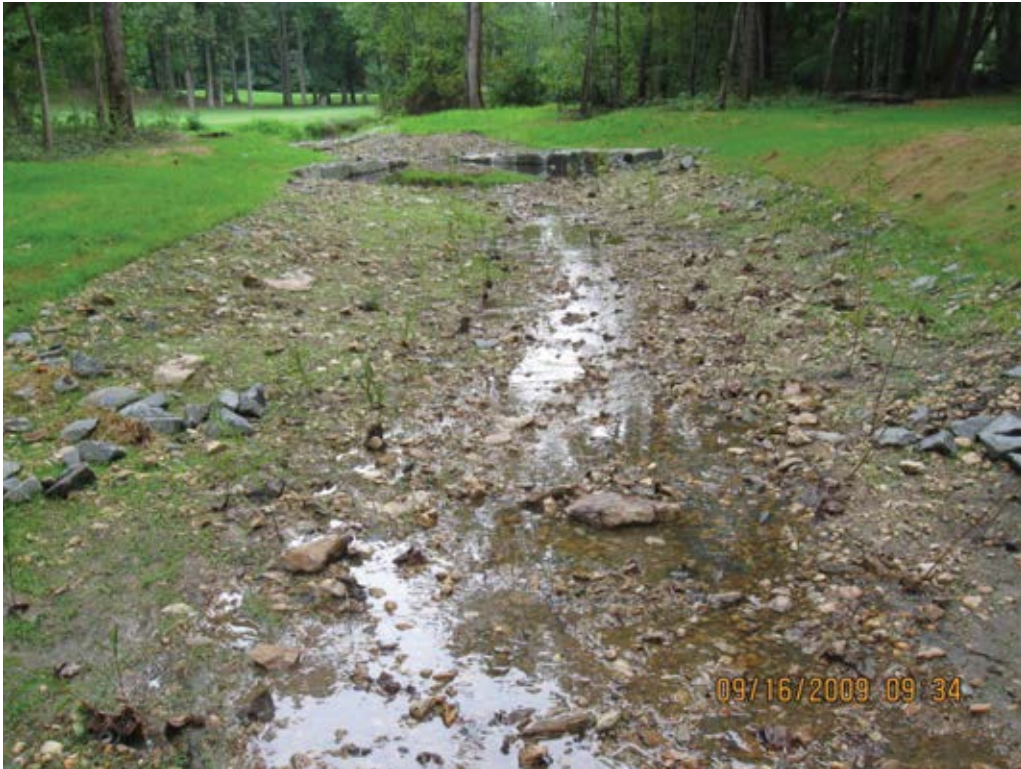
3. Looking northwest (upstream) at Reach 2-B of an unnamed tributary of Snakeden Branch on the eastern portion of the study area during the 2009 post construction, Year 1, fieldwork. Photograph taken September 16, 2009.

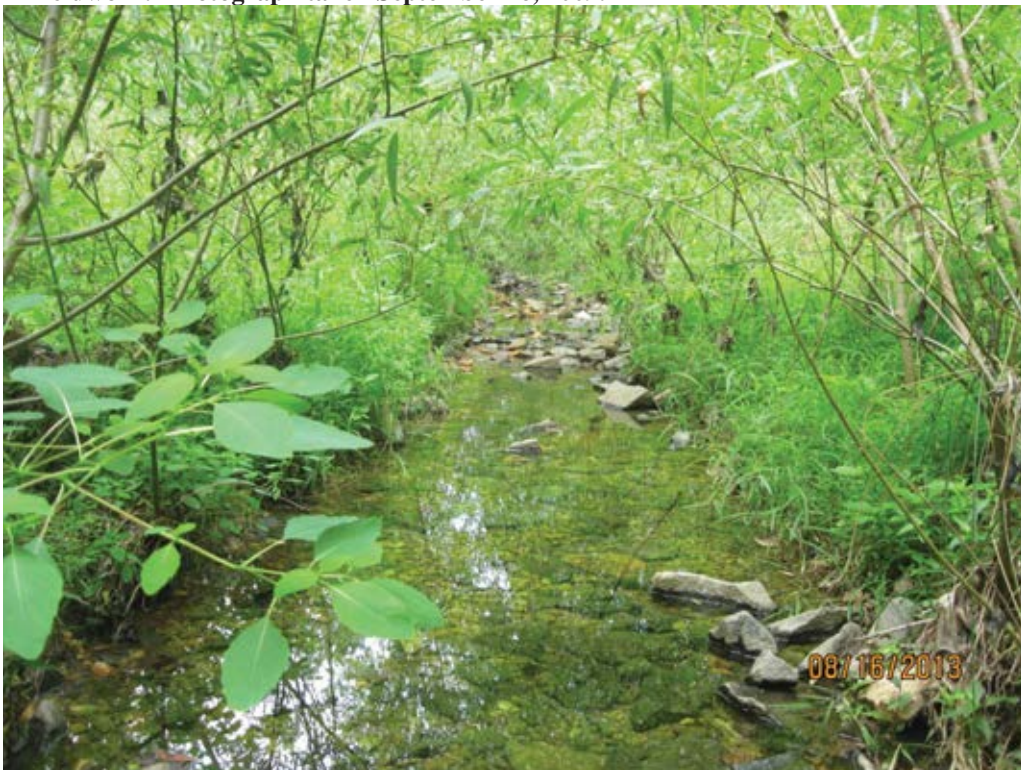
4. Looking northwest (upstream) at Reach 2-B of an unnamed tributary of Snakeden Branch on the eastern portion of the study area during the 2013 post construction, Year 5, fieldwork. Photograph taken August 2013.

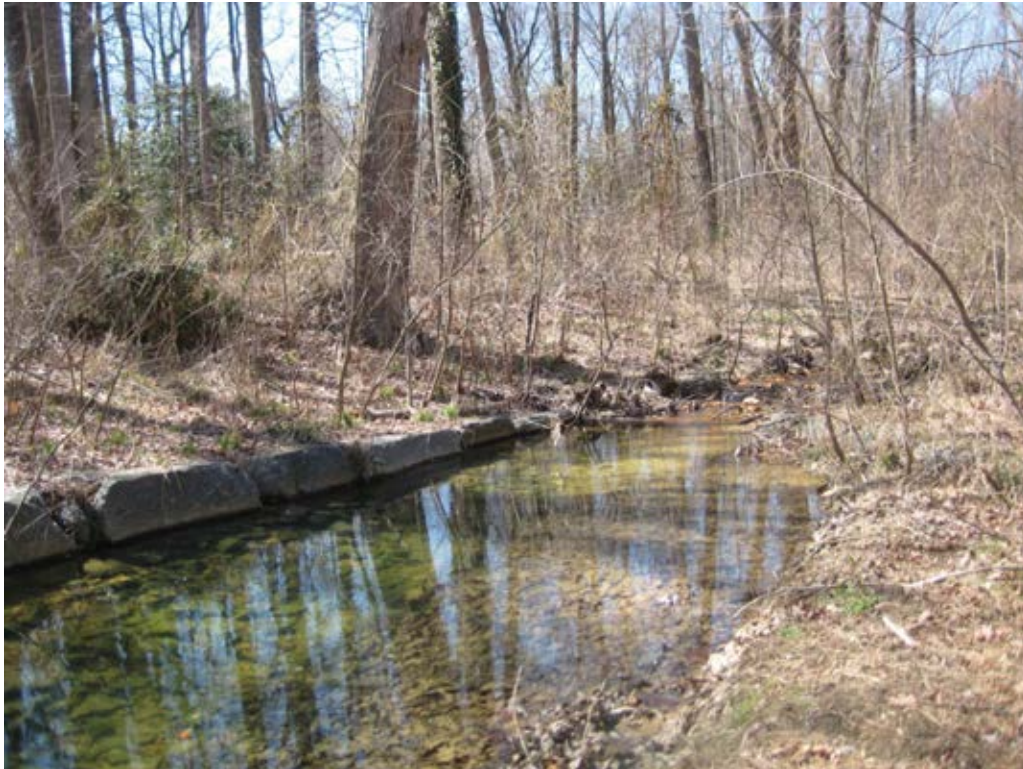
- 5. Looking northwest (upstream) at Reach 2-B of an unnamed tributary of Snakeden Branch on the eastern portion of the study area during the 2015 post construction, Year 7, fieldwork. Photograph taken April 2015.**

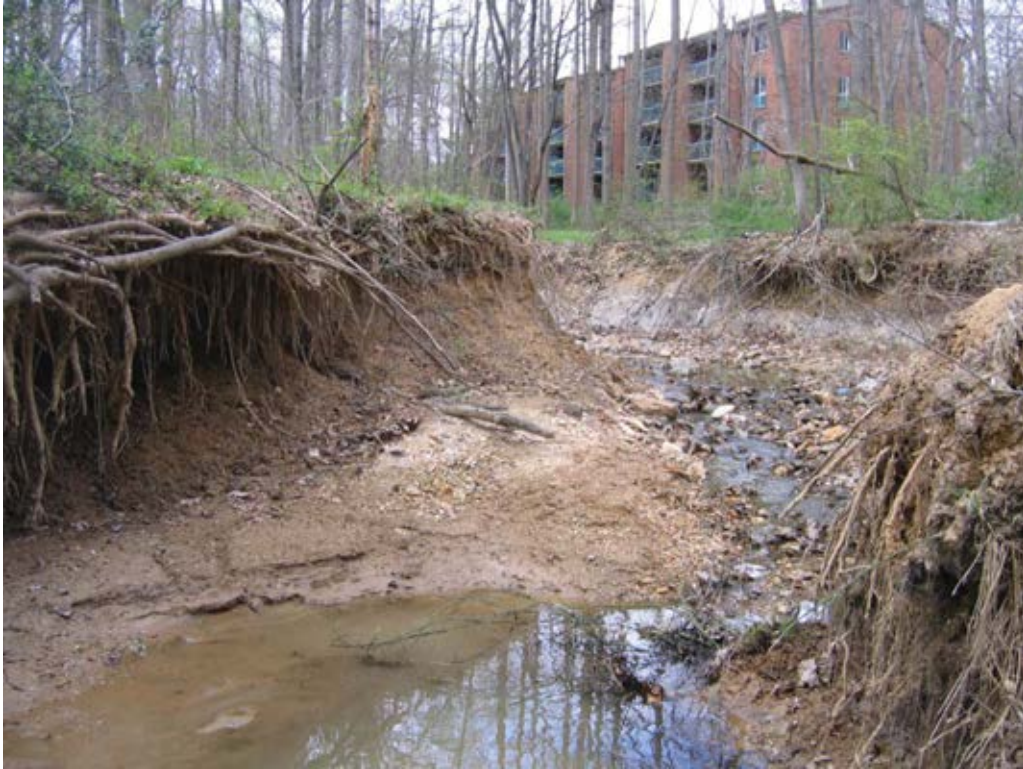
1. Looking west (upstream) at Reach 3-A, an unnamed tributary of Snakeden Branch on the western portion of the study area during the 2007 preconstruction fieldwork. Photograph taken April 2007.

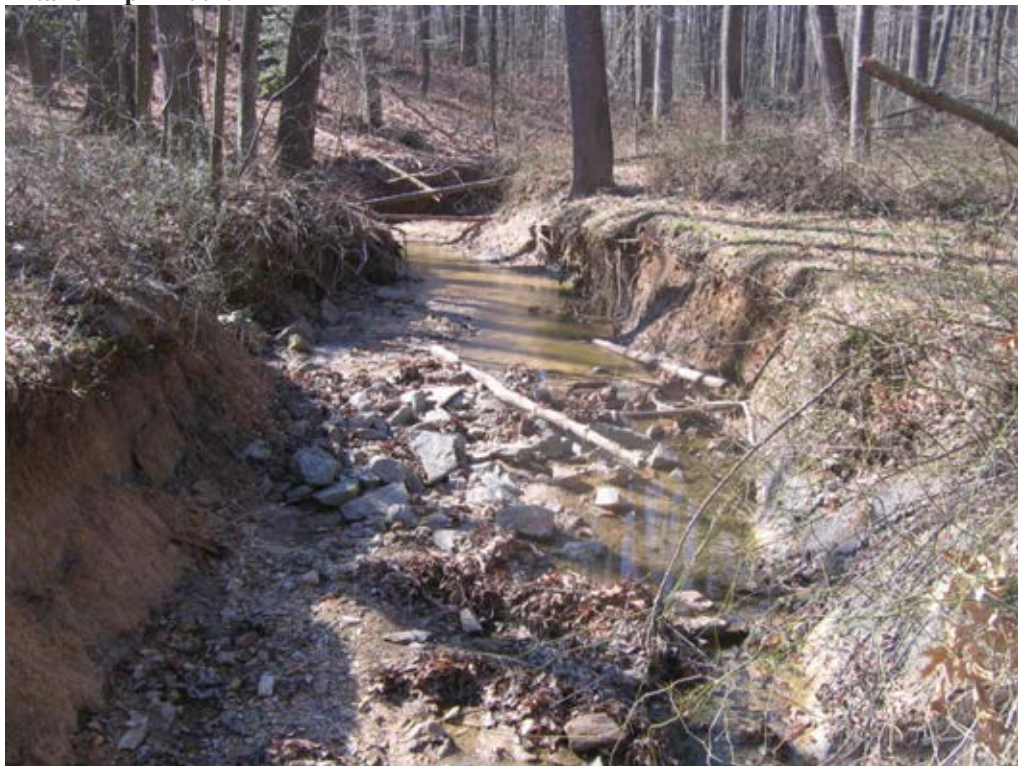
2. Looking west (upstream) at Reach 3-A, an unnamed tributary of Snakeden Branch on the western portion of the study area during the 2008 preconstruction fieldwork. Photograph taken February 2008.

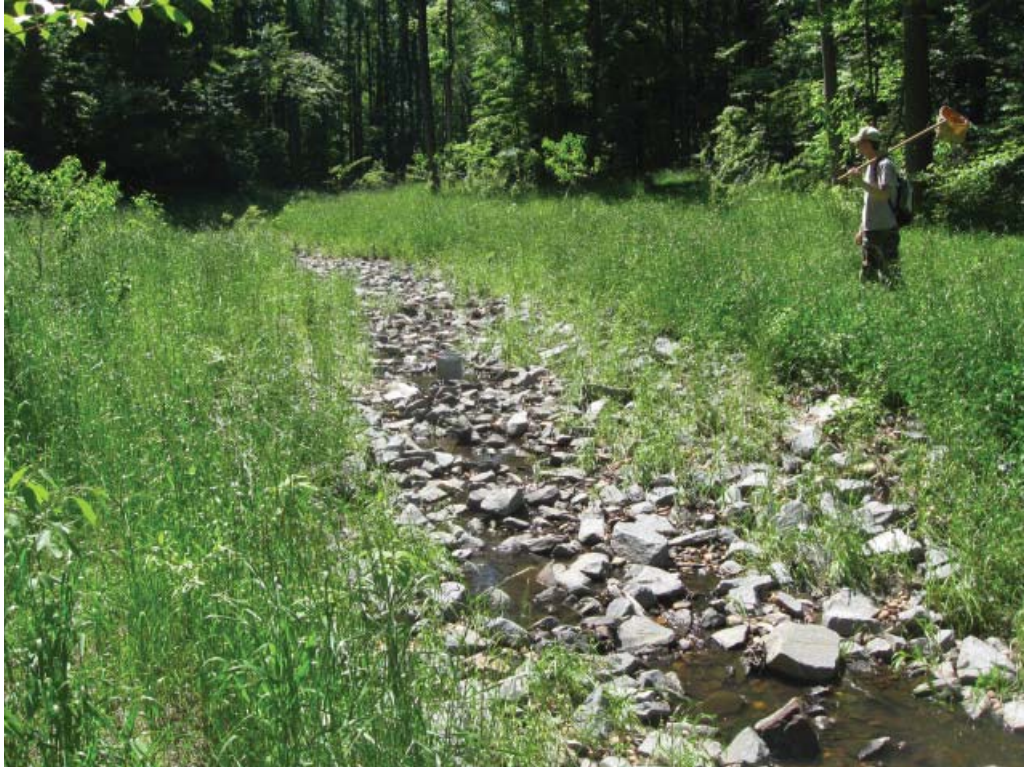
3. Looking west (upstream) at Reach 3-A, an unnamed tributary of Snakeden Branch on the western portion of the study area during the 2009 post construction, Year 1, fieldwork. Photograph taken May 2009.

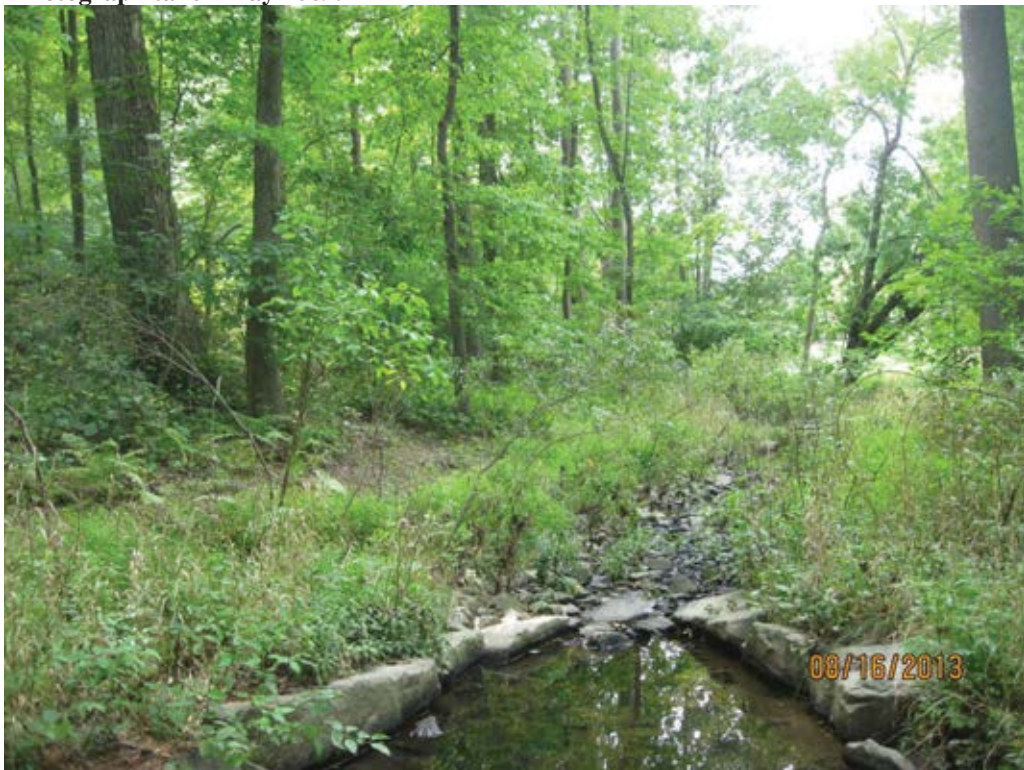
4. Looking west (upstream) at Reach 3-A, an unnamed tributary of Snakeden Branch on the western portion of the study area during the 2013 post construction, Year 5, fieldwork. Photograph taken August 2013.

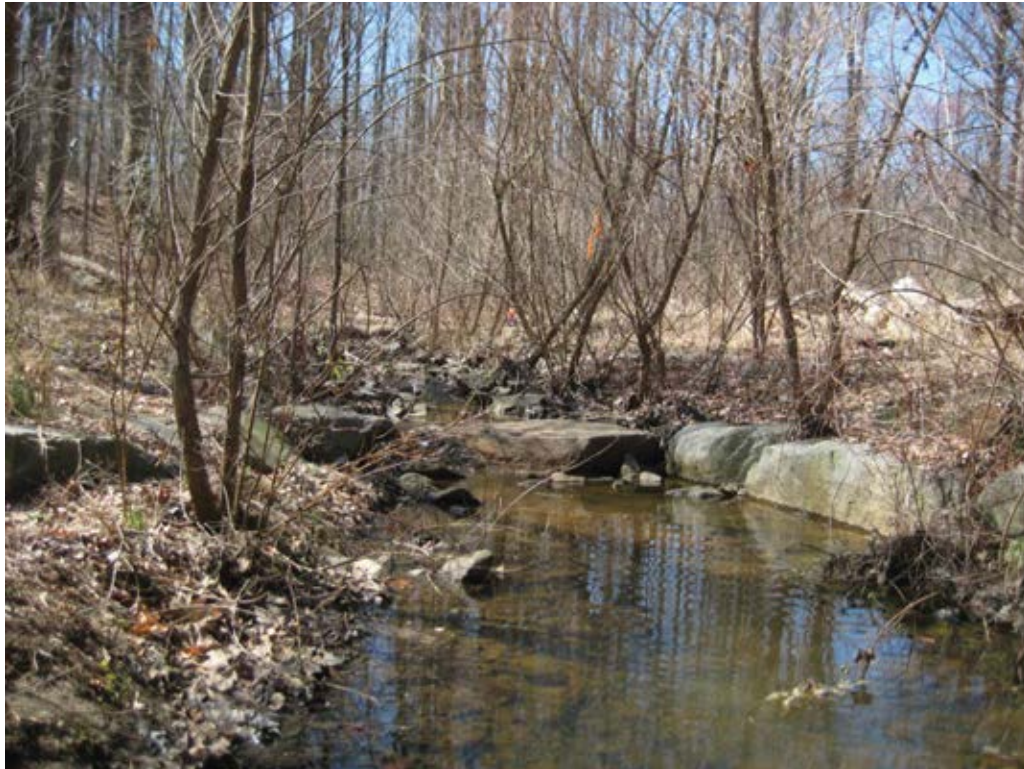
5. Looking west (upstream) at Reach 3-A, an unnamed tributary of Snakeden Branch on the western portion of the study area during the 2015 post construction, Year 7, fieldwork. Photograph taken April 2015.
