Northern Virginia Stream Restoration Bank
 Colvin Run - Forest Edge South
 Fairfax County, Virginia

Grading Plan and Longitudinal Profile

Sheet #
 6A of 70

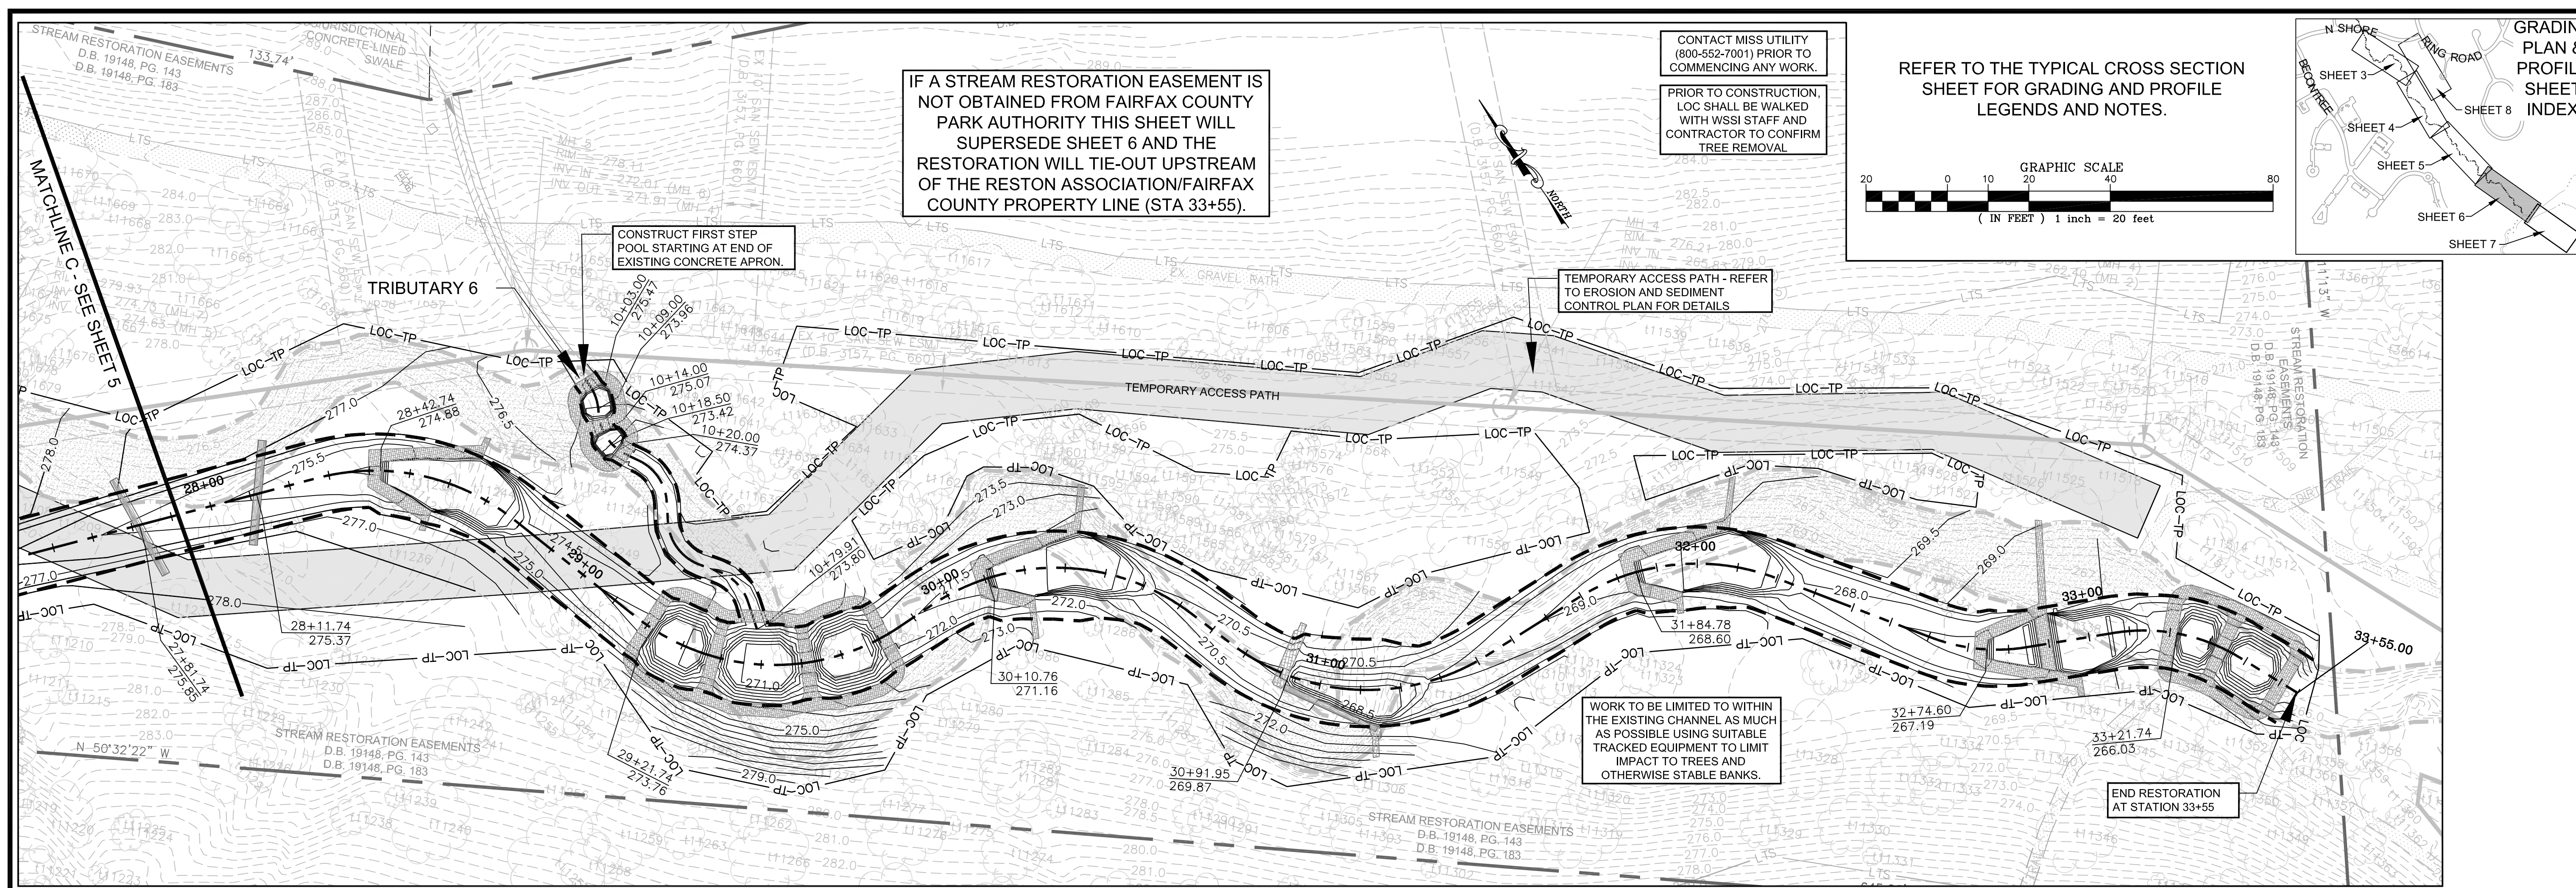
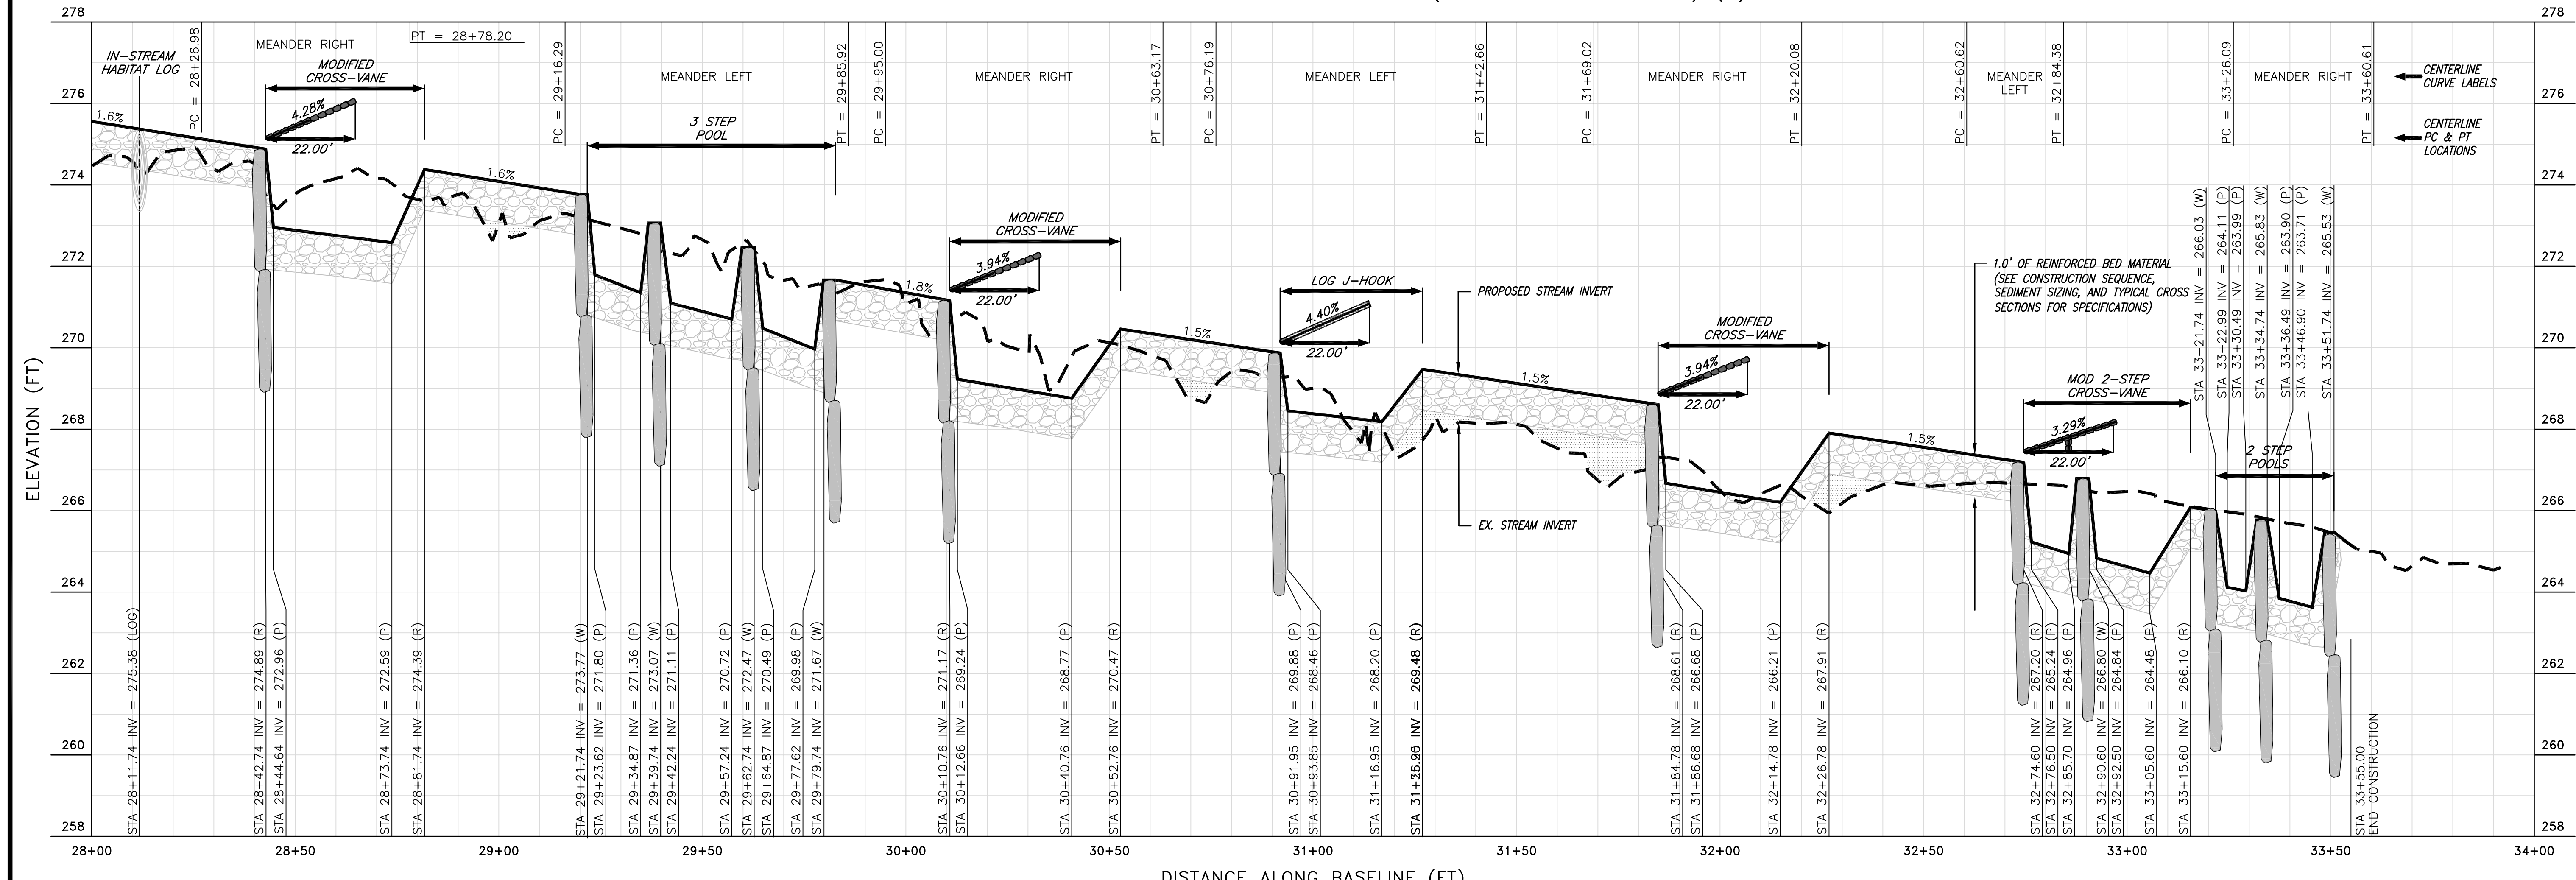
LONGITUDINAL PROFILE - FOREST EDGE SOUTH (STA 28+00 TO 34+00) (1)

LONGITUDINAL PROFILE
 H: 1" = 20'
 V: 1" = 2'
