NORTHERN VIRGINIA STREAM RESTORATION BANK
THE GLADE - REACH 4A

Fairfax County, Virginia

Preliminary Plan

Sheet #
2 of 3

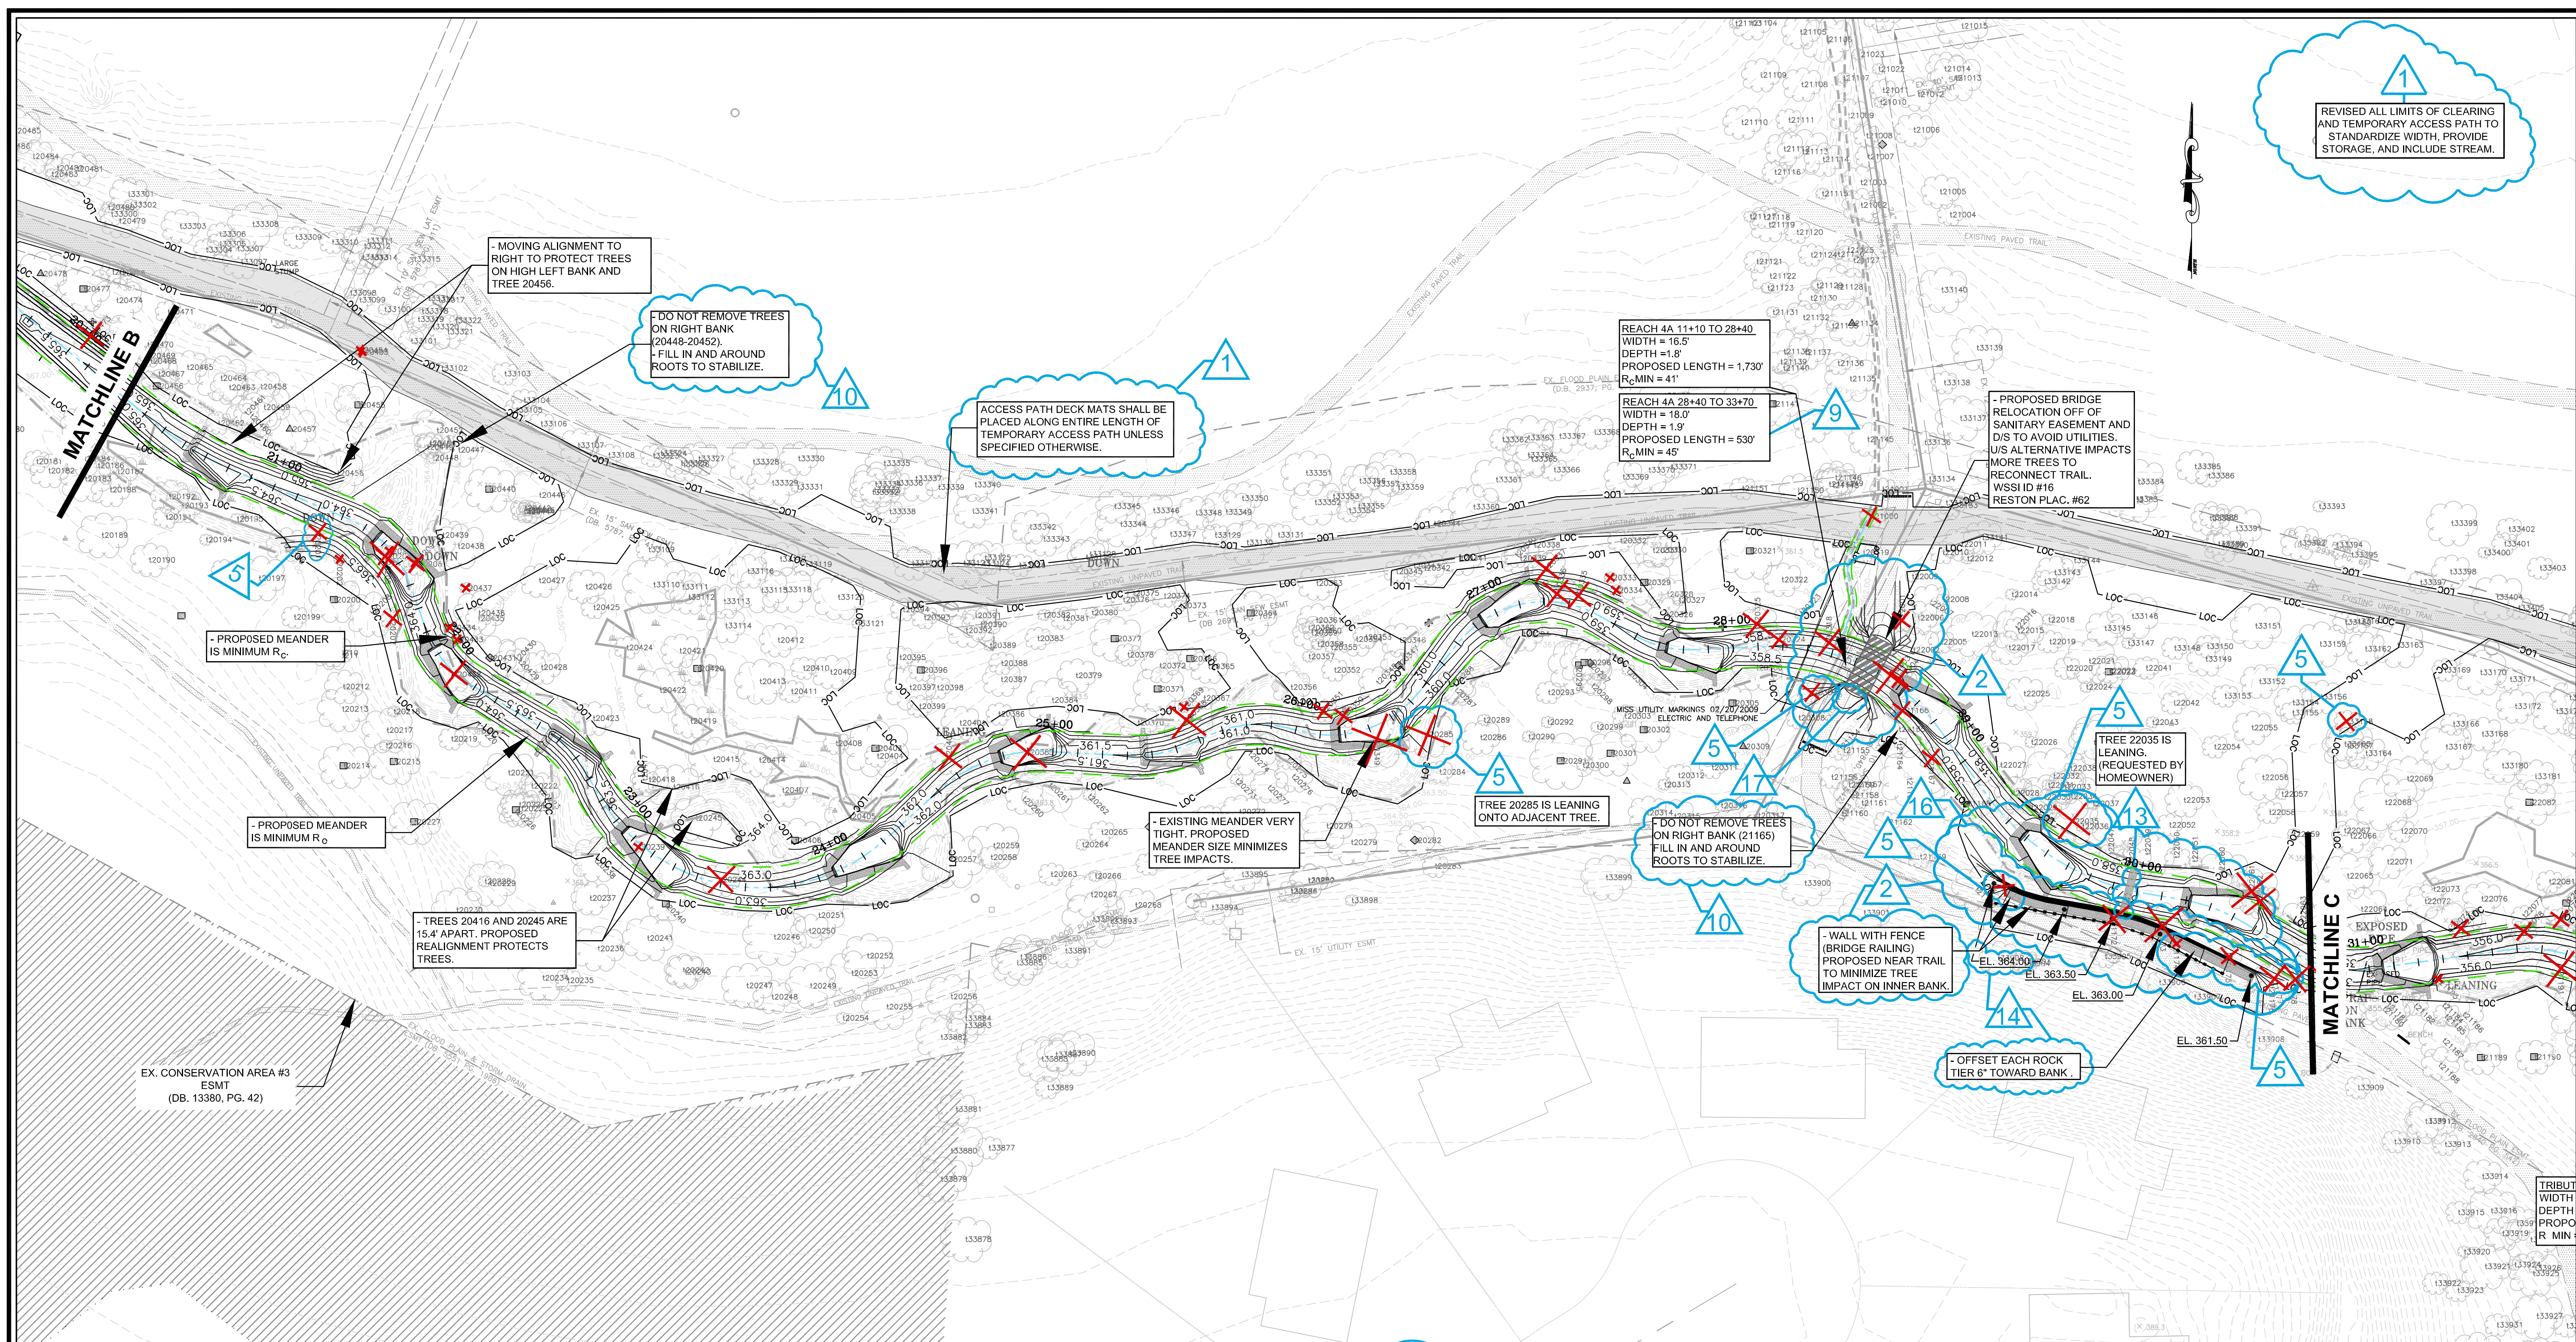
10
DO NOT REMOVE TREES ON RIGHT BANK (20449-20452). FILL IN AND AROUND ROOTS TO STABILIZE.

9
REACH 4A 11+10 TO 28+40. WIDTH = 16.5', DEPTH = 1.8', PROPOSED LENGTH = 1,730', R_c MIN = 41'

9
REACH 4A 28+40 TO 33+70. WIDTH = 18.0', DEPTH = 1.9', PROPOSED LENGTH = 530', R_c MIN = 45'

PROPOSED BRIDGE RELOCATION OFF OF SANITARY EASEMENT AND D/S TO AVOID UTILITIES. U/S ALTERNATIVE IMPACTS MORE TREES TO RECONNECT TRAIL. WSSI ID #16 RESTON PLAC. #62

TREES 20416 AND 20425 ARE 15.4' APART. PROPOSED REALIGNMENT PROTECTS TREES.

EXISTING MEANDER VERY TIGHT. PROPOSED MEANDER SIZE MINIMIZES TREE IMPACTS.

10
DO NOT REMOVE TREES ON RIGHT BANK (21165) FILL IN AND AROUND ROOTS TO STABILIZE.

5
WALL WITH FENCE (BRIDGE RAILING) PROPOSED NEAR TRAIL TO MINIMIZE TREE IMPACT ON INNER BANK.

14
OFFSET EACH ROCK TIER 6' TOWARD BANK.

6
STREAM LENGTH:
REACH 4A = 2,417'
TRIBUTARY 1 = 307'
TRIBUTARY 2 = 233'
TOTAL = 2,957'
