NORTHERN VIRGINIA STREAM RESTORATION BANK
THE GLADE - REACH 6
 Fairfax County, Virginia

Preliminary Plan

REVISED LIMITS OF CLEARING AND TEMPORARY ACCESS PATH

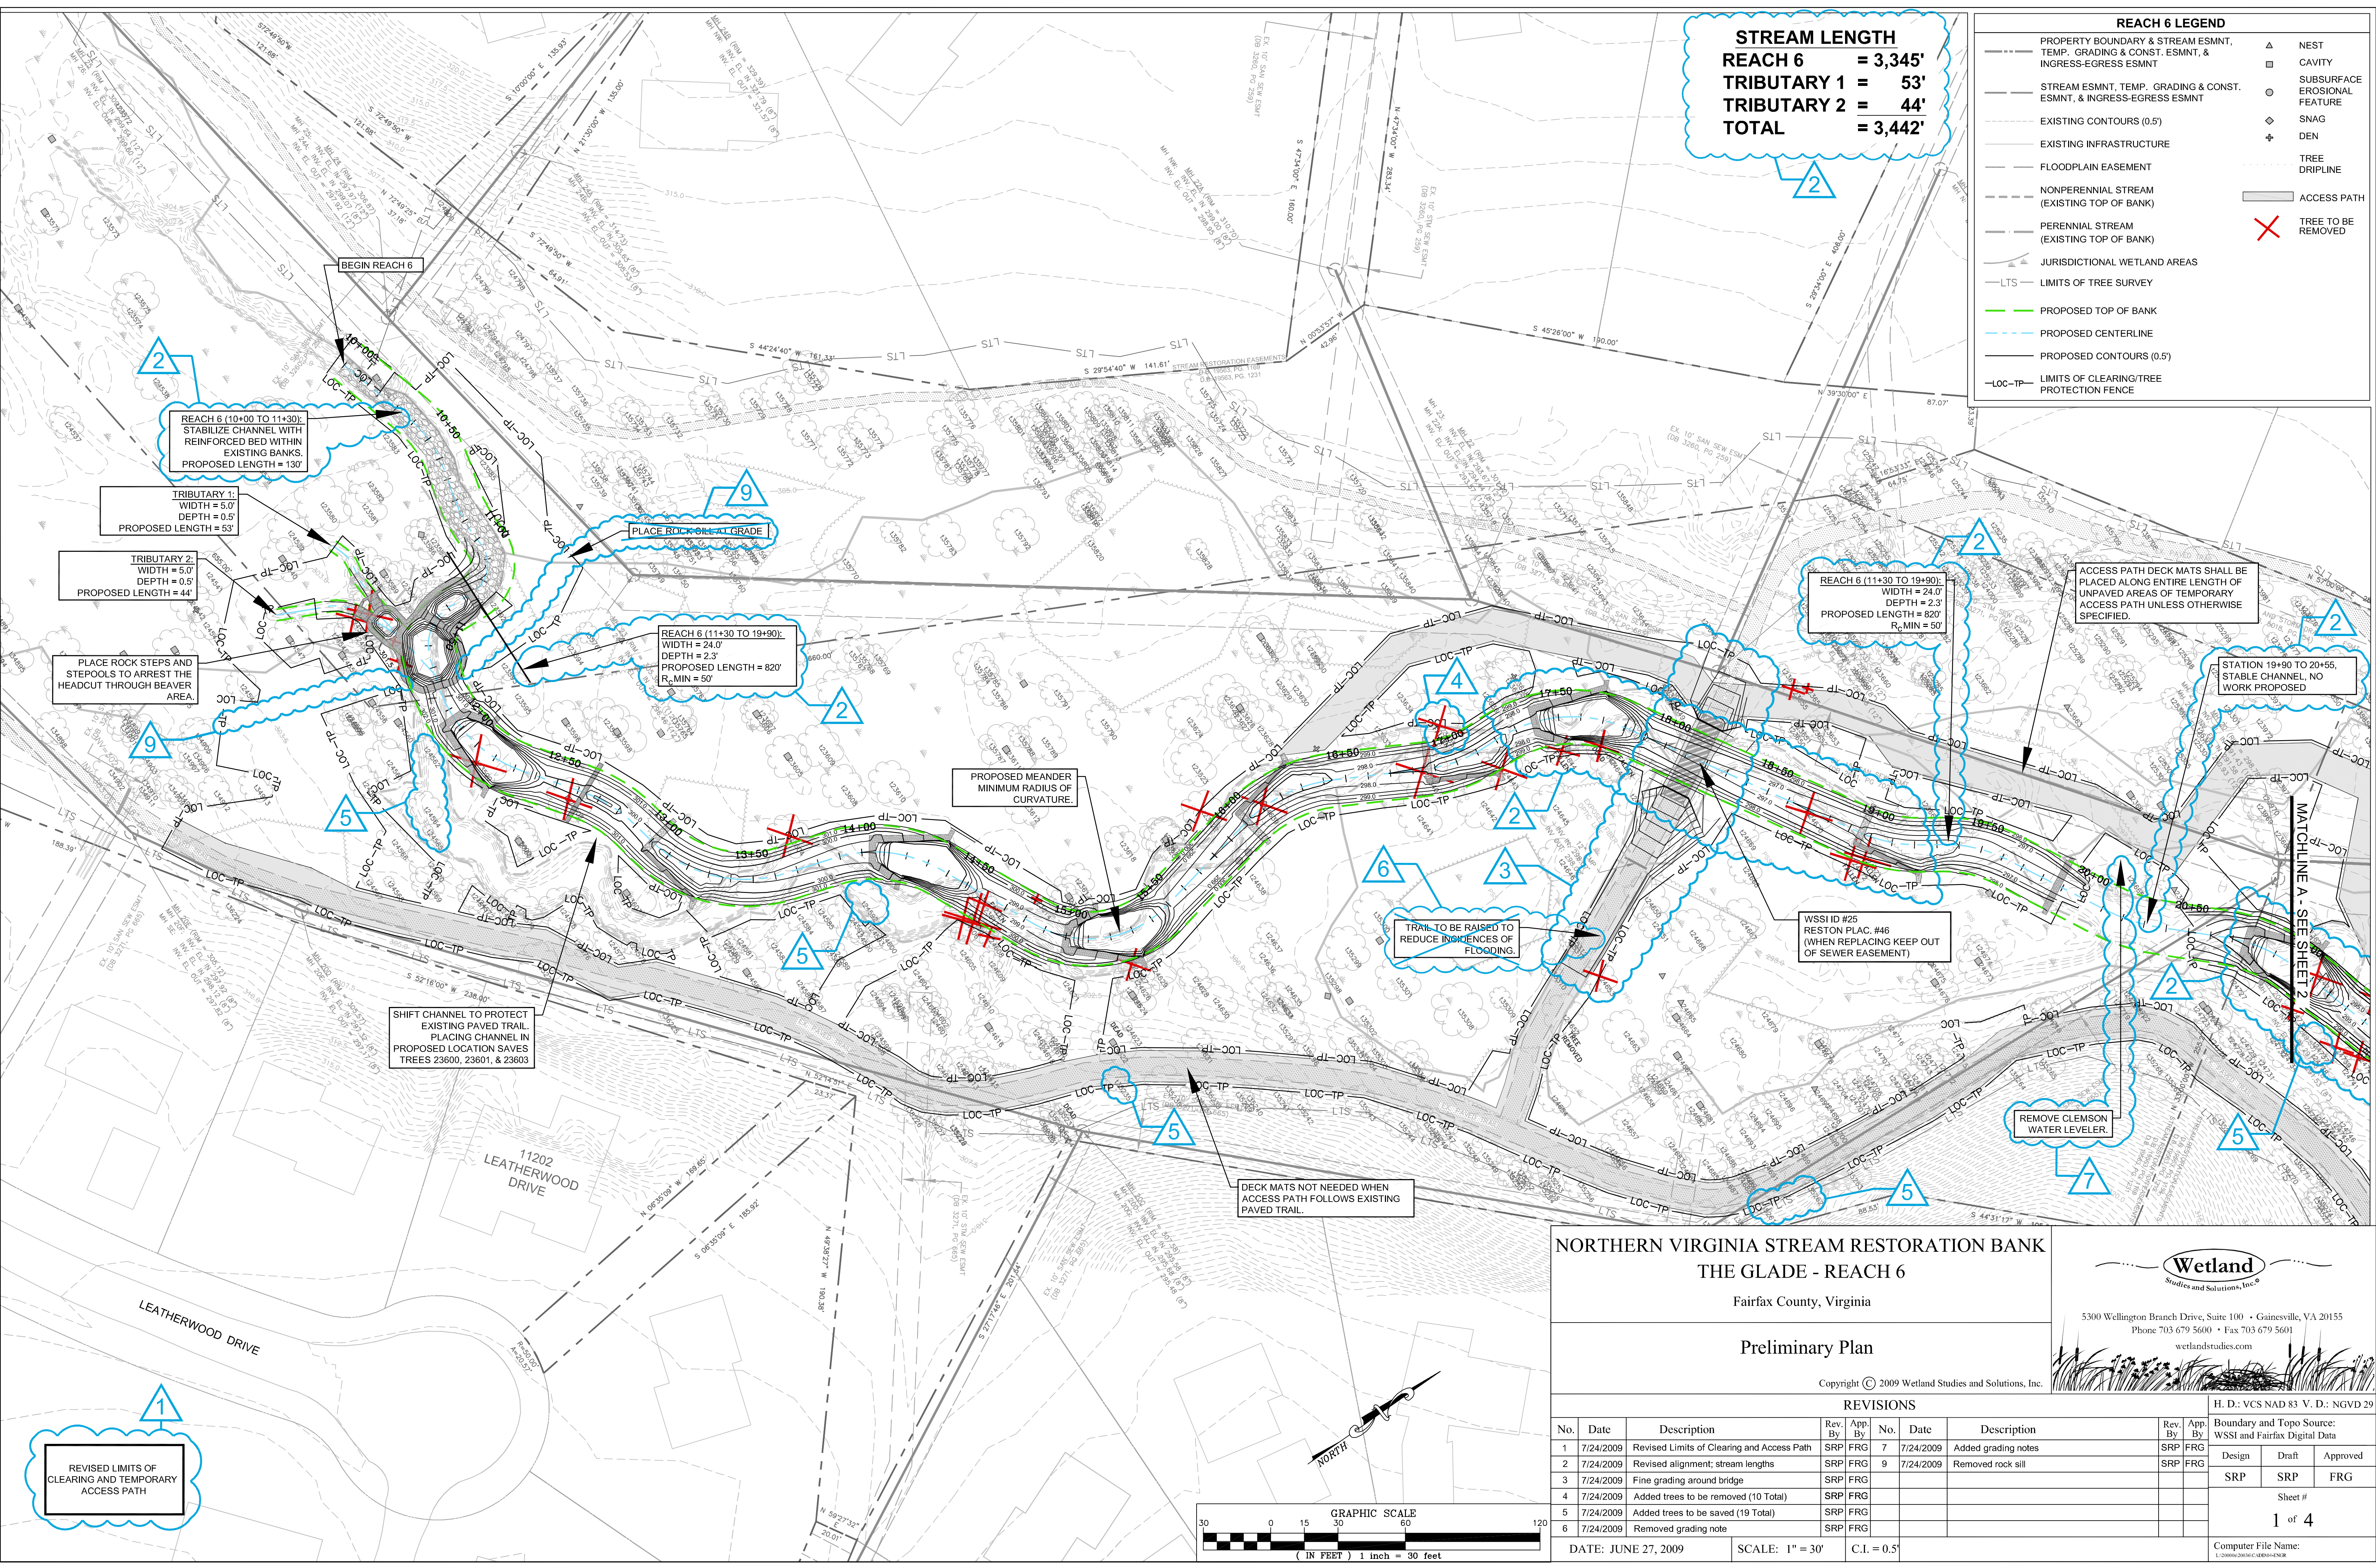
STREAM LENGTH
REACH 6 = 3,345'
TRIBUTARY 1 = 53'
TRIBUTARY 2 = 44'
TOTAL = 3,442'
