# **Northern Virginia Stream Restoration Bank- The Glade-Reaches 1 and 1A** Fairfax County, Virginia

WSSI #20030, Task I6

**Mitigation Monitoring Report** Seventh Growing Season (2015)

November 20, 2015

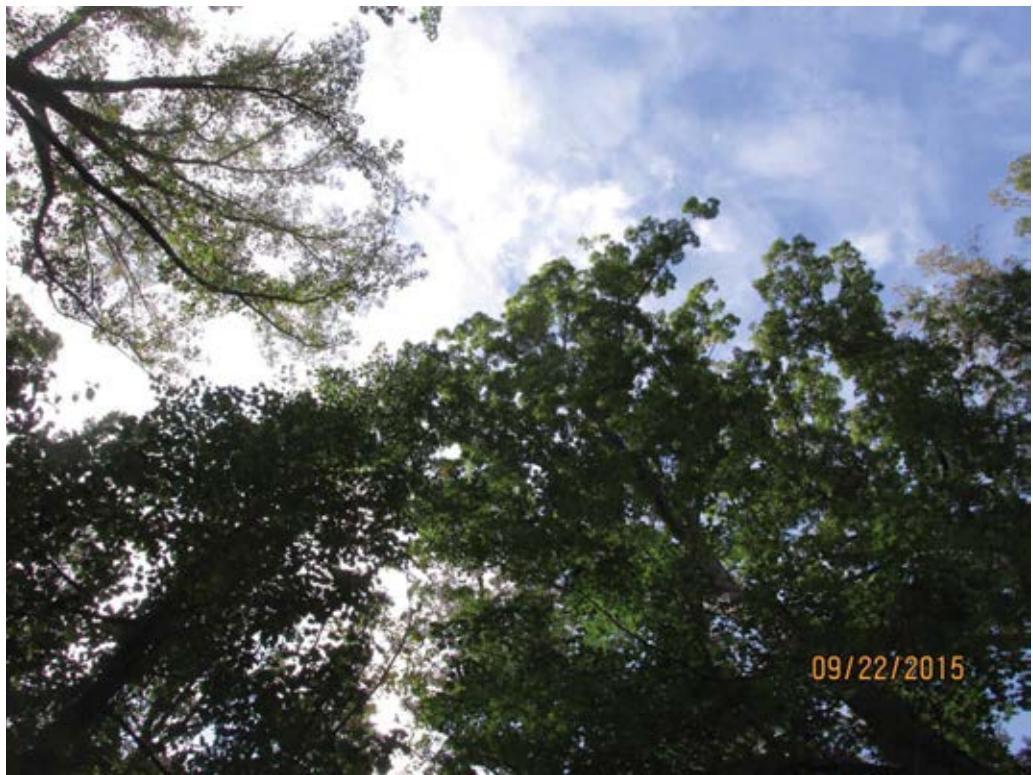
1. Monitoring station 1: Looking at canopy cover.

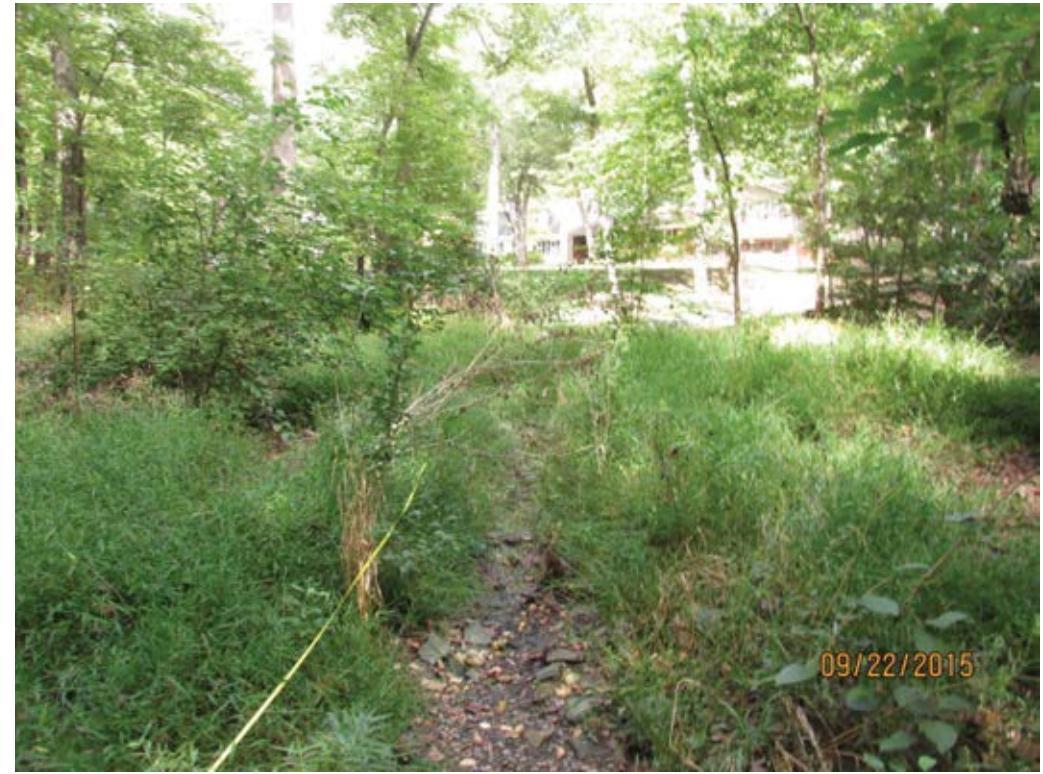
2. Monitoring station 1: Looking upstream.

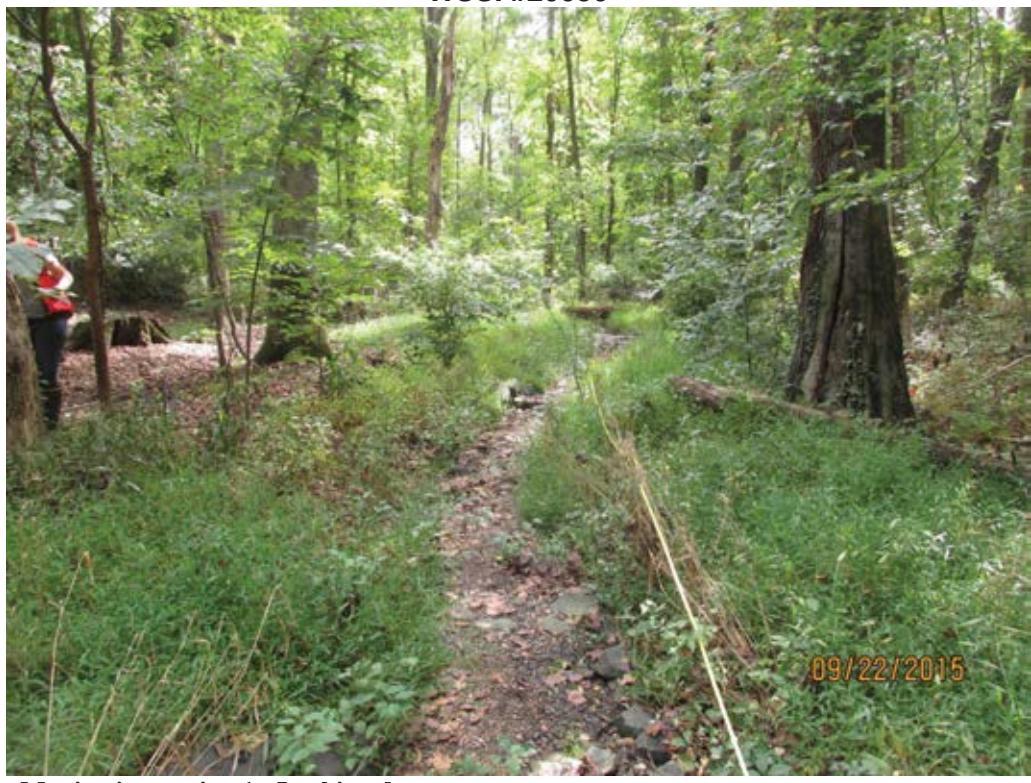
3. Monitoring station 1: Looking downstream.

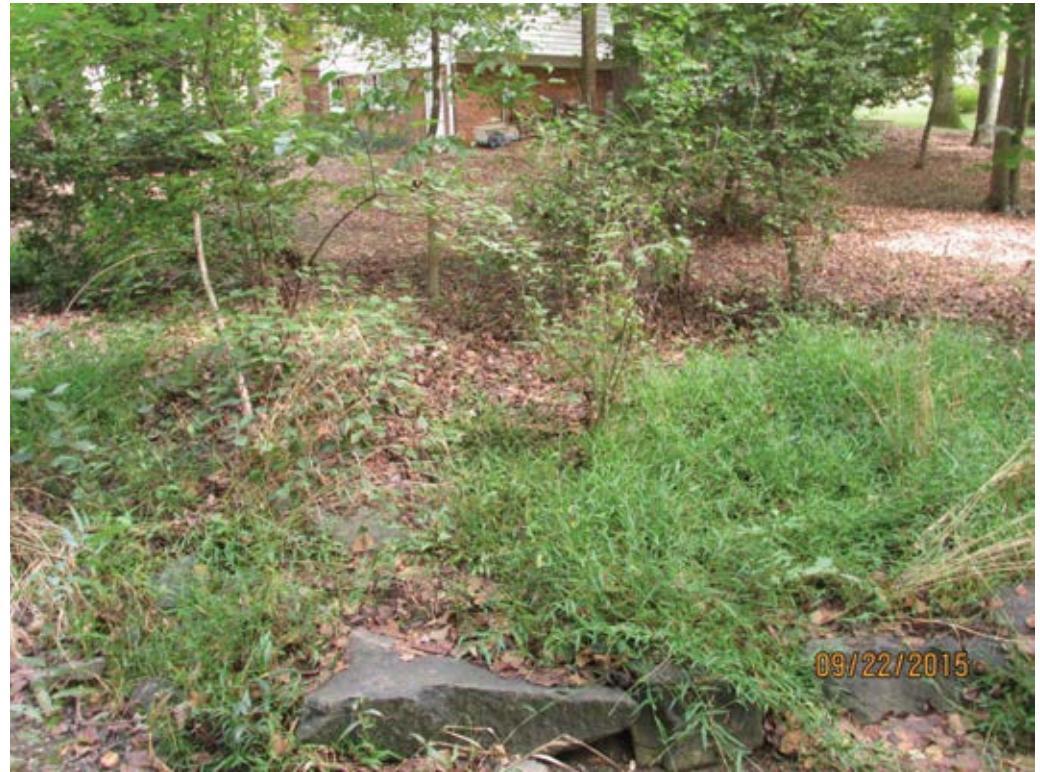
4. Monitoring station 1: Looking at the left bank.

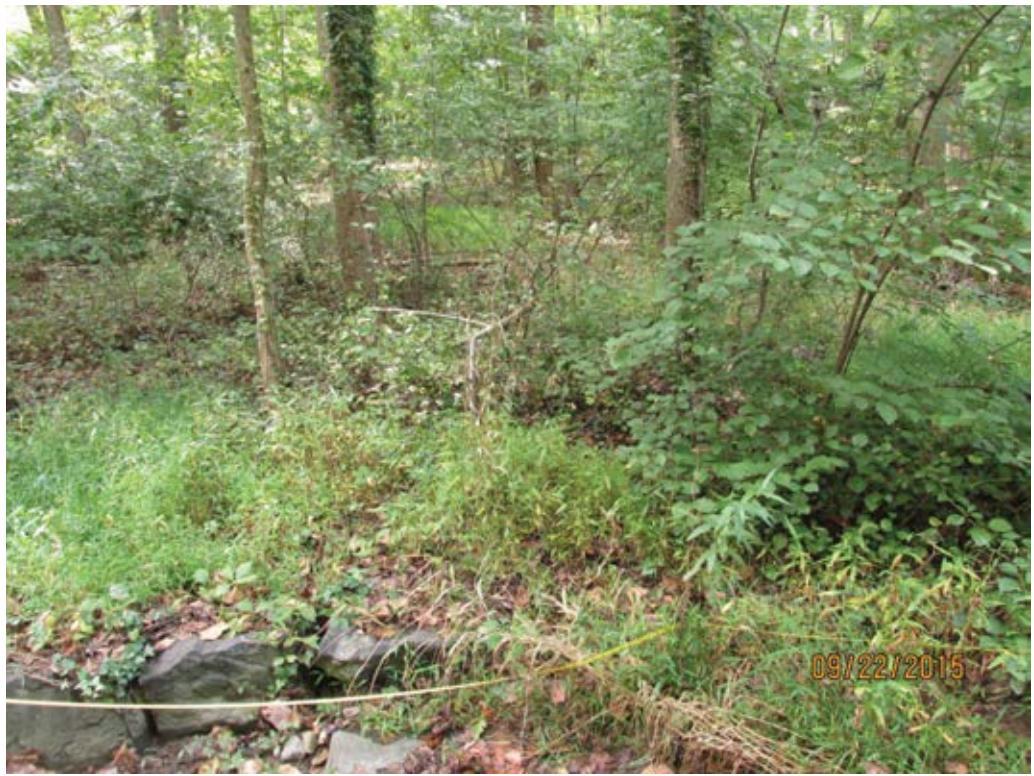
5. Monitoring station 1: Looking at the right bank.

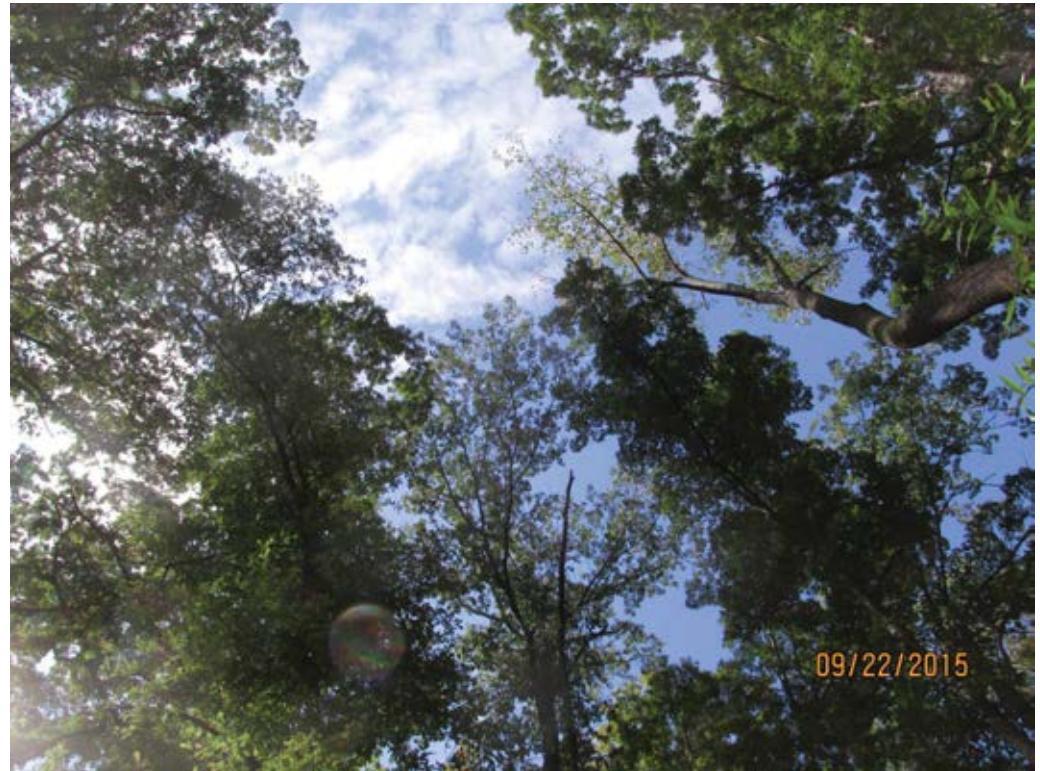
6. Monitoring station 2: Looking at canopy cover.

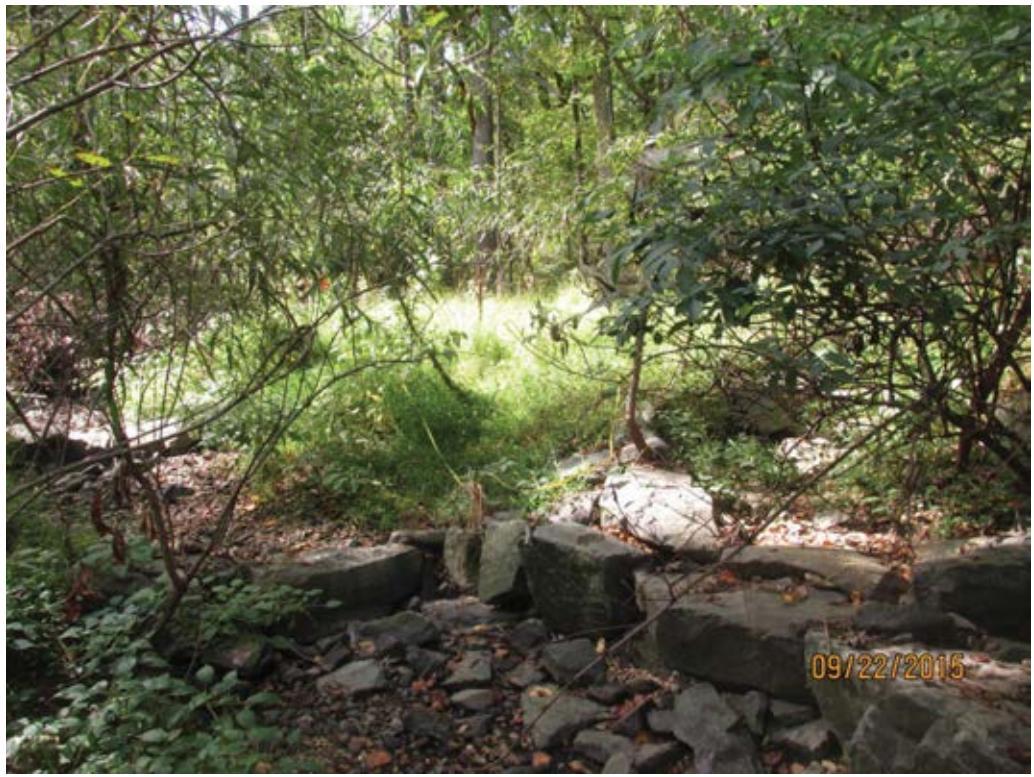
7. Monitoring station 2: Looking upstream.

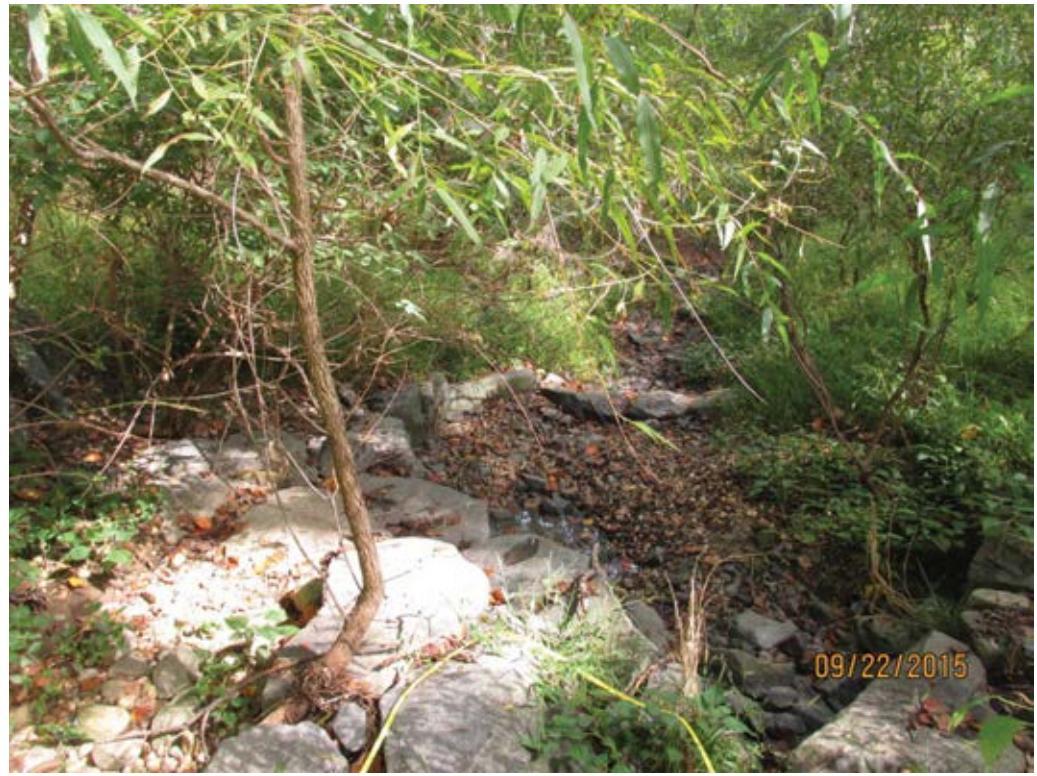
8. Monitoring station 2: Looking downstream.

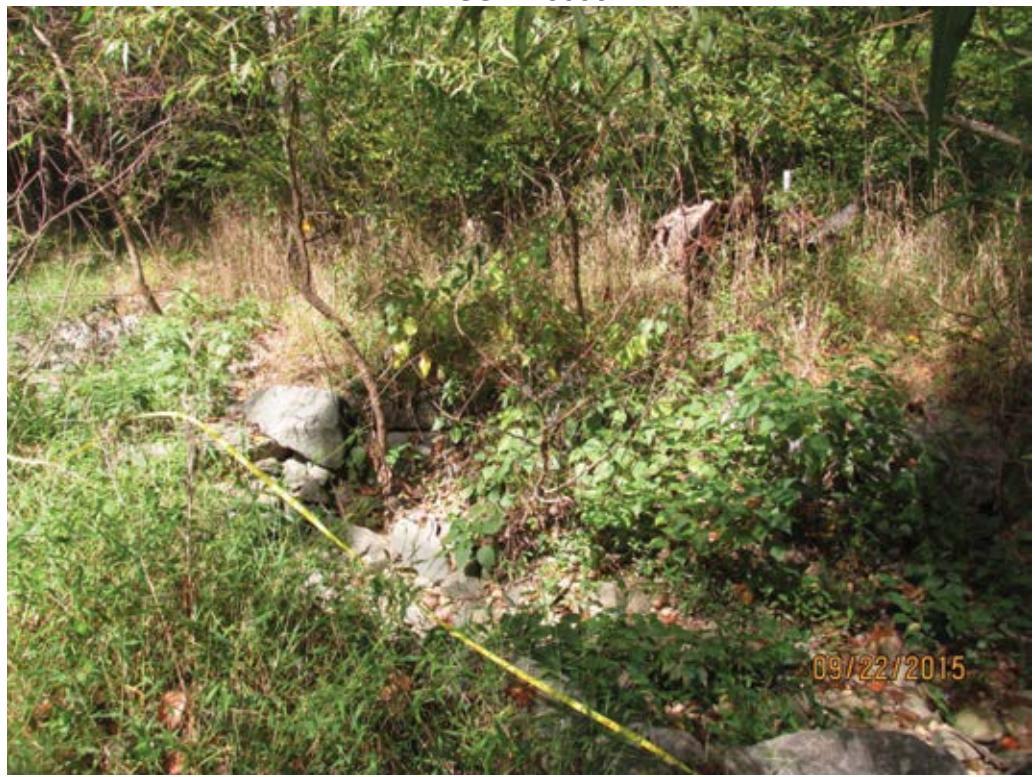
9. Monitoring station 2: Looking at the left bank.

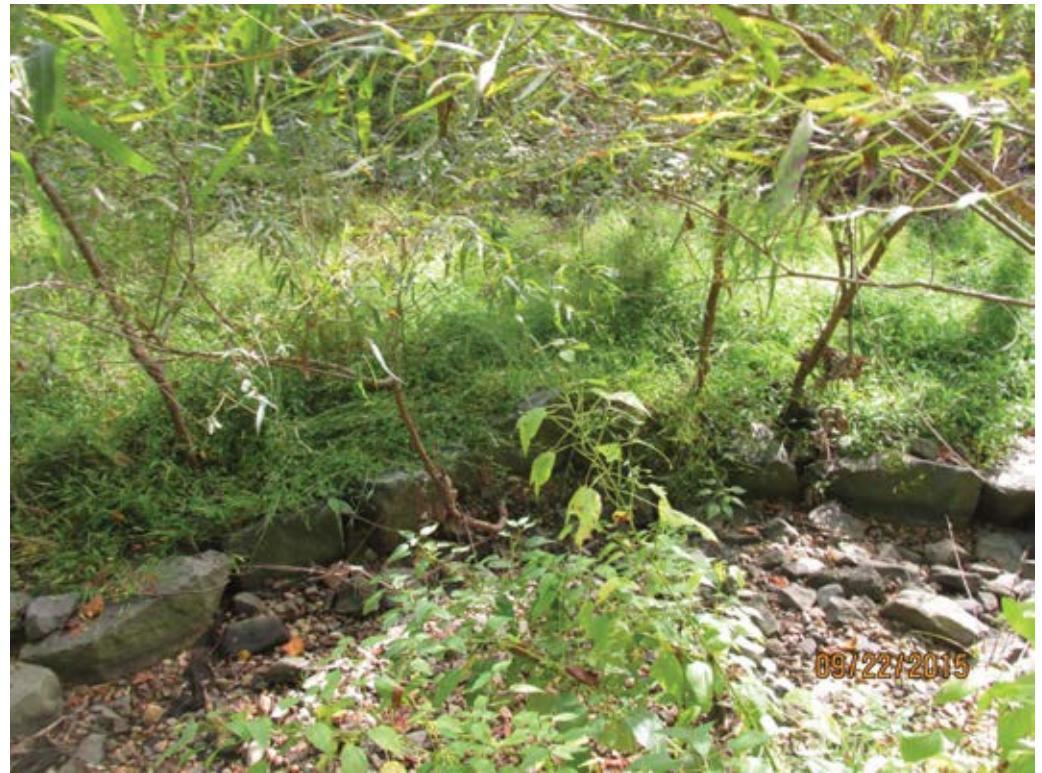
**10.** Monitoring station 2: Looking at the right bank.

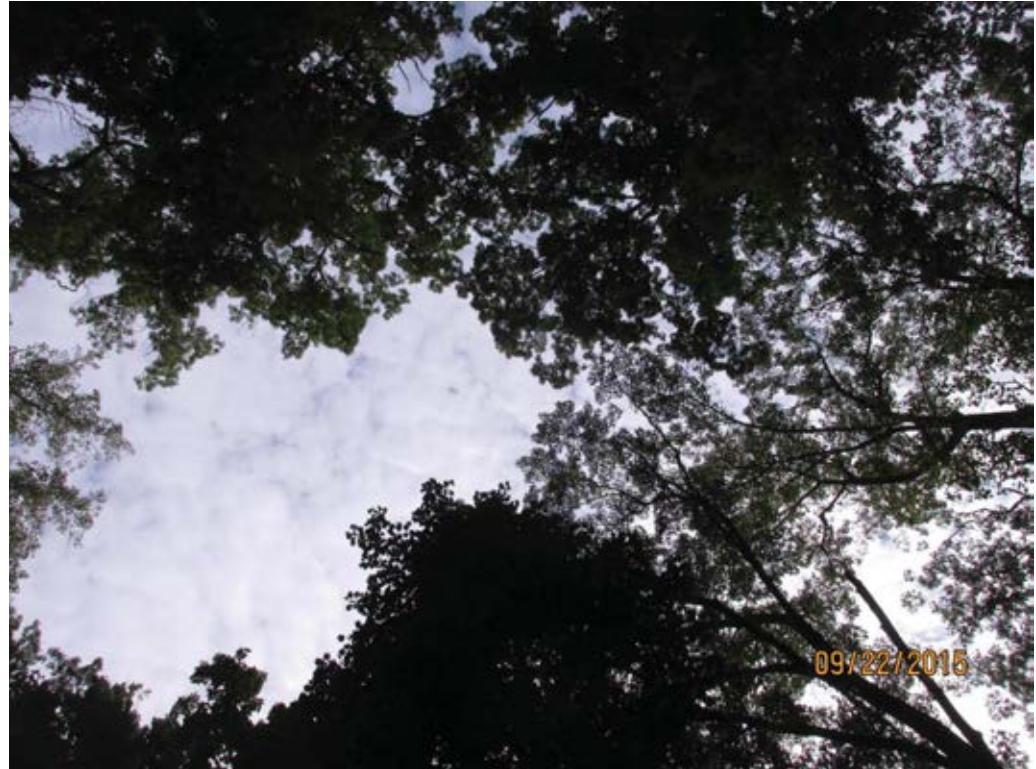
11. Monitoring station 3: Looking at canopy cover.

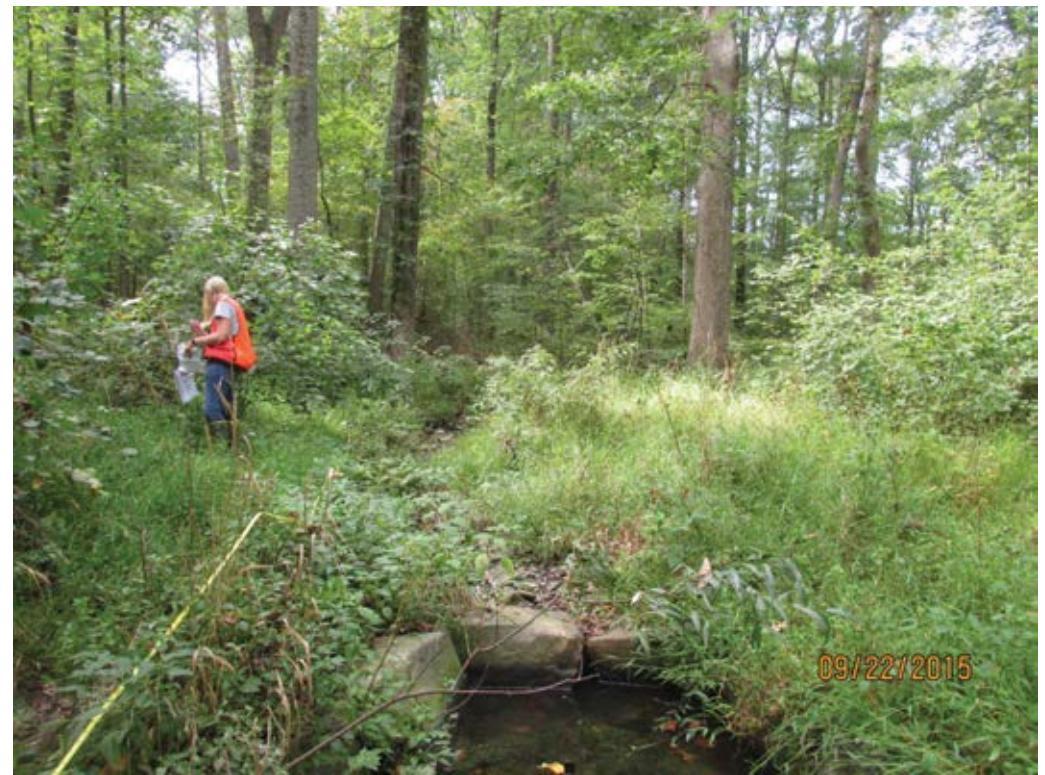
12. Monitoring station 3: Looking upstream.

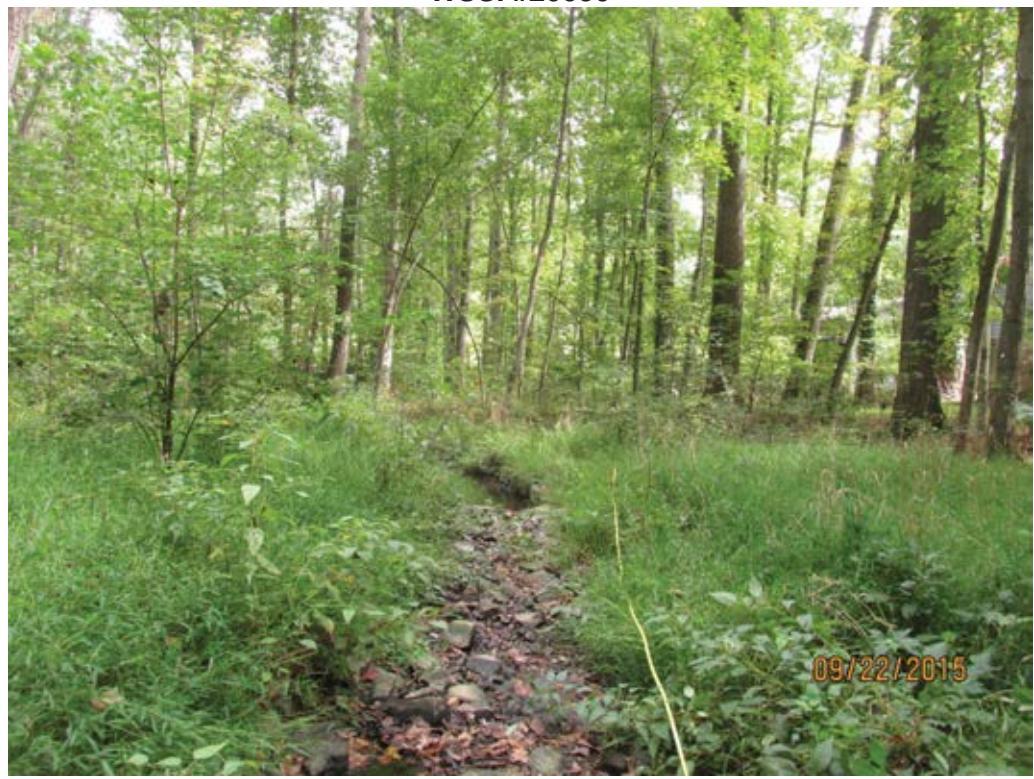
13. Monitoring station 3: Looking downstream.

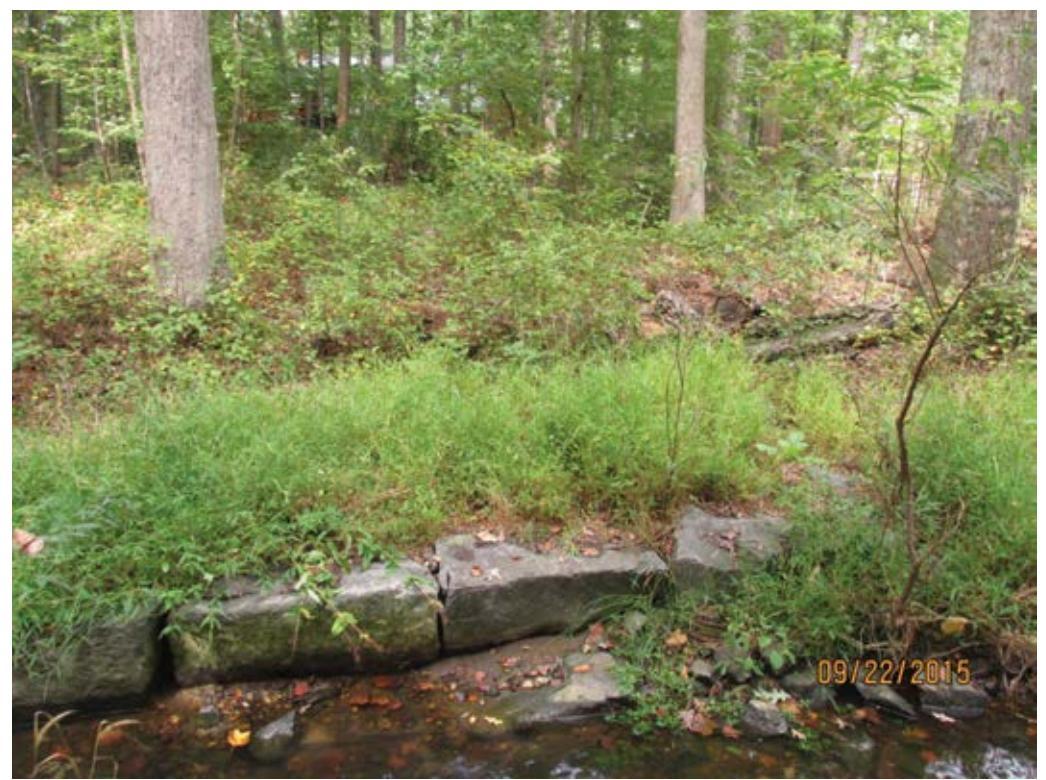
14. Monitoring station 3: Looking at the left bank.

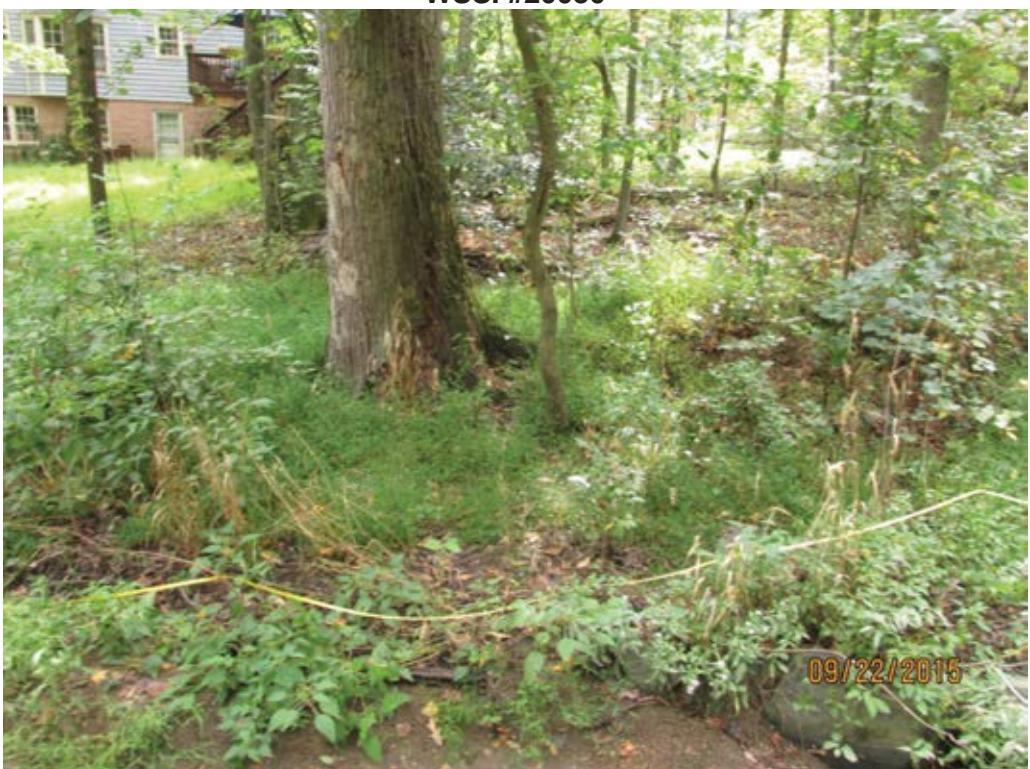
15. Monitoring station 3: Looking at the right bank.

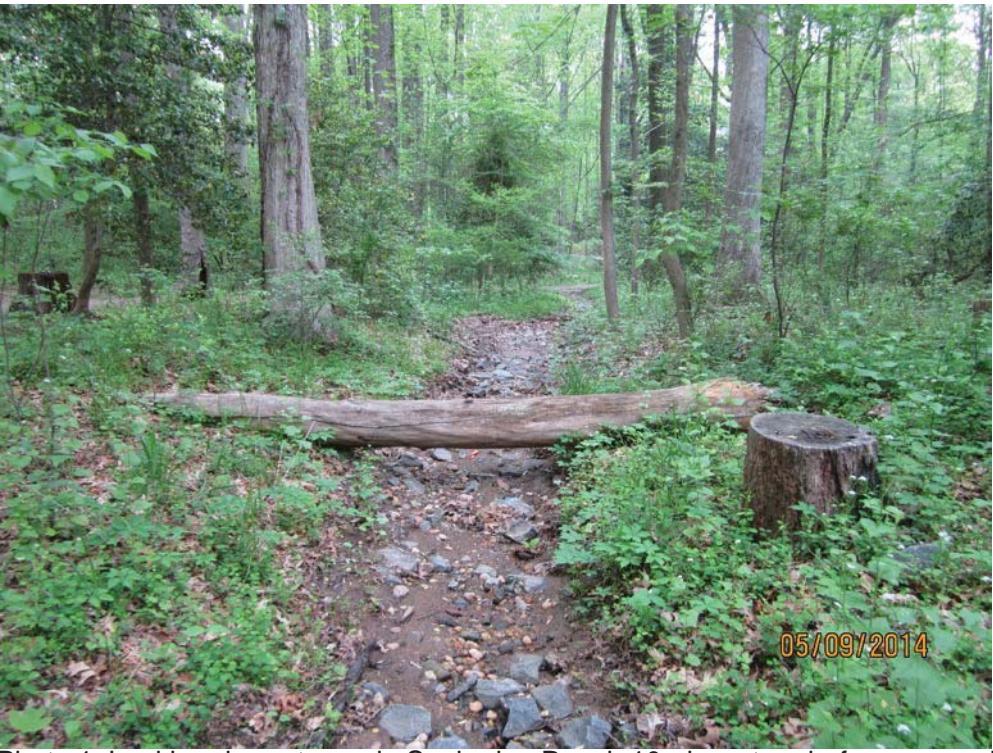
All restored streams were visually inspected between May 7-9th, 2014 by WSSI staff (Bryce Aiken, Marshall Willis, and Hannah Largen). From these inspections, the streams once again handled the bankfull storm flows very well with only minor additional maintenance items noted that included one down tree in Snakeden Reach 9 (Photo 4) and one down tree in Snakeden

Photo 1: Looking downstream in Snakeden Reach 10; down tree before removal.

Reach 10 (Photo 1). The down tree in Snakeden Reach 10 has already been removed (Photo 2) and the down tree in Snakeden Reach 9 is scheduled to be removed during the week of 5/12/2014.

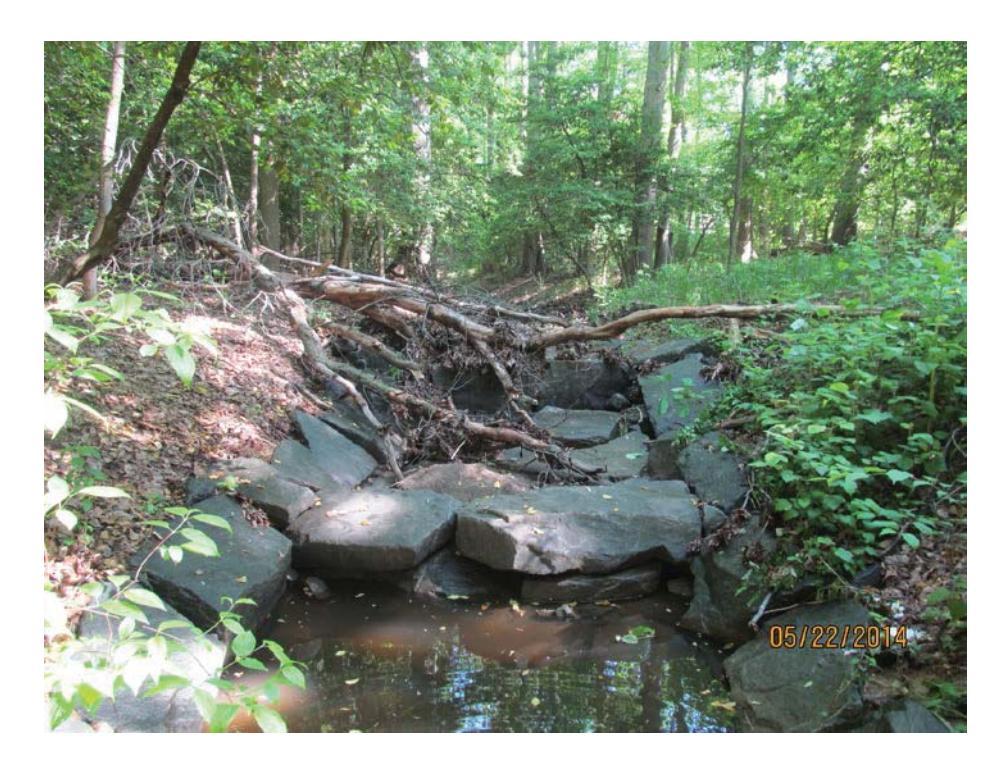
All restored streams were visually inspected between May 20-23<sup>rd</sup>, 2014 by WSSI staff (Bryce Aiken, Marshall Willis, and Jason Beeler). From these inspections, the streams once again handled the bankfull storm flows very well with only minor additional maintenance items noted that included a down tree in Snakeden Reach 6a (Photo 1), a down tree in Snakeden Reach

Photo 1: Looking upstream in Snakeden Reach 6a; down tree scheduled for removal.

12 (Photo 2), a down tree in Glade Reach 3 (Photo 3), and a down tree in Glade Reach 4a (Photo 4). The down trees are scheduled for removal during the week of June 9<sup>th.</sup>

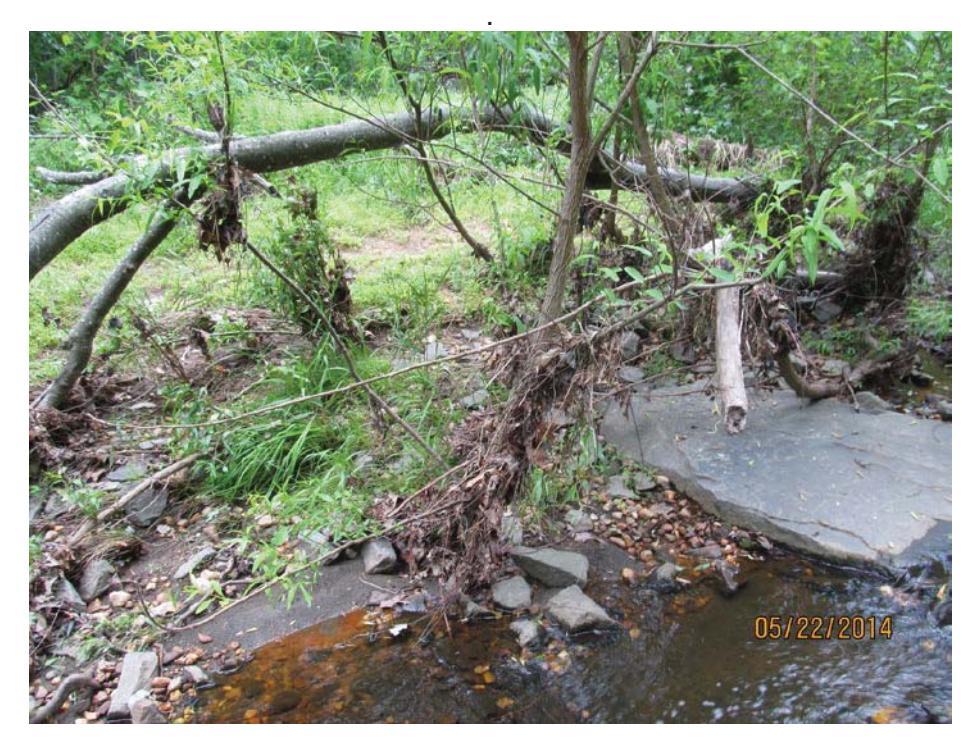
Photo 2: Looking upstream in Snakeden Reach 12; down tree scheduled for removal.

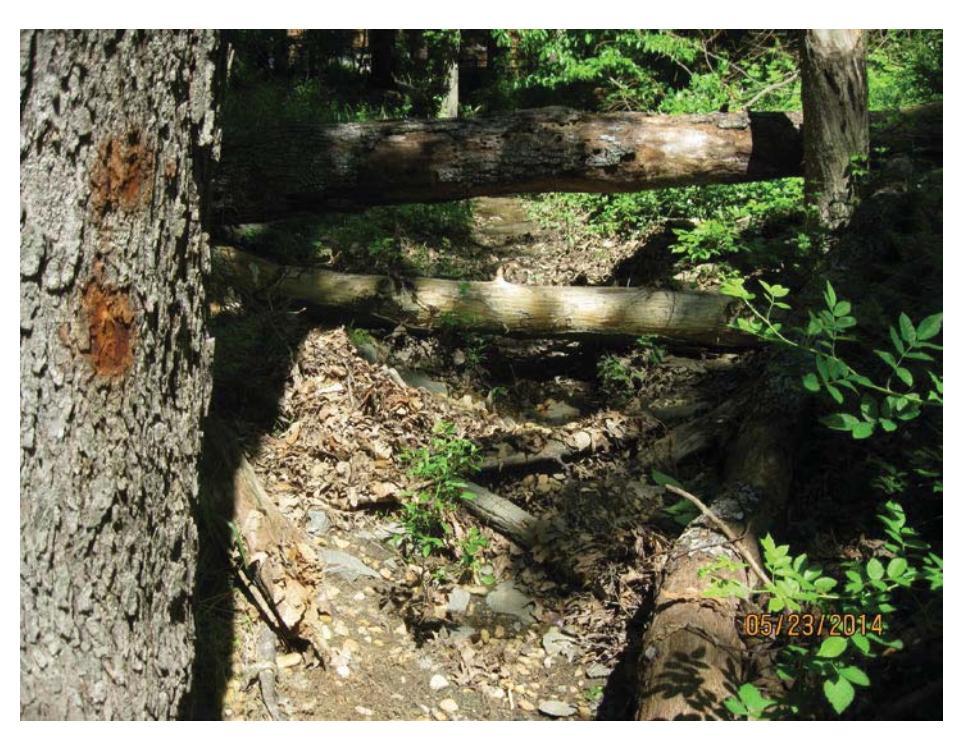
Photo 3: Looking upstream in Blade Reach 3, Tributary#2. Tree scheduled for removal.

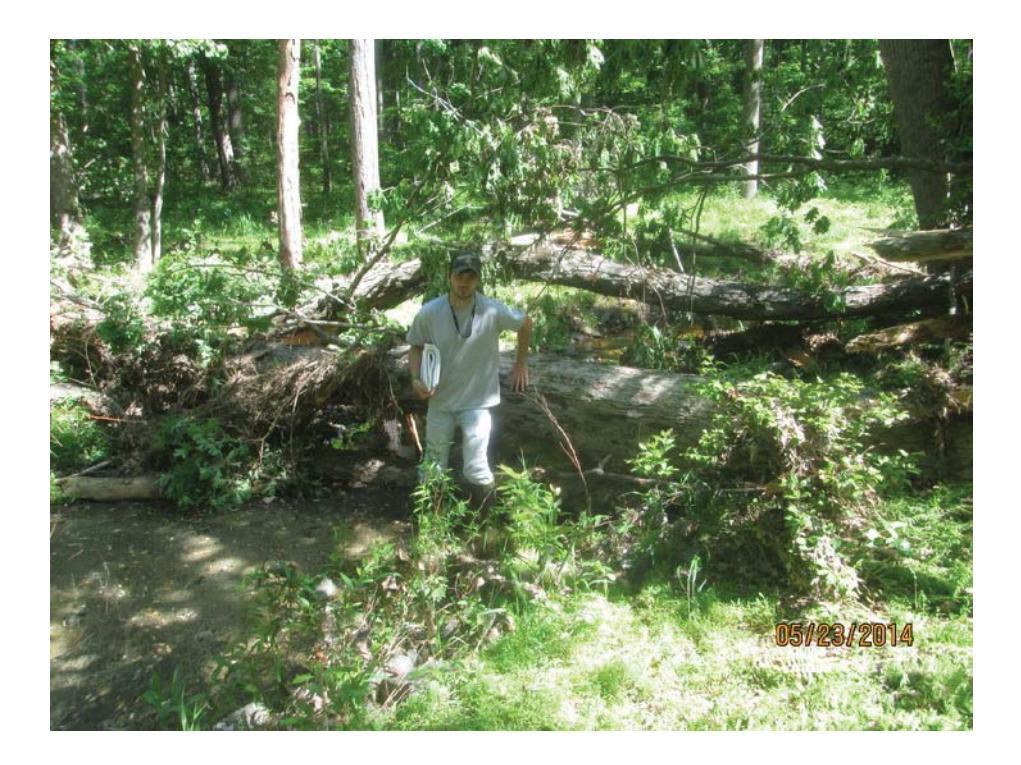
Photo 4: Looking downstream at fallen tree in Glade Reach 4a. Tree scheduled for removal.
