NORTHERN VIRGINIA STREAM RESTORATION BANK  
SNAKEDEN BRANCH WATERSHED

MITIGATION MONITORING REPORT

FIRST MONITORING SEASON (2009)

November 17, 2009

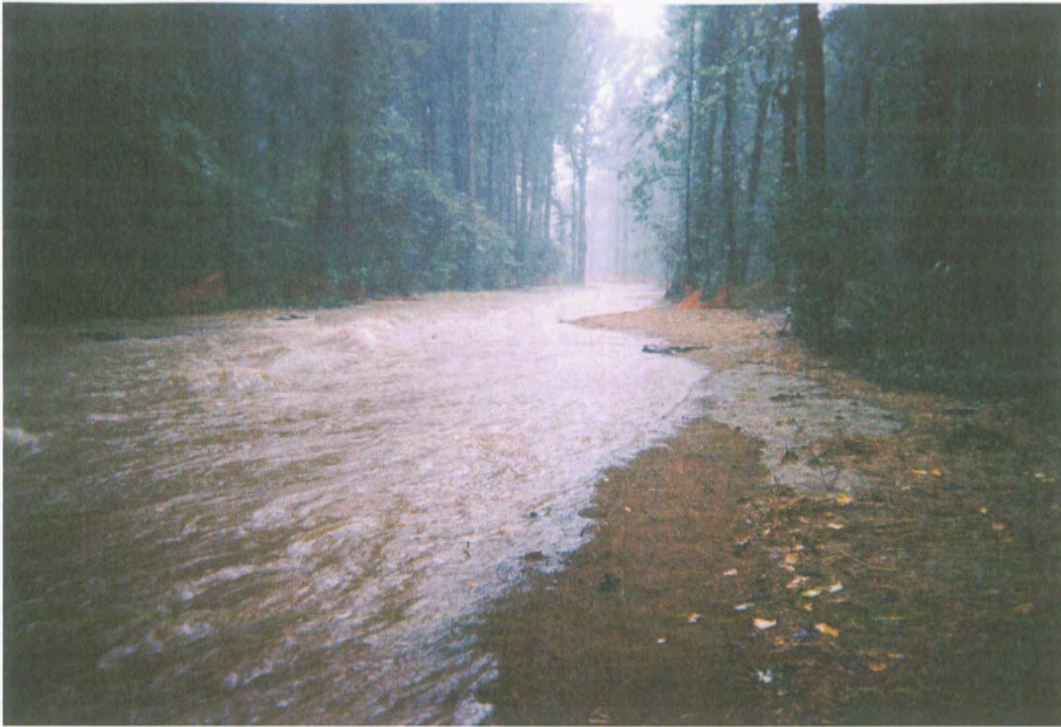
Photo 1 – Lower end of a recently completed section.

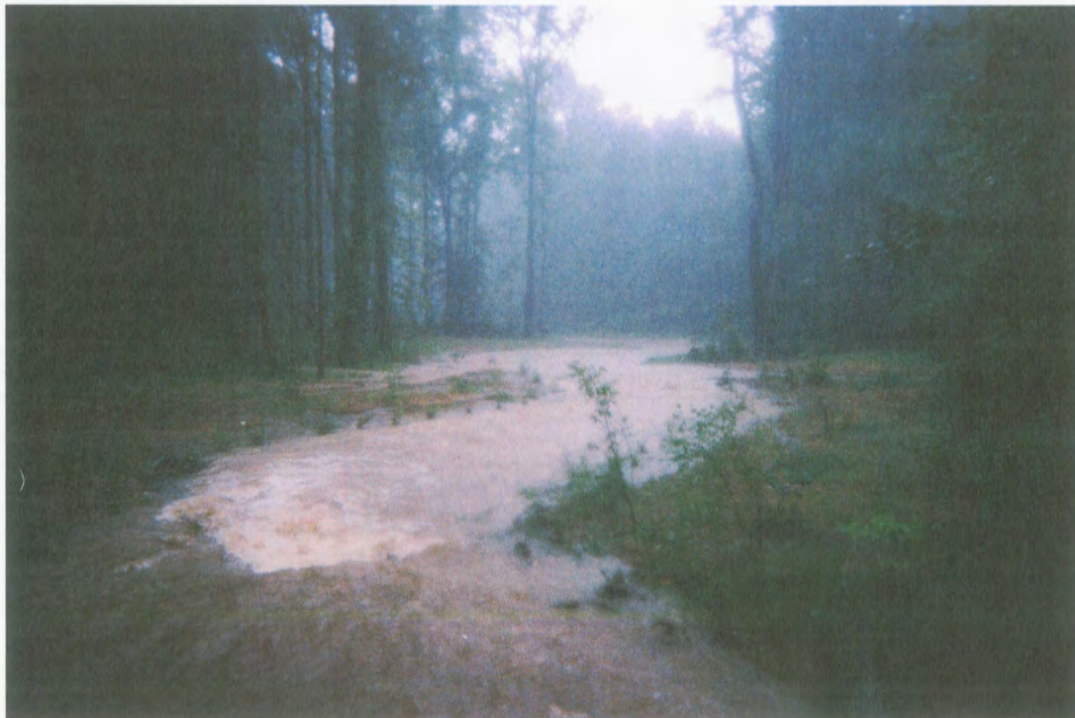
Photo 2 – Looking downstream in Reach 3 at a structure.

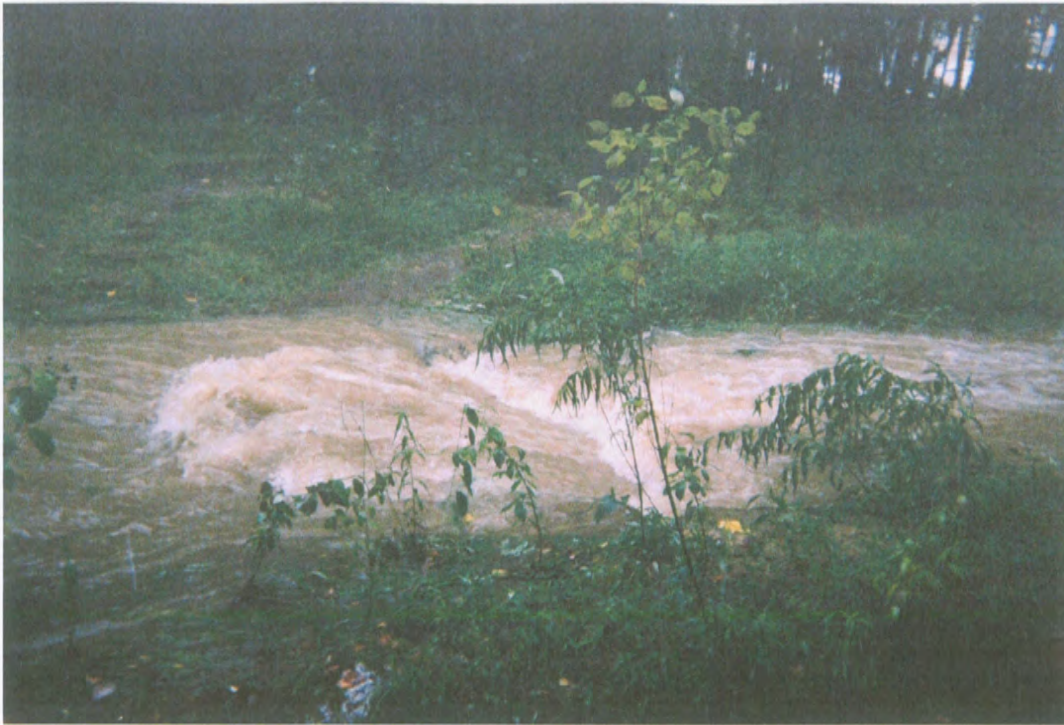
Photo 3 – Reach 2 double cross-vane.

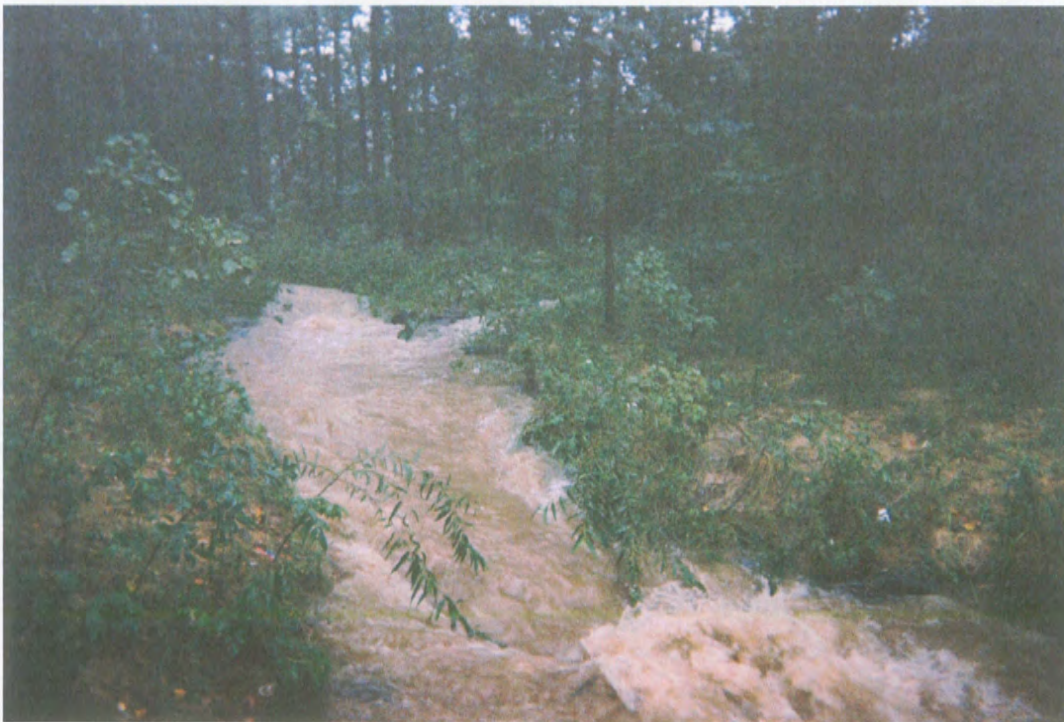
Photo 4 – Looking upstream in Reach 1.

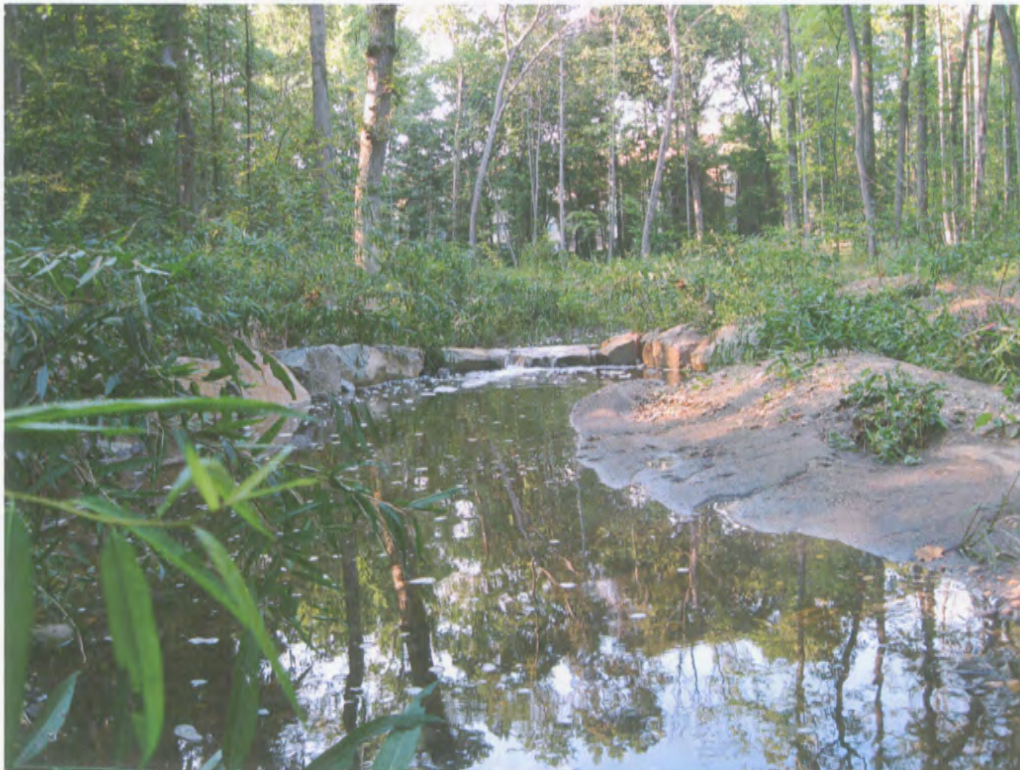
Photo 6 – Reach 3 cross-vane.

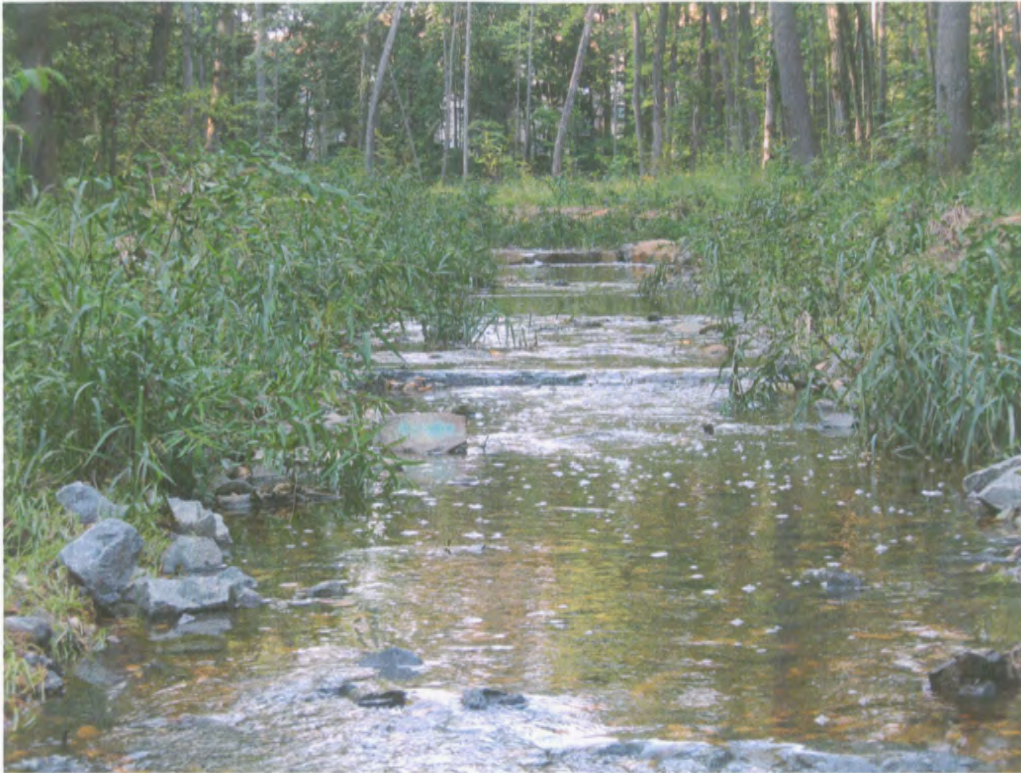
Photo 7 – Reach 3 riffle.
